Assessment Report for  
Wisconsin, SPS Experiment 1

Visit date: December 14, 2004

A visit was made to the Wisconsin SPS-1 site on December 14, 2004 for the purpose of conducting an assessment of the WIM system located on US Route 29 at milepost 189.8, 1.25 miles east of Hilltop Road. The LTPP lane is the driving lane in the westbound direction and is identified as lane number 4 in the WIM controller.

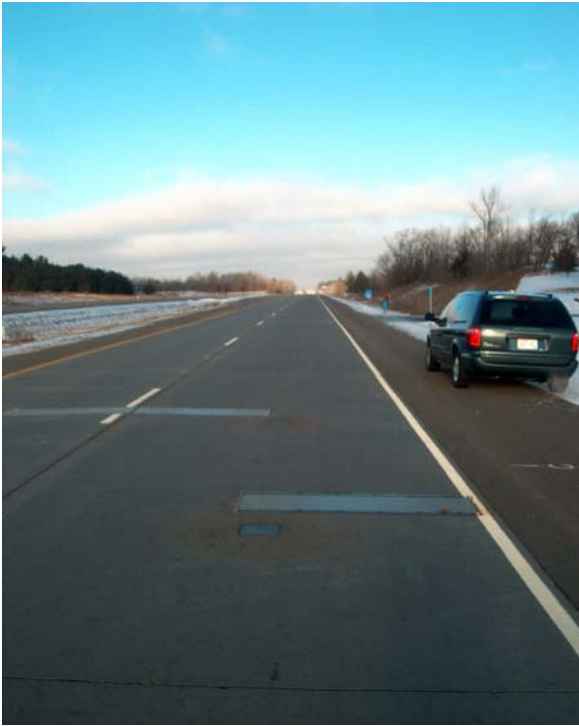
**Figure 13-1 Pavement Condition in the Downstream Direction at 550100**

The pavement appears to be in good condition with little or no distress. Figure 13-1 and Figure 13-2 show the condition of the pavement in the downstream and upstream direction respectively.

A visual inspection of the pavement 425 feet in advance of the WIM area and 75 feet following the WIM area was conducted. No significant pavement distress that would affect the performance of the WIM scales was detected.

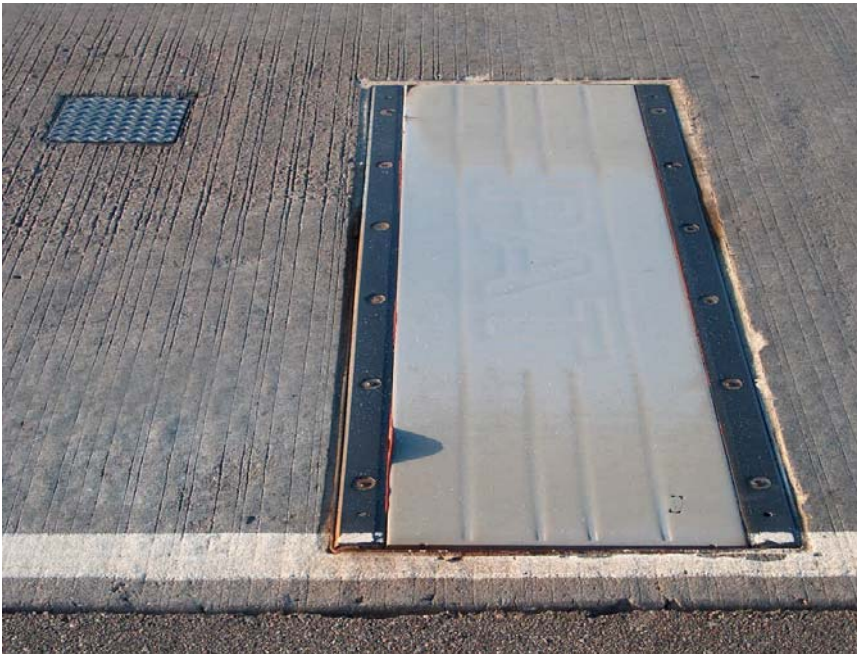
**Lead\_Weigh\_Sensor\_TO\_7\_55\_144\_0100\_12\_14\_04.JPG**

The hold-down bolt on the approach side-securing rail, of the leading weigh-pad frame is broken and the weight-pad is loose in the frame. The securing rail and the weigh-pad are vibrating as heavier vehicles traverse the weighing sensor. This bolt needs to be repaired or replaced.

An electronic check of all WIM components was performed. The insulation resistance for the leading weigh-pad indicated a value below acceptable tolerances. All other in-road sensors and WIM controller components appear to be working properly.

Due to the loose weigh-pad vibrations, it is suspected that the interaction between the truck tires and weigh-pad is causing errant axle detections and/or misses.

- Leading Plate Weighing Sensor has a broken hold-down bolt which secures the weight-pad to the frame. This bolt needs to be repaired or replaced.
- Replace the lead-in cable splice for the leading weigh-pad, or replace the weigh-pad, if required.
- Make adjustments to the equipment algorithms to correctly classify 5-axle single unit vehicles and semi-trailer trucks.
