# Impact of Environmental Factors on Pavement Performance in the Absence of Heavy Loads

PUBLICATION NO. FHWA-HRT-16-084

MARCH 2019

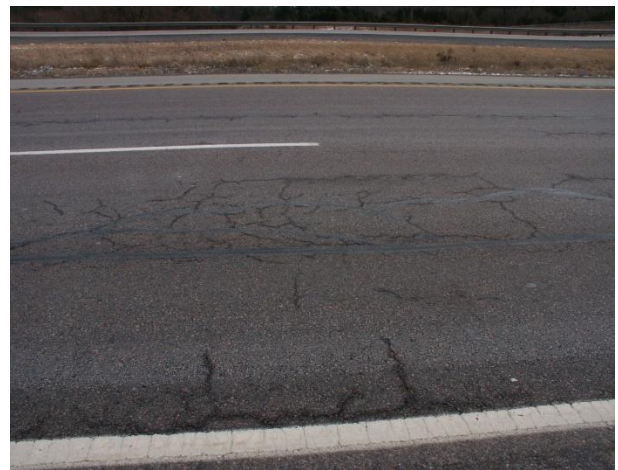
Figure 54 shows different stages of longitudinal cracking distress and how this distress can be confused with alligator cracking. Note the similarity of this distress to bottom-up fatigue alligator cracking.

A. View of first stage—occurrence of short longitudinal cracks in and/or adjacent to the wheel path.

C. Second view of first stage—occurrence of short longitudinal cracks in and/or adjacent to the wheel path.

B. Second stage—occurrence of parallel longitudinal cracks.
