## CELL 96

0-50ft

11/6/07 4/14/08  
5/14/07 TRC

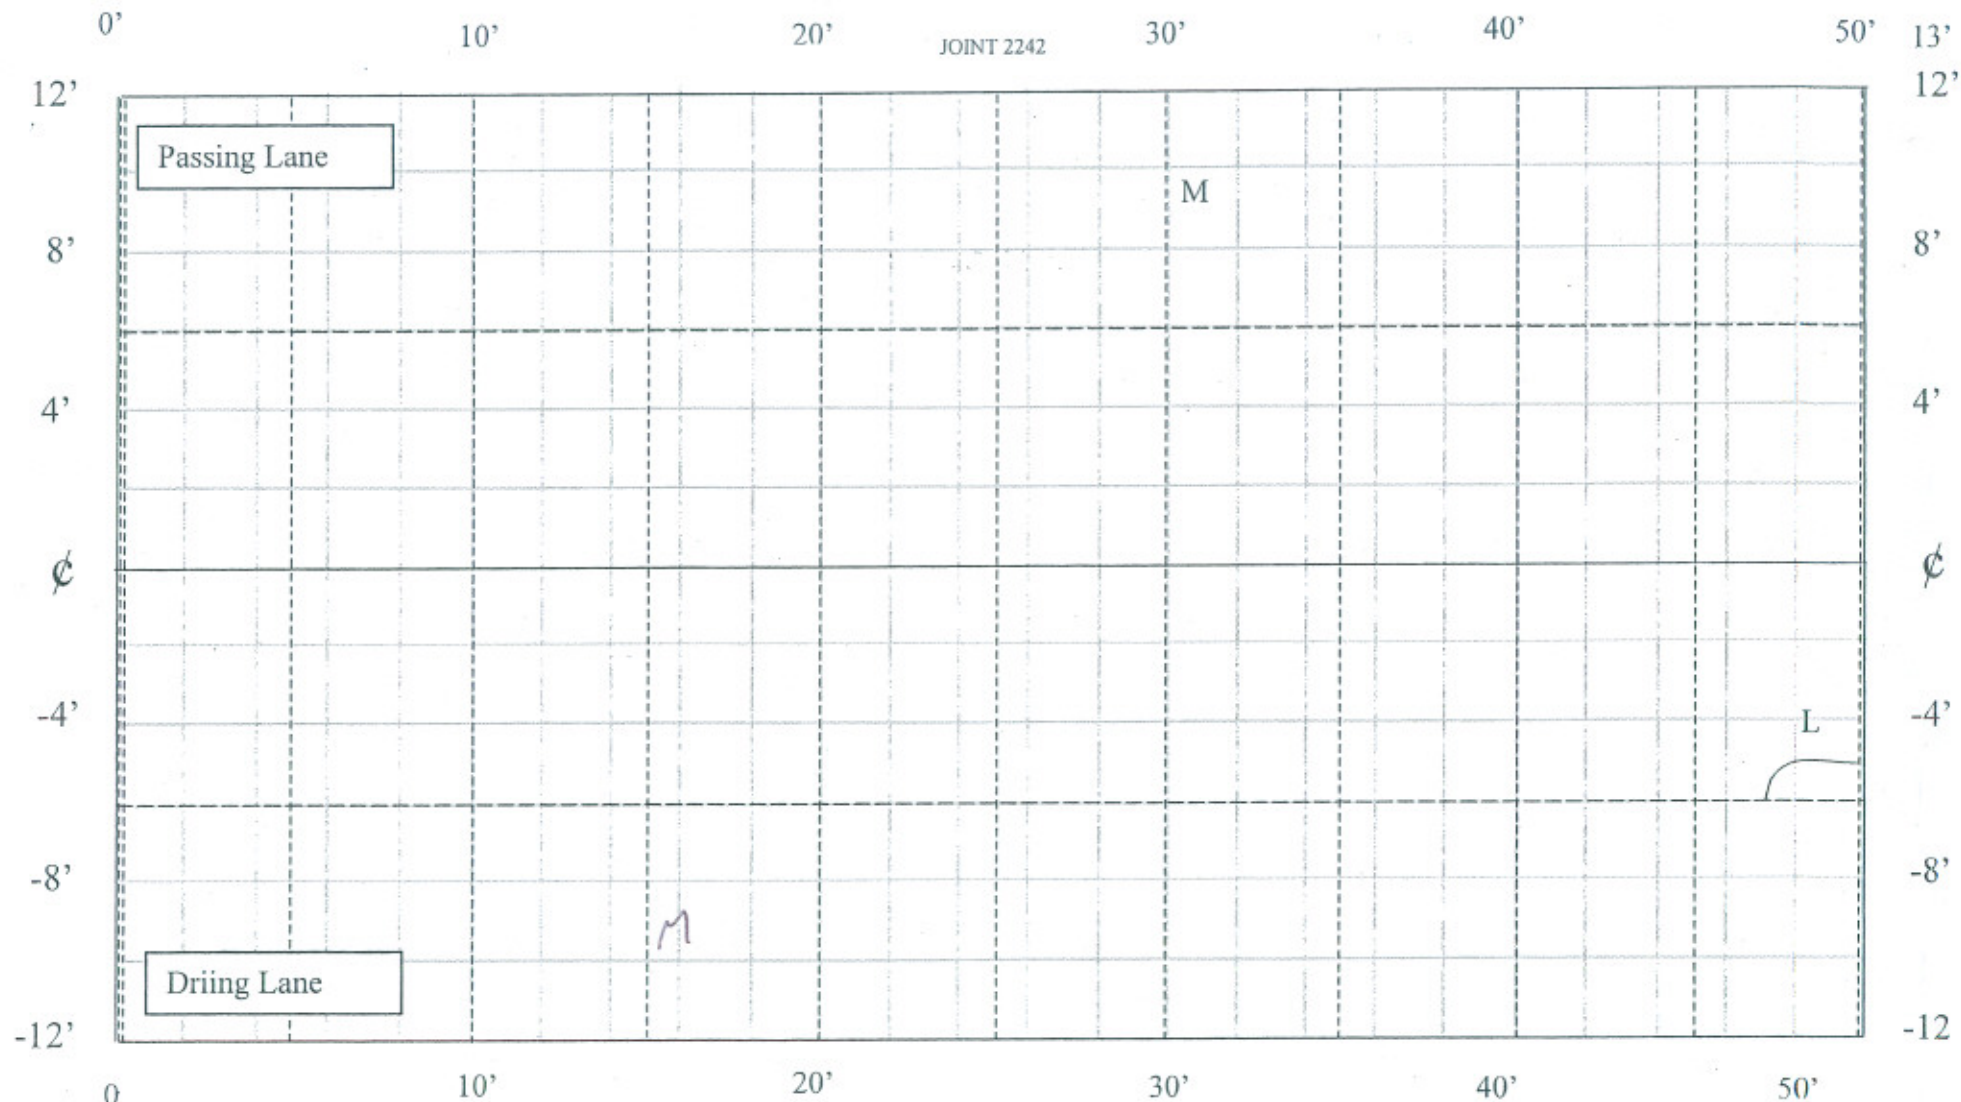
- \* All transverse & long (6') joints sealed L unless otherwise noted
- \* CL & both shoulder joints – seal gone

beginning to see damage (spoiling)  
along its, especially driving lane  
- fibers showing

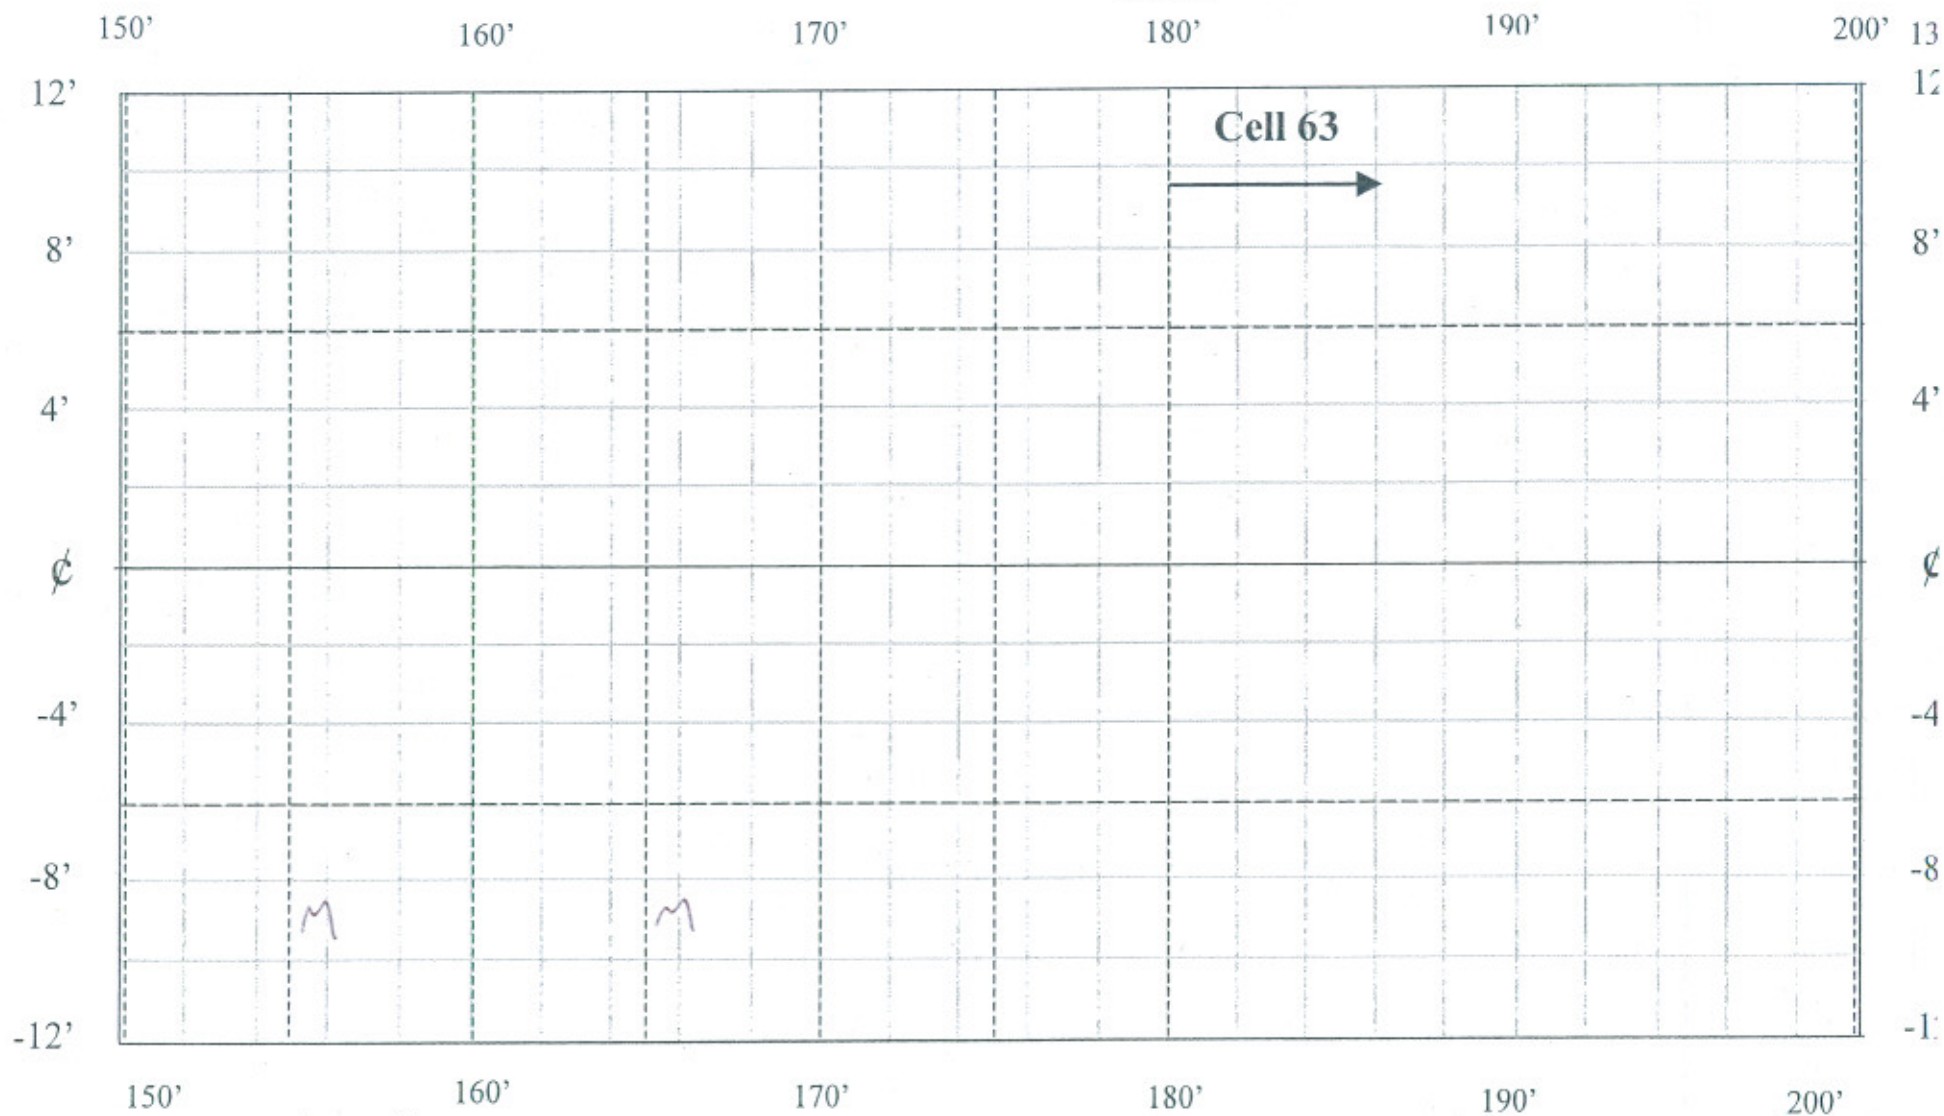
150-200ft

evidence of pumping on DL shoulder  
- selected joints
