# CELL 96

150-200ft

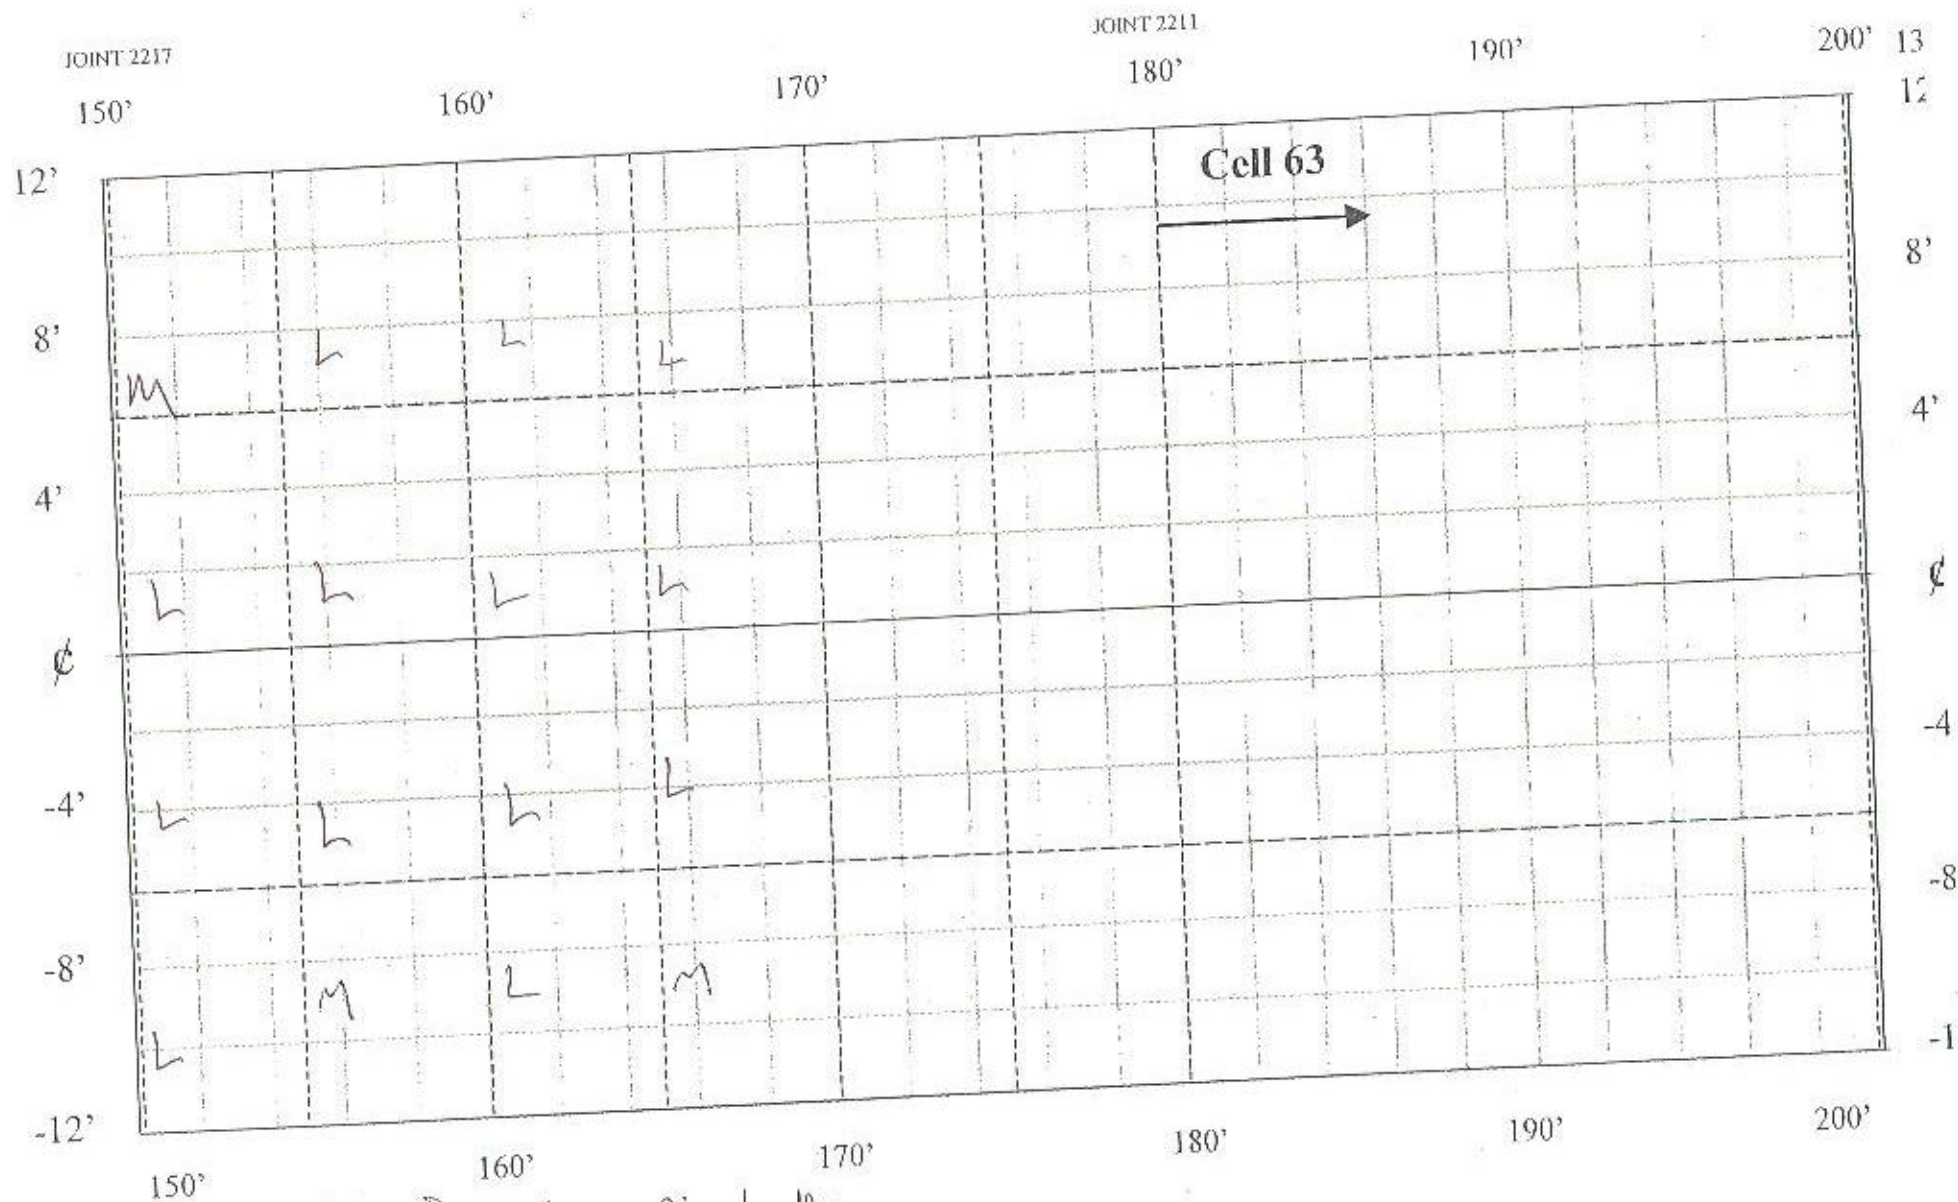
evidence of pumping on DL shoulder  
- selected joints

\* All transverse & long (6') joints  
sealed L unless otherwise noted  
\* CL & both shoulder joints -  
seal gone

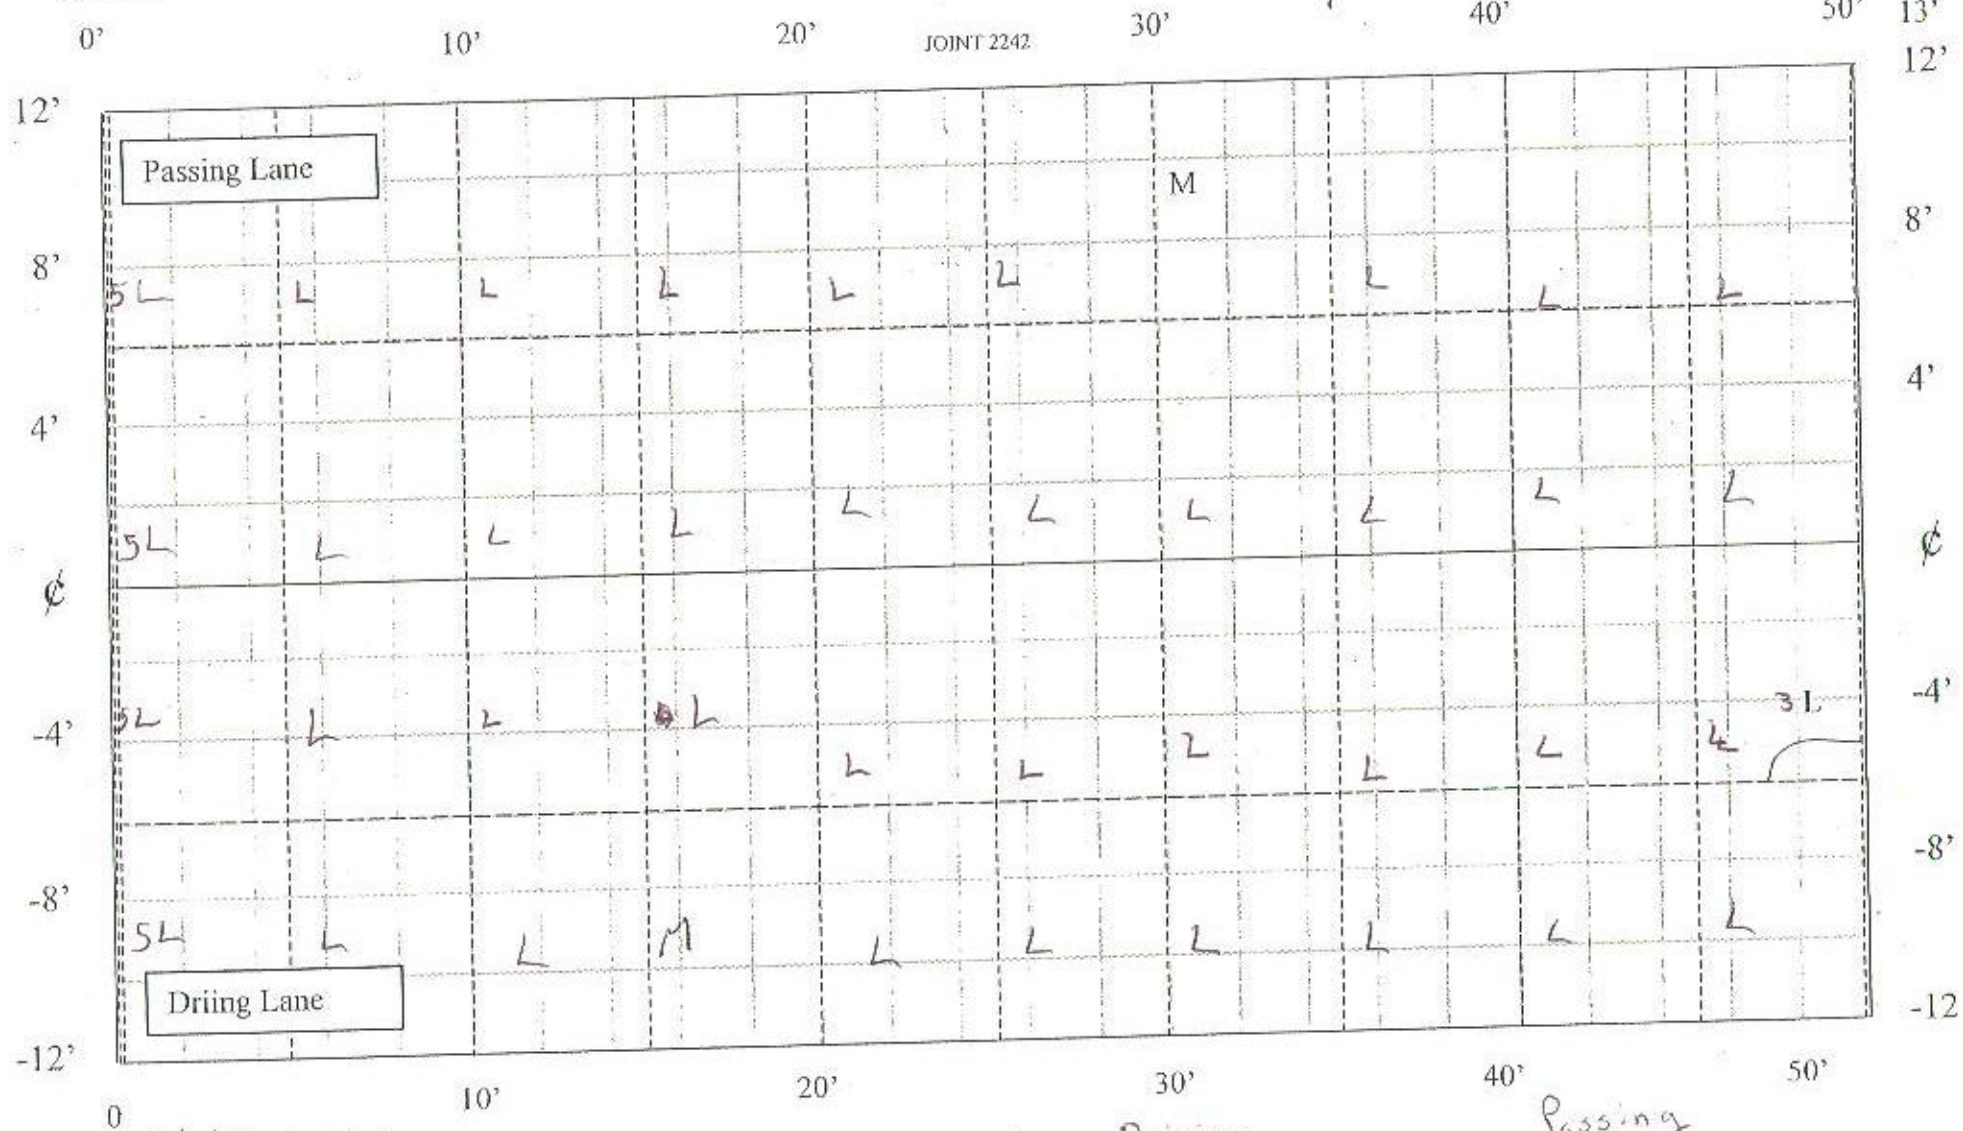
0-50ft

beginning to see damage (sprinkling)  
along its, especially driving lane  
fibers showing

Driving  
SL - 60  
SM - 8  
3L - 11) 64t

Passing  
SL - ~~60~~ 62  
SM - 6
