CELL 53  
0 - 50 ft

Cell 53

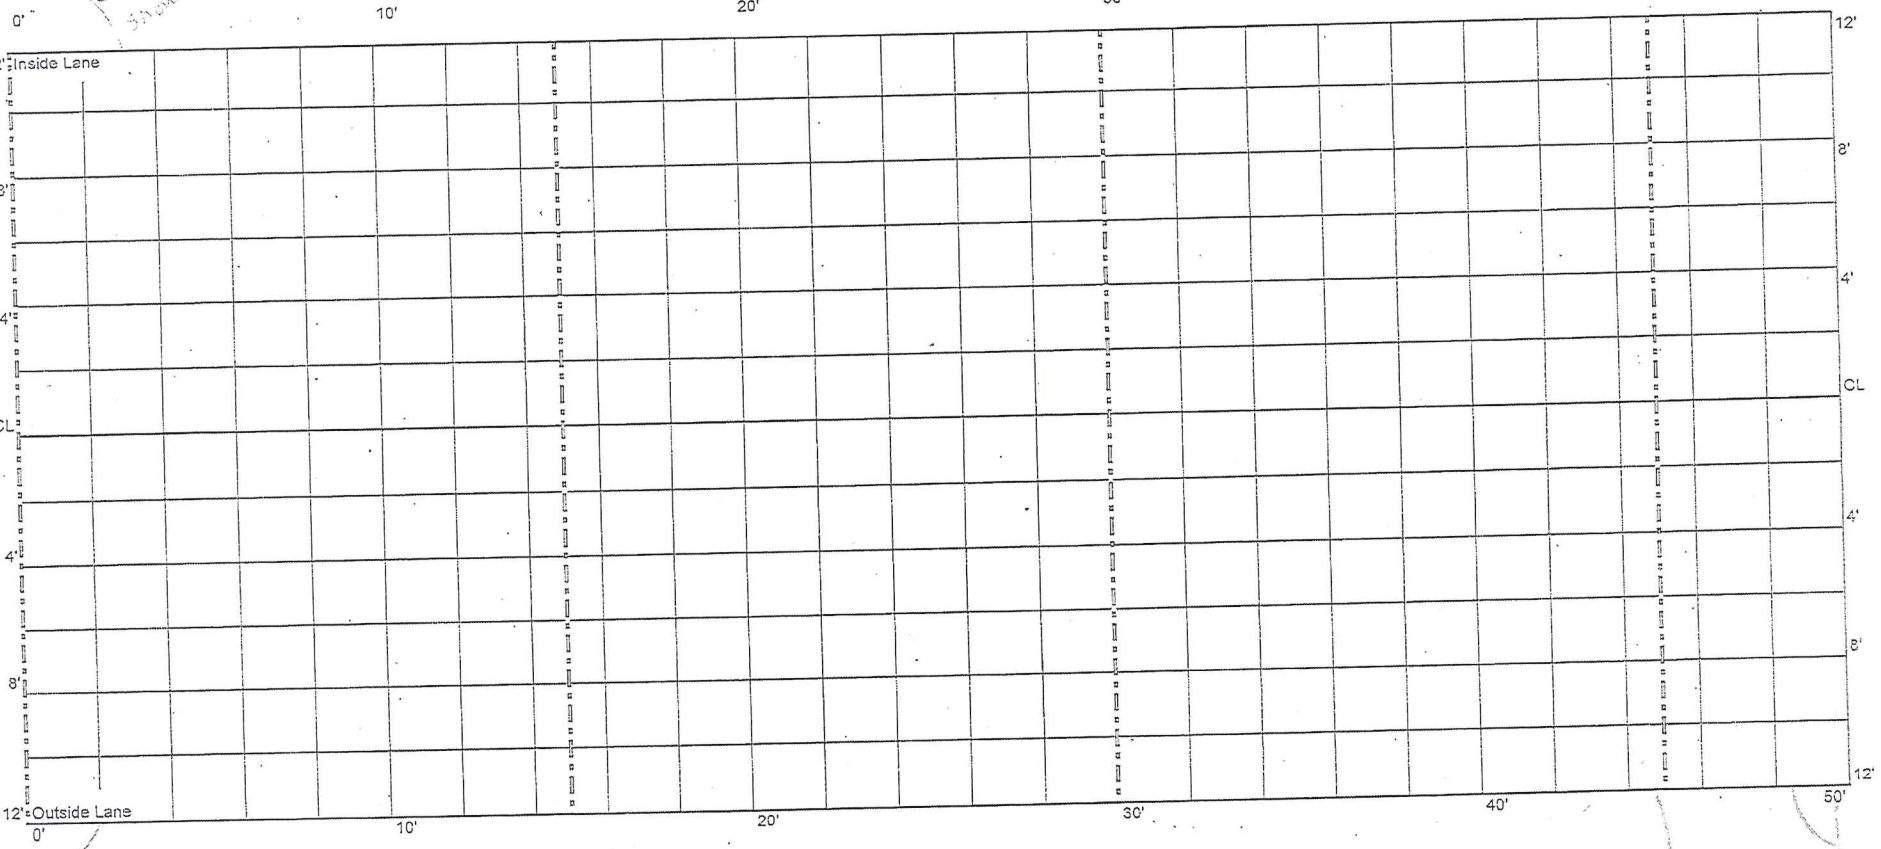
-1st panel on east end in both shlds (OL & IL) is cracked

8/16 panels cracked  
inside shld JT 3

9/16 panels cracked  
outside shld
