Cell 23, 50 Feet - 100 Feet

Station  
1241+05

HMA Cracking Study

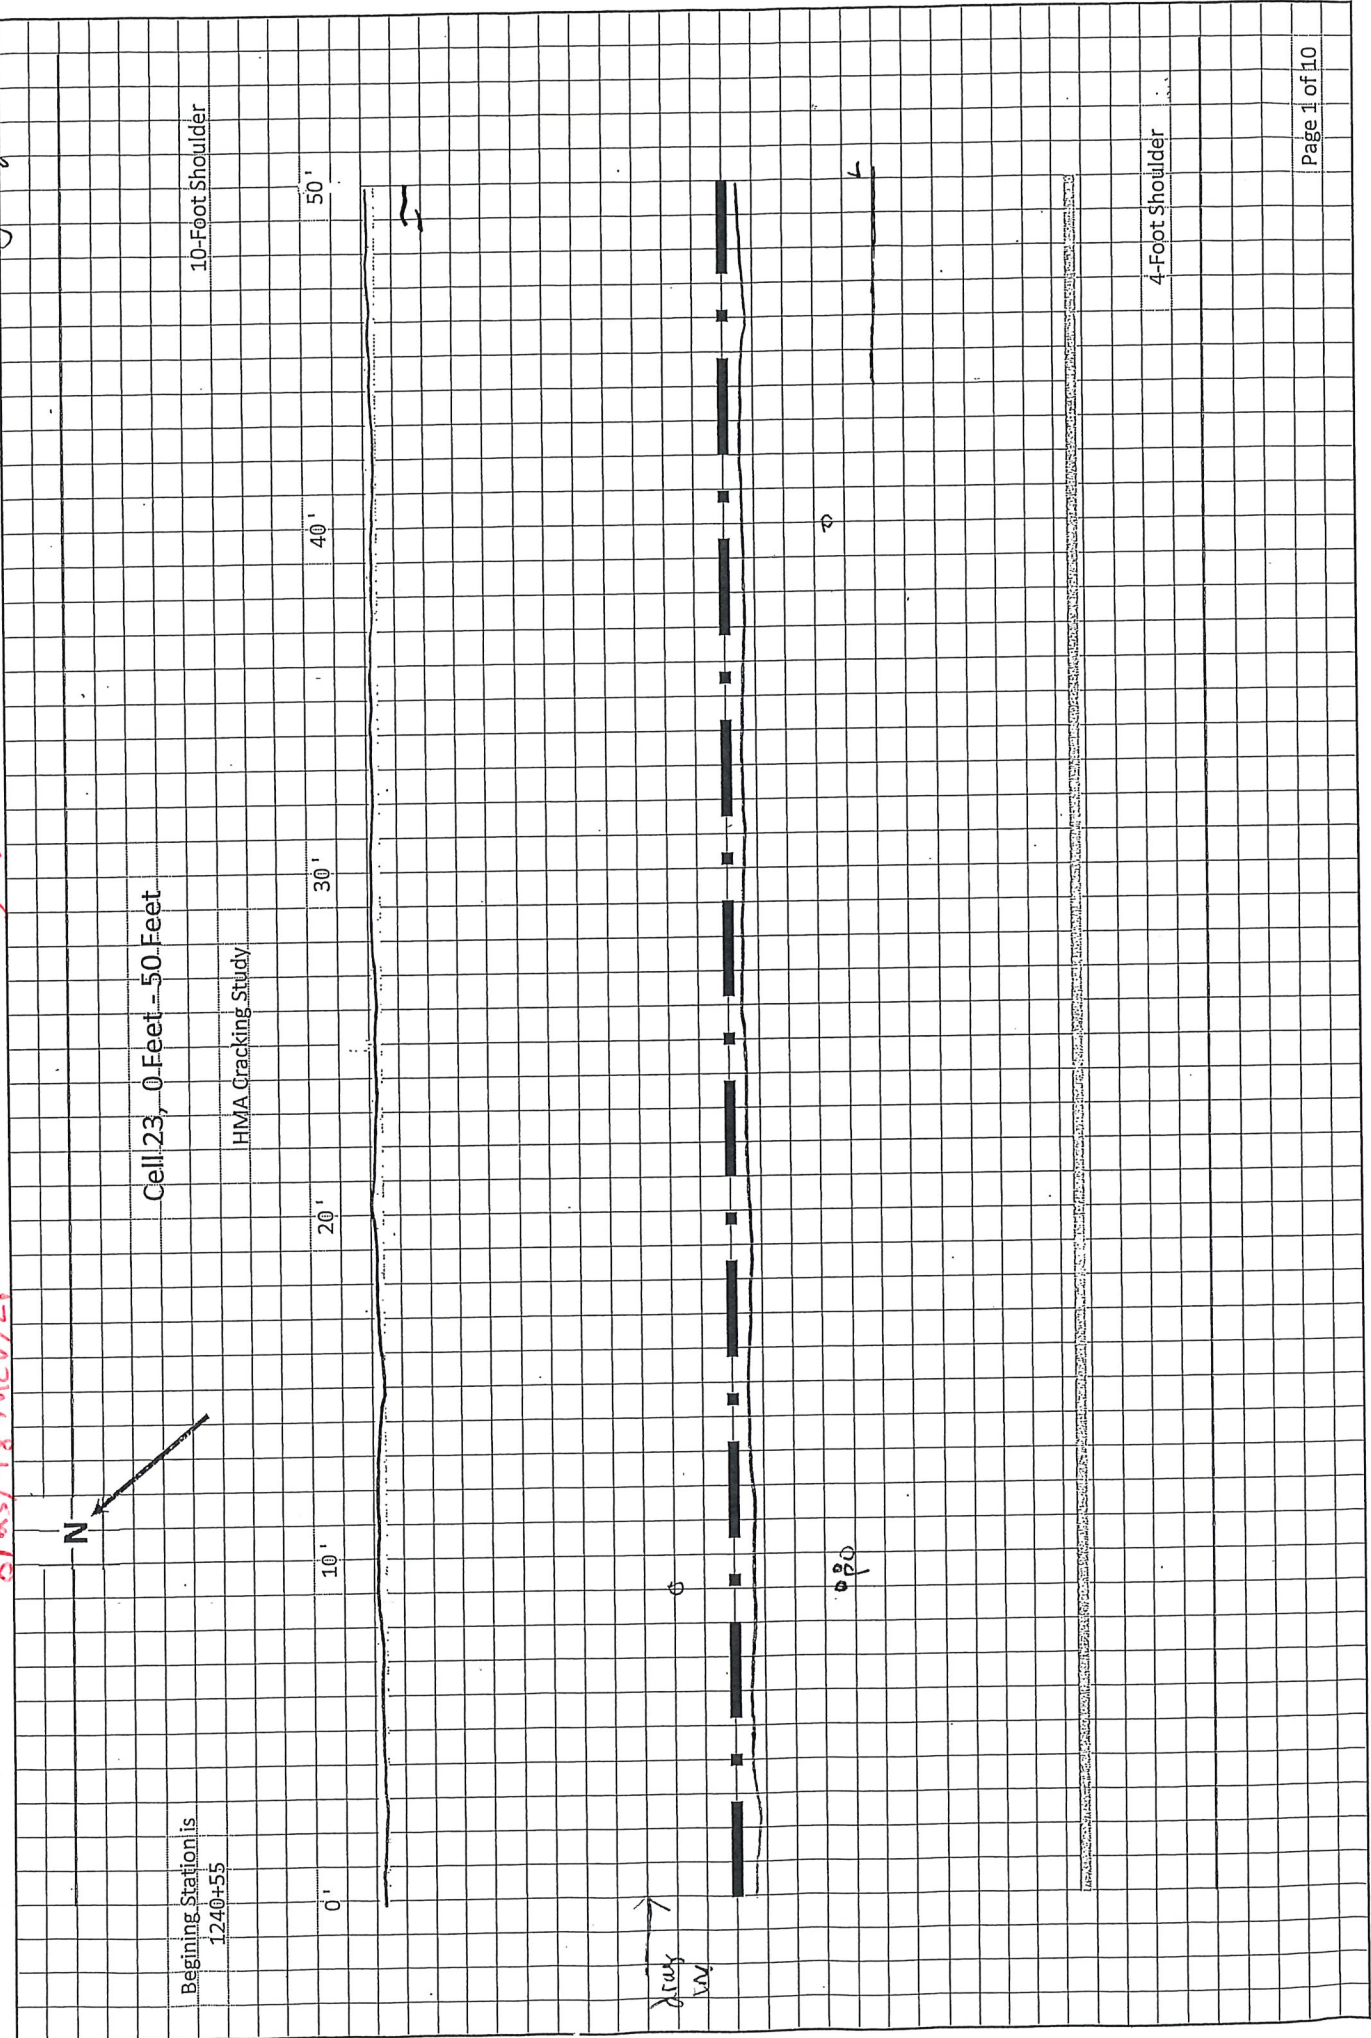
8/23  
Not visible  
throughout No  
crack @ bottom  
of gauge

Drag line/gauge in LWP on  
driving lane throughout cell  
↳ Not cracked under gauge

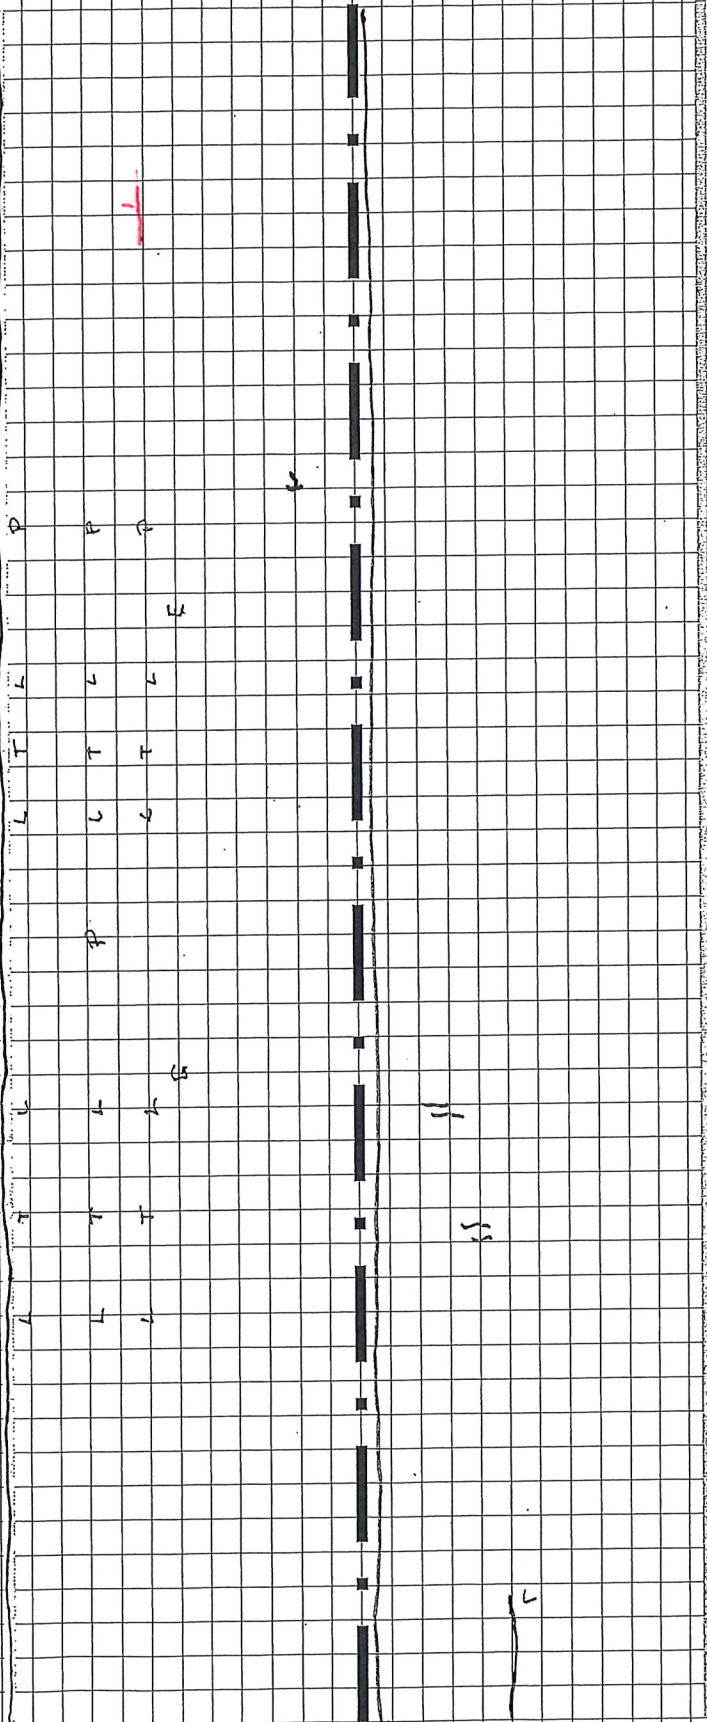
Cell 23, 100 Feet - 150 Feet

drag
