LTPP Pavement Maintenance Materials: SPS-4 Supplemental Joint Seal Experiment, Final Report

PUBLICATION NO. FHWA-RD-99-151

OCTOBER 1999

U.S. Department of Transportation
Federal Highway Administration

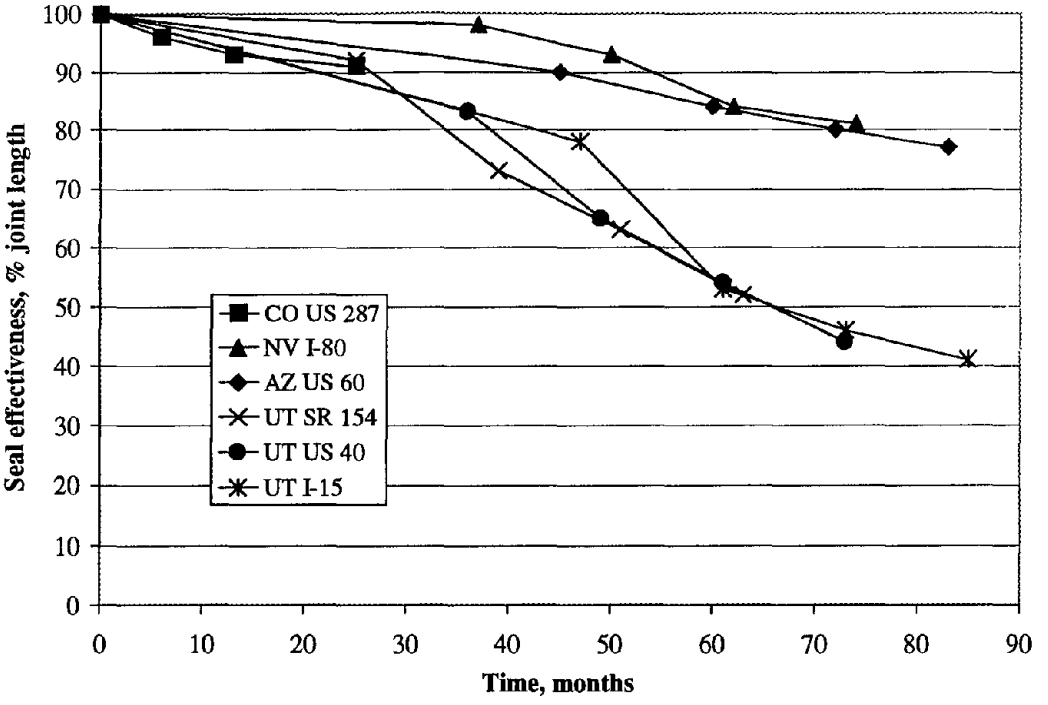
Figure 23. Overall performance of primary transverse joint seals at each test site.

As seen in figure 23, a comparison by test site of the overall performance of the transverse joint seals gives an indication of the rate of joint seal deterioration at each site. Though these performance trends are based on the individual performance trends of different groups of joint seal treatments, the greatest deterioration rates have been at the three Utah sites, whereas the lowest deterioration rates have been at the Mesa and Wells sites.

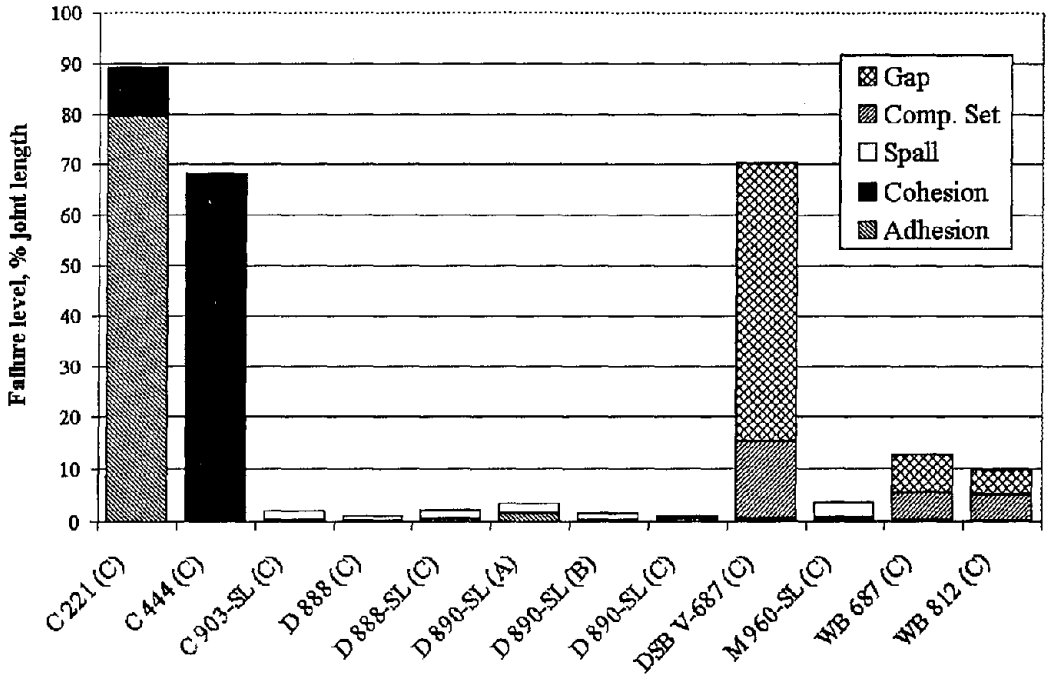
Figure 24. Overall failure of transverse joint seals at Mesa, Arizona test site.

Figures 24 through 29 show, by test site, the overall percentage of failure that each treatment exhibited at the time of the 1997-1998 field inspections. These figures also show the types and percentages of individual failure modes contributing to the overall failure percentage. As can be seen, the predominant modes of failure varied by sealant type and by test site. Generally speaking, the main mechanism of failure in hot-applied seals (e.g., Crafco RS 221, Koch 9012) was adhesive failure, as illustrated in figure 30. Cohesive failure, which can also be seen in figure 30, was significant in some of the seals.

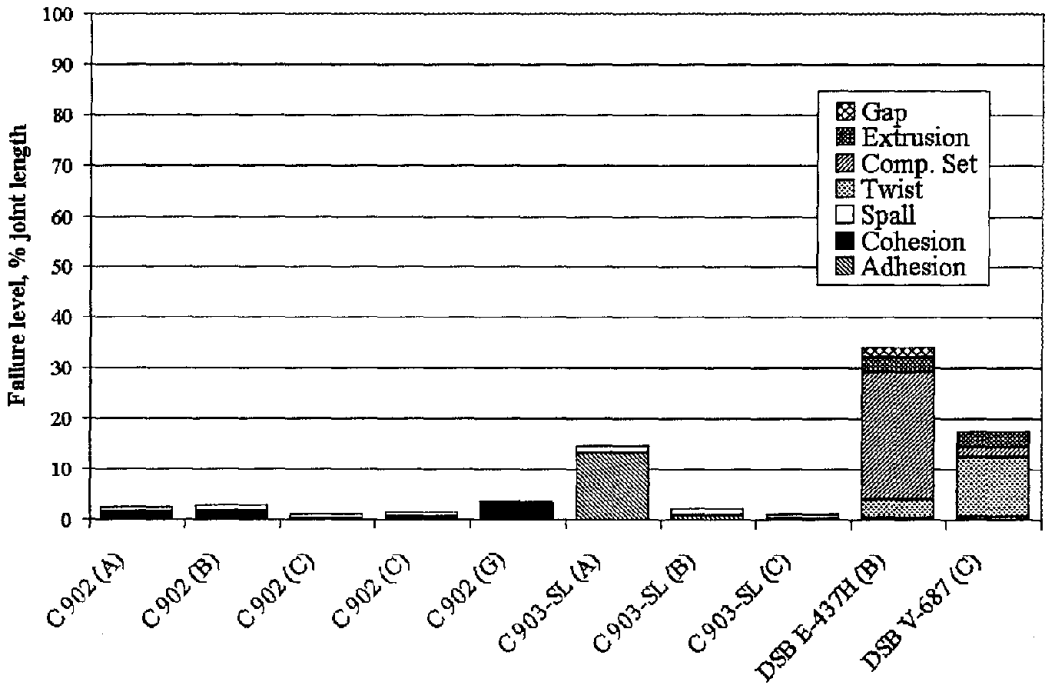
Figure 25. Overall failure of transverse joint seals at Campo, Colorado test site.

- Compression seals are performing statistically poorer than silicone seals after a period of 24 months, primarily because of improper installation techniques. As mentioned in chapter 2, the compression seal installation machine did not function well during the installation process, so the two compression seals were installed by hand using putty knives. The result was considerable failure in the form of twisted seal and compression set.

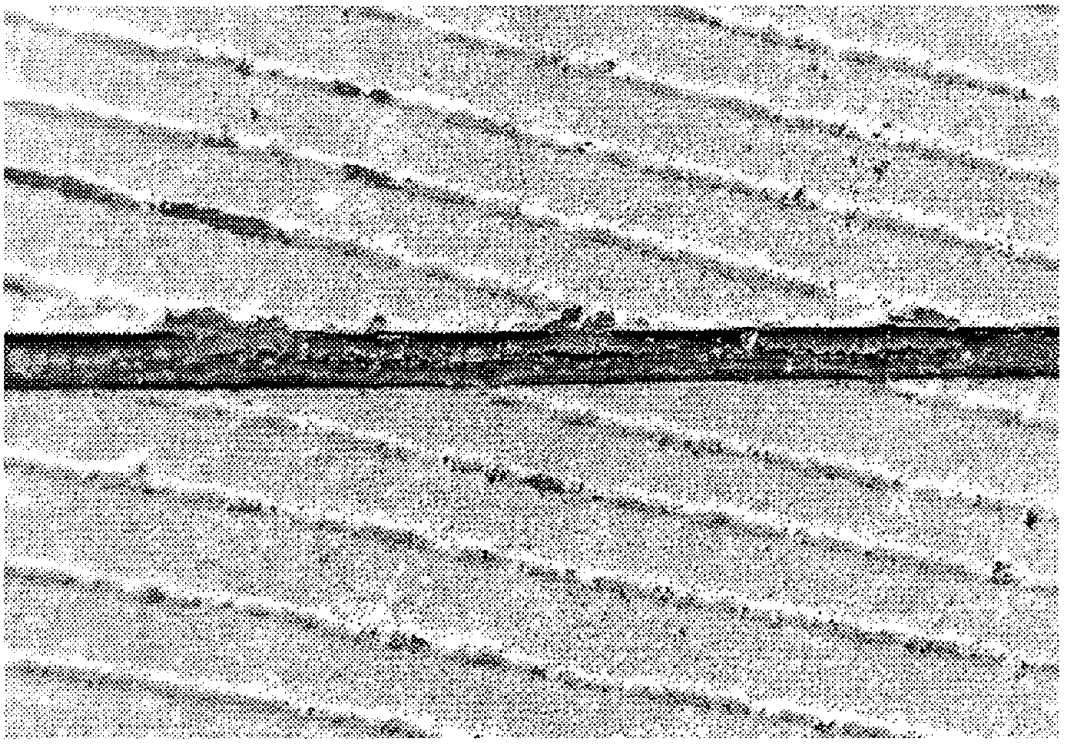
Figure 30. Adhesion and cohesion failure in hot-applied rubberized asphalt seal.

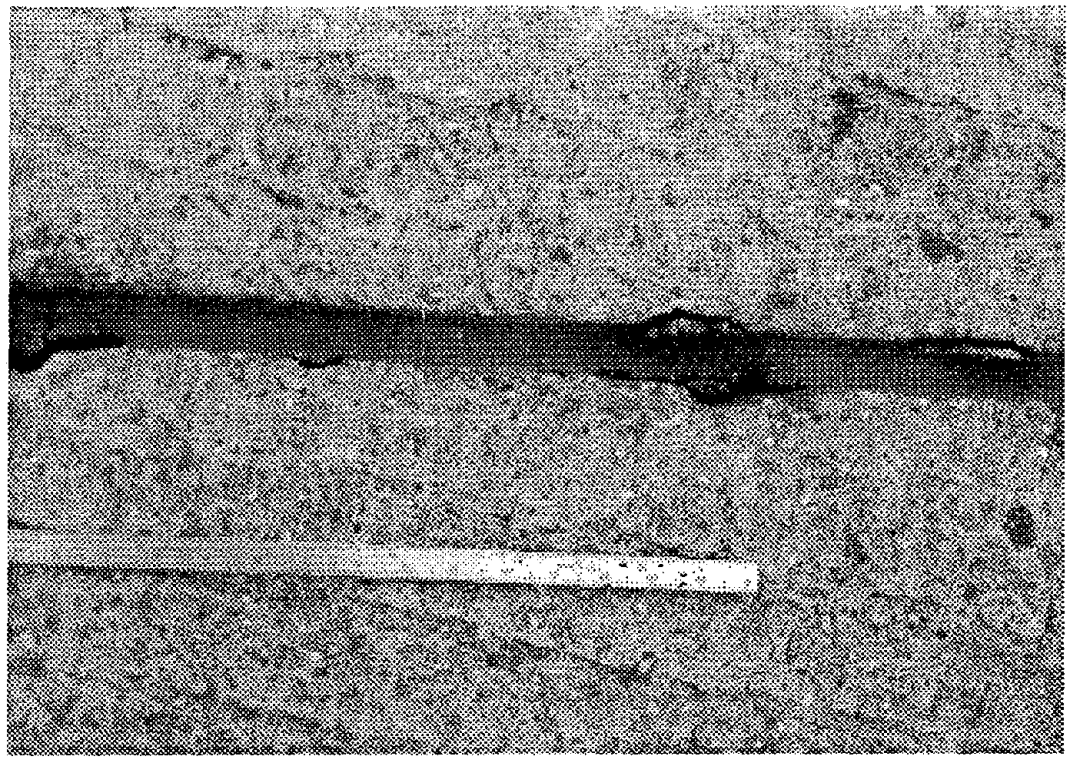
For the non-self-leveling silicone seals, the primary failure mode varied. At a majority of the sites, spall failure (figure 31) comprised most of the failure in these seals, whereas at other sites, adhesive failure was the controlling mechanism. Similar performance characteristics were observed with the self-leveling silicone sealants, except that adhesive failure was predominant at the majority of sites.

Figure 31. Spall failure in self-leveling silicone seal.

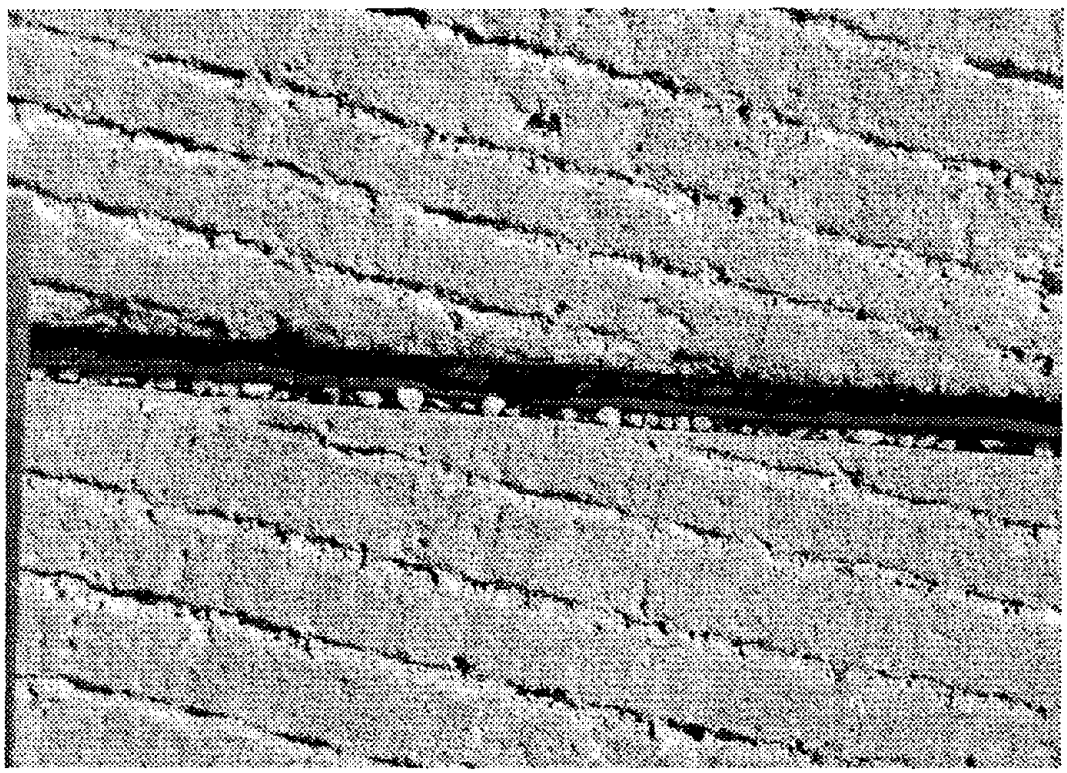
The most common failure modes for the compression seals were compression set and gap failure. In compression set, the neoprene web structure loses its ability to exert outward pressure as a result of being in a state of compression for very long periods of time. Thus, when the joint opens, the seal loses contact with the joint sidewall and an opening in the seal system is created that allows infiltration of moisture or debris. Gap failure, which is closely related to compression set, occurs when joints open wider than the compression seal is able to span, and stones work their way between the edge of the compression seal and the edge of the joint. When the joint contracts, the stones remain between the seal and the joint edge and allow water to bypass the edge of the seal. Figure 32 illustrates the gap phenomenon.

Figure 32. Gap failure in preformed neoprene compression seal.

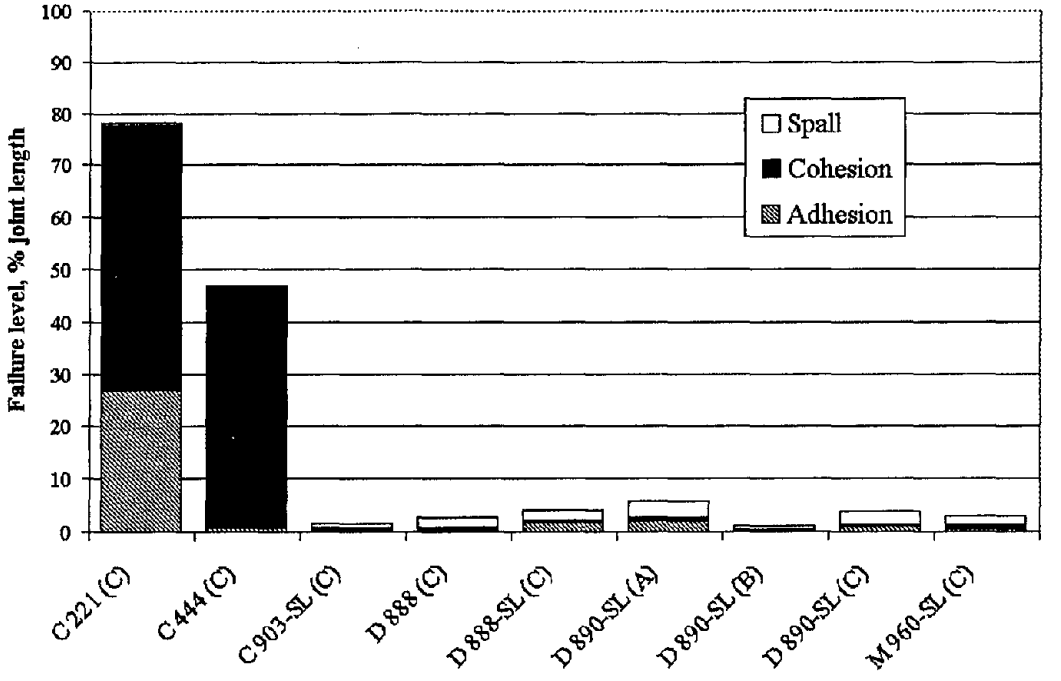
Figure 33. Overall failure of longitudinal joint seals placed at Mesa, Arizona test site.

Longitudinal joints were sealed with the same material as the transverse joints at the Mesa and Wells sites, and similar evaluations were conducted on these seals. The overall failure levels and failure mode breakdowns for each seal type placed at these two sites are displayed in figures 33 and 34. For the most part, the failure levels and modes for these seals are similar to those of the transverse joint seals. The primary exception is that the polyethylene sealant placed at the Wells site is performing significantly better in the longitudinal joints than in the transverse joints. This can probably be attributed to less joint movement at the longitudinal joint.

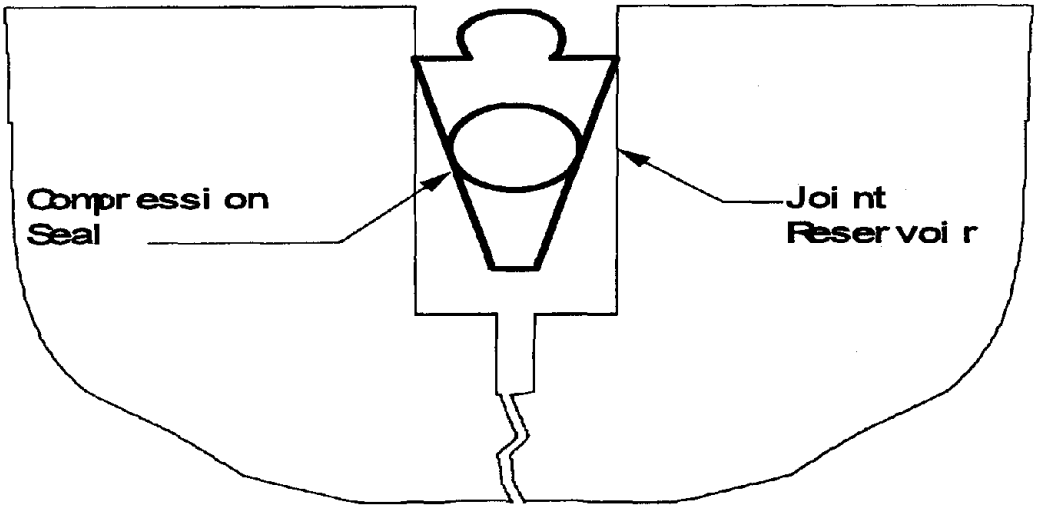
The one-celled Kold Seal Neo Loop seal (figure 35), installed at Tremonton, performed very poorly, with only 1 percent of its length still effective after the 1997-1998 field inspections. The primary mode of failure in this product was gap failure, which is believed to be partly the result of the seal's design and the roadway conditions. The seal has a bulb at its surface that projects

Figure 35. Kold Seal Neo Loop compression seal design.

above the top of the main seal flanges. Small stones and sand wedged between the bulb and the joint edges when the joints were at their widest opening. In the summer, the joints closed to a smaller width, but the stones between the bulb and the joint walls remained in place. Because the bottom of the seal was allowed to compress inward toward the center of the joint, a gap developed between the seal flanges and the joint edge. In some cases, the width of the gap was nearly 3 mm, thus allowing the infiltration of water and debris into the joint.

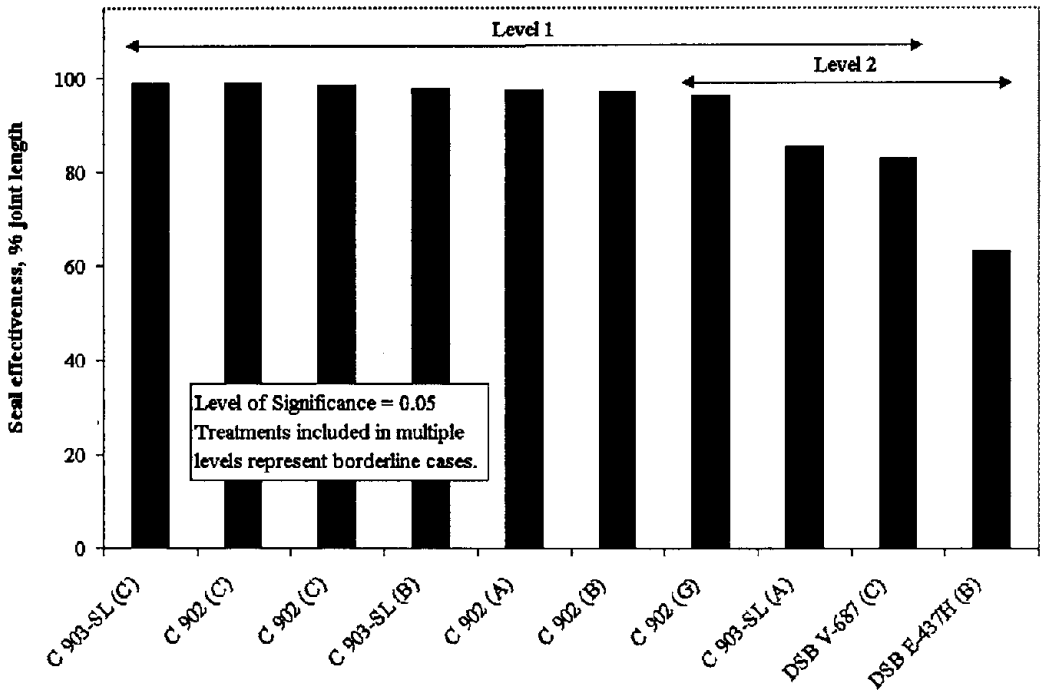
Figure 37. Overall effectiveness groupings for Campo, Colorado transverse joint seal treatments.

- In general, insufficient failure has occurred in the silicone treatments in order to find any statistical differences at this time. However, marginally poorer performance has been identified in the Crafco 902 seals placed in 9-mm-wide beveled joints and the Crafco 903-SL seals placed in 6-mm-wide joints. The former treatment was placed too thin in several joints (mean shape factor of 0.32 in one section), resulting in some cohesive failure. The latter treatment was placed too high in many locations, which exposed the seal to contact with traffic and has resulted in considerable adhesion failure.

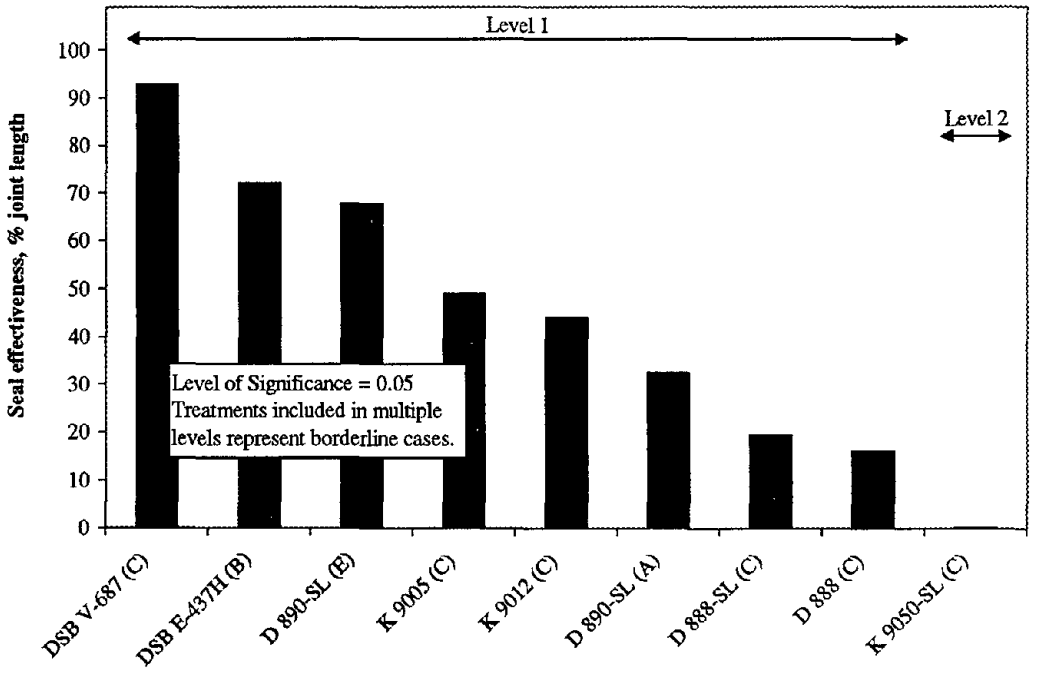
Figure 41. Overall effectiveness groupings for Heber City, Utah transverse joint seal treatments.

- Tukey groupings indicate that all treatments, except Koch 9050-SL polysulfide, are statistically performing the same at this site. However, as seen in figure 41, there is a wide range in the effectiveness levels of the various treatments. It is believed that the variability in performance between replicate sections is the reason for no overall statistical differences among eight of the nine treatments. Recall from table 3 (chapter 2) that the joints in the eastbound lane test sections received much higher waterblasting and airblasting pressures than the joints in the westbound lane test sections. Other factors in the performance of some of these sealants are as follows:

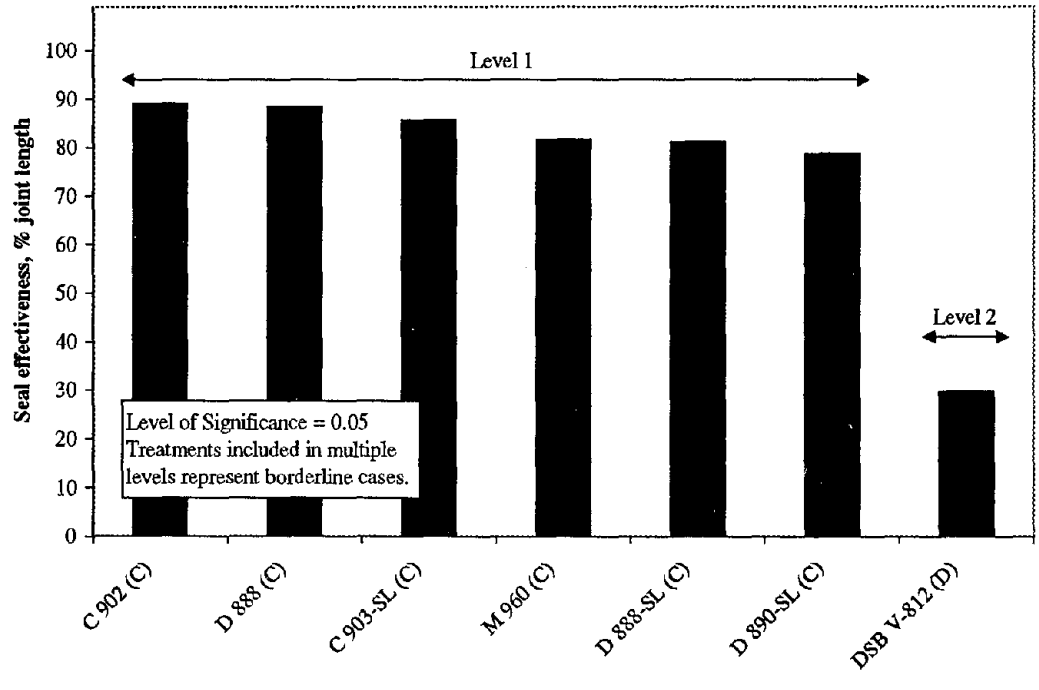
Figure 43. Overall effectiveness groupings for Wells, Nevada longitudinal joint seal treatments.

The results of the Tukey comparisons of current (1997-1998) longitudinal joint seal effectiveness are illustrated in figures 42 and 43. Noteworthy observations regarding the performance groupings of these seals at the Mesa and Wells sites are given below.

- Like the transverse joint seals at Wells, the statistical performance breakout of longitudinal joint seals at this site show the D.S. Brown V-812 compression seals with distinctly lower performance than all silicone seals. Full-depth spalling has also been the cause for considerable overall failure in the silicone treatments.

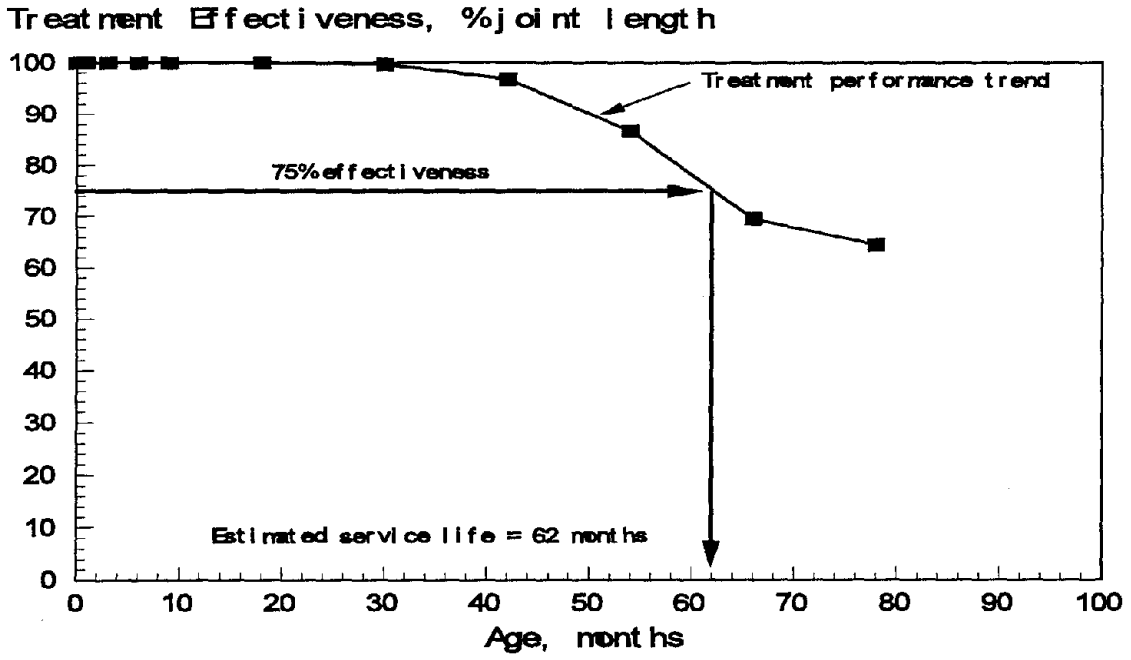
Figure 44. Illustration of service life estimation, based on 75 percent effectiveness.

To conduct a service life analysis, it was first necessary to define a minimum acceptable effectiveness level. Because of the highly varying levels of failure observed throughout the SPS-4 test sites, a value of 75 percent effectiveness was chosen for this analysis. Figure 44 illustrates the service life determination concept. In this figure, a particular joint seal treatment has exhibited varying losses in effectiveness over time. After 54 months, the treatment maintained an 88 percent effectiveness rating. However, after 66 months, the treatment dropped to a 69 percent effectiveness rating. At the level of 75 percent effectiveness, the corresponding estimated age (i.e., service life) is 62 months.

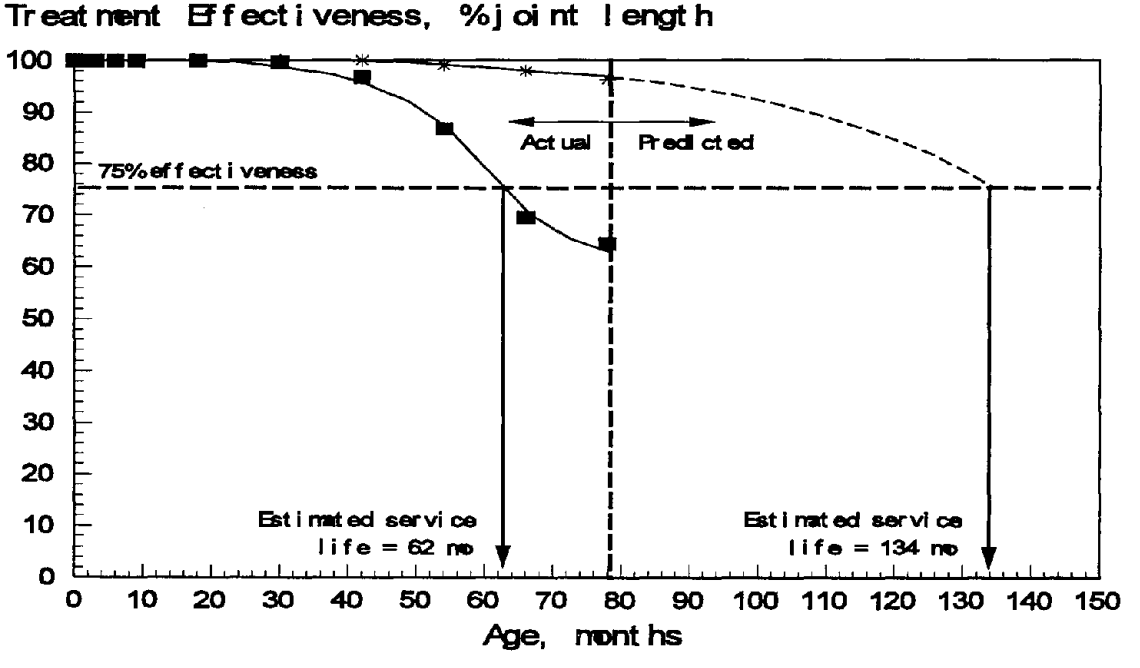
Figure 45. Illustration depicting estimates of actual and predicted service lives.

percent effectiveness by its final evaluation, and the computed *Age* value represented an estimate of the predicted life. Figure 45 illustrates these two cases.

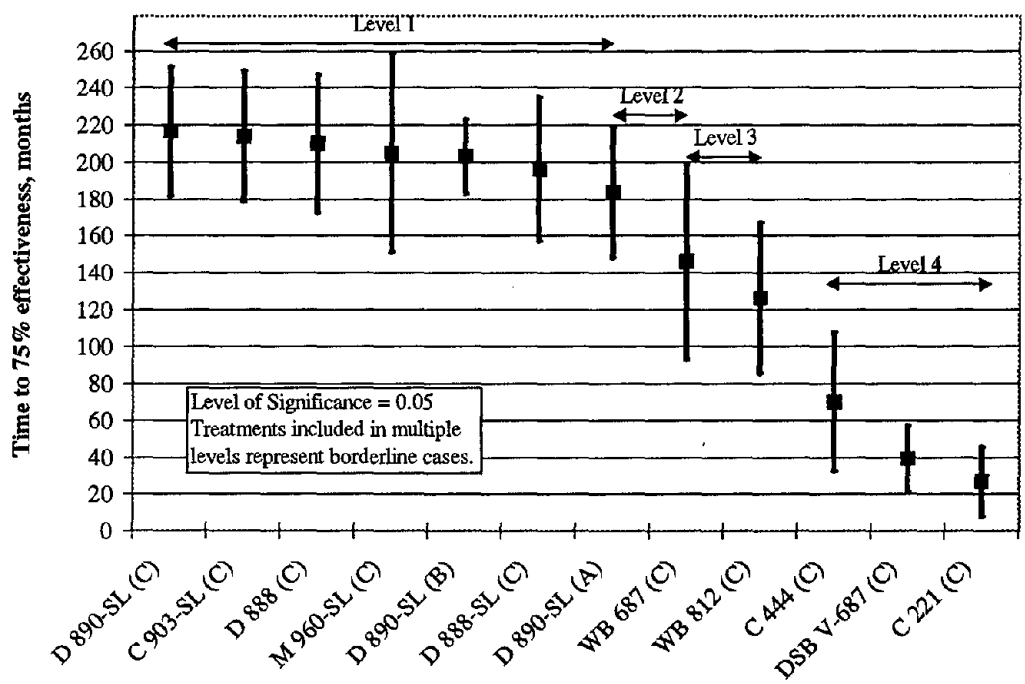
Figure 46. Tukey analysis of estimated transverse joint seal service lives at Mesa, Arizona test site.

In general, the Tukey service life groupings reinforce the observations made previously regarding current performance groupings. For instance, at Mesa, the standard silicone seal treatment and five of the six self-leveling silicone seal treatments showed statistically longer service lives than the compression seals and hot-applied seals. The sixth self-leveling silicone seal treatment, Dow 890-SL placed in 3-mm-wide joints, showed a statistically longer service life than the two hot-applied seals and two of the three compression seals. However, this material showed a marginally shorter service life in 3-mm-wide joints than in 6- and 9-mm-wide joints.

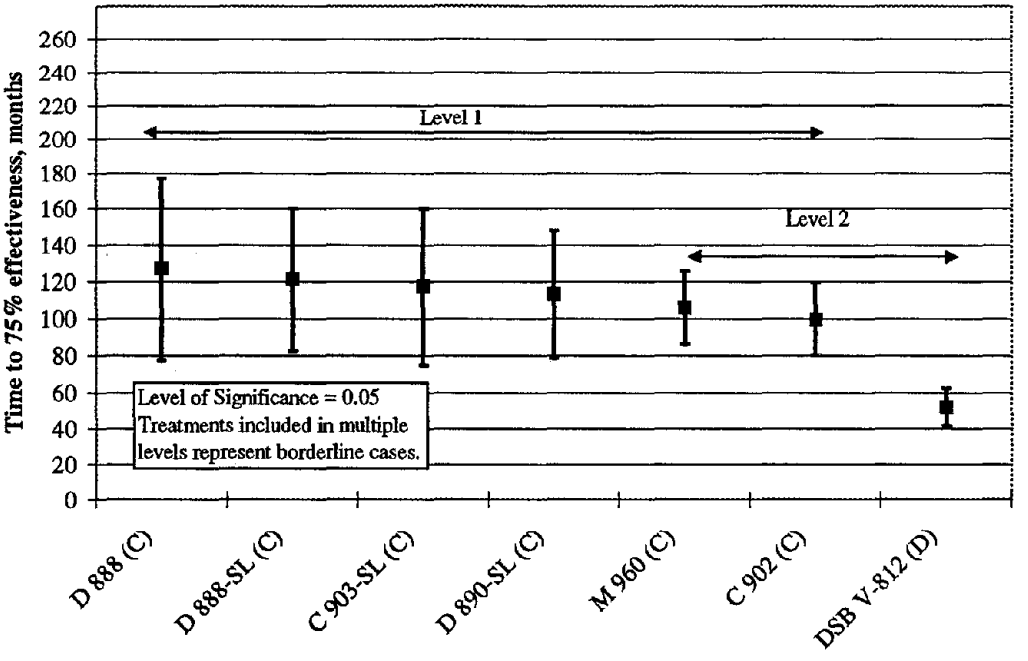
Figure 47. Tukey analysis of estimated transverse joint seal service lives at Wells, Nevada test site.

Most of the silicone seal treatments at Wells have statistically outperformed the compression seal at that site. Only the Mobay 960 and Crafco 902 seals placed in 9-mm joints showed the same statistical service life as the D.S. Brown V-812 compression seal. Due to the lack of pre-1991 performance data on the polyethylene seal, no estimates of service life could be made for this material. Though it was installed in 1980, it showed 100 percent failure in the initial field inspections of 1994-1995.

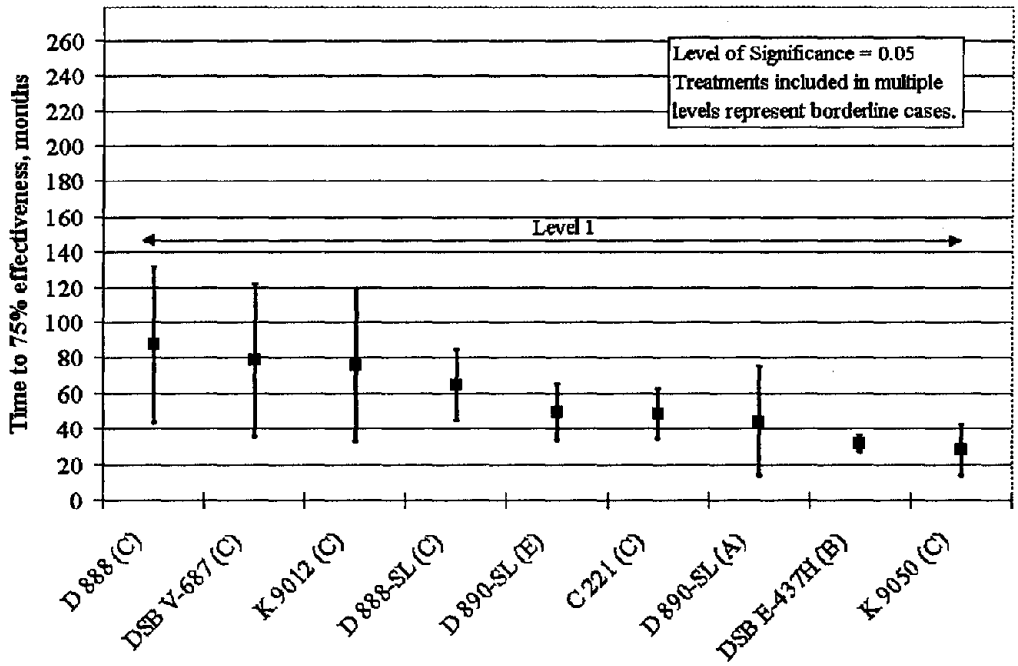
Figure 49. Tukey analysis of estimated transverse joint seal service lives at Salt Lake City, Utah test site.

As with the results of the Tukey analysis of current performance, no statistical distinctions in estimated service life were found among the treatments at the Salt Lake City site. However, it can again be pointed out that a more cost-effective sawing method than conventional sawcutting is the Soff-Cut method.

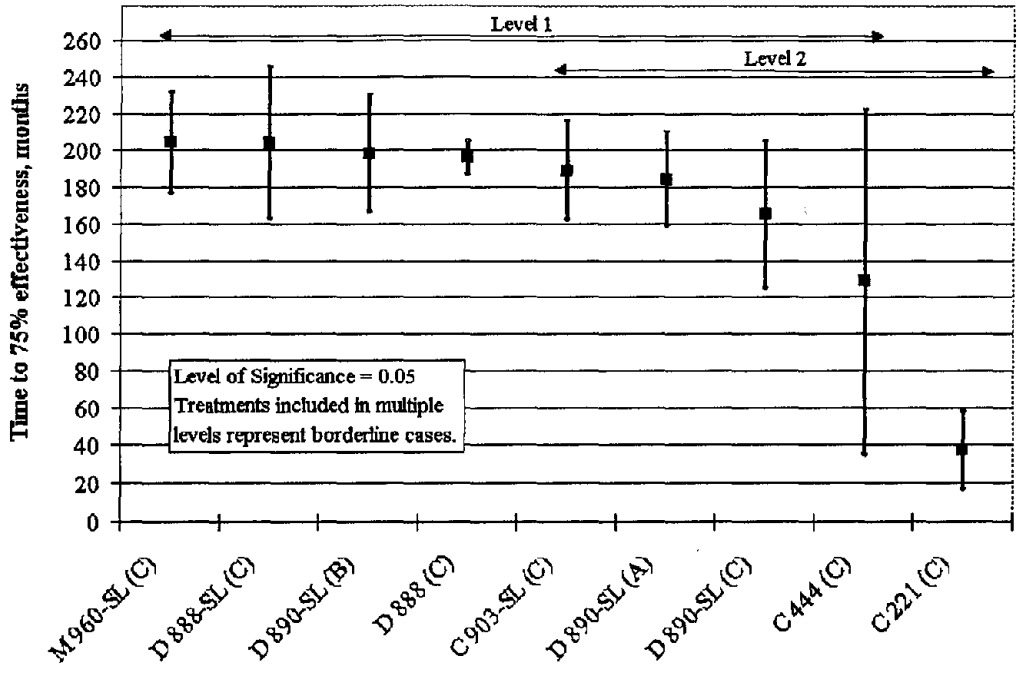
Figure 51. Tukey analysis of estimated longitudinal joint seal service lives at Mesa, Arizona test site.

The results of the Tukey analysis of estimated longitudinal joint seal service lives are illustrated in figures 51 and 52. The only statistical distinction in estimated service life at Mesa was between the Crafco RS 221 joint seal treatment (significantly lower service life) and four of the seven silicone seal treatments. Recall that no distinctions were apparent in the evaluation of current performance levels.

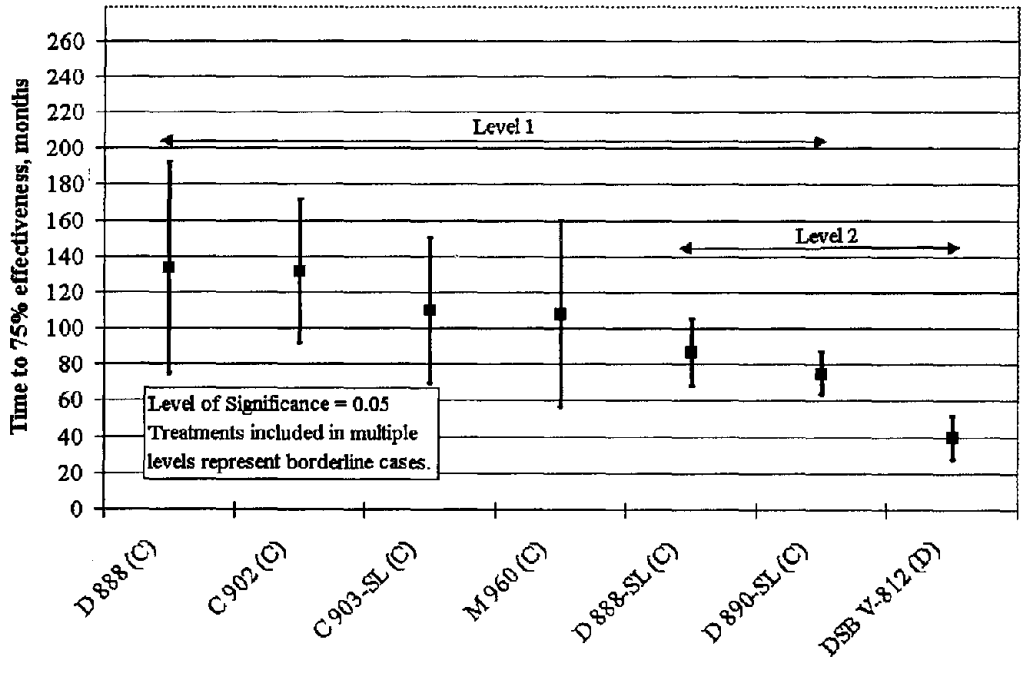
Figure 52. Tukey analysis of estimated longitudinal joint seal service lives at Wells, Nevada test site.

Among the longitudinal joint seal treatments at Wells, it was found that the D.S. Brown V-812 compression seal treatment showed a statistically shorter service life than the three standard silicone treatments installed at that site and one of the three self-leveling silicone treatments. This compression seal showed statistically poorer performance than its counterparts during the 1997-1998 field inspections.
