Highway Concrete Technology Development and Testing, Volume III: Field Evaluation of SHRP C-205 Test Sites (High-Performance Concrete)

PUBLICATION NO. FHWA-RD-02-084

MAY 2006

Field Evaluation of SHRP C-205 Test Sites (High-Performance Concrete)

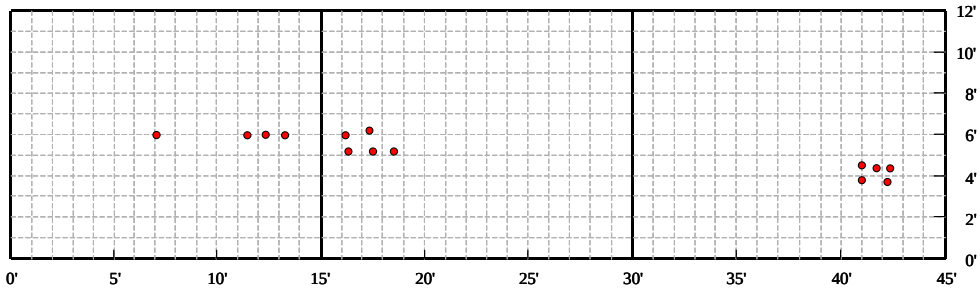
Figure 25. Graph. Distress map for patch NC-1 in North Carolina—1994.

Comments: No signs of D-cracking or scaling.

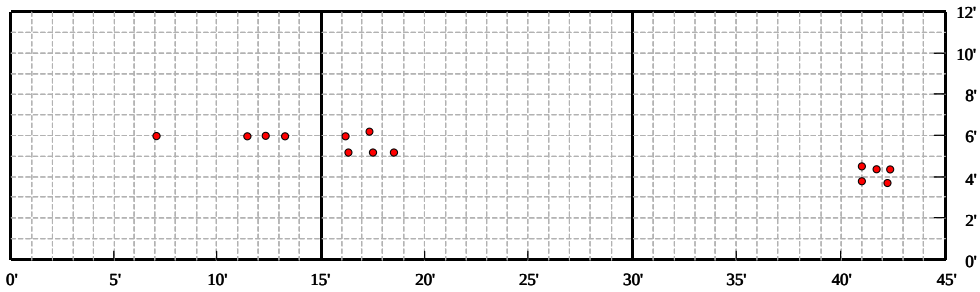
Figure 26. Graph. Distress map for patch NC-1 in North Carolina—1998.

Comments: No signs of D-cracking or scaling.

No change in condition (1995; 1996; 1997; 1998).

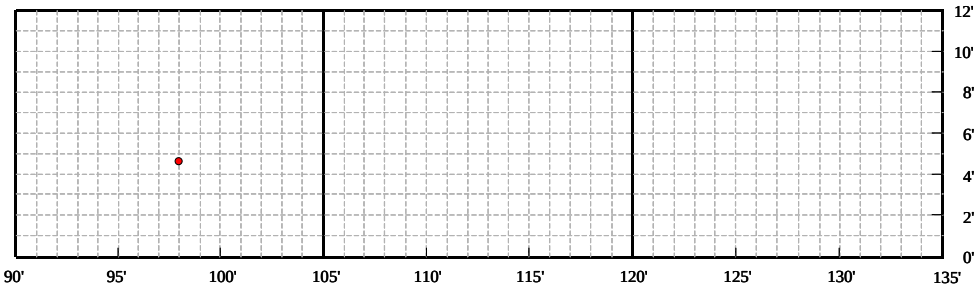
Figure 27. Graph. Distress map for patch NC-2 in North Carolina—1994.

Comments: Wide joint at location 120'.

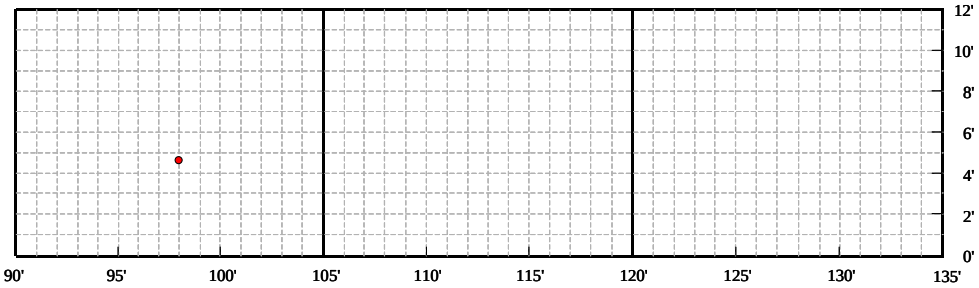
Figure 28. Graph. Distress map for patch NC-2 in North Carolina—1998.

Comments: Wide joint at location 120'.

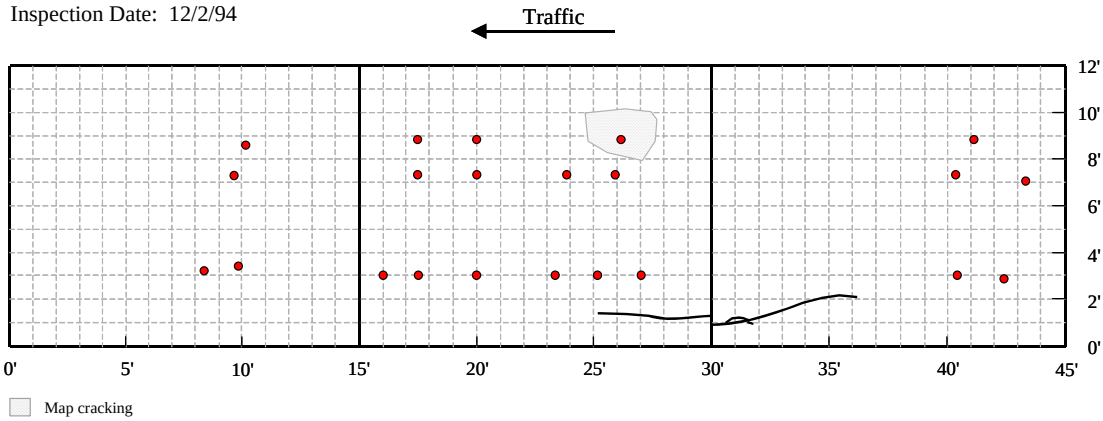
Figure 29. Graph. Distress map for patch AR-1 in Arkansas—1994.

Comments: All joints are well sealed with HP sealant. No signs of scaling or D-cracking (12/2/94)

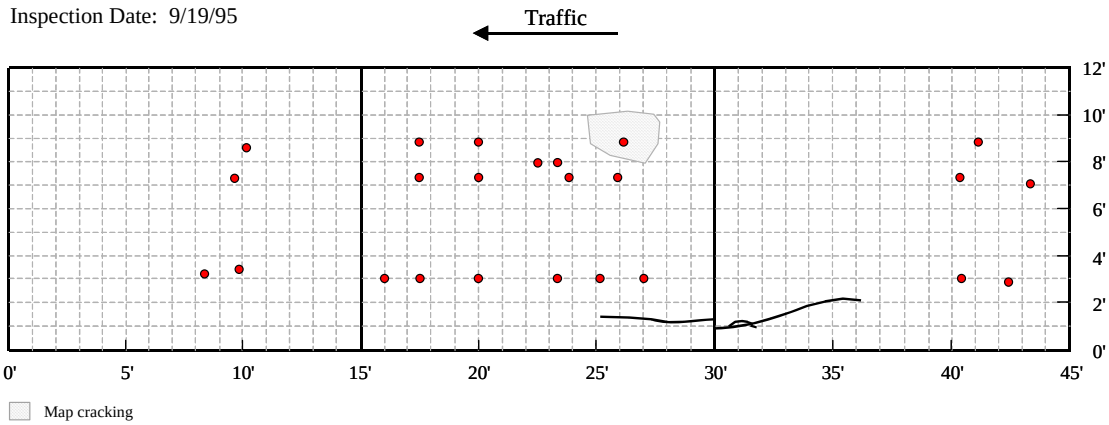
Figure 30. Graph. Distress map for patch AR-1 in Arkansas—1995.

Comments: All joints are well sealed with HP sealant. No signs of scaling or D-cracking (12/2/94)

Some surface crazing was noted on slab 2 (1995). Joint seals remain in good condition.

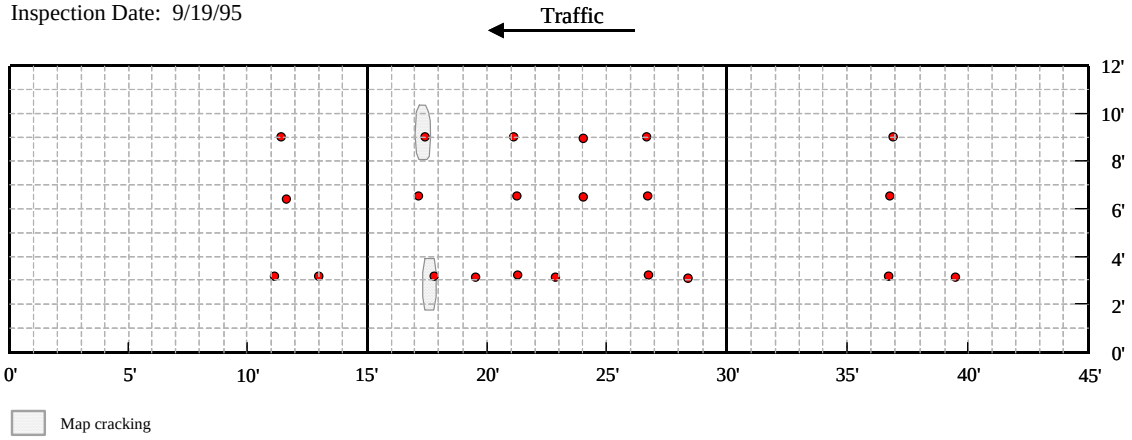
Figure 31. Graph. Distress map for patch AR-2 in Arkansas—1994.

Comments: Slight map cracking on slab no.2. No signs of D-cracking or scaling.

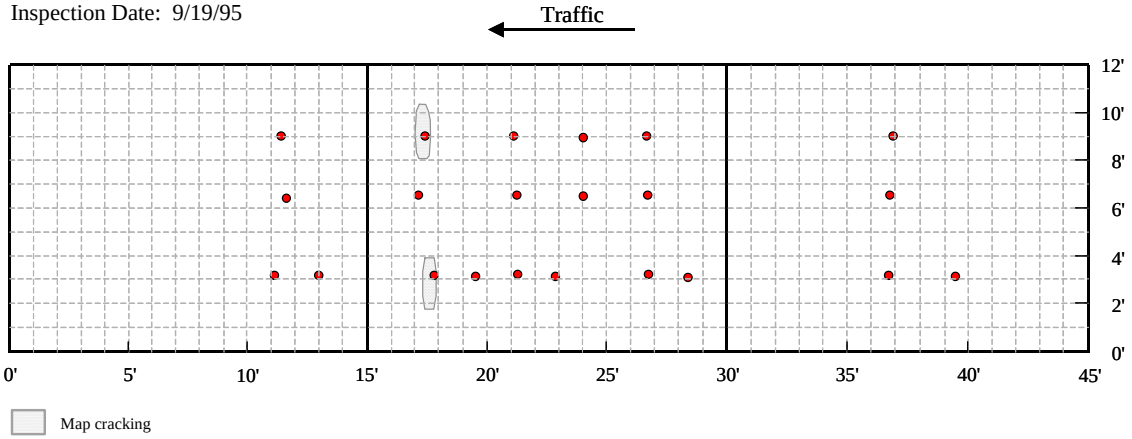
Figure 32. Graph. Distress map for patch AR-2 in Arkansas—1995.

Comments: Slight map cracking on slab no.2. No signs of D-cracking or scaling.

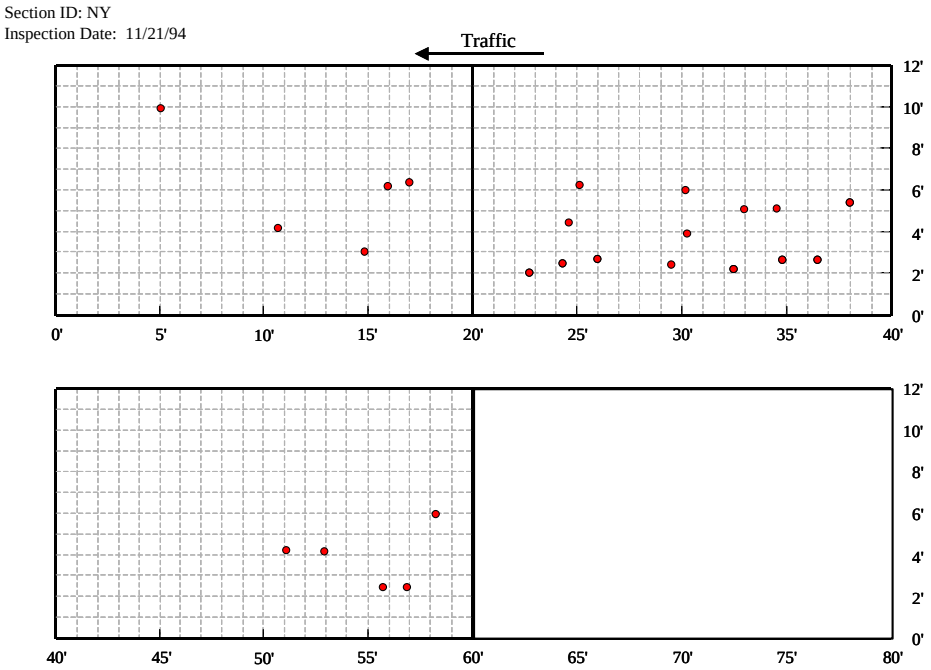
Figure 33. Graph. Distress map of section in New York—1994.

Comments: Rough texture on all slabs. The mixture was very dry when placed.

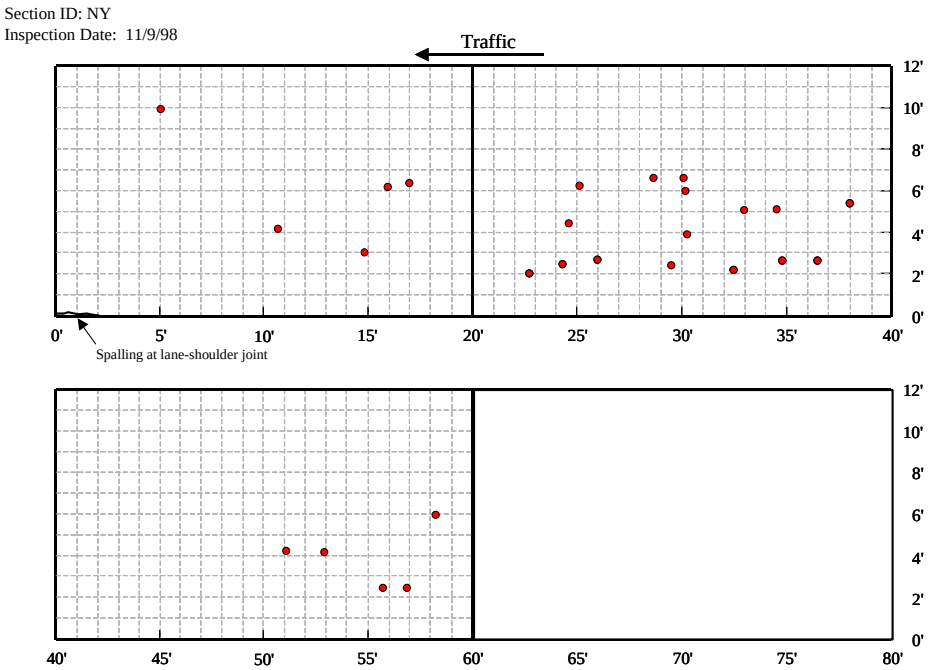
Figure 34. Graph. Distress map of section in New York—1998.

Comments: Rough texture on all slabs. The mixture was very dry when placed.
Some spalling observed on longitudinal edge joint (1995). No noticeable change from last year (1996; 1997; 1998).

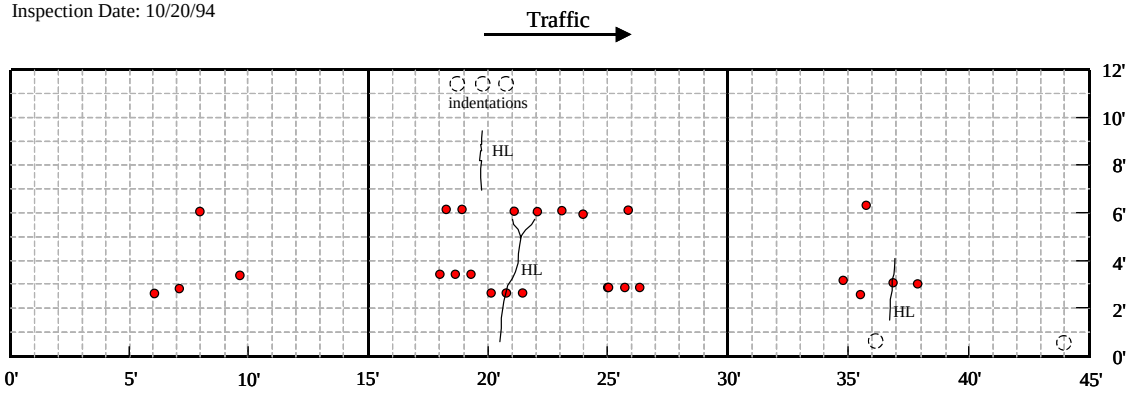
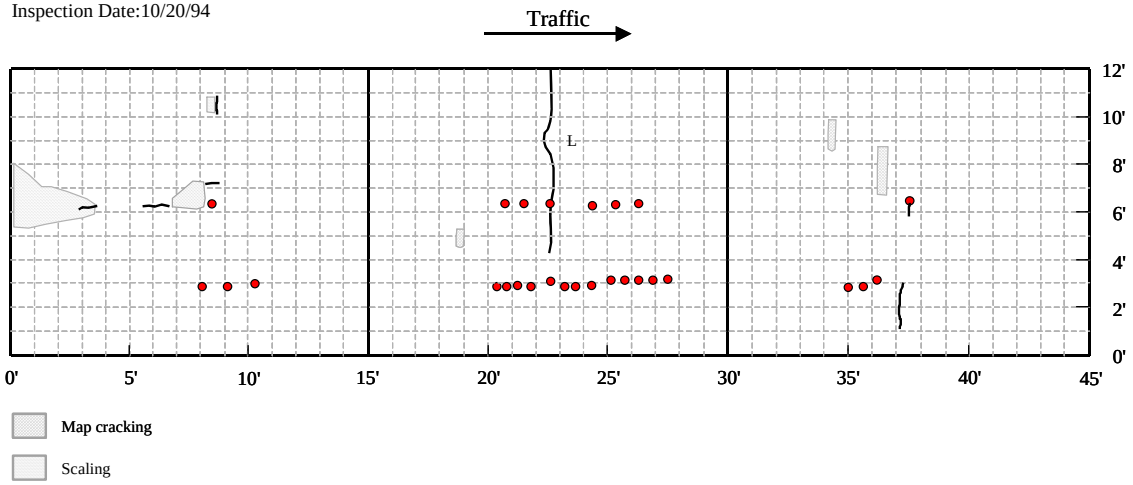
Figure 35. Graph. Distress maps for patches IL-1 and IL-2 in Illinois—1994.

The Illinois sections exhibit some map cracking. The level of cracking did not change substantially over the monitoring period, although some progression of map cracking was noted over the years. One plausible cause for this distress is the potential use of deicing salts on these patches. Subjectively, at least, the sections generally seemed more deteriorated in 1998 than in 1994 (perhaps the impression is due to more scaling). However, as noted earlier, these changes were difficult to quantify. Figures 35 through 39 in appendix A show that both Illinois sections had some transverse cracking. The structural crack in the IL-2 section existed since 1994, and no significant changes in progression or deterioration of the crack occurred over the monitoring period. Other cracks are a result of the interconnecting of map cracks. A minor progression of these cracks occurred over the monitoring period, but none appeared to have progressed to a working, structural crack.

Comments: Insulated. Some scaling, which appear to be construction related. Much cleaner finish than IL-2.

Comments: Noninsulated. Shrinkage cracks, minor map cracking, and scaling. Surrounding pavement had been milled.

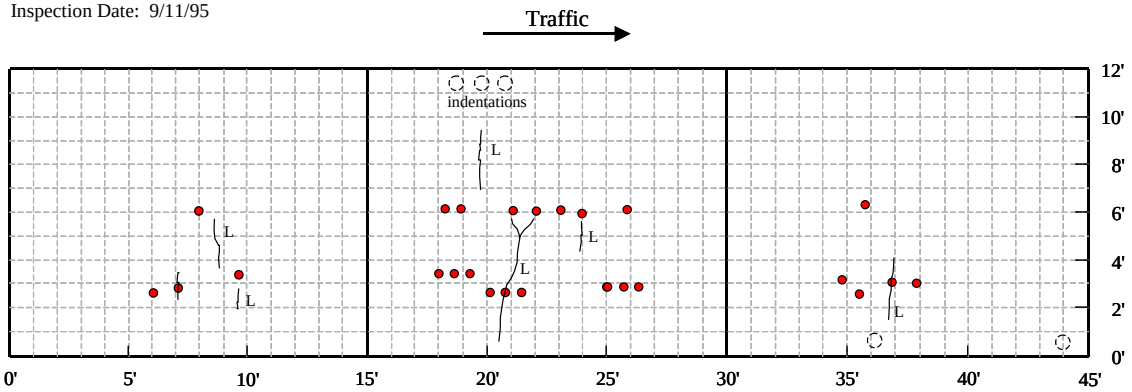
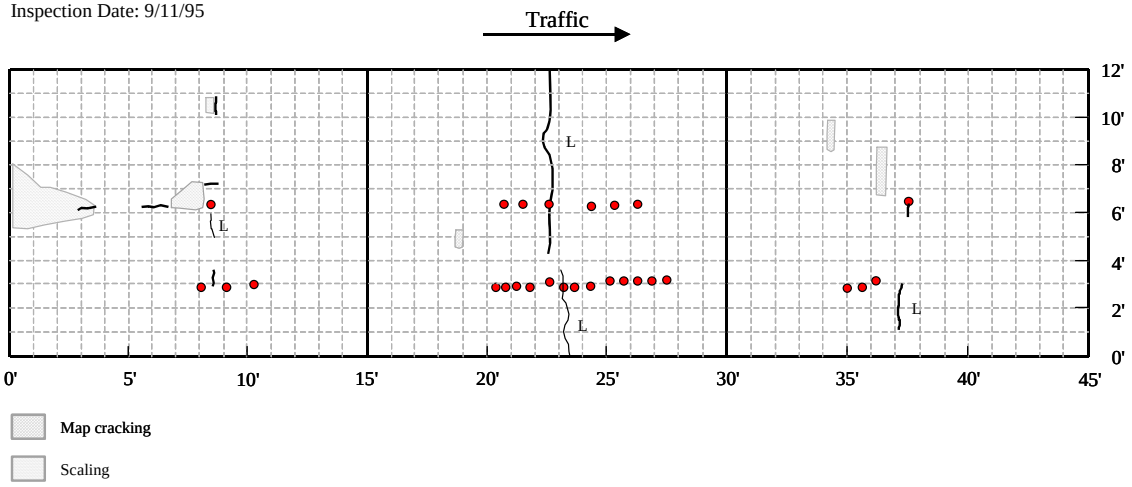
Figure 36. Graph. Distress maps for patches IL-1 and IL-2 in Illinois—1995.

Comments: Insulated. Some scaling, which appear to be construction related. Much cleaner finish than IL-2.

Comments: Noninsulated. Shrinkage cracks, minor map cracking, and scaling. Surrounding pavement had been milled.

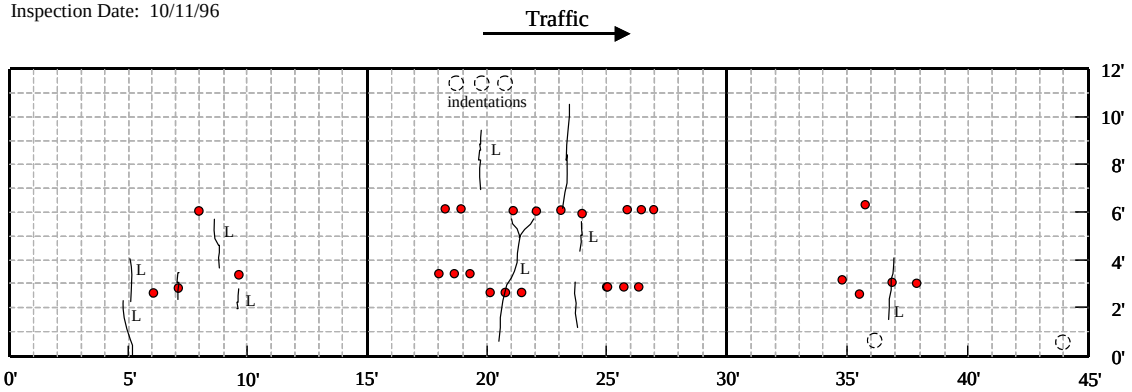
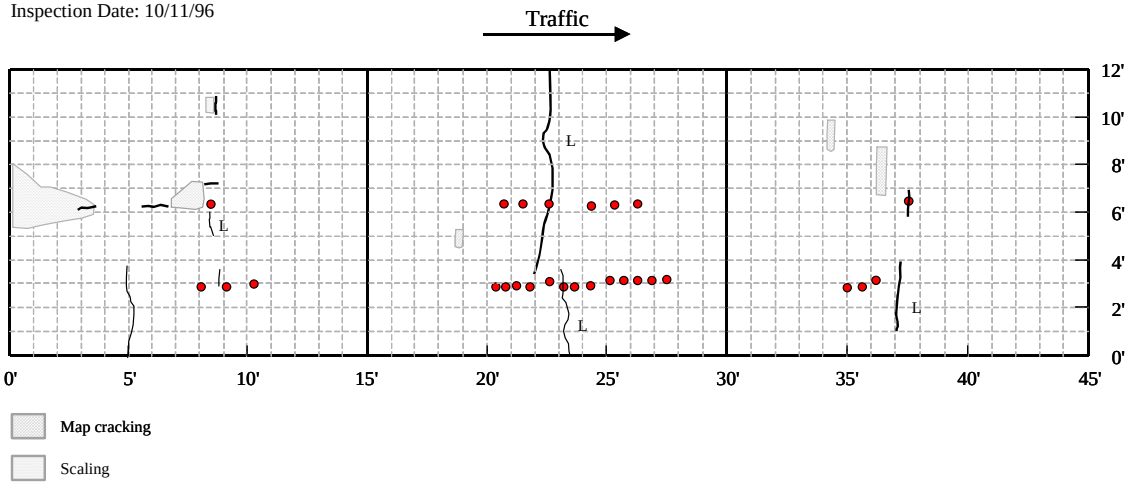
Figure 37. Graph. Distress maps for patches IL-1 and IL-2 in Illinois—1996.

Comments: Insulated. Some scaling, which appear to be construction related. Much cleaner finish than IL-2.

Comments: Noninsulated. Shrinkage cracks, minor map cracking, and scaling. Surrounding pavement had been milled.

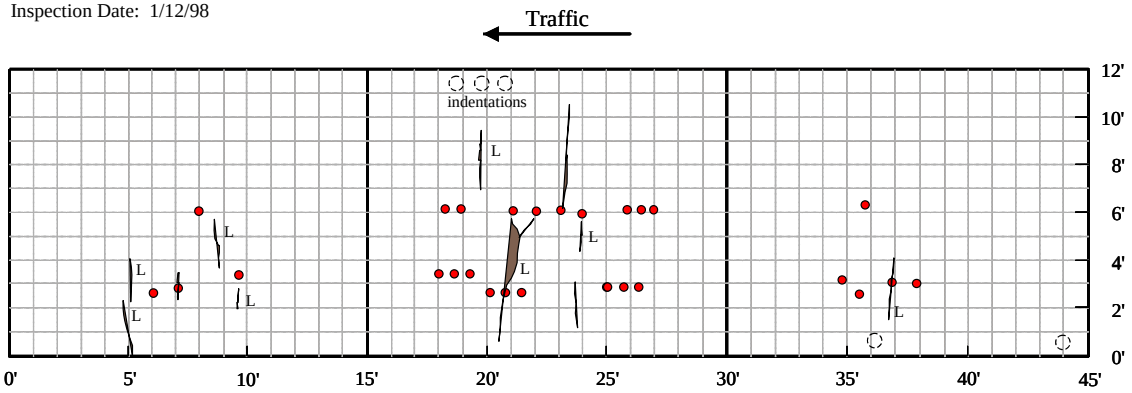
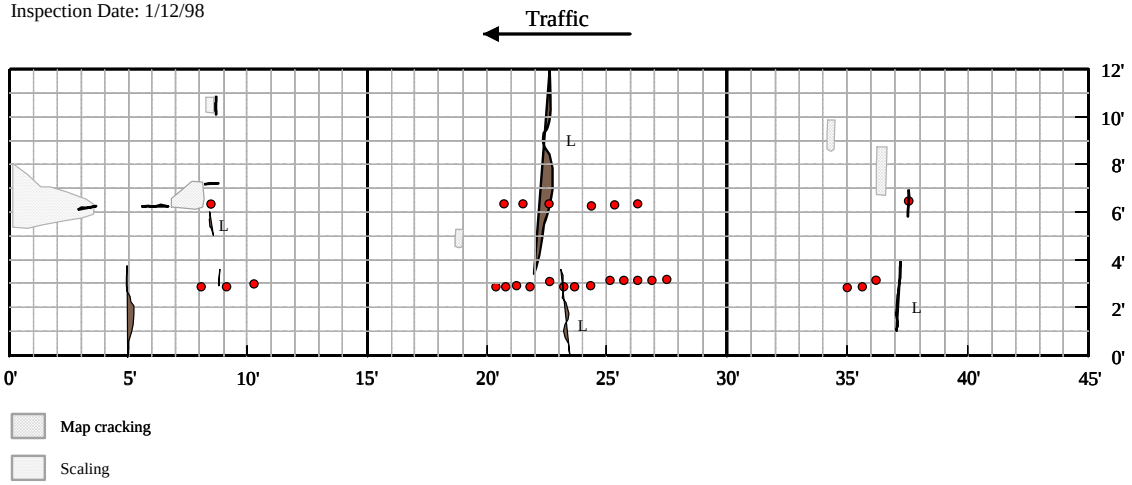
Figure 38. Graph. Distress maps for patches IL-1 and IL-2 in Illinois—1997.

Comments: Insulated. Some scaling, which appear to be construction related. Much cleaner finish than IL-2.

_Slight increase in map cracking (1997)_____

Comments: Noninsulated. Shrinkage cracks, minor map cracking, and scaling. Surrounding pavement had been milled.

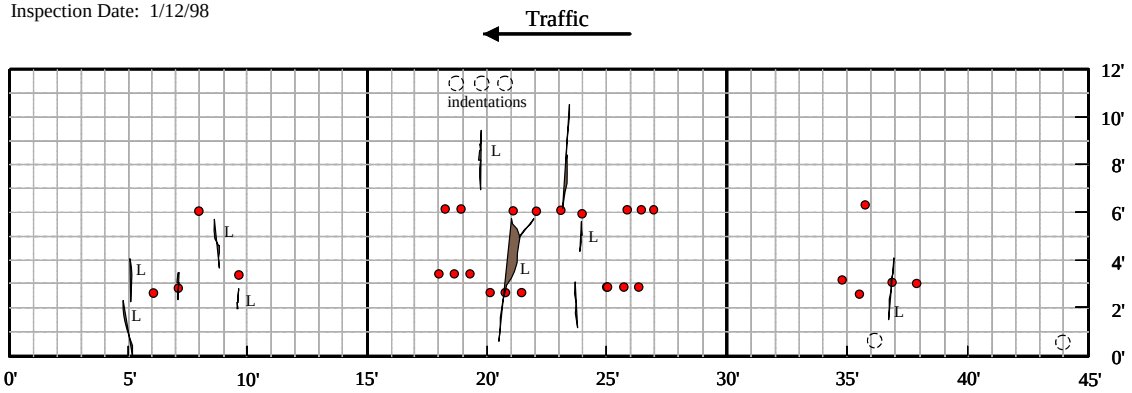
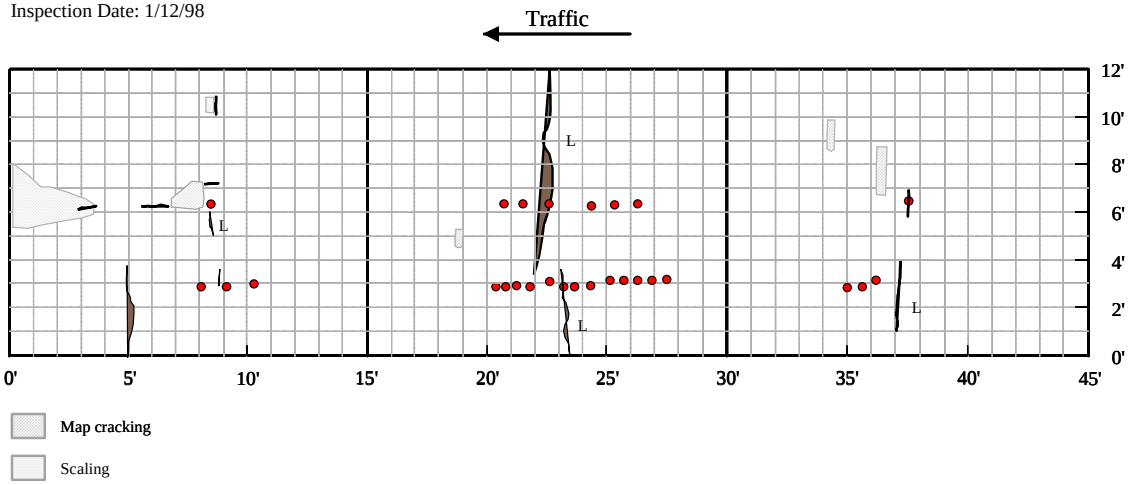
Figure 39. Graph. Distress maps for patches IL-1 and IL-2 in Illinois—1998.

Comments: Insulated. Some scaling, which appear to be construction related. Much cleaner finish than IL-2.

_Slight increase in map cracking (1997)_____

Comments: Noninsulated. Shrinkage cracks, minor map cracking, and scaling. Surrounding pavement had been milled.

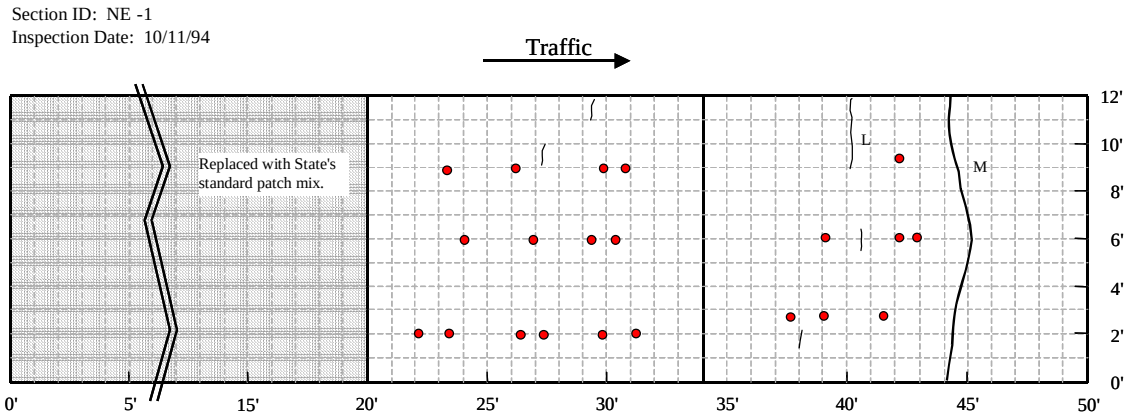
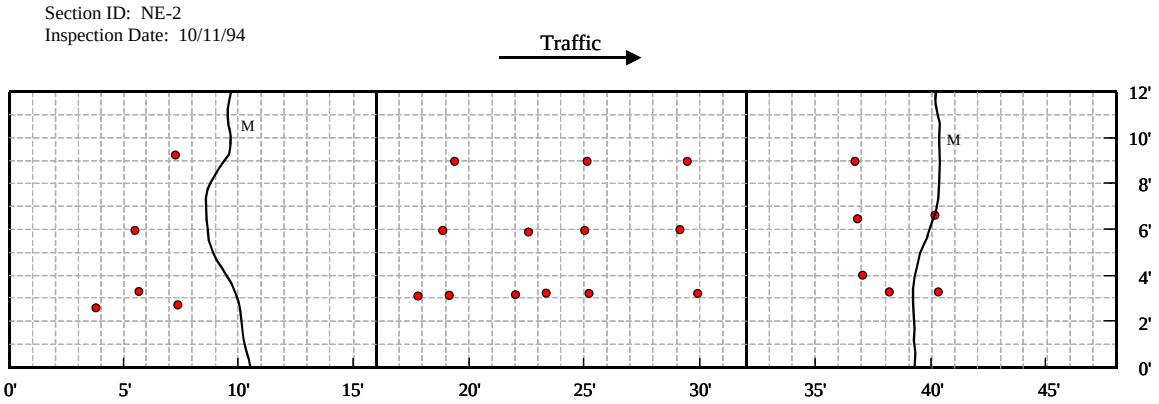
Figure 40. Graph. Distress maps for patches NE-1 and NE-2 in Nebraska—1994.

The Nebraska sections have a few transverse cracks, which have existed since 1994 (see figures 40 through 44 in appendix A). A modest increase in map cracking was noticed in 1998. The map cracking occurred mostly along the joints and cracks and around the cores. The pattern cracking appeared characteristic of ASR, which is known to occur in the area. It is interesting to note, however, that map cracking appeared to be a problem only on the repair slabs (not just the SHRP repairs, but also other repairs in the area). The original concrete, placed in 1957, did not exhibit any signs of map cracking.

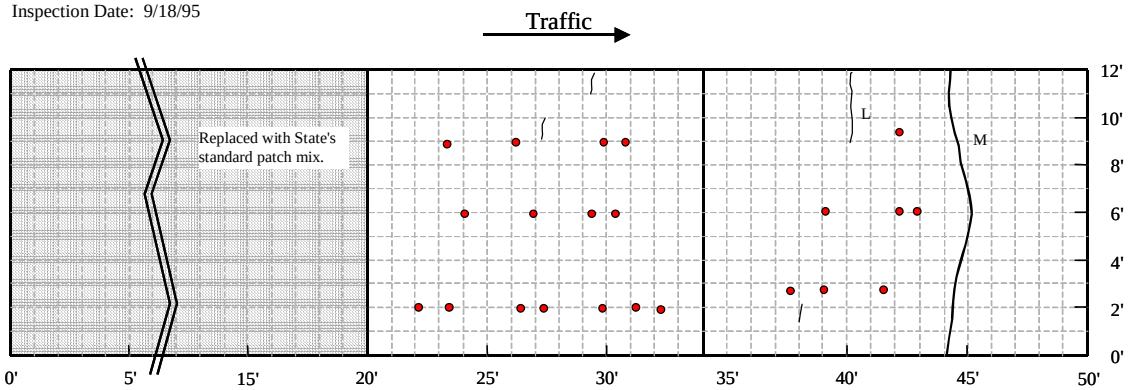
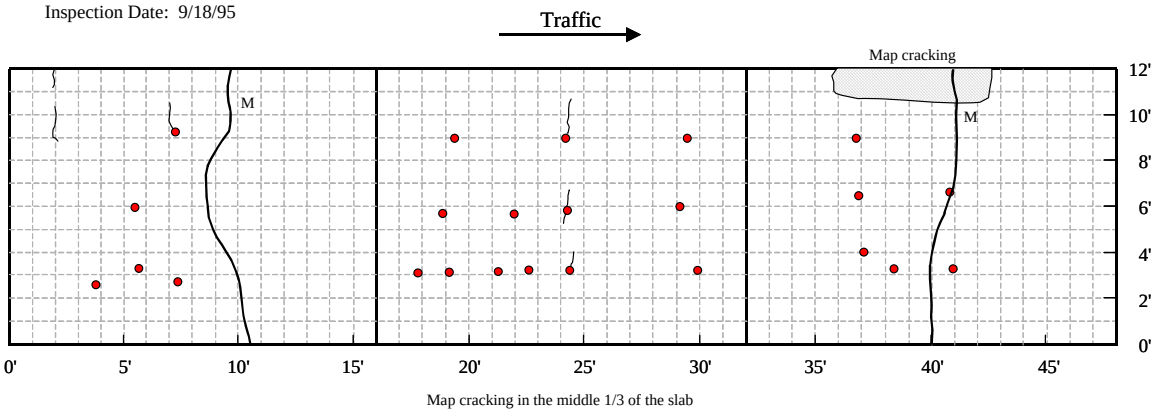
Figure 41. Graph. Distress maps for patches NE-1 and NE-2 in Nebraska—1995.

No significant change in condition (1995).

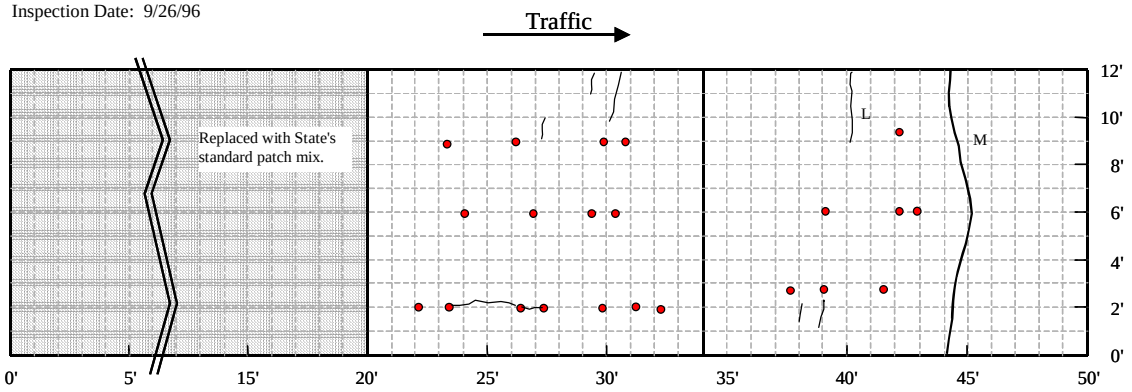
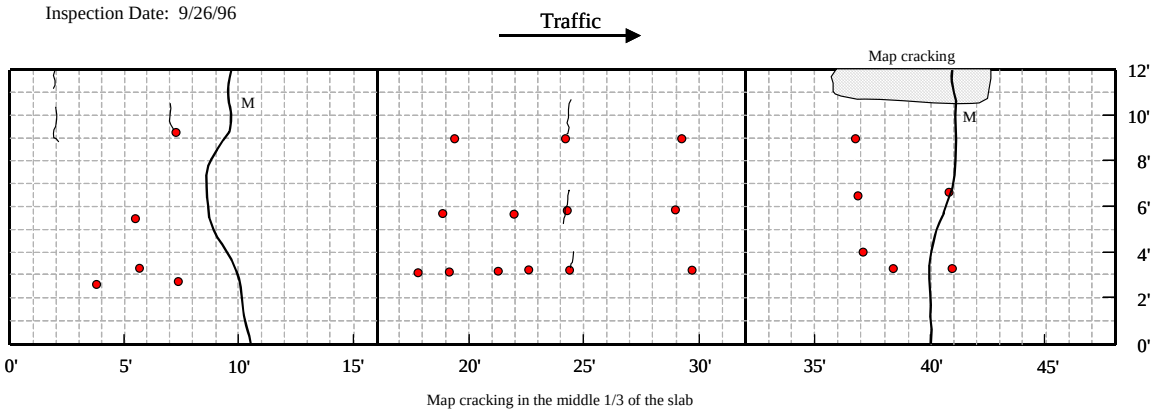
Figure 42. Graph. Distress maps for patches NE-1 and NE-2 in Nebraska—1996.

No significant change in condition (1995).

No significant change in condition other than progress of surface cracks shown on the map (1996).

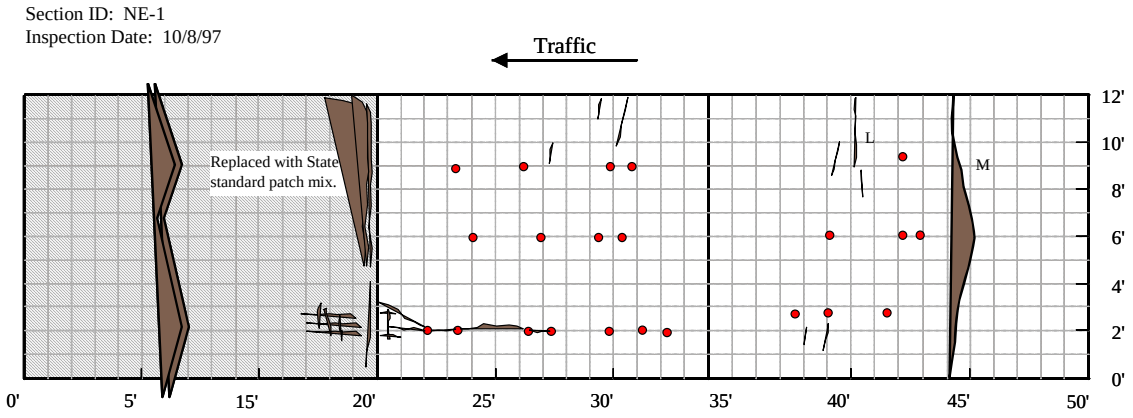
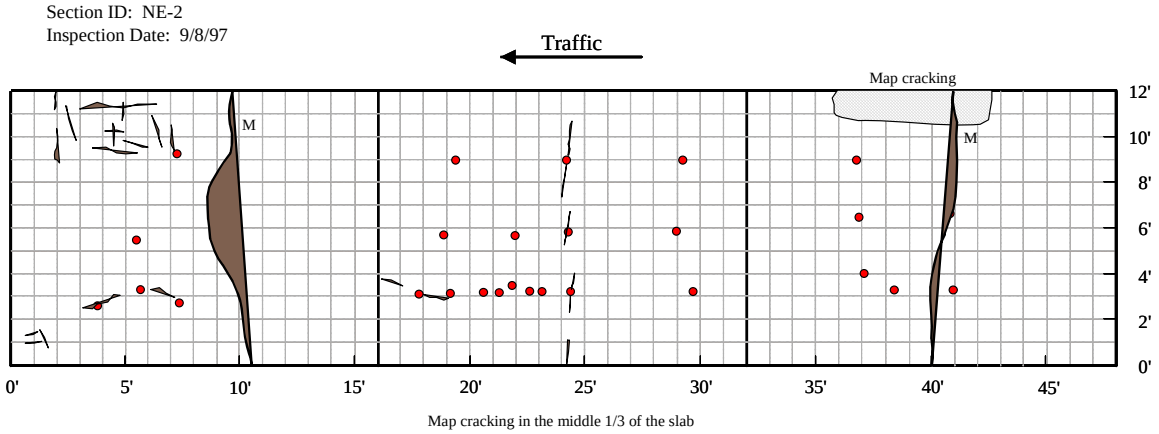
Figure 43. Graph. Distress maps for patches NE-1 and NE-2 in Nebraska—1997.

No significant change in condition (1995).

No significant change in condition other than progress of surface cracks shown on the map (1996).

Increase in map cracking (1997).

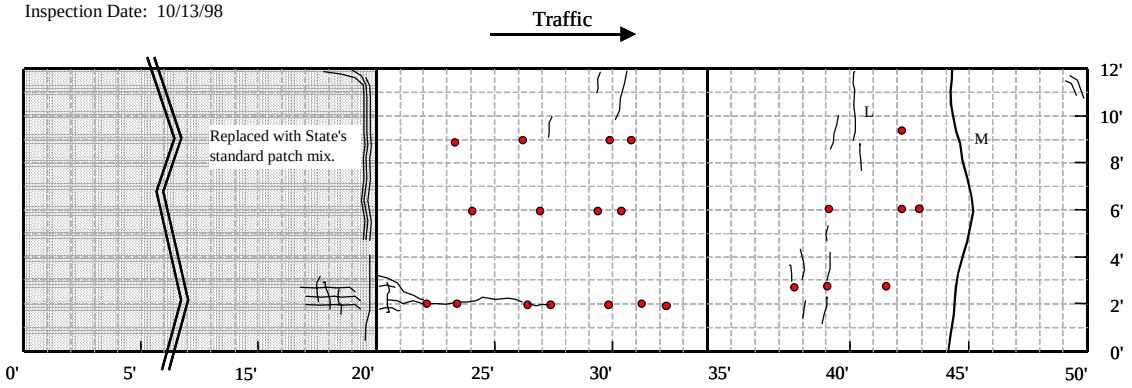
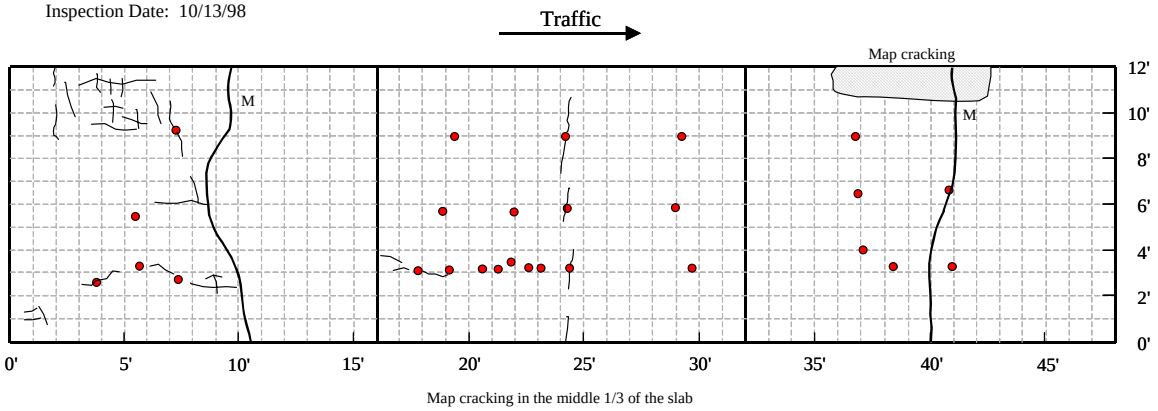
_No significant change in condition (1995).

_Increase in map cracking (1997).

_Significant increase in map cracking (1998).
