# Long-Term Effects of Electrochemical Chloride Extraction on Laboratory Specimens and Concrete Bridge Components

PUBLICATION NO. FHWA-HRT-10-069

SEPTEMBER 2011

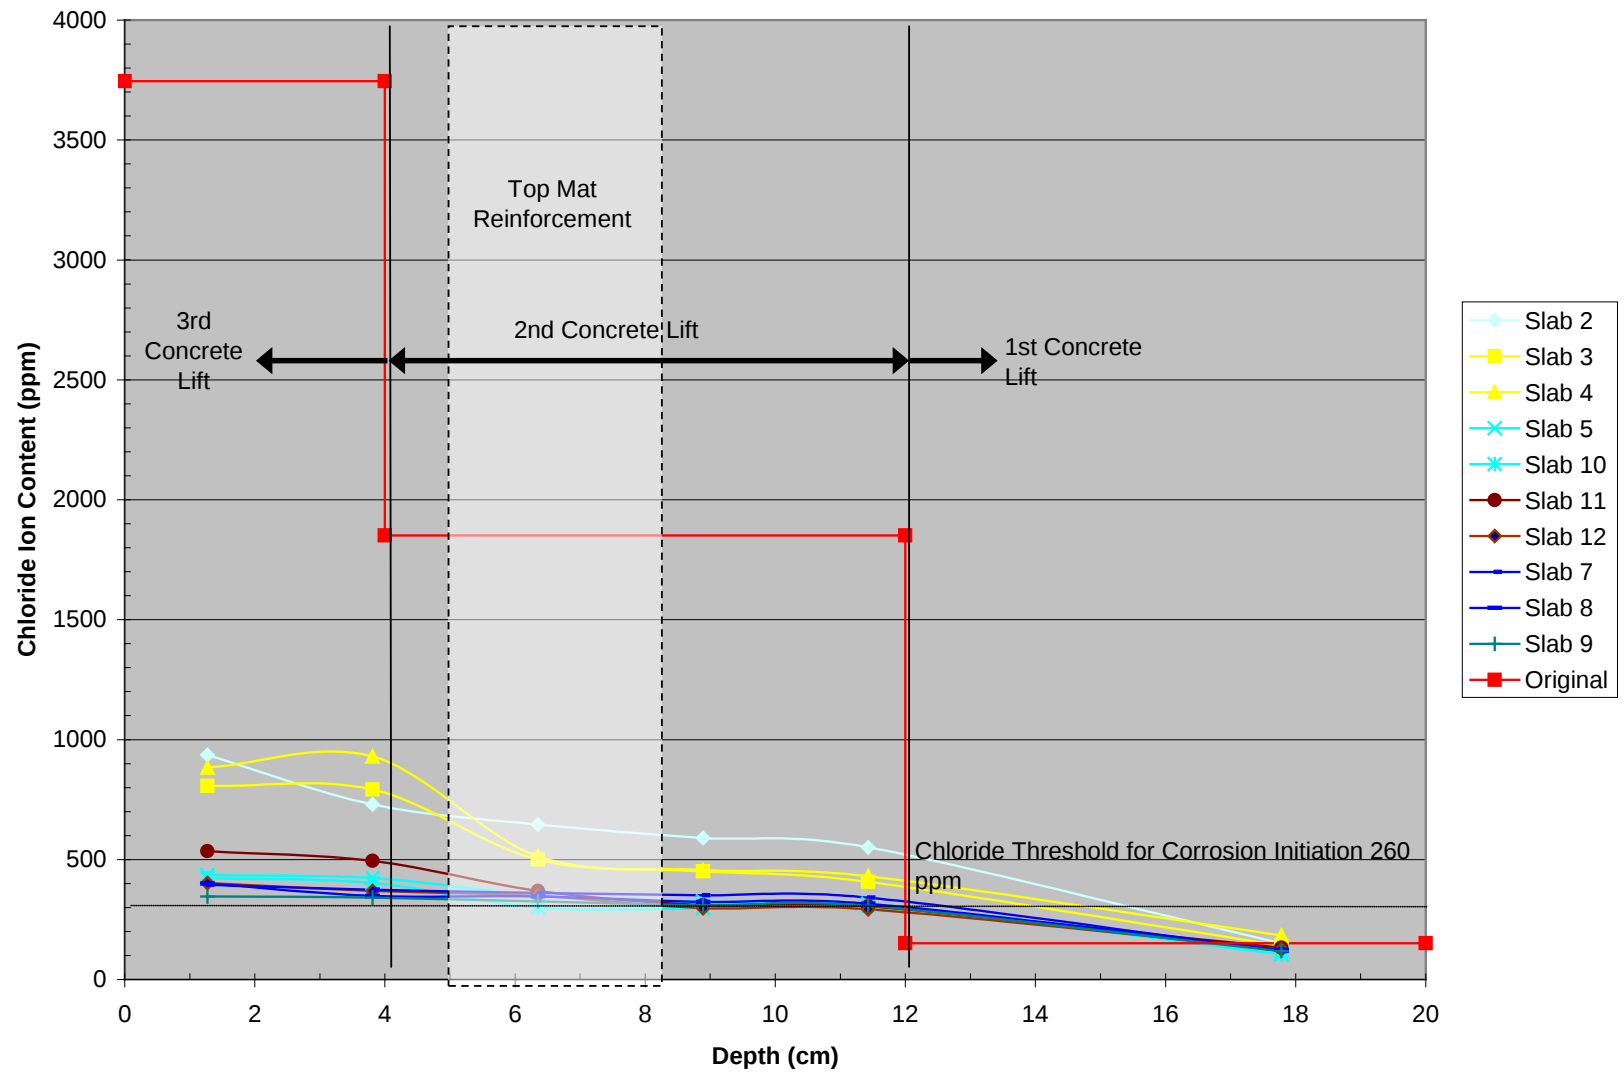
Figure 1. Graph. Chloride ion content versus depth.

At the end of the study in December 1999 (10.25 years after ECE treatment), one core was collected from each slab, and chloride ion content analyses were performed on powdered samples from the cores. Concrete samples were collected from five nominal depths of 0.50, 1.50, 2.50, 3.50, 4.50, and 7.00 inches (12.7, 38.1, 63.5, 88.9, 114.3, and 177.8 mm). Concrete from 0.50 inches (12.7 mm) above and 0.50 inches (12.7 mm) below each nominal depth was powdered and mixed to prepare a sample representing that nominal depth. The collected powdered samples were analyzed for total chloride ion content, and the results are presented in figure 1.

Prior to the application of ECE, the average chloride ion content measured in the bottom 3.1 inches (78.7 mm) of the slabs (first lift) was 151 ppm. Additionally, the average chloride ion measured in the middle 3.1 inches (78.7 mm) of the slabs (second lift) was 1,851 ppm, while the average chloride ion content measured in the top 1.6 inches (40.6 mm) of the slabs (third lift) was 3,475 ppm (see figure 1 for comparison purposes). Comparison of the chloride profile for slab 2 to the chloride profile for original chloride ion content shows the effect of diffusion at the end of 10.25 years. Over time, the chloride ions in slab 2 were diffused to reach a uniform distribution at all depths. The total quantity of chloride ions in slab 2 was calculated using the profile of chloride distribution assuming that the chlorides were uniformly distributed in the horizontal plane at each depth. Based on this calculation, the total quantity of chloride ions present in the slab after 10.25 years was approximately 3.5 oz (100 g). The calculated quantity (based on initial quantities of chlorides in each lift) of chloride ions added to the slab at construction was 9.38 oz (268 g), and the removal of cores from the slab accounted for 2.38 oz (68 g) of chloride ions. The difference of 3.5 oz (100 g) can be explained by the leaching of chloride ions from cracks and the delaminations along the top mat rebar and in the core holes.

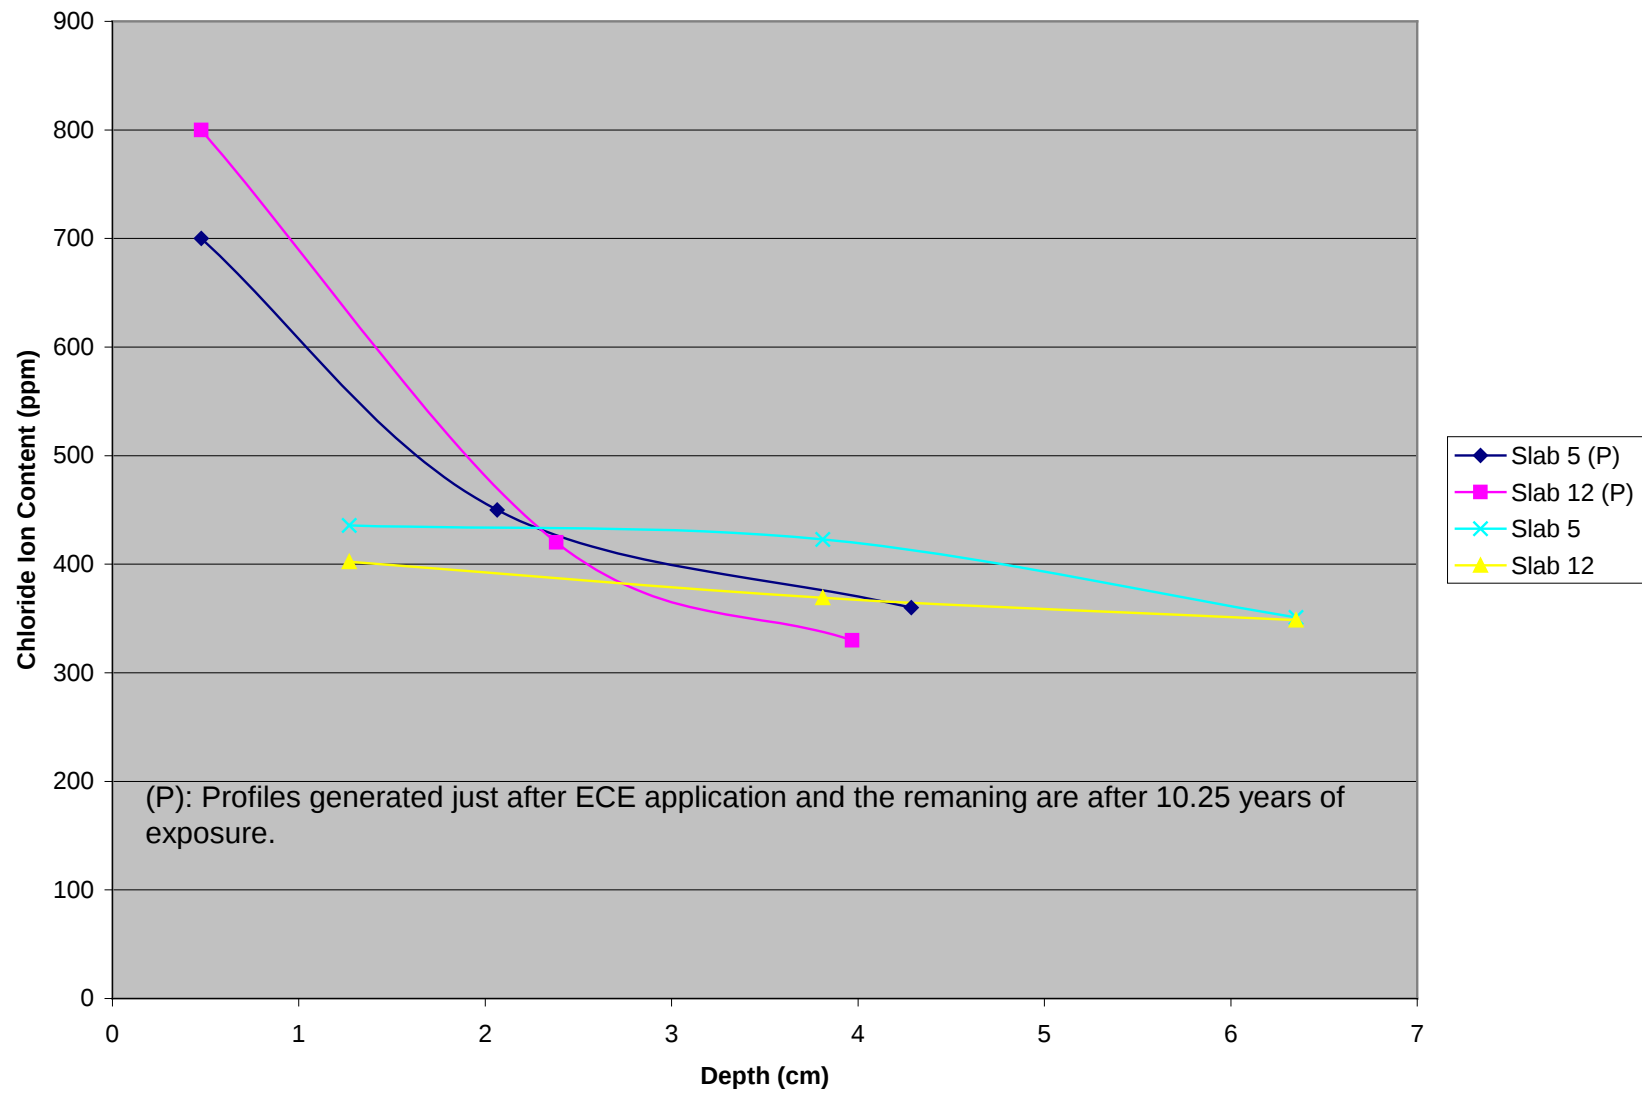
**Figure 2. Graph. Comparison of chloride profiles.**

All ECE slabs showed a distribution of chloride ions similar to that of slab 2, albeit at a lower but somewhat uniform concentration. Slabs 3 and 4, which received the least amount of ECE treatment (59.9 A-h/ft<sup>2</sup> (645 A-h/m<sup>2</sup>) compared to over 186 A-h/ft<sup>2</sup> (2,000 A-h/m<sup>2</sup>)) for other slabs), had a higher level of chloride ion concentration than the other ECE slabs at all depths in the second and the third lifts of concrete. To ascertain if this distribution of chloride ions in the ECE slabs resulted from diffusion of chloride ions and/or the application of ECE, chloride profiles from various time periods needed to be compared for each ECE slab. Limited profile data were available. Immediately after ECE application, chloride ion content from several depths of one core from slabs 5 and 12 were analyzed. Comparison of those profiles with profiles after 10.25 years of exposure suggests that some amount of diffusion occurred in the third lift of concrete for these two slabs (see figure 2).

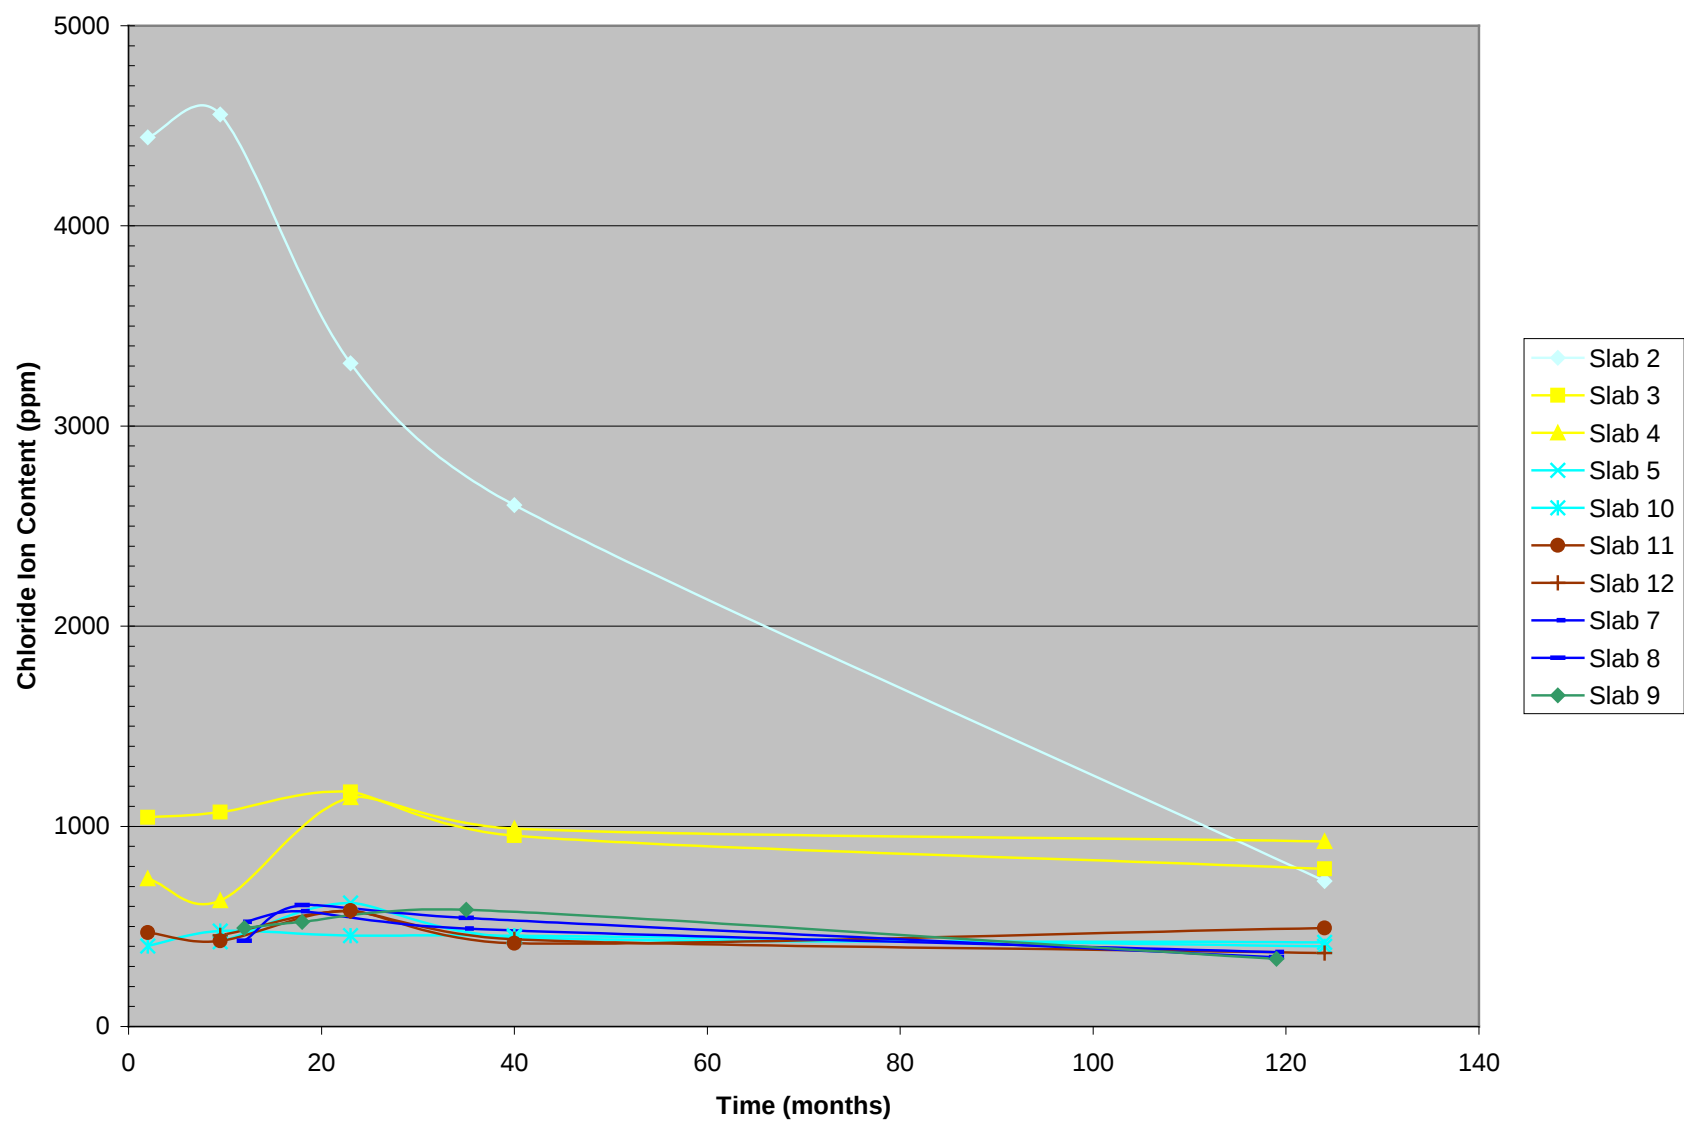
Figure 3. Graph. Chloride content versus time.

Figure 3 shows the diffusion of chloride ions with time from the top trace of the top mat rebar of slab 2. A similar but much lower magnitude trend is discernable in the ECE slabs, which is in agreement with data presented in figure 2. The chloride ion content above the top rebar trace in slabs 3 and 4 was higher than the other ECE slabs.

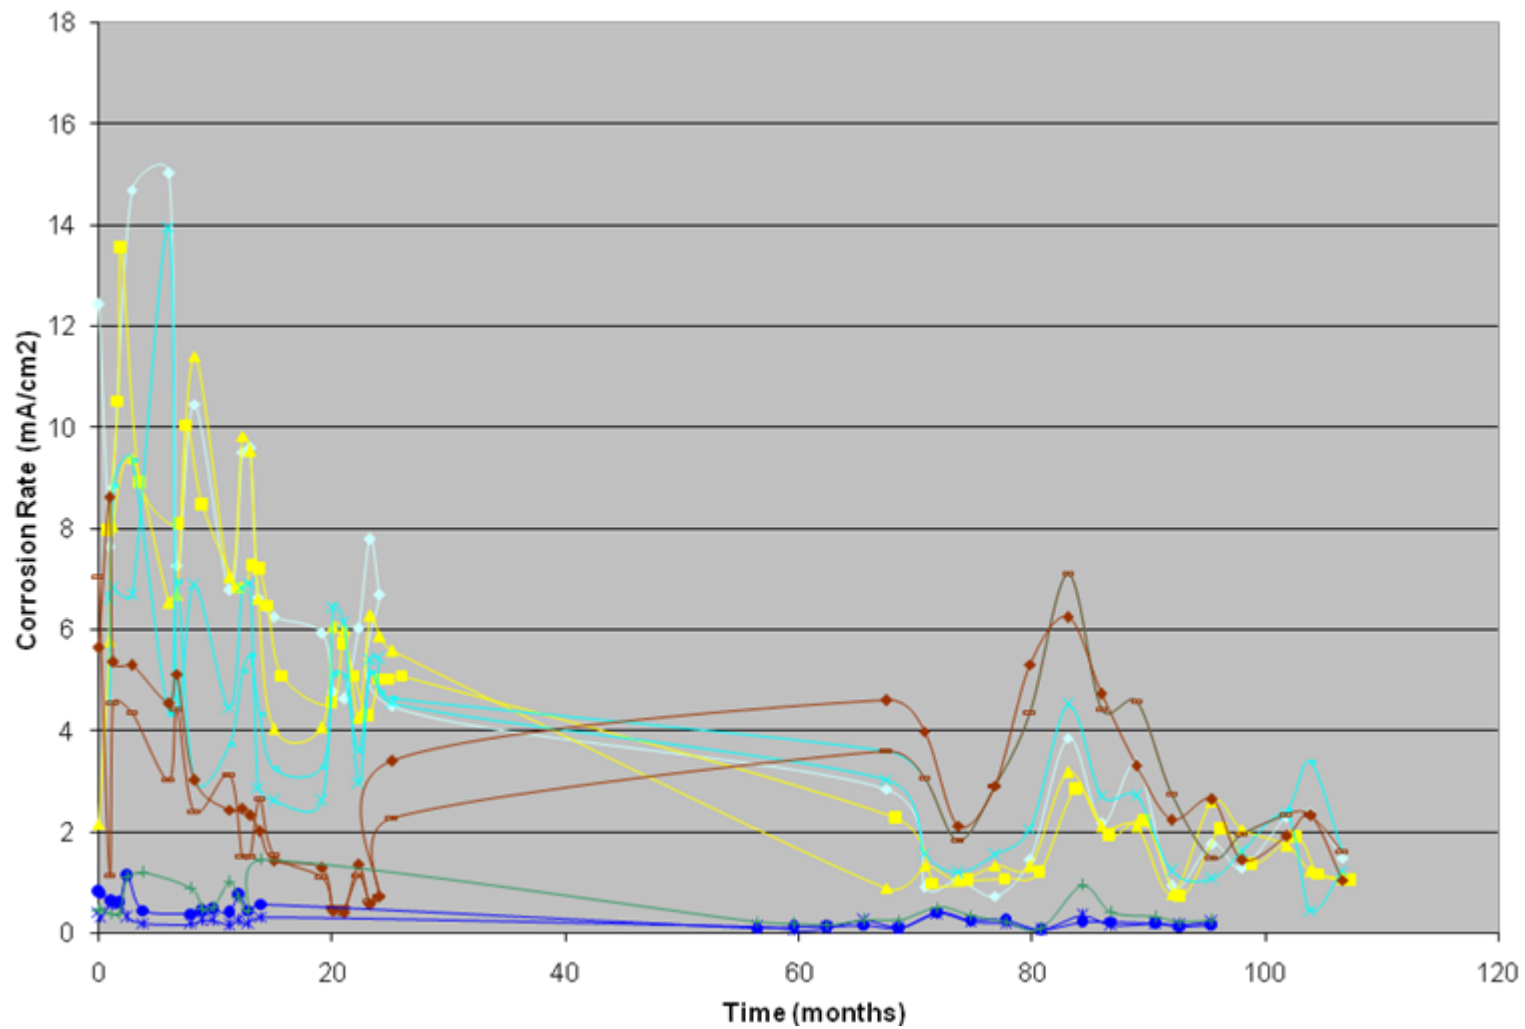
**Figure 25. Graph. Corrosion rate versus time.**

Corrosion rate measurements were influenced by many variables including concrete temperature, relative humidity inside the concrete, concrete resistance, etc. After the application of ECE, low corrosion rates are normally expected. As a result, the high corrosion rates observed for pH-ECE slabs contradicted that expectation. Either ECE was not effective or the rate measurements did not accurately reflect the true values. The effectiveness of the ECE process was demonstrated by all other data. Thus, the accuracy of the measurement was suspect. The difference in the corrosion rates measured between pH-ECE slabs and n-ECE slabs suggests that the control of pH impacts the ability to accurately measure corrosion rates. No experimentation was performed either in the SHRP study or in this study to ascertain the impact of pH control during the application of ECE on the measurement of corrosion rate.

The 3LP-NBS device does not have any control over the length of the rebar over which the measurement was made. For the purpose of calculating the corrosion rate, the length and size of the rebar under the probe of the device was used. Generally, the device makes the measurement over a much larger length of the rebar than the length that used in the calculation. The length of the rebar effected by the measurement was dependent on the depth of the rebar and the resistance of the concrete between the probe and the steel. An estimate of resistivity between the probe and steel can be obtained by looking at the resistance between the two mats of steel. Although the resistivity of the top layer of concrete and the layer of concrete between the two mats may not be the same, the change in resistivity probably would be in unison. Resistance between the two mats normalized to 69.8 °F (21 °C) is presented in figure 26, which shows that the resistance of the slabs increased over time. As increase in resistance reduced the error in the measurement of the rate and the actual corrosion currents also reduced. Thus, the increase in resistance should be accompanied by a reduction in the corrosion rate measurements. Figure 24 shows the reduction in corrosion rate with time as resistance increased. The variation in the corrosion rates with time is partially explained by the increase in resistance.

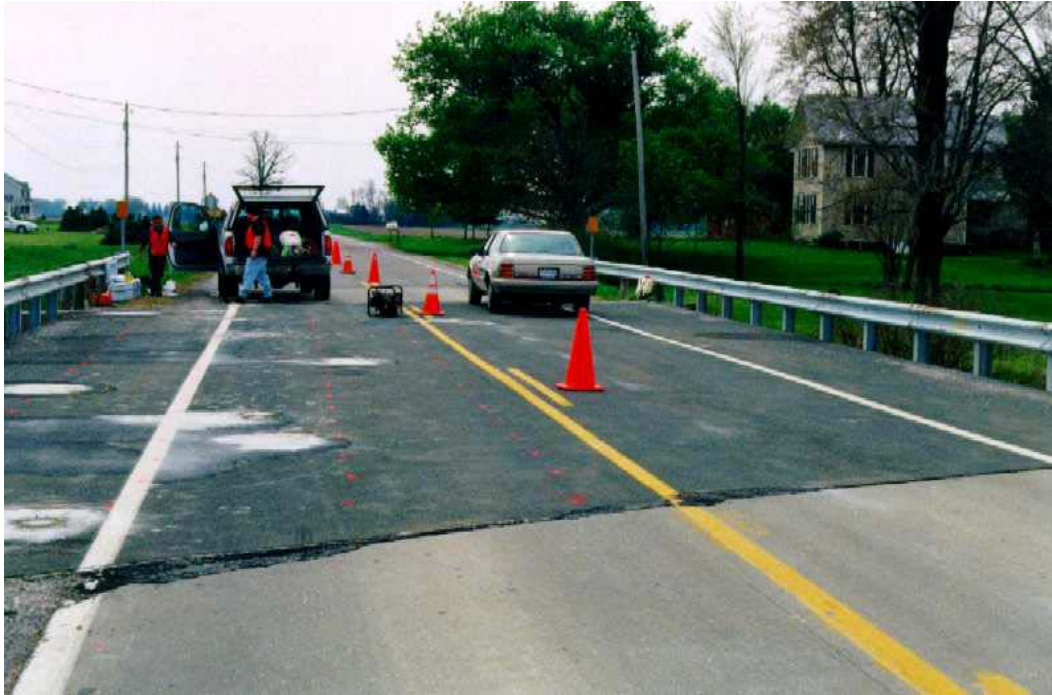
**Figure 27. Photo. Deck surface of bridge carrying SR-295 over Blue Creek in Lucas County, OH.**

A corrosion condition evaluation of the deck conducted in March 1991 documented a delaminated area of 148.81 inches<sup>2</sup> (93,005.58 mm<sup>2</sup>).<sup>(1)</sup> The average chloride content varied from 5,820 ppm at a nominal depth of 0.55 inches (14 mm) to 860 ppm at a nominal depth of 2.54 inches (65 mm). Corrosion potential mapping identified 18 percent of the deck area to have a 90 percent probability of active corrosion. Corrosion rate measurements taken at four locations on the deck were in the high range (6.90 to 11.4  $\mu\text{A}/\text{inches}^2$  (1.07 to 1.78  $\mu\text{A}/\text{cm}^2$ )), which are considered to result in concrete damage within 2 to 10 years.<sup>(1)</sup> Petrographic analysis determined that the deck concrete was of excellent quality considering materials, consolidation, air entrainment, water-cement ratio, and cement maturity.

In September 1991, an ECE treatment was applied to the eastern half of the bridge deck covering 1,317.6 ft<sup>2</sup> (122 m<sup>2</sup>). The western half was not treated and was designated as a control.

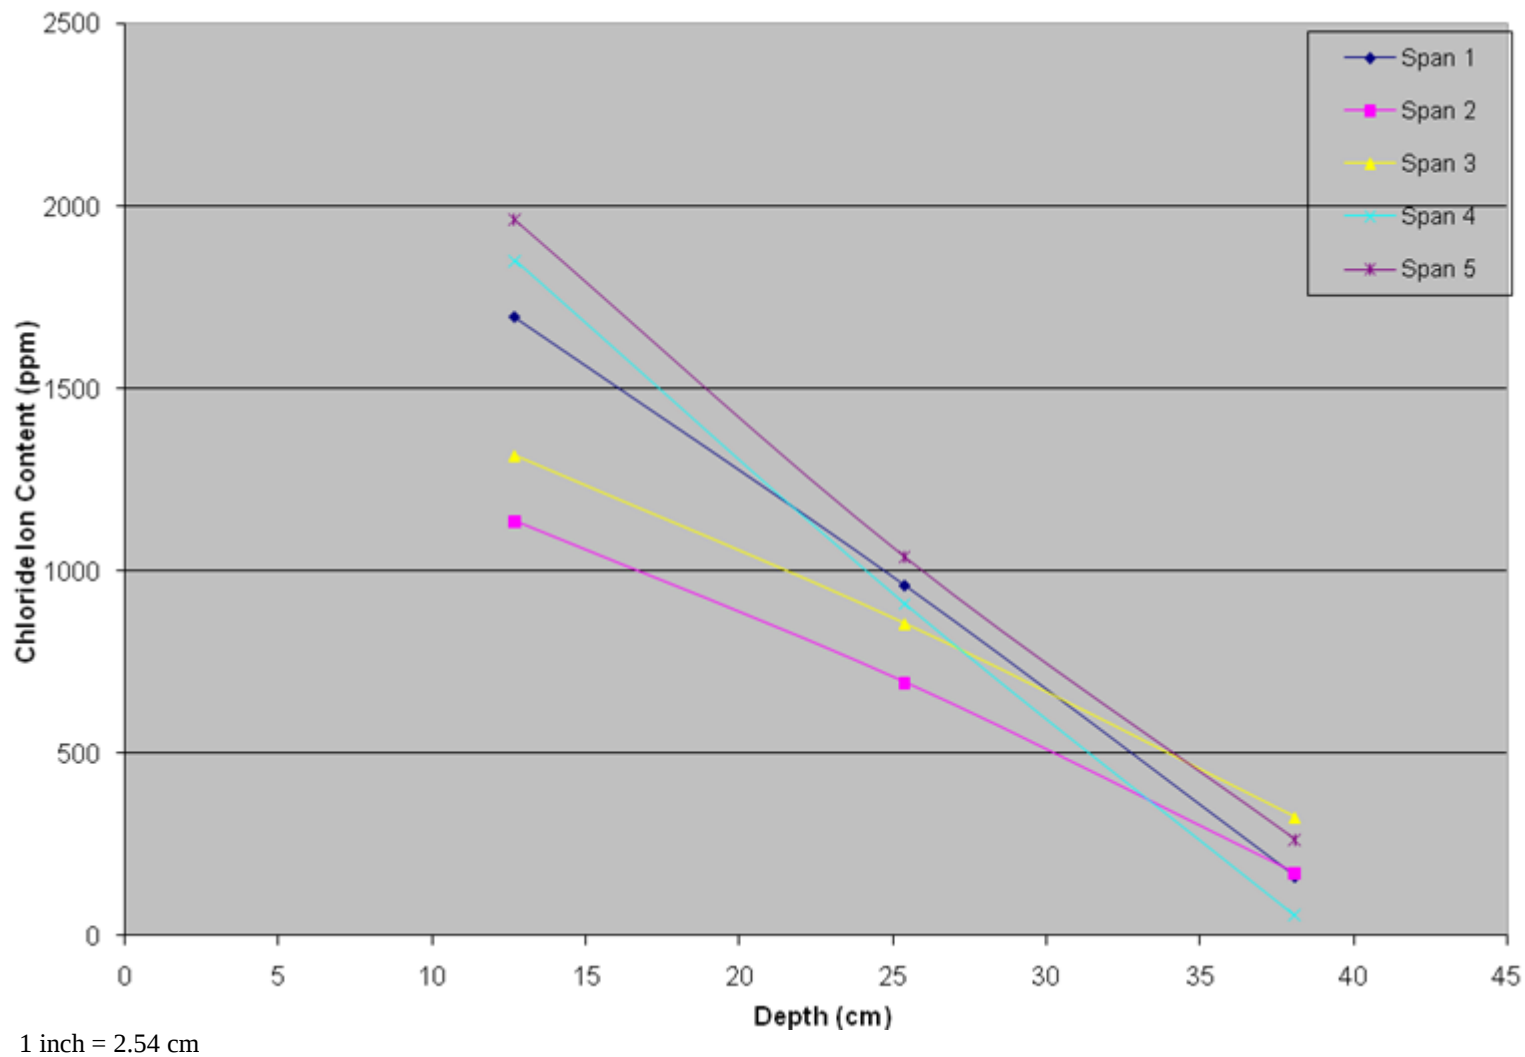
Figure 32. Graph. Pretreatment chloride profiles.

The average clear concrete cover varied from 0.75 to 1.8 inches (19 to 45 mm) and averaged 1.3 inches (33 mm). The average chloride content extrapolated to the average steel depth of 1.3 inches (33 mm) was 971 ppm. Corrosion potential mapping indicated that 78 percent of the deck had a low probability of corrosion activity, and 3 percent had a high probability of corrosion activity. The corrosion status of the remaining 19 percent was uncertain. In total, 48 corrosion rate measurements were made, with 68 percent of these measurements in the passive range and 32 percent in the low to moderate range.

Rehabilitation of the bridge deck was performed between March and September 1995. All unsound concrete was removed and patched with a cementitious material. Budgetary constraints did not allow application of ECE to the entire bridge, and the treatment was limited to spans 4 and 5, totaling 7,776 ft<sup>2</sup> (720 m<sup>2</sup>) of deck surface area. Spans 1–3 were designated as controls. Although spans 4 and 5 had lower levels of corrosion-induced damage, the chloride content interpolated to the average steel depth of 1.3 inches (33 mm) was 649 and 929 ppm compared to 819, 654, and 912 ppm for spans 1–3, respectively. Also, chloride content at lower depths in spans 4 and 5 were generally higher than the other spans (see figure 32). The lower levels of damage on spans 4 and 5 made them more advantageous for ECE application.

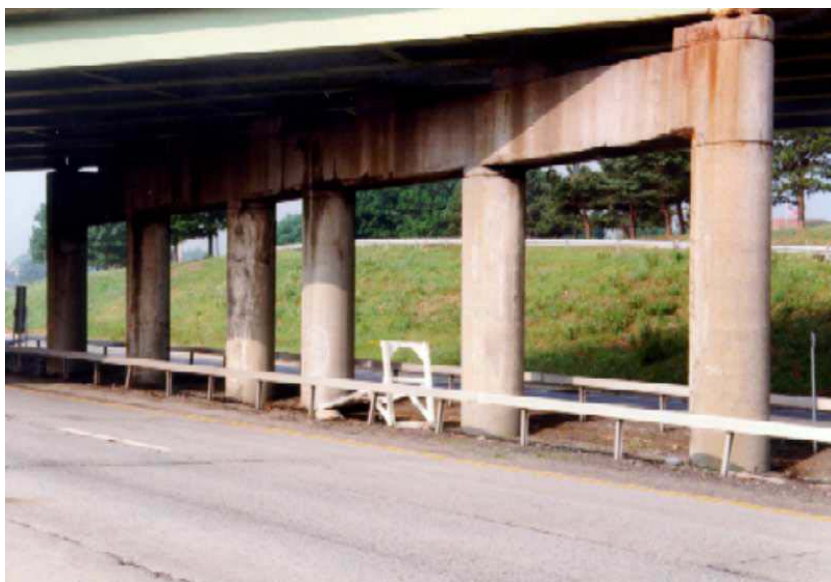
**Figure 36. Photo. Pier 2 of the Campus Loop Bridge in Albany, NY.**

In May 1992, all delaminated concrete from subject columns was removed to the rebar level and repaired by patching with a cementitious material. In June 1992, electrochemical chloride extraction treatment developed under the SHRP program was applied to the six columns on pier 2. The pier cap beams were not treated.

Each column was wrapped by a 10.99-ft (3.35-m)-long anode/blanket composite, which was covered by a plastic film, and a 0.3 M sodium borate buffered electrolyte was used. The anode/blanket composite contained three layers of blanket material and the anode. The first layer was designed to retain the electrolyte and provide contact. A titanium mesh anode was sandwiched between the remaining two layers of blankets. The electrolyte was pumped to the top of the anode/blanket composite and allowed to flow down the column by gravity and collect in a sump. The containment of the electrolyte within the anode/blanket assembly was paramount to the success of the treatment. On columns 1 and 4, the containment could not be accomplished. Because these columns could not be treated, they were designated as untreated controls. For the application of ECE, two electrical zones were established, each containing two columns.<sup>(1)</sup> Zone 1 included columns 2 and 3, and zone 2 contained columns 5 and 6.

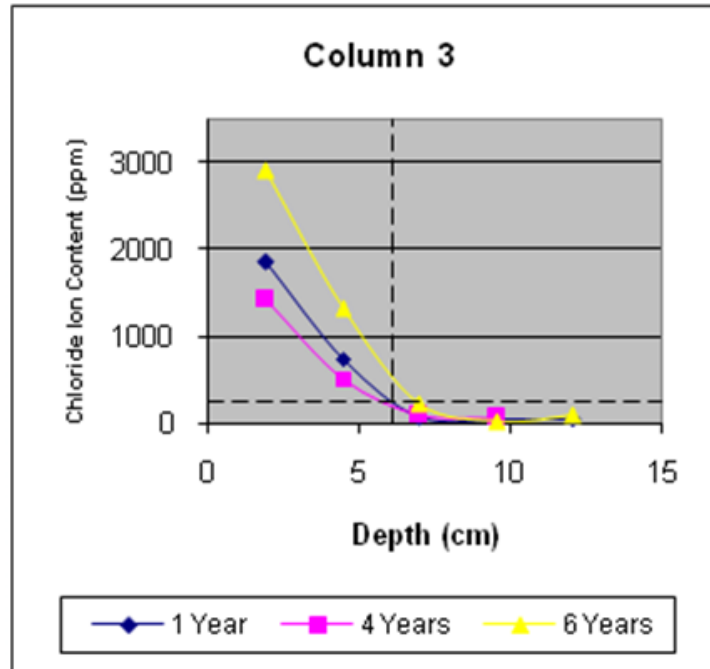
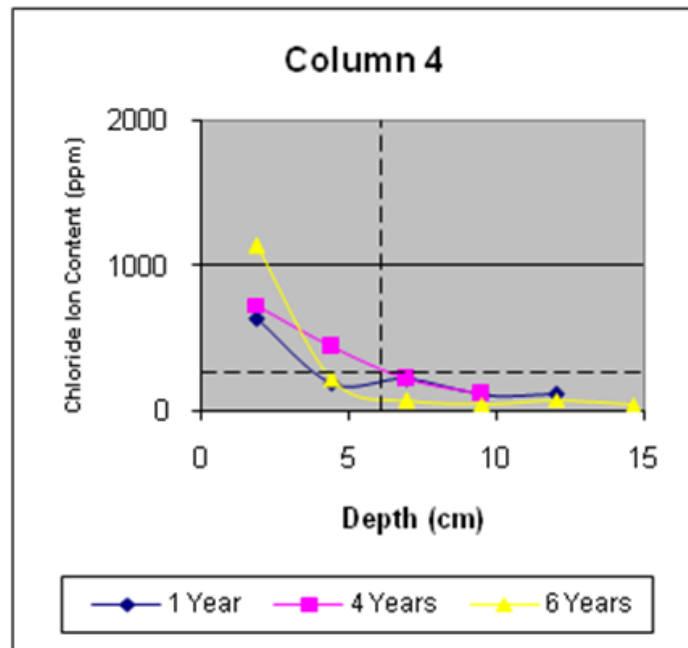
Figure 45 through figure 50 present the average variation of chloride ion content as a function of depth for each column. The data suggest that chloride ion content generally increased with time for all columns. This was expected as columns were exposed to chloride contaminated water runoff and splash. The chloride ions continued to migrate into the column concrete.

The average chloride ion content at the average steel depth was below the corrosion threshold for columns 2 and 4–6 and was above the threshold for the remaining columns. This explains the reduction in rate of increase of delaminations with time. Corrosion-induced damage primarily

occurred in patched areas with cracks and occurred adjacent to cracks in other areas where chloride ions had direct access to the steel.

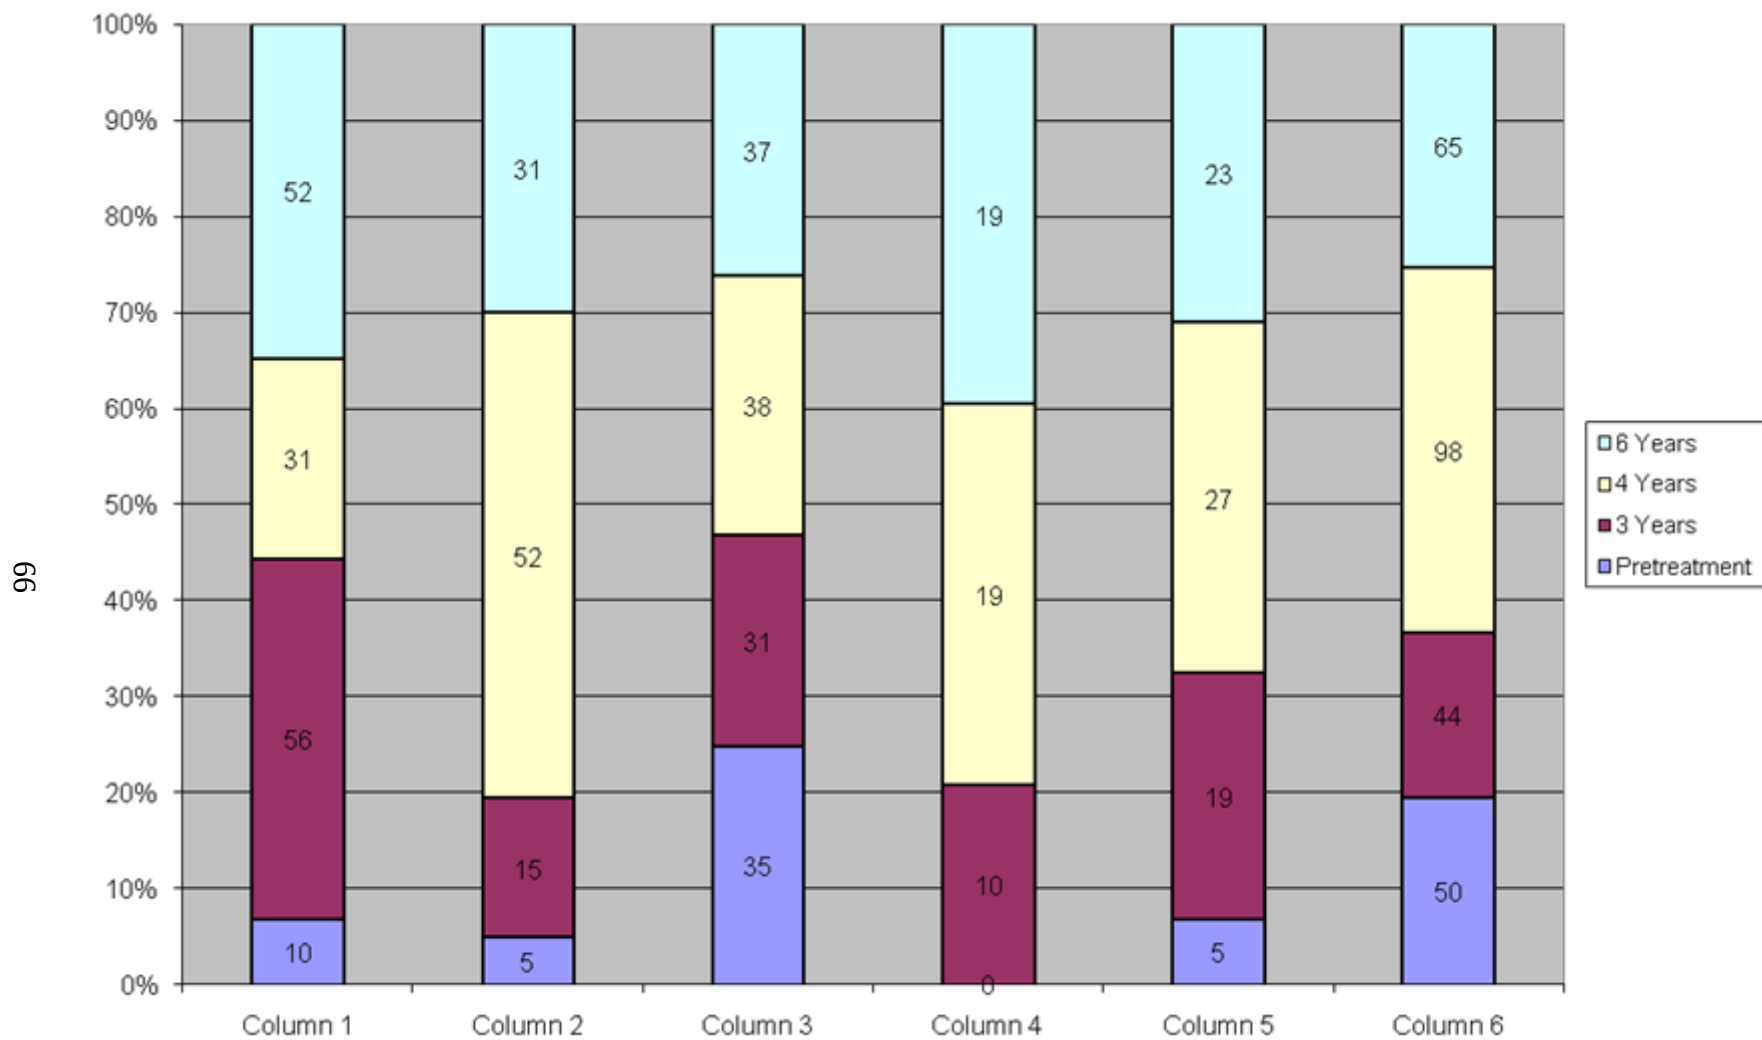
**Figure 51. Graph. Distribution of active potentials versus time.**

A half-cell potential survey was performed on a 2.00-ft (0.61-m) grid on each column with a copper-copper sulfate half-cell during each evaluation. In five of the six columns, the percentage of active potentials increased with time, and it remained constant in column 3 (see figure 51).
