# Highway Concrete Pavement Technology Development and Testing: Volume V— Field Evaluation of Strategic Highway Research Program (SHRP) C-206 Test Sites (Bridge Deck Overlays)

PUBLICATION NO. FHWA-RD-02-086

AUGUST 2006

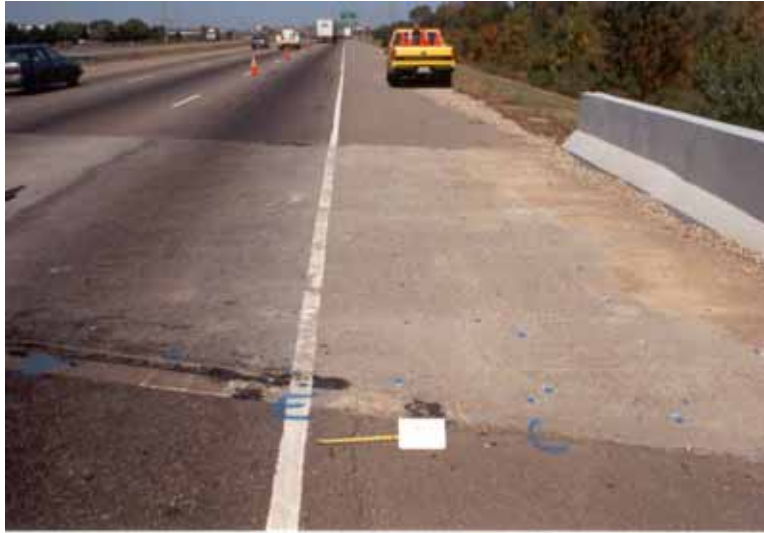
**Figure 2. Photograph showing test section on I-270 northbound (1995).**

The test sections studied on both spans include the shoulder and travel (outside) lanes. Examination of the deck overlay surface indicated several narrow longitudinal cracks in the shoulder lanes of both bridges. Cracks were more frequent in the travel lanes. The travel lane of the northbound SFC bridge had mostly single nonconnected cracks running in both the longitudinal and transverse directions with very little branching. The travel lane of the southbound LMC bridge had more and longer longitudinal cracks and also more branching of cracks.

Severe cracking and spalling was noted in the exposed travel surfaces of the abutments of the northbound SFC structure. The overlay at the approach joint was spalled away and had been patched with a soft tar-like material. The joint between the bridge and the abutment on the leave side of the bridge was irregular, with a separate one-foot wide closure pour placed between the deck and the abutment. The joint between the closure pour and the abutment was well-sealed, but the formed joint between the deck and the closure pour was open and packed with debris.

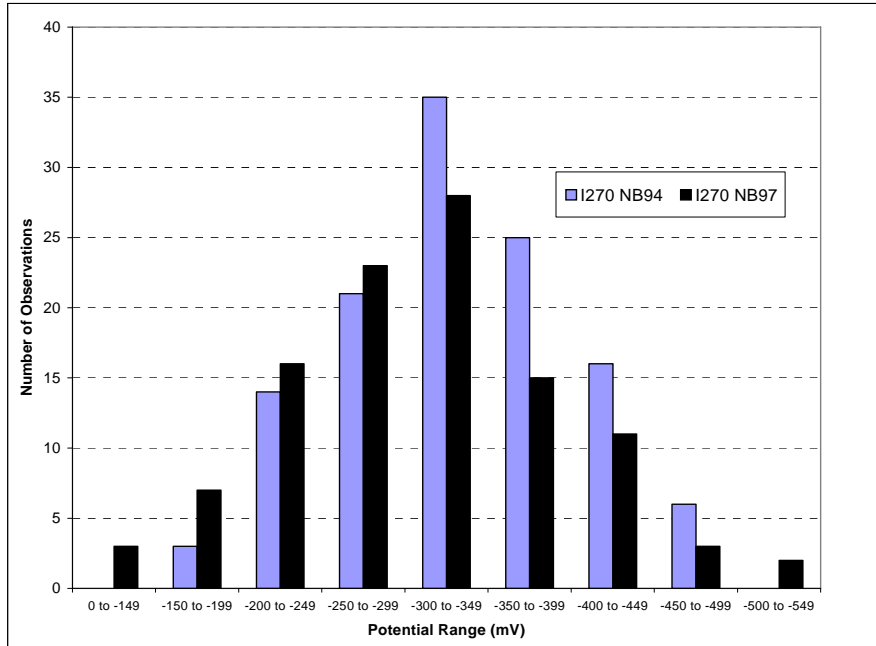
The half-cell potential survey was performed using a 0.6-m (2-ft) grid spacing over the entire test area (shoulder and outside travel lane) of each span in 1994 and 1997. The electrical connection to the top layer of reinforcement was made using a 50-mm (2-inch) diameter core hole drilled to the top layer of reinforcing steel. A hole was drilled in the reinforcing bar and a self-tapping screw was used to make the connection. The half-cell readings for the northbound lanes SFC in 1994 ranged from -179 mV to -471 mV, with large potential differences between nearby areas. These readings tend to indicate that some corrosion is taking place in the bridge. Table 4 shows the cumulative frequency of the half-cell potentials for the northbound SFC structure in 1994. Table 5 shows the cumulative frequency of the half-cell potentials measured in 1997. These numbers range from -133 mV to -535 mV. A histogram of the data for the I-270 northbound SFC structure for 1994 and 1997 is shown in figure 4. The potentials tend to be less negative in 1997 than in 1994, however, many areas remain very negative, indicating continued corrosion.

**Figure 4. Histogram of half-cell potentials for I-270 NB SFC test section for 1994 and 1997.**

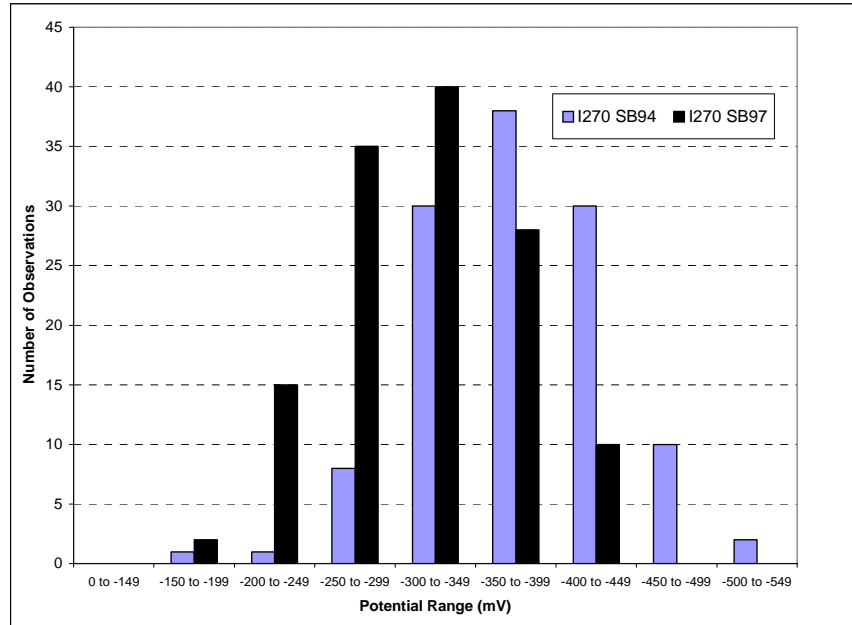
The half-cell potentials for the southbound LMC span in 1994 range from  $-188$  mV to  $-540$  mV. A cumulative percentage summary of the data is shown in table 6. The data for 1997 is shown in table 7. For 1997 the data ranges from  $-167$  mV to  $-449$  mV. A histogram of the data for the southbound LMC test section for the years 1994 and 1997 is shown in figure 6. The potential generally shift less negative (less corrosion) in 1997 versus 1994.

**Figure 6. Histogram of half-cell potential readings for the I-270 southbound LMC-III test section for 1994 and 1997.**

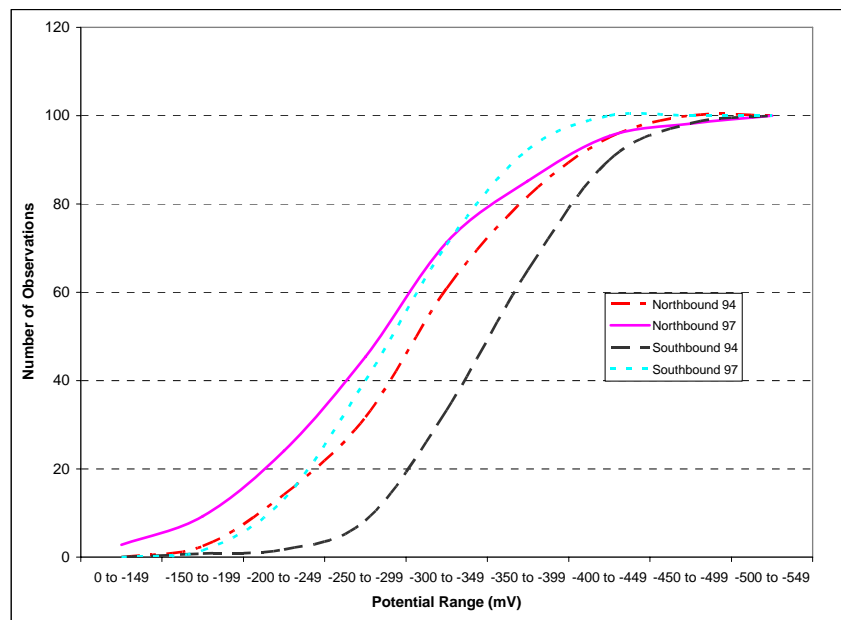
Past experience with research performed at the contractor site and published in FHWA report FHWA-RD-86-193, *Protective Systems for New Prestressed and Substructure Concrete*, indicates that corrosion potentials more negative than approximately  $-230$  mV indicate that corrosion is taking place in bridge deck type structures. According to the  $-230$  mV criteria, the majority of the locations surveyed had potentials indicating that corrosion was taking place. Both structures appear to be undergoing corrosion over the majority of their deck area. The ends of the bridges and the areas under cracked delaminations appear to be especially vulnerable. A cumulative frequency diagram of the potentials is shown in figure 8. The curve for both bridge decks is shifted to the left from 1994 to 1997. This indicates a decrease in the overall half-cell potentials. The shift is larger for the southbound lanes which have the latex-modified overlay.

**Figure 8. Cumulative frequency diagram for I-270 (NB and SB) for years 1994 and 1997.**

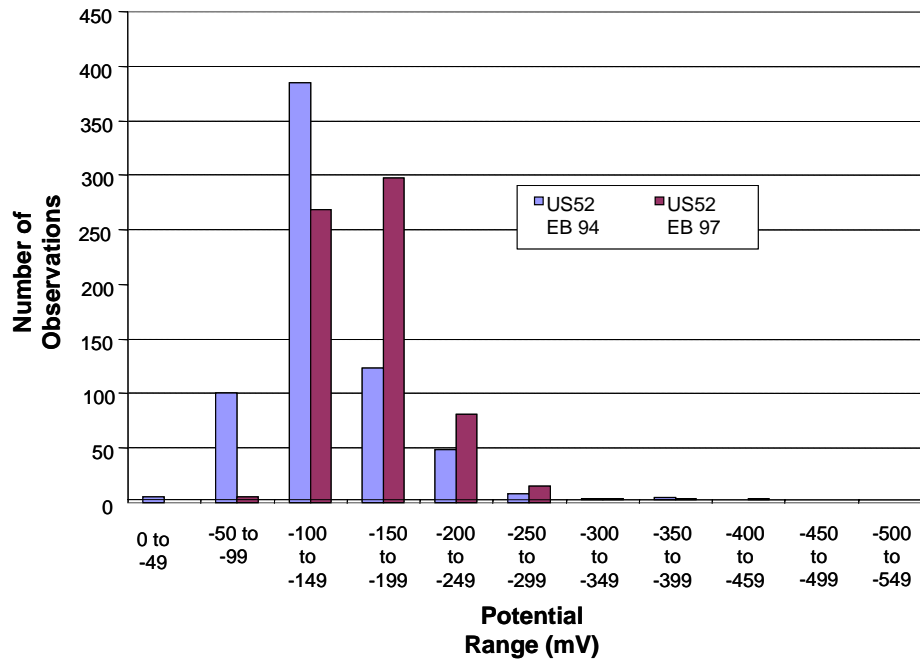
The readings for the eastbound travel lane in 1997, shown in table 21, range from  $-0.089$  V to  $-0.412$  V. Over 97 percent of the readings are below  $-0.250$  V. A histogram for the eastbound travel lane in 1994 and 1997 is shown in figure 12. The half-cell readings for the westbound travel

**Figure 12. Histogram of half-cell potential readings for U.S. 52 eastbound travel lane LMC in 1994 and 1997.**

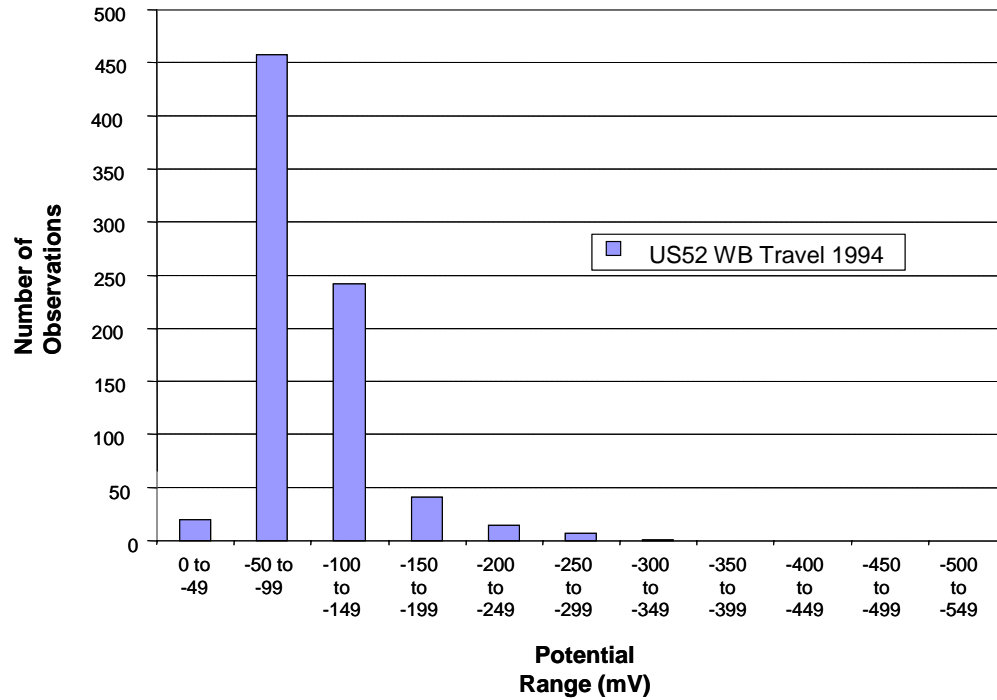
lane LMC in 1994 are shown in table 22 and in a histogram in figure 13. The readings ranged from  $-0.001$  V to  $-0.307$  V, and table 22 indicates 99 percent are below 0.25 V. This is similar to the eastbound LMC data and indicates a small probability of scattered corrosion occurring in the westbound travel lane.

**Figure 13. Histogram of half-cell potentials for U.S. 52 westbound travel lane LMC in 1994.**

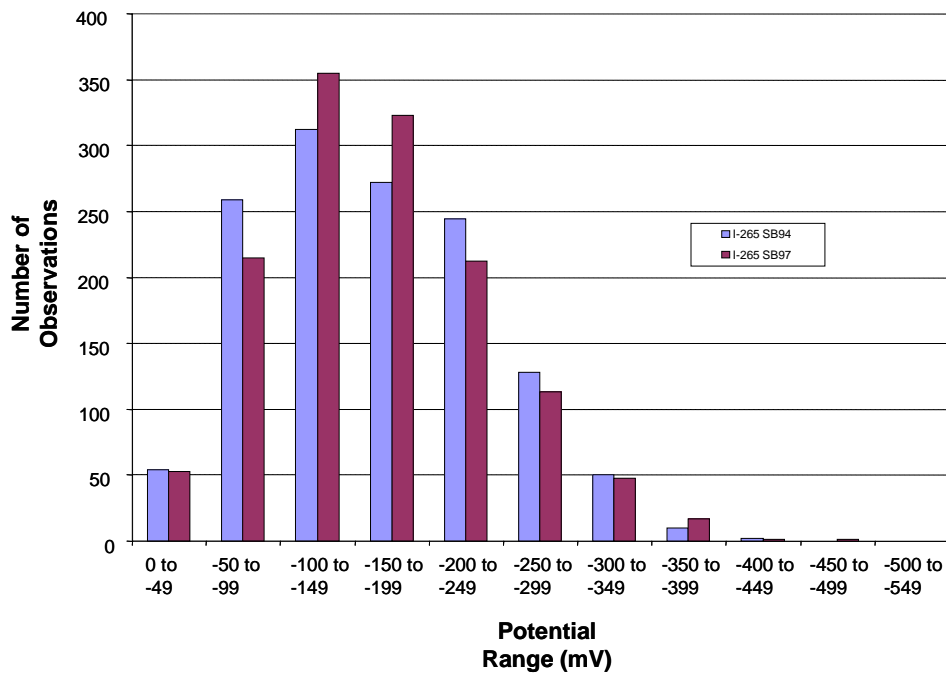
In 1997, the half-cell potentials ranged from +265 mV to -600 mV. Span 1 again had the highest average potential reading of -207 mV. Span 2 again had the highest potential reading at -600 mV and the lowest average reading at -149 mV. Span 3 had an average potential reading of -160 mV. Tables 35 and 36 give the cumulative frequencies of the half-cell potentials for the southbound test section of I-265 for 1994 and 1997, respectively. In 1994, over 85 percent of the readings were less negative than -250 mV. In 1997, over 86 percent of the readings were less negative than -250 mV. A histogram of the half-cell potential readings for the southbound test section in 1994 and 1997 is shown in figure 19.

**Figure 19. Histogram of half-cell potential readings for I-265 southbound SFC test section.**

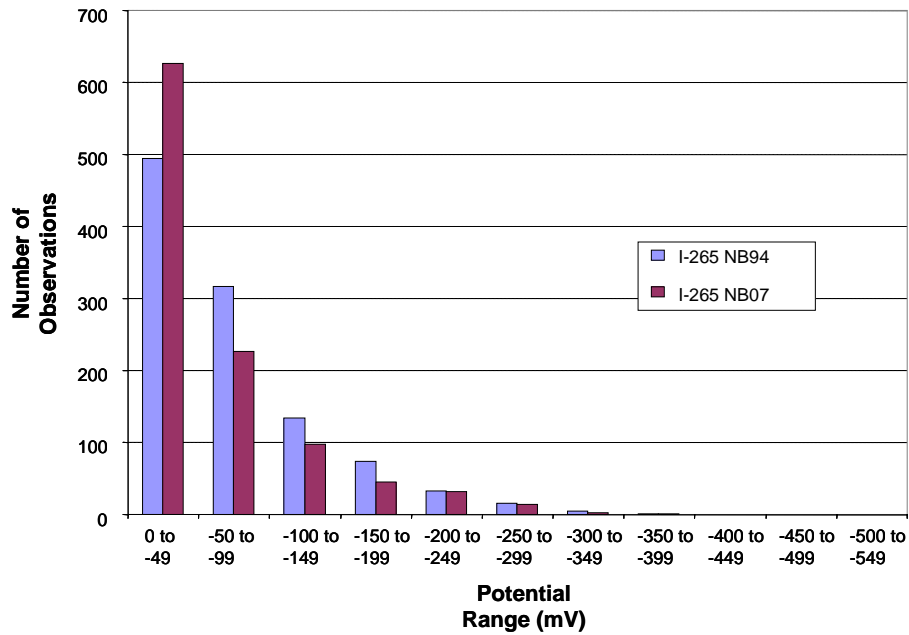
Span 2 had the highest individual reading at  $-356$  mV but had an average reading of only  $-65$  mV. Span 1 had an average potential reading of  $-55$  mV. In 1997, span 3 again had the highest average potential reading at  $-86$  mV but also had the highest individual reading at  $-352$  mV. Span 2 had an average potential reading of  $-61$  mV and span 1 had an average of  $-27$  mV. Tables 37 and 38 show the cumulative frequency of the half-cell readings for the northbound spans in 1994 and 1997. A histogram of the half-cell potential readings for the northbound test section for 1994 and 1997 is shown in figure 20. In 1994 and 1997, approximately 98 percent of the readings were less negative than  $-250$  mV. In areas away from the joints, the potentials were generally less negative than  $-100$  mV, indicating that very little corrosion is taking place in the bridge.

**Figure 20. Histogram of half-cell potential readings for the I-265 northbound LMC test section.**

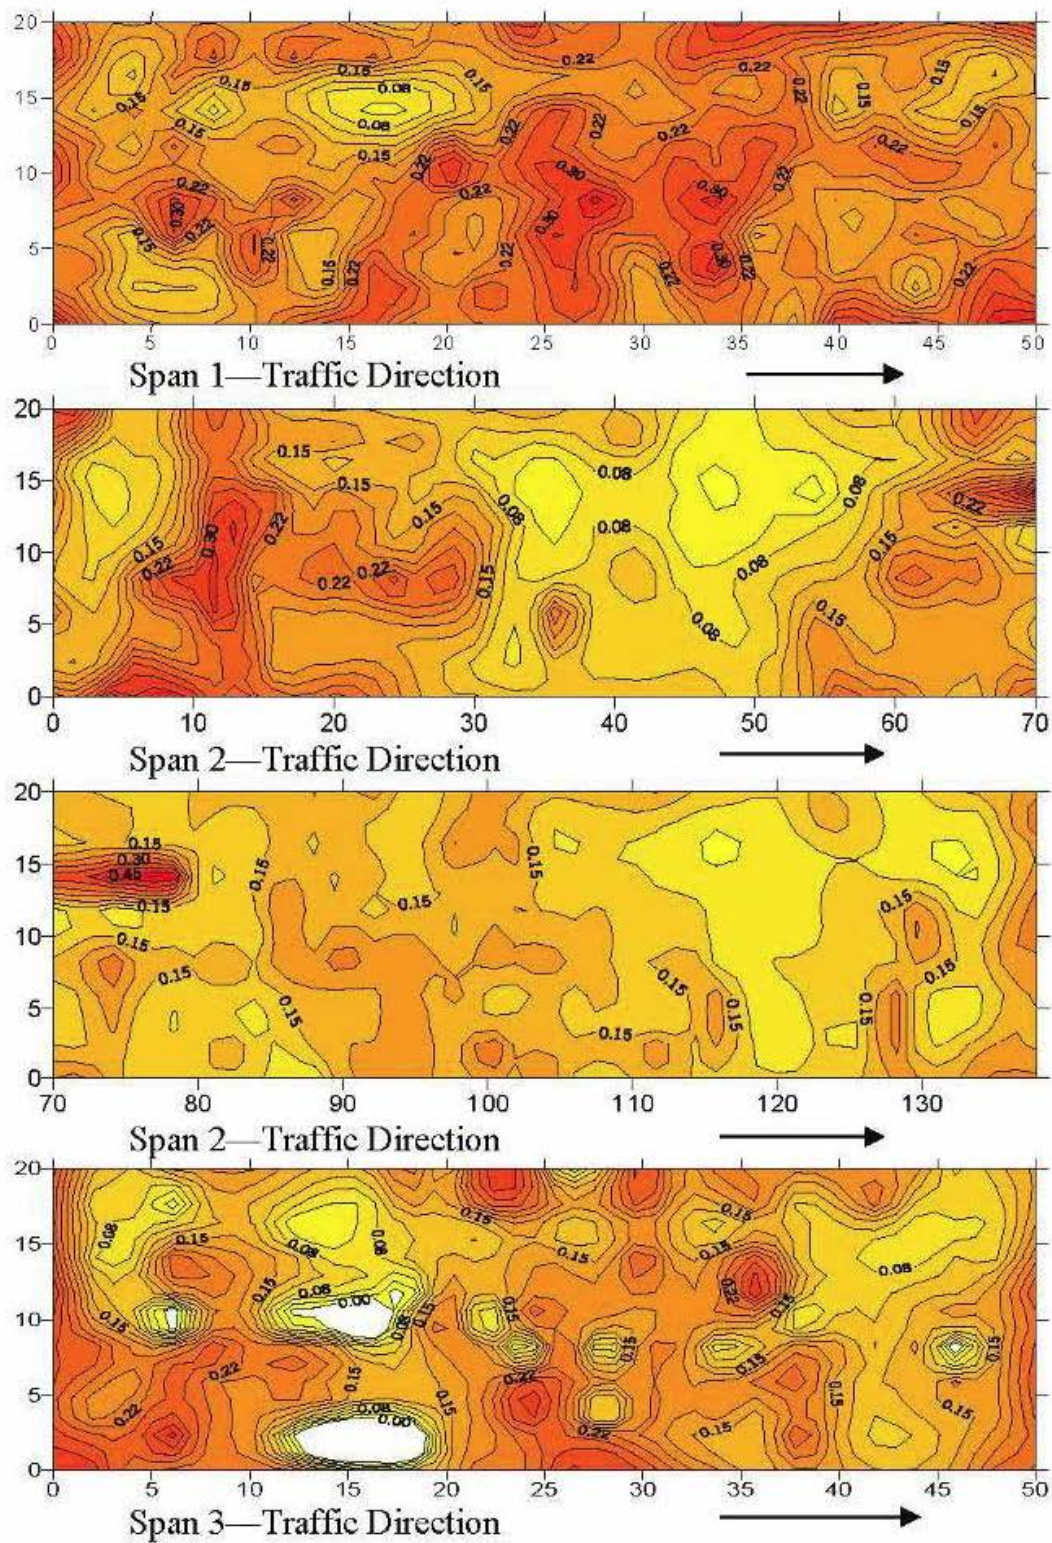
Figure 21 shows an equipotential map of the half-cell readings for the southbound SFC test section for 1997. Spans 1 and 3 appear to have more isolated spots of corrosion (anodic) activity than the main span. An equipotential map of the half-cell potential readings for the northbound LMC test section for 1997 is shown in figure 22. The magnitude of the half-cell readings is much lower in the northbound LMC test section than in the southbound SFC test section. However, some anodic areas are present, mainly near the joints and in the main span.

**Figure 21. Equipotential maps of half-cell potentials of the three southbound spans SFC of the I-265 test section in 1997.**

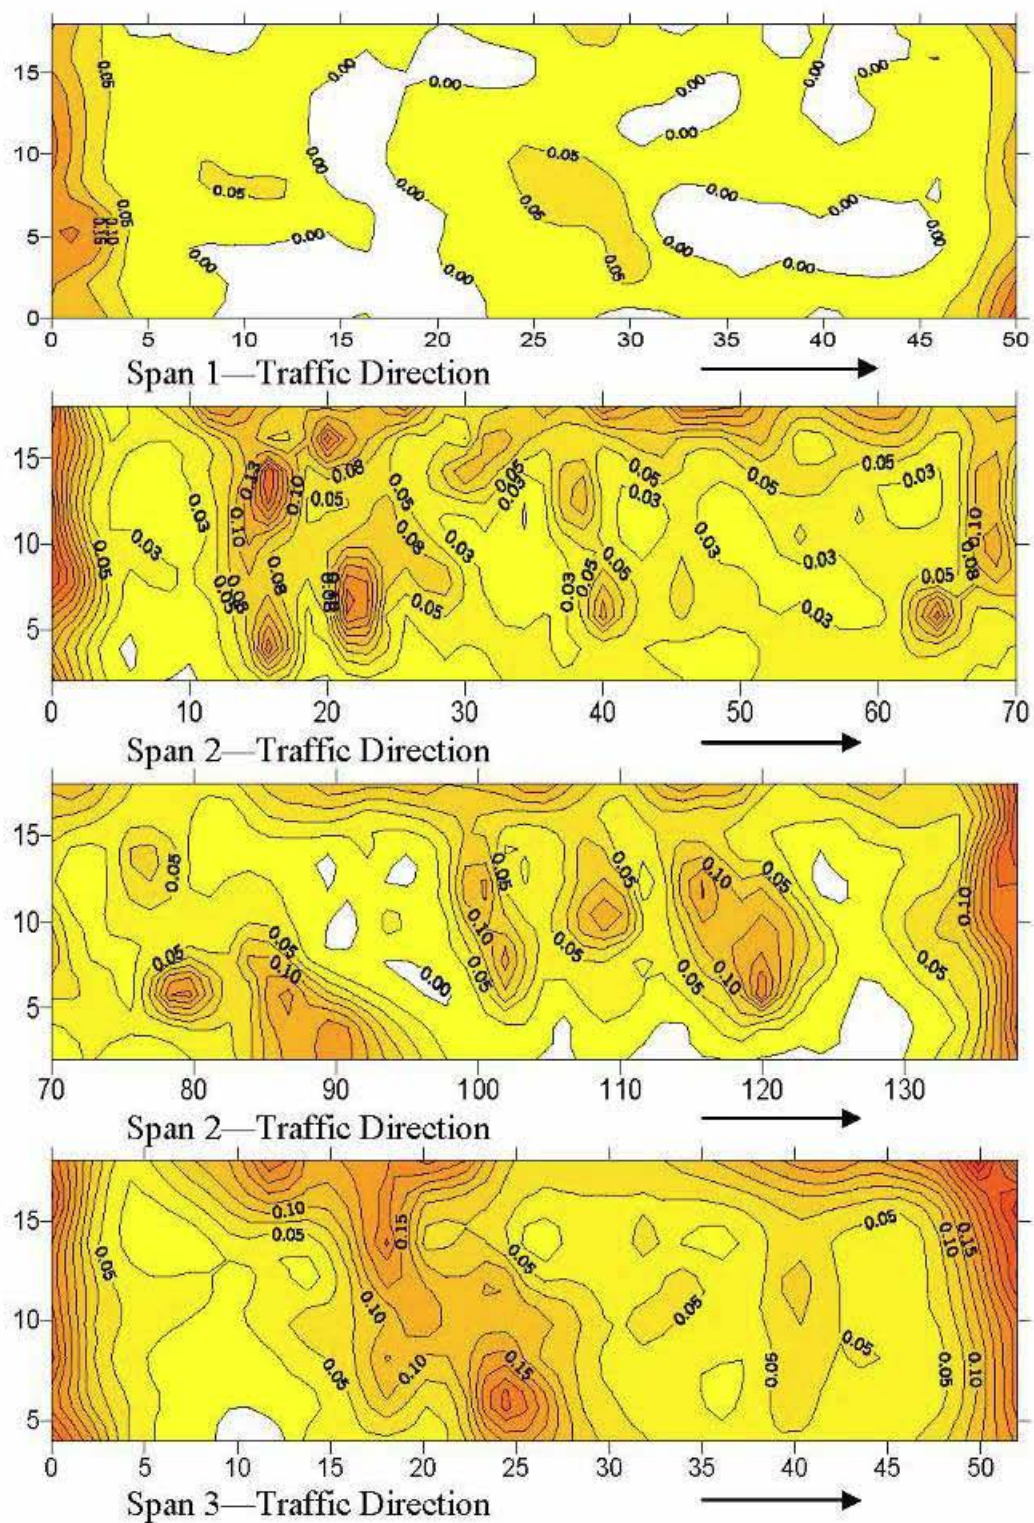
**Figure 22. Equipotential maps of half-cell potentials of the three northbound spans LMC of the I-265 test section in 1997.**

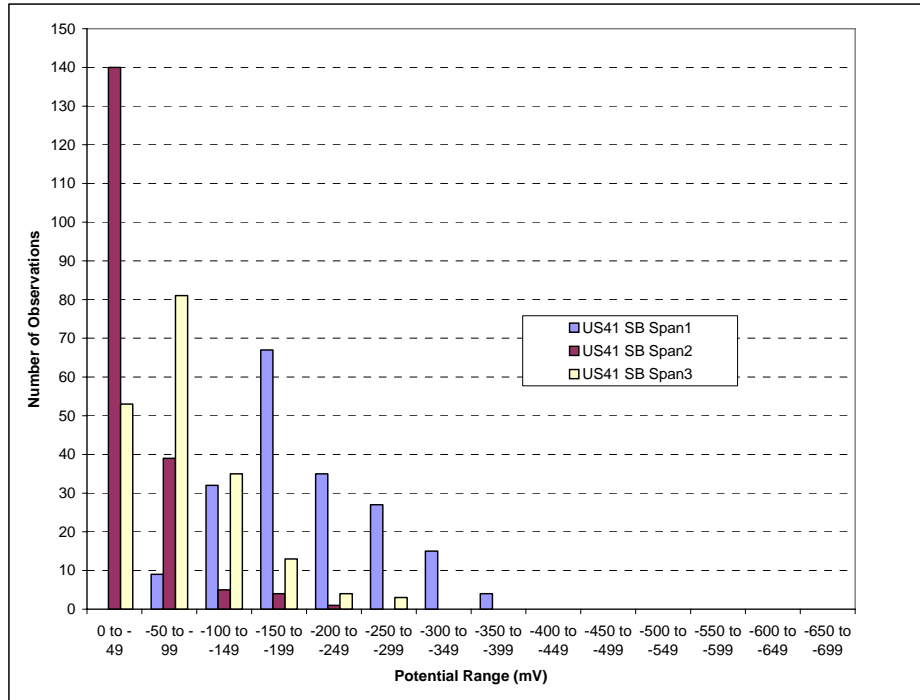
A summary of the half-cell potential measurements for the southbound travel lane SFC of the U.S. 41 test section in 1994 is shown in table 49. Span 1 had the most negative (corrosive) half-cell potentials of the three spans. The most negative measurement was  $-389$  mV and the least negative was  $-71$  mV. The average half-cell measurement for Span 1 was  $-201$  mV compared to  $-28$  mV for Span 2 and  $-84$  mV for Span 3. Span 2 had 54 half-cell readings out of 189 that were positive. The most positive reading was  $+74$  mV. For tabulation, the positive half-cell measurements were classified as 0 mV. Overall, the southbound SFC test section was in good condition in 1994. For Span 1, 76 percent of the half-cell readings were less negative than  $-250$  mV. This compares to 100 percent for Span 2 and 98.4 percent for Span 3. Overall, 91 percent of the measurements were less negative than  $-250$  mV. A histogram of the distribution of half-cell measurements for the three spans in 1994 is shown in figure 27. Span 1 has clearly shifted more negative (corrosive) compared to the other two spans.

**Figure 27. Histogram of half-cell potential readings for U.S. 41 southbound in 1994 SFC.**

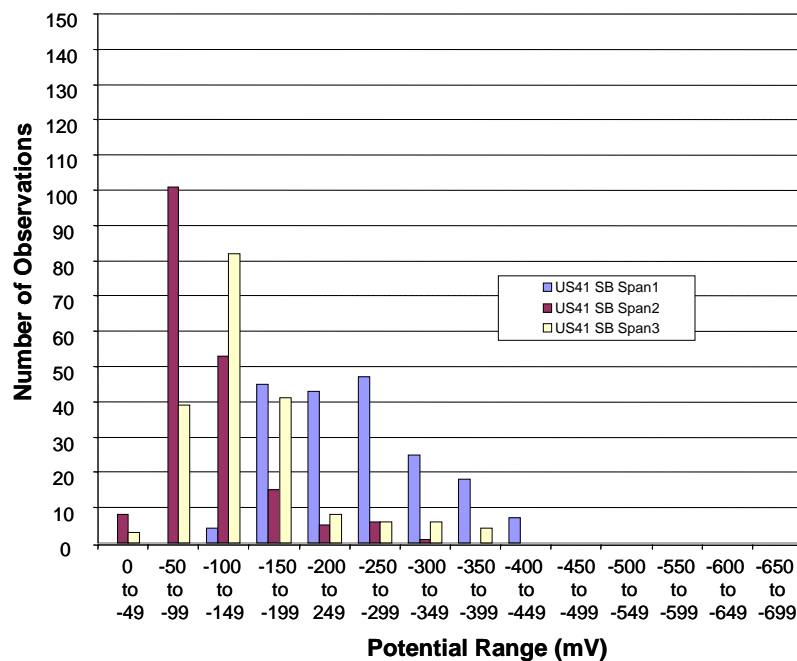
A summary of the half-cell measurements for the southbound structure in 1997 is shown in table 50. The half-cell measurements were more negative for all three spans in 1997 than in 1994. Span 1 had an average reading of 258 mV with a maximum negative reading of -435 mV and a minimum negative reading of -134 mV. Span 2 had an average of -108 mV with a maximum of -305 mV and a minimum of -19 mV. Span 3 had an average reading of -142 mV with a maximum of -383 mV and a minimum of -16 mV. The average half-cell reading for Span 1 was above the 250 mV threshold for corrosion to occur. A histogram comparing the distribution of half-cell readings for the southbound section in 1997 is shown in figure 28. A histogram comparing the distribution of half-cell measurements for the entire southbound test section in 1994 and 1997 is shown in figure 29. The curve for 1997 is shifted significantly to the right which indicates a probability of increased corrosion activity, especially in Span 1.

**Figure 28. Histogram of half-cell potential readings for U.S. 41 southbound in 1997 SFC.**

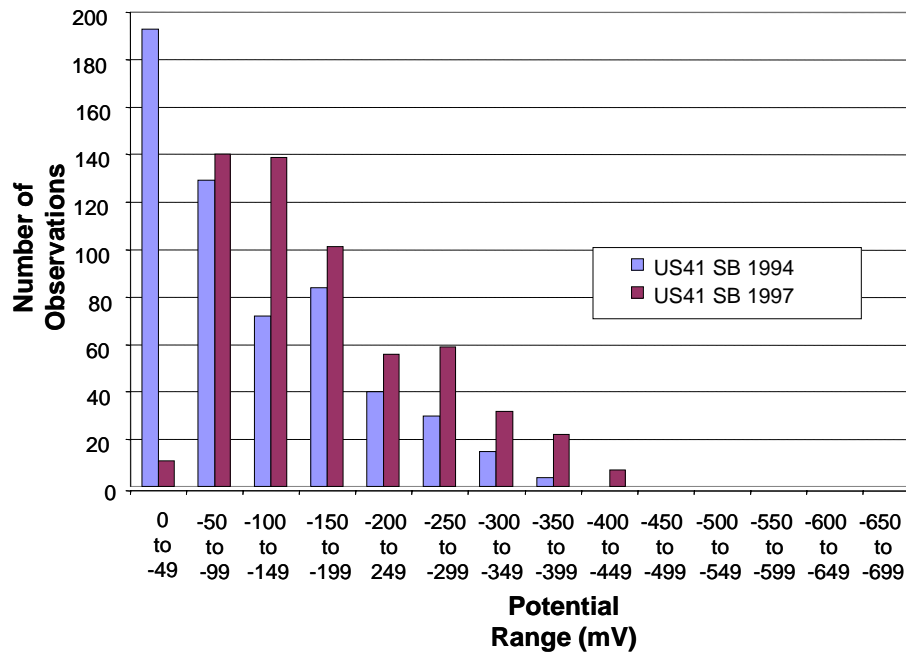
**Figure 29. Histogram of half-cell potential readings for U.S. 41 southbound SFC in 1994 and 1997.**

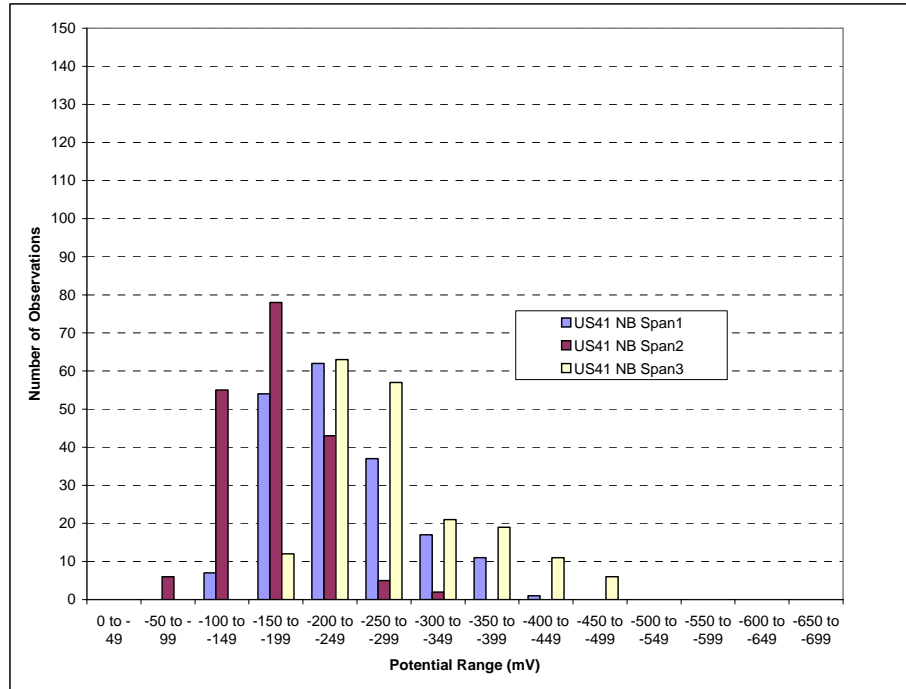
A summary of the half-cell potential readings for the northbound LMC spans in 1994 is shown in table 51. Span 3 has higher magnitude half-cell readings than the other two spans. The average half-cell potential reading for Span 3 was -281 mV, compared to -235 mV for Span 1, and -171 mV for Span 2. The average for Span 3 was over the threshold limit of 250 mV needed for corrosion. The maximum half-cell potential for Span 3 is -499 mV, for Span 1 is -425 mV, and for Span 2 is -320 mV. All three spans had half-cell potentials indicative of corrosion occurring in the deck. A histogram of the distribution of half-cell potentials for the northbound LMC spans in 1994 is shown in figure 30. Span 3 had the most negative potentials (most corrosive).

**Figure 30. Histogram of half-cell potential readings for U.S. 41 northbound LMC in 1994.**

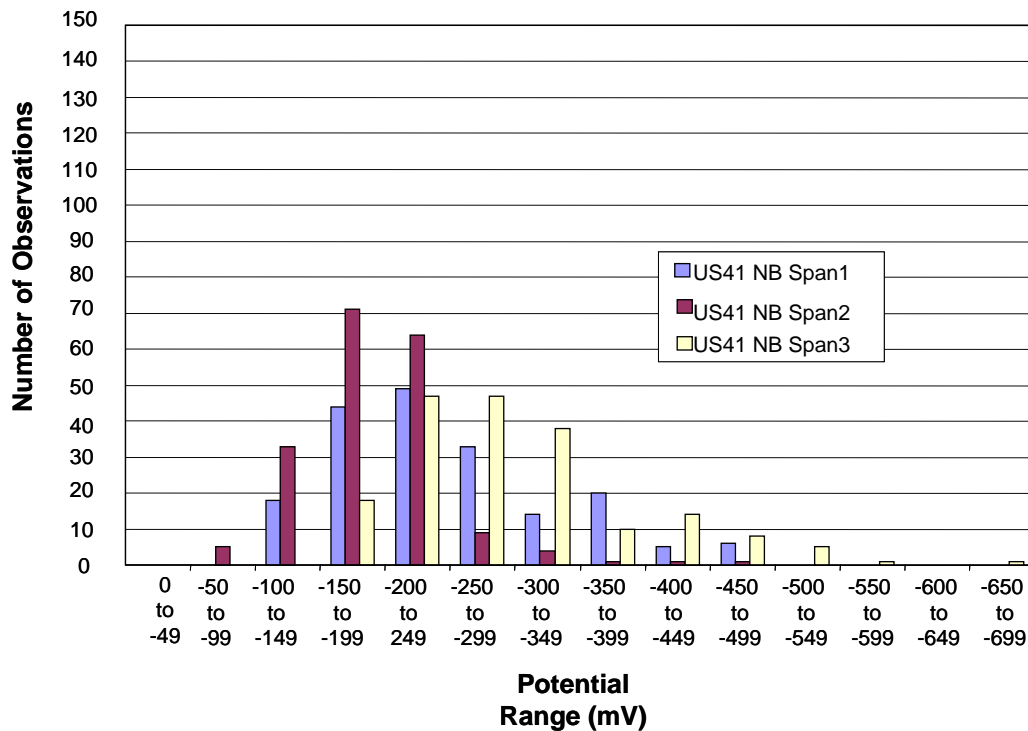
All three spans have a considerable number of half-cell readings above the -250 mV threshold for corrosion. A histogram of the half-cell potential readings for the northbound spans in 1997 is

**Figure 31. Histogram of half-cell potential readings for U.S. 41 northbound LMC in 1997.**

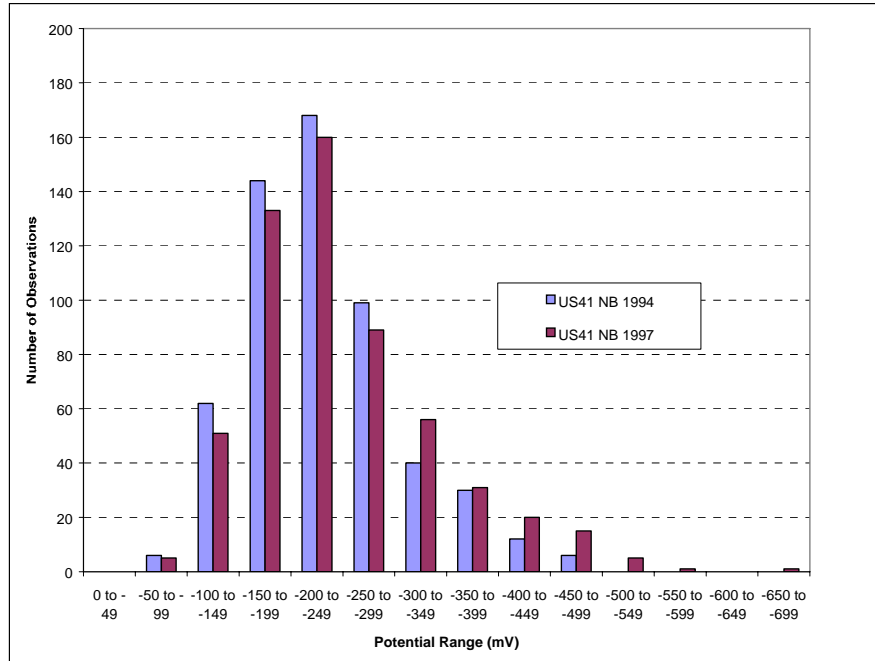
shown in figure 31. A histogram of the half-cell potential readings for the entire northbound structure in 1994 and 1997 is shown in figure 32. The distribution appears similar but the curve for 1997 is shifted to the right, indicating a probability of increased corrosion.

**Figure 32. Histogram of half-cell potential readings for U.S. 41 northbound spans in 1994 and 1997.**

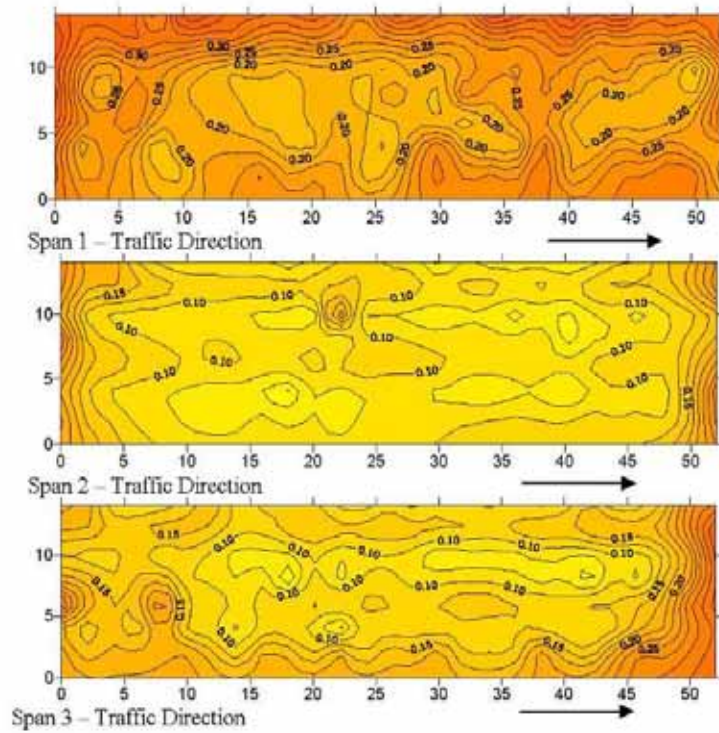
**Figure 34. Equipotential maps of half-cell potentials for the three spans of the southbound test section of U.S. 41 in 1997 SFC.**

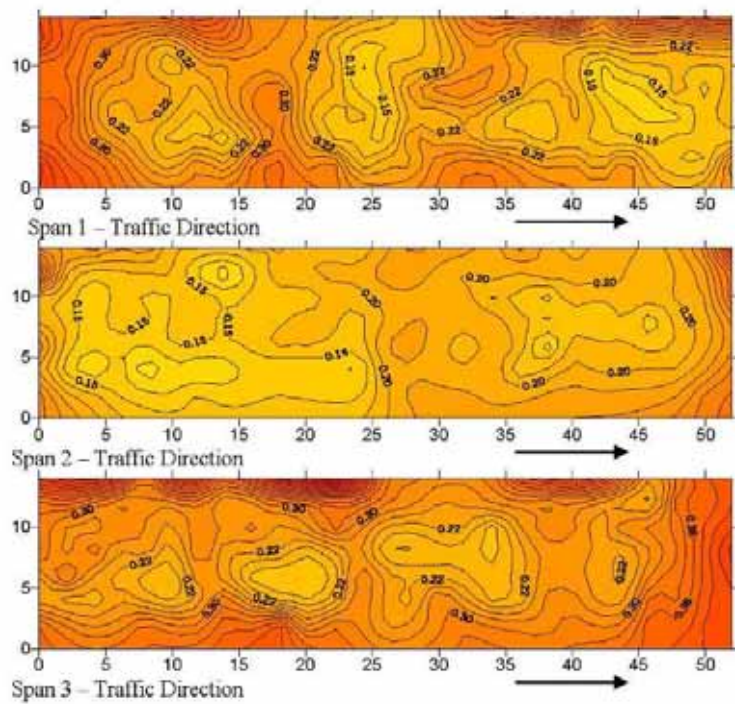
A cumulative frequency diagram for both test sections of U.S. 41 is shown in figure 33. The figure shows the shift to the right for both test sections. The shift in the curve for the southbound SFC spans is much greater than that for the northbound spans LMC. However, the northbound spans LMC had more negative values both initially and at the end of the study than the southbound SFC spans. An equipotential map of the half-cell readings for the southbound spans SFC of U.S. 41 is shown in figure 34. The figure for Span 1 indicates there is corrosion occurring along the edge between the travel and passing lane and at the two ends of the span. The figures for Span 2 and Span 3 indicate corrosion is occurring in isolated areas and also at the ends of the spans. An equipotential map for the half-cell readings for the northbound spans LMC is shown in figure 35. The maps for Span 1 and Span 3 indicate corrosion occurring over much of both spans and especially along the edge between the travel and passing lanes. The map for Span 2 indicates isolated areas of corrosion but most areas are at the ends of the span.

**Figure 35. Equipotential maps of half-cell potentials for the three spans of the northbound test section of U.S. 41 in 1997 LMC.**
