# Highway Concrete Pavement Technology Development and Testing: Volume I— Field Evaluation of Strategic Highway Research Program (SHRP) C-202 Test Sites (Alkali-Silica Reaction (ASR))

PUBLICATION NO. FHWA-RD-02-082

AUGUST 2006

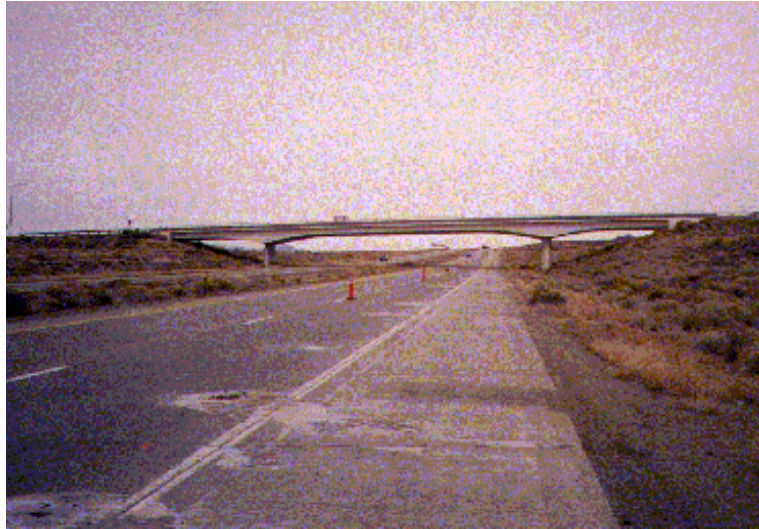
This test site is the pavement described in the SHRP C-343 report, “Eliminating or Minimizing Alkali-Silica Reactivity.” The test section consists of eleven 24.4-meter (m) groups of five-slab panels on the travel (number 2) lane of U.S. Interstate 80 (I-80) just east of Winnemucca, NV. The pavement was built in 1981. It consists of a plain, jointed, 20.3-centimeter (cm)-thick concrete slab over a 15.2-cm portland cement-treated base and a 7.6-cm gravel subbase. An asphalt concrete bondbreaker was used between the base and subbase. Non-doweled, skewed transverse joints are spaced at a repeating pattern of 3.66, 3.97, 5.49, and 5.80 m. Coarse aggregate was reportedly obtained from a commercial source in Winnemucca, and an American Society of Testing Materials (ASTM) Type II low-alkali cement was used. An overall view of the section is shown in figure 1. A key to the sections is given in figure 2.

**Figure 1. Overall view of Winnemucca, NV test site.**

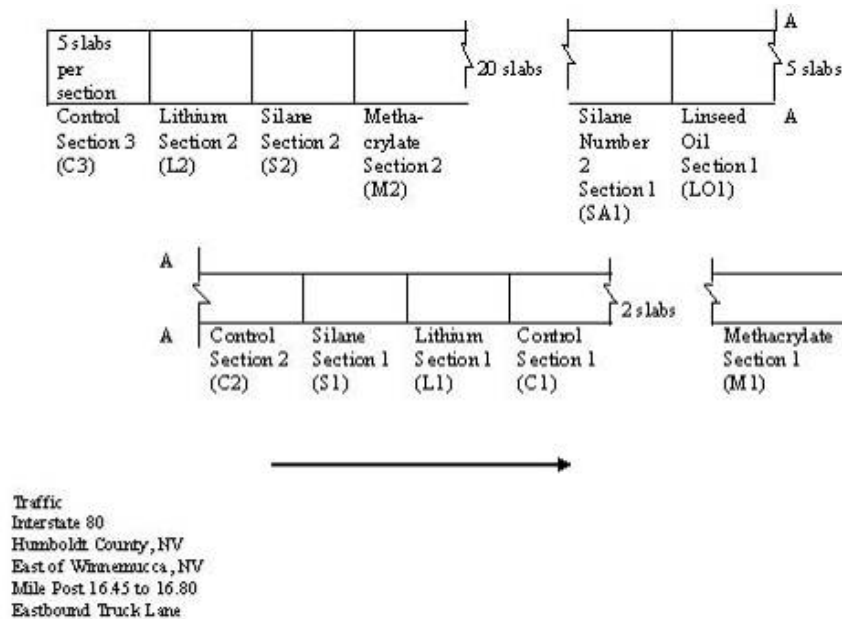
**Figure 2. Winnemucca, NV test section layout.**

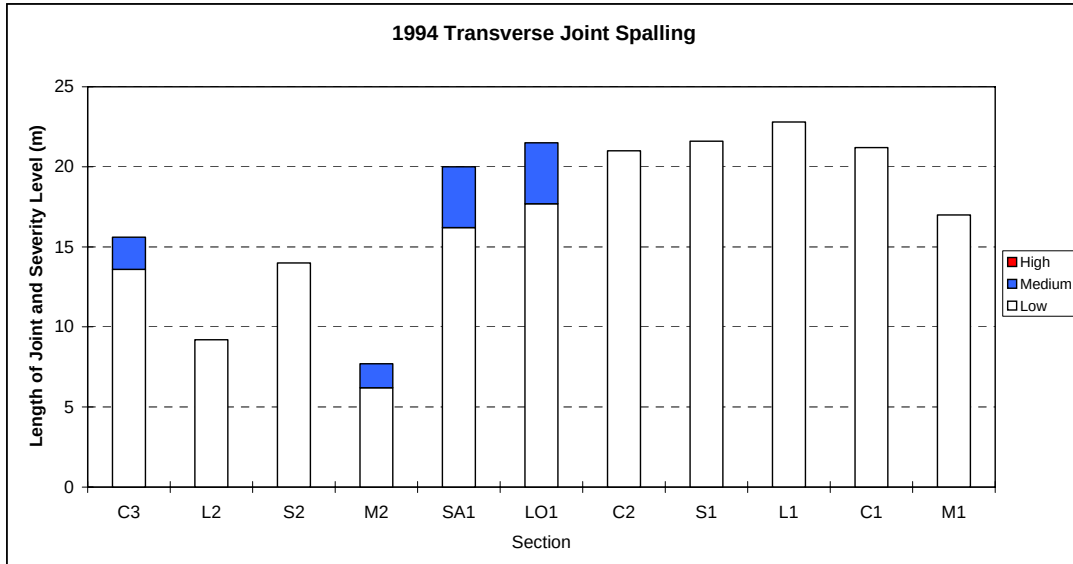
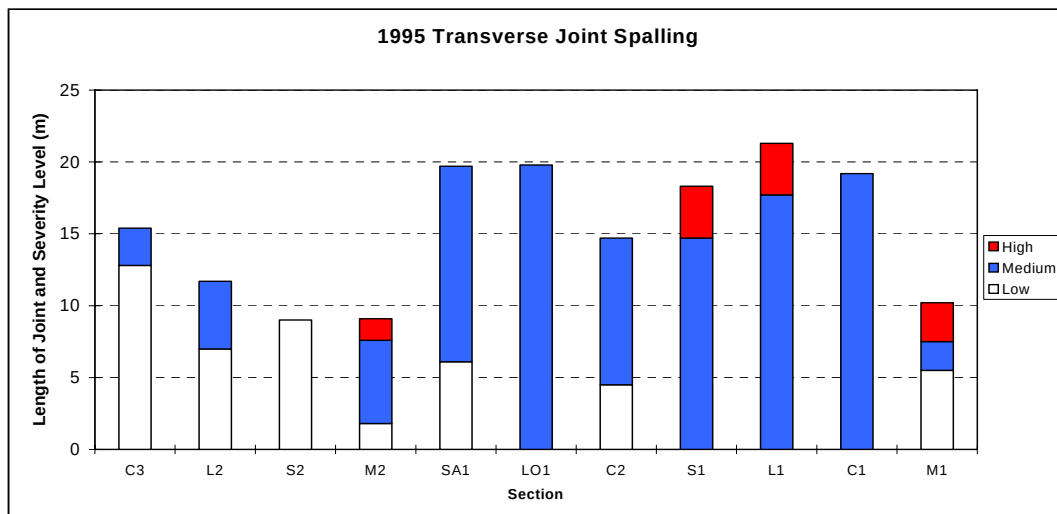
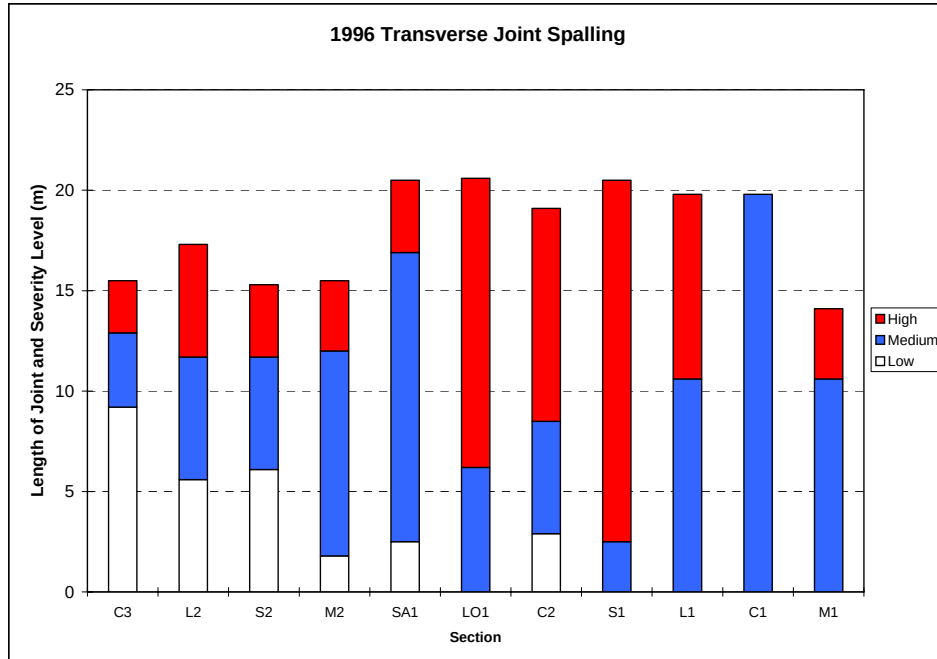
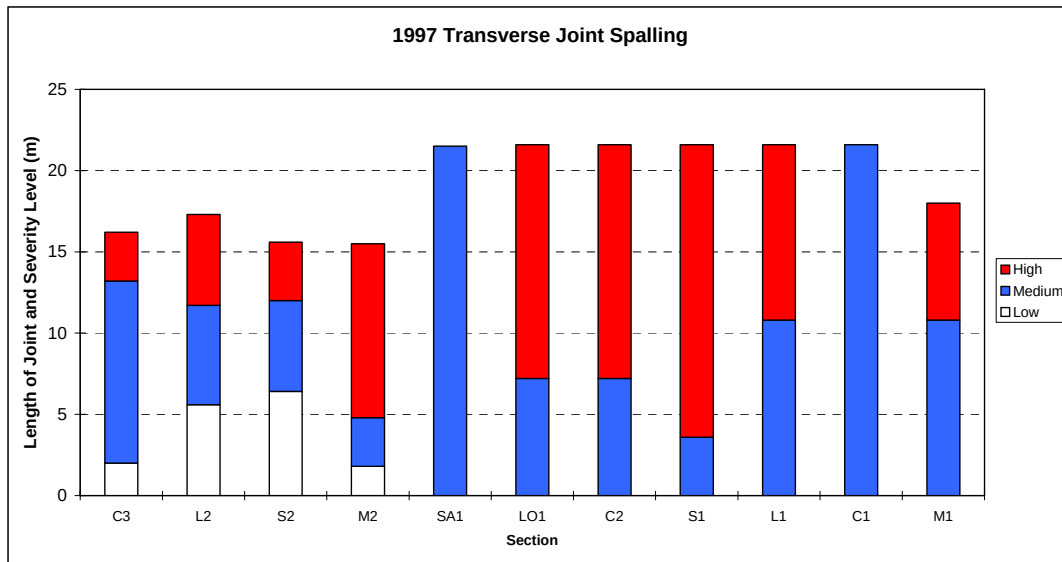
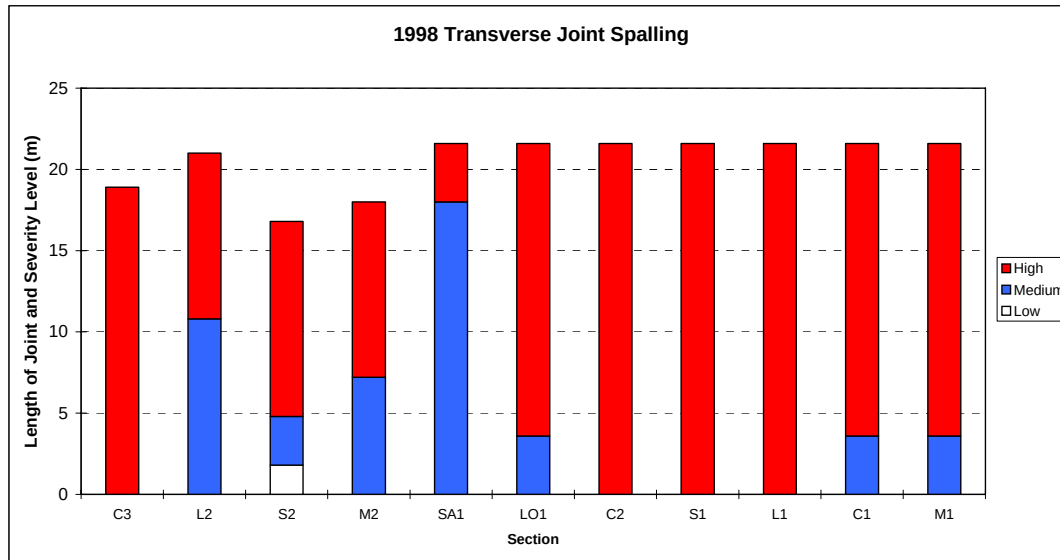
Figures 5 through 9 show the amount and severity of joint distress for each section over the 4 years of the study. The figures are based on the 10 percent rule defined in the LTPP rating system. The amount and severity of joint distress has increased considerably during the study period. In 1994, all the joint distress was rated low except for small areas in sections SA1, C3, LO1, and M2 where the rating was medium. At that time, there were a large number of joints that had lengths without cracking or spalling. The deterioration increased to a point in 1998 where almost the entire length of all transverse joints in each test section is distressed. The only section with any joint length rated low was section S2 (figure 9). The joints in several sections (C2, L1, C3, and S1) are rated high using the 10 percent rule.

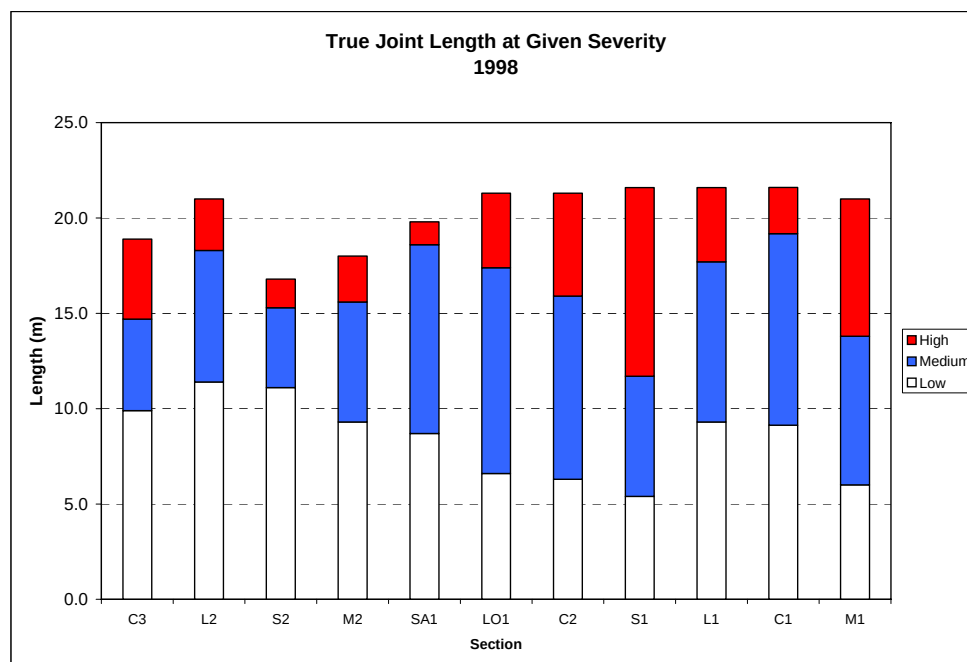
Figure 10 shows the actual measured joint length at each level of severity for all the sections in 1998. If the true joint length at each severity is considered, all sections have some areas of low-severity spalling. The length of high-severity joint spalling per section is less than the length of low- and medium-severity spalling. The section with the most high-severity joint distress is S1. The sections with the least amount of high joint distress are SA1 and S2, but these slabs were in better condition at the start of the study. Of the sections in the same group or beginning condition as S1, the section with least amount of high-severity spalling is section C1 (control). The next best is section L1. In the second group of sections, which were initially in better shape, the one with the most high-severity spalling is C3, followed by section LO1.

**Figure 10. Actual joint length of each severity level for each section (Winnemucca, NV, 1998).**

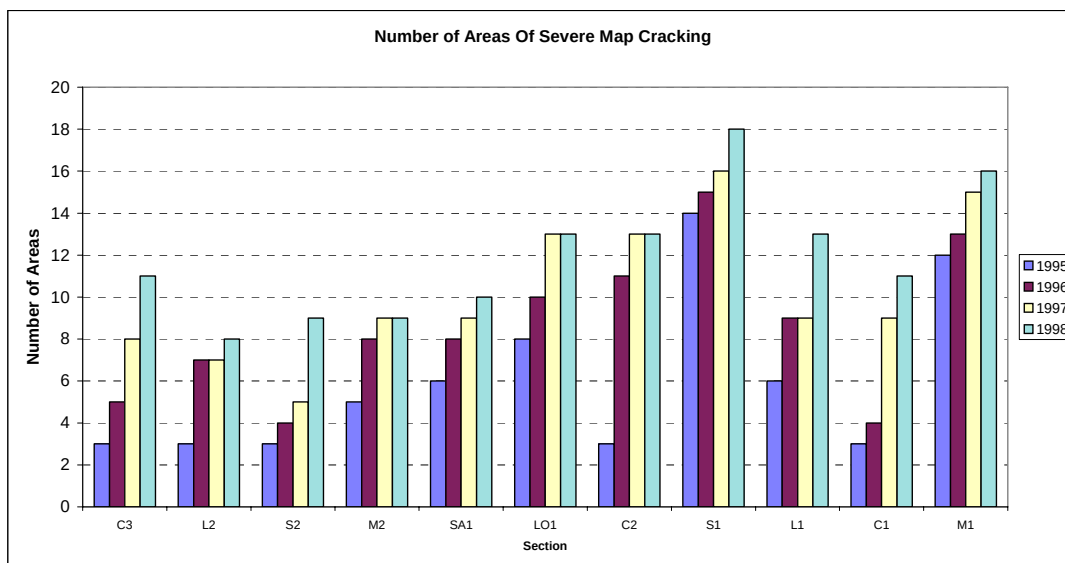
The number of areas of severe map cracking in each section has increased each year over the 4 years. However, sections C2, LO1, and M2 have remained nearly constant for the last 2 years. Figure 13 shows the number of areas of severe map cracking in each section for the years 1995 through 1998. The sections with the most severe map cracking in 1998 are sections M1 and S1 with 16 and 18 areas, respectively. The sections with the least number of areas are sections L2 with eight areas and M2 and S2 with nine areas.

**Figure 13. Number of areas of severe map cracking in each section from 1995 through 1998 (Winnemucca, NV).**

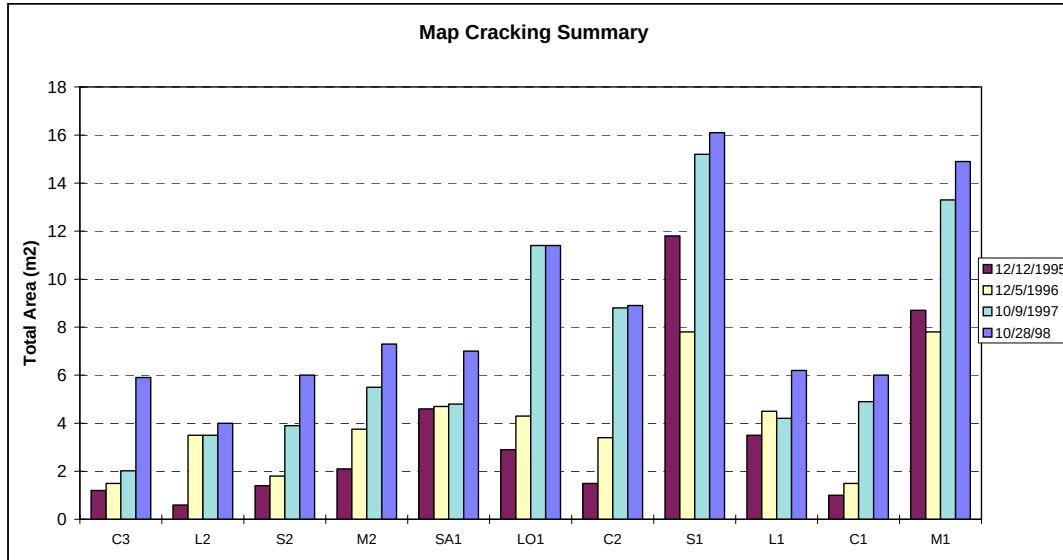
Figure 14 shows the total area of severe map cracking for each section for the years 1995 and 1998. The most distressed sections are the S1 and M1 sections, which have approximately 16 and 15 square meters ( $m^2$ ) of severe cracking, respectively. These sections also had the most distress at the start of the study. They are followed by section LO1 with approximately 11  $m^2$  and section C2 with about 9  $m^2$ . These sections are all at the eastern end of the test site, which had the more severe cracking at the start of the test. sections L1 and C1 have the least area affected of the sections in the eastern end. Of the sections in the western end of the site, section M2, with over 7  $m^2$  of severe map cracked area, is the worst. The best performing section in this group is section L2, with 4  $m^2$ .

Overall, the only treatment that shows minor improvement in severe map cracking over the control sections is the LiOH (sections L1 and L2). In 1998, section L2 had less area affected than control 3 in the western end of the site. Section L1 in the eastern end had less area affected than control 2 and about the same amount as control 1. In general, all the test sections are performing similar to or worse than the control sections.

**Figure 14. Total area of severe map cracking for each section for 1995 through 1998 (Winnemucca, NV).**

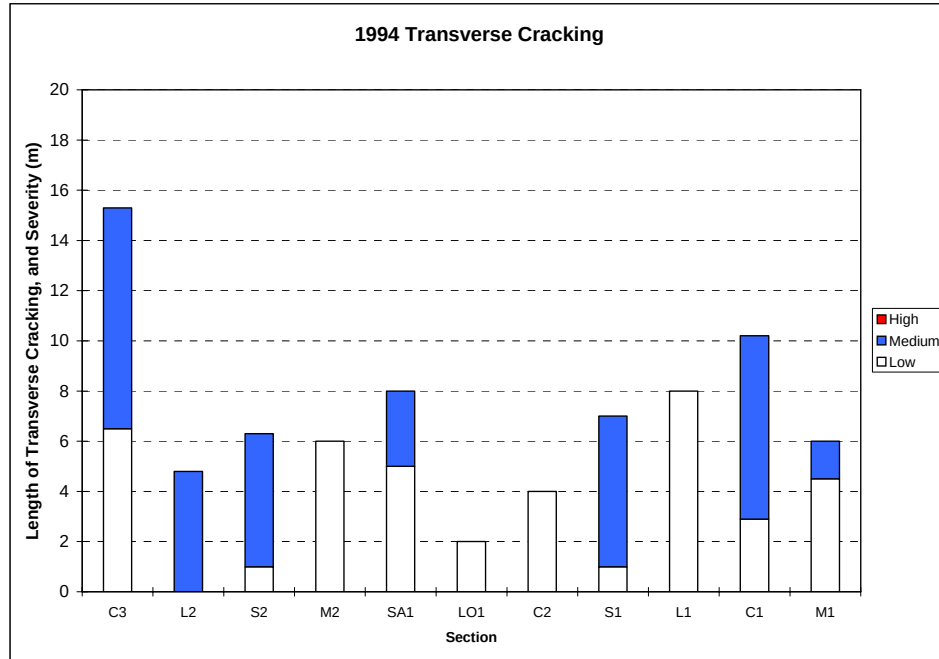
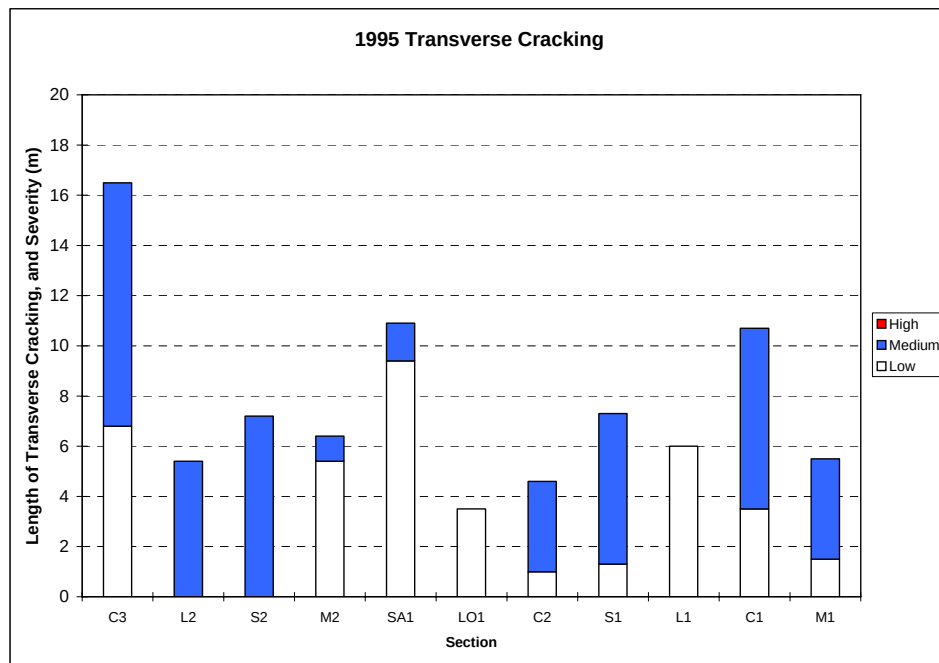
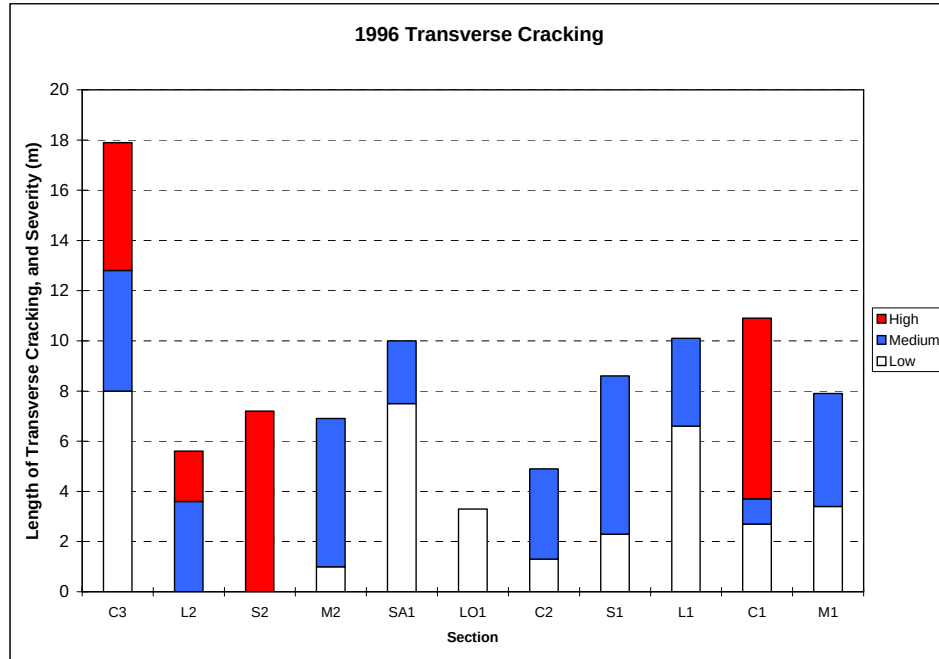
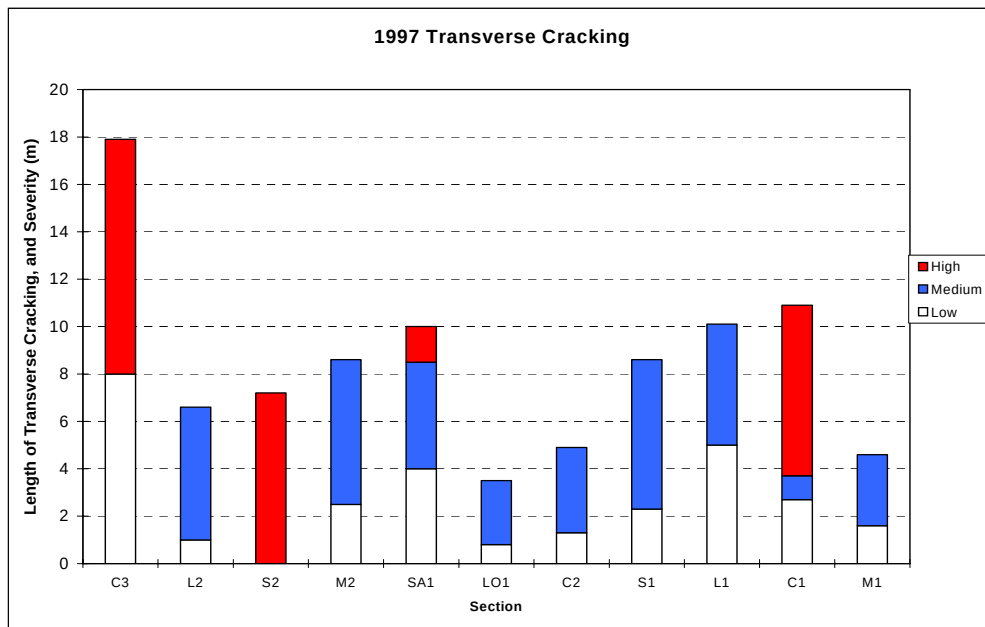
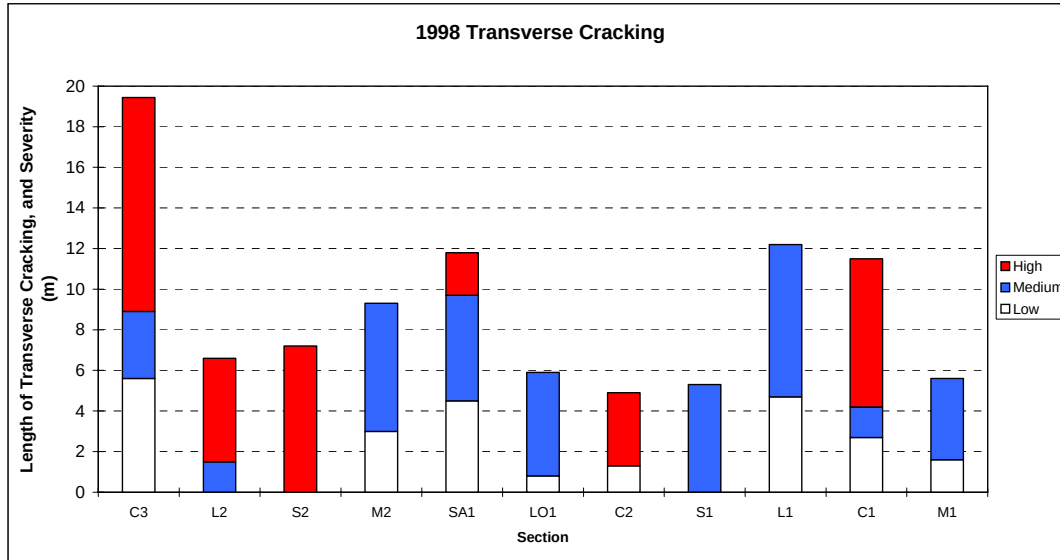
All of the test sections have several transverse cracks, such as that shown in figure 15. Some extend full width while others only reach partway across the lane. Some other transverse cracks, such as the one in figure 16, intersect with longitudinal cracks. A comparison of the transverse cracking for each year is shown in figures 17 through 21. Table 3 indicates the number of transverse cracks in each section for all years of the study. A transverse crack consists of a single distinct crack or a single crack with only a few branches. The number of transverse cracks in a section can decrease if the crack becomes part of an area of severe map cracking.

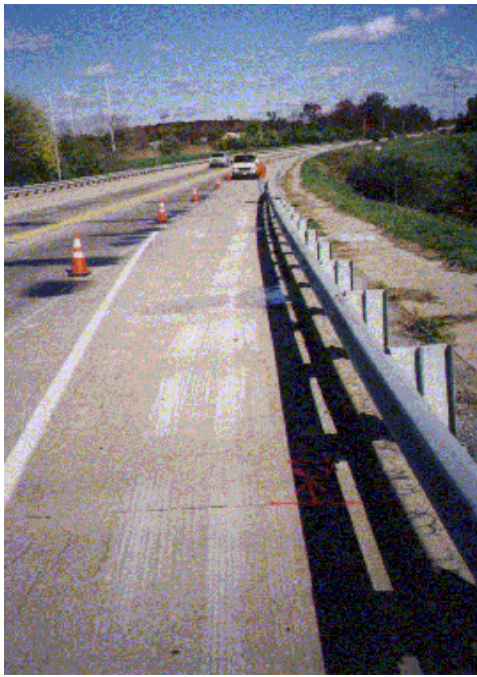
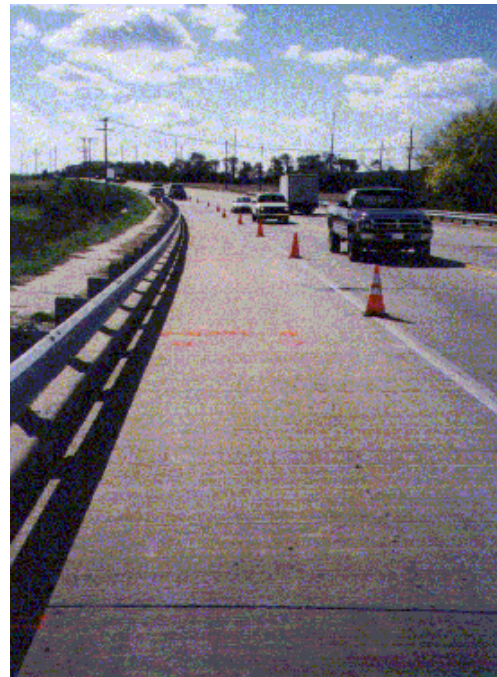
**Figure 22. North and south views of the Newark, DE site.**

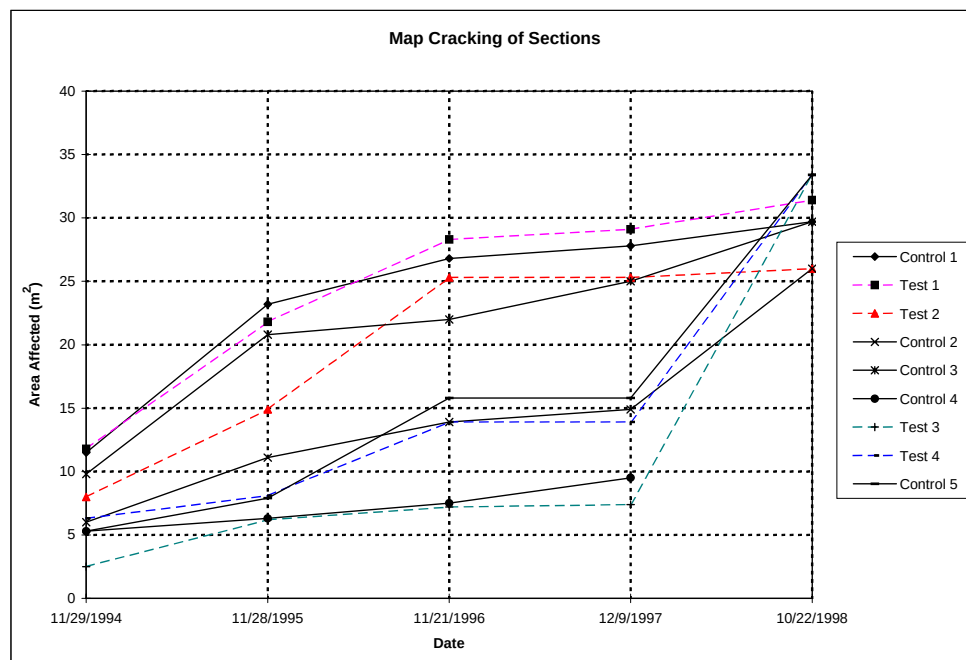
The area of each slab affected by map cracking has increased over the 4 years of the study. Figure 25 shows a graph of the area affected in each section over the 4 years of the study. Two levels of distress are apparent. One group, which consists of control 1, test section 1, test section 2, and control 3, has approximately the same area affected by map cracking. The area has gradually been increasing over the 5 years. The other group consists of control 2, test section 3, test section 4, control 4, and control 5. The area of these sections affected increased gradually over the first 4 years but at a lower level than the other group. However, the area affected increased sharply in the last year of the study and was at the same level as the other group. This can also be seen in figure 26, which shows the area affected by map cracking as a percentage of the total section area. All sections had more than 60 percent of their area affected by map cracking in 1998. There is no value for control 4 in 1998. Test section 3, test section 4, and control 5 have the most area affected, at over 80 percent, but these areas had the smallest affected areas the year before. All the map cracking was of low severity.

**Figure 25. Area of each slab affected by map cracking over the 5 years of the study (Newark, DE).**

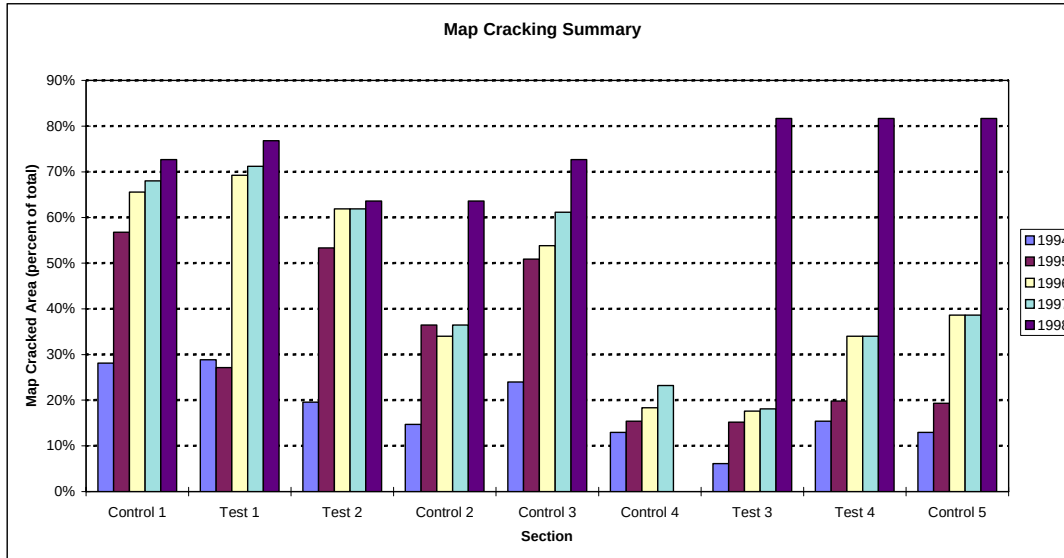
**Figure 26. Area of each slab affected by map cracking expressed as a percentage of the total section area (Newark, DE).**

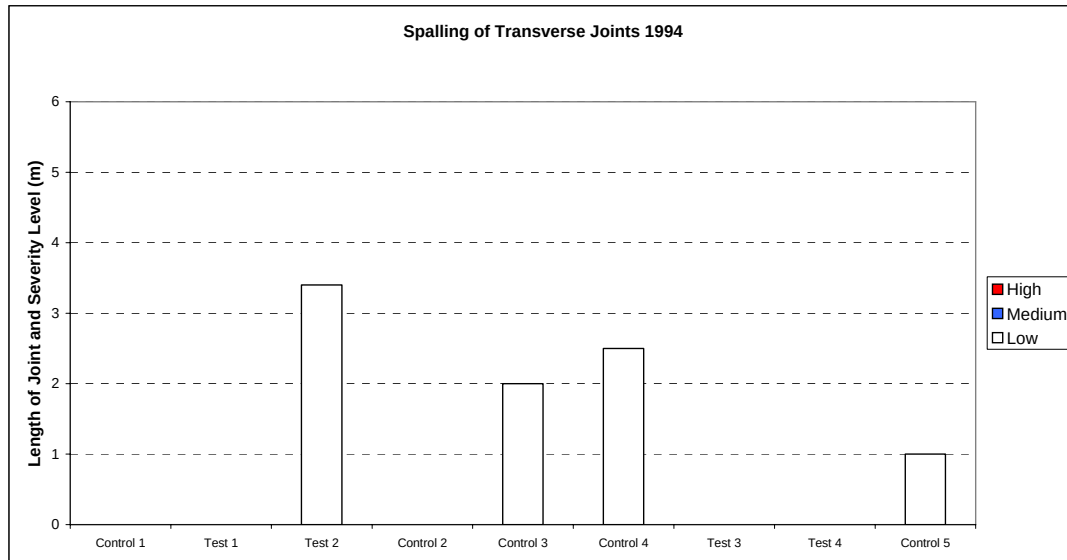
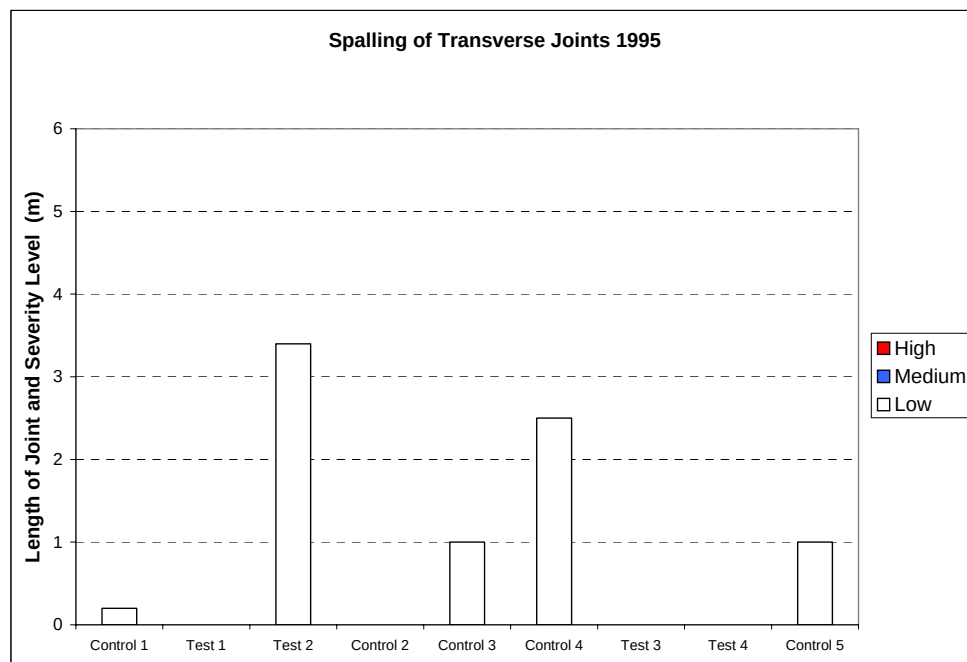
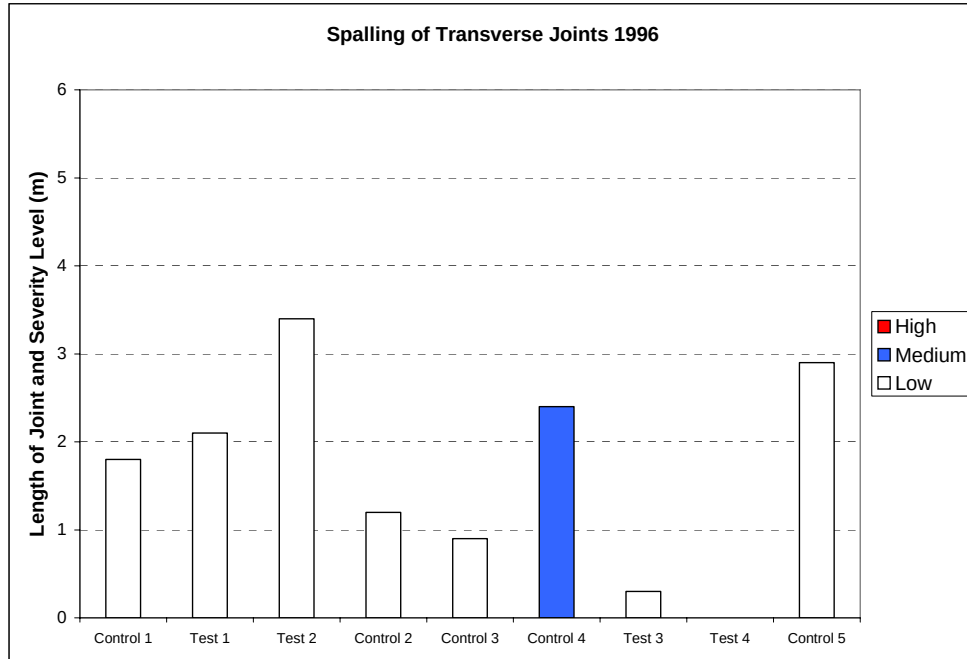
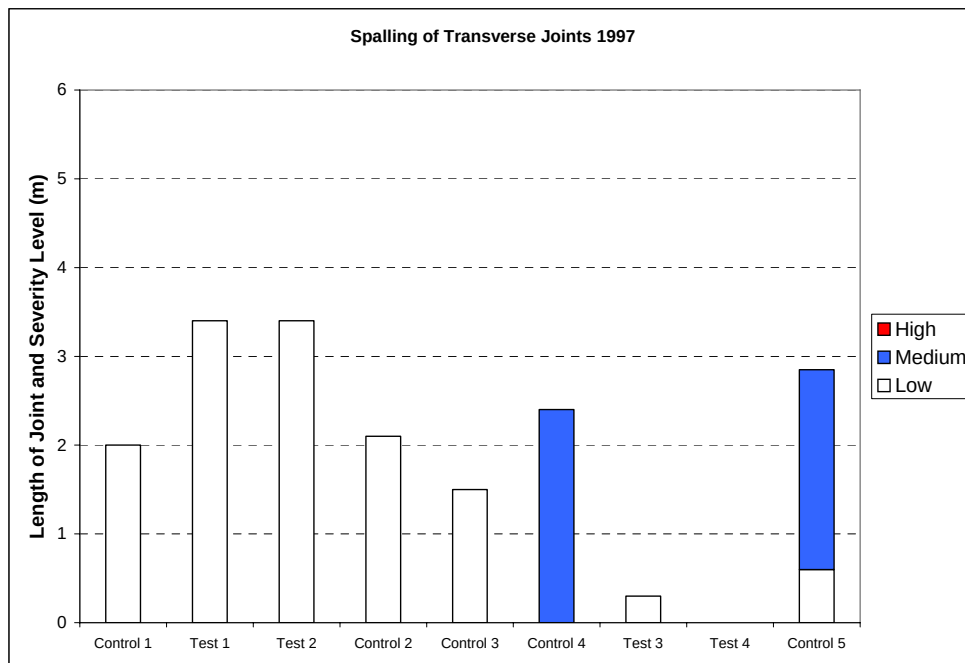
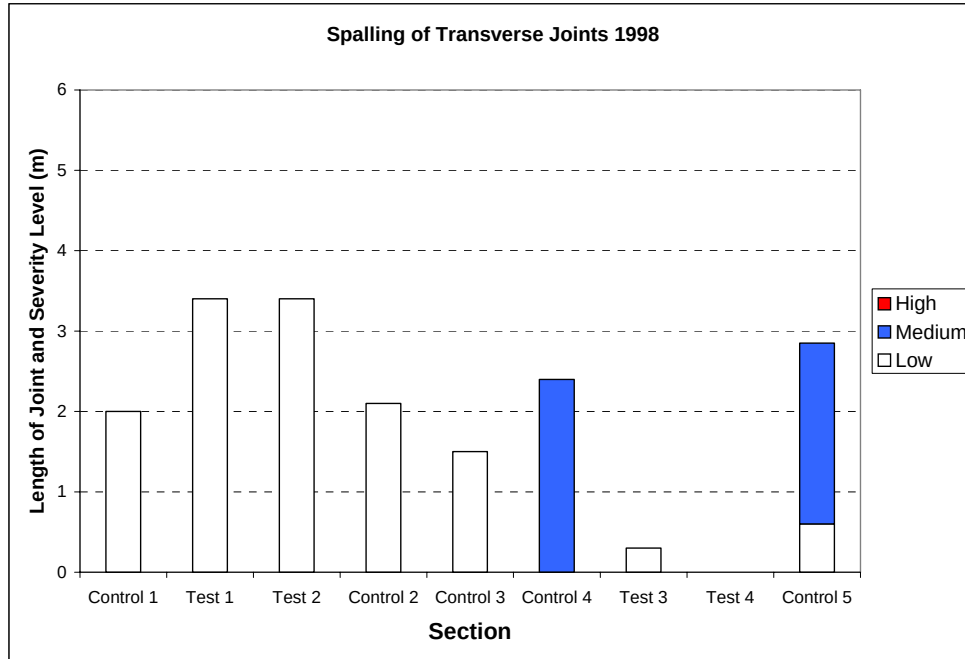
Figures 29 through 33 show the amount and severity of joint spalling over the 5 years of the study. In 1994, the control 3, control 4, control 5, and test section 2 had joint spalling. At this time the spalling was all low severity. In 1998, all sections except test section 4 have transverse joint spalling. All sections have low-severity spalling except control 4 and control 5, which have spalling of medium severity. Test sections 3 and 4 are performing much better than test sections 1 and 2 with respect to transverse joint spalling. This likely is due to the different exposure conditions previously discussed.

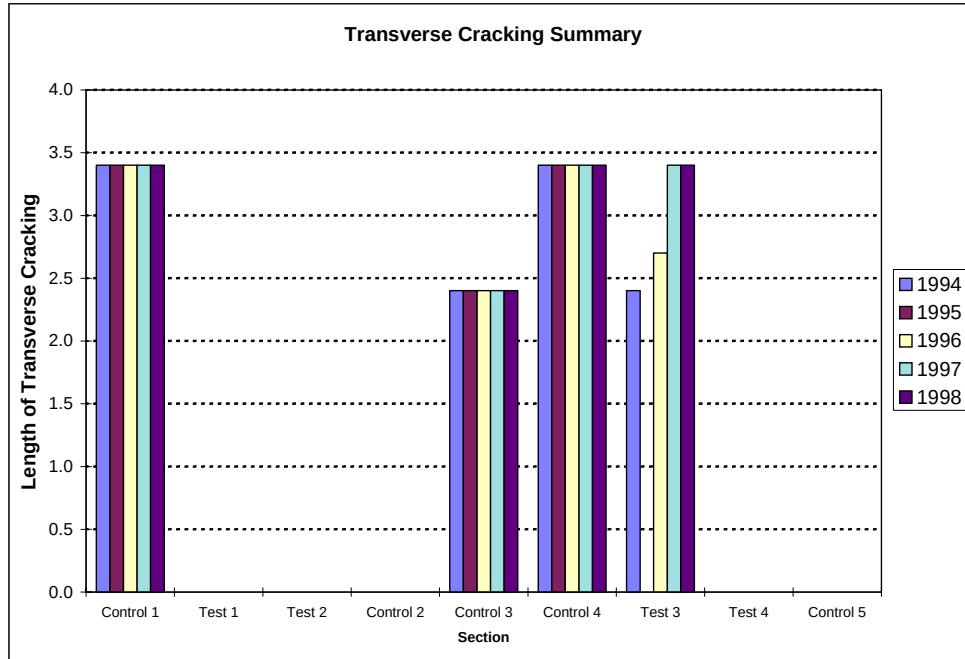
A summary of the transverse cracking in each section over the 5 years is shown in figure 34. The only sections with transverse cracking are control 1, control 3, control 4, and test section 3. The cracking in the three control sections had occurred before the first year of the study and did not increase in length or severity during the next 4 years of the study. The cracking in test section 3 had also occurred before the first year of the study but increased in length over the 4 years. There was no increase in severity, and all severity ratings are low. Generally, the transverse cracking of the Delaware test sections were there before the study began and do not appear to be getting more severe.

**Figure 34. Summary of transverse cracking in each section for the five inspections (Newark, DE).**

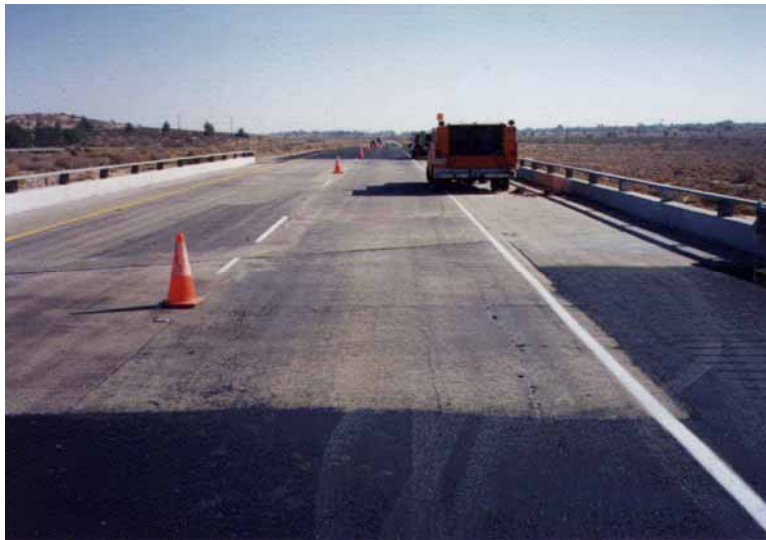
The Boron overhead, Bridge No. 50-353R 9-KER-58-R141.5, consists of two parallel structures carrying State Route 58 over the rail spur leading to the U.S. Borax mine in Boron, CA. Each structure consists of a three-span continuous bridge with no expansion joints. Each bridge has two traffic lanes and a shoulder. The bridge beams were cast integrally with the deck slab. The entire deck appears to be undergoing significant ASR, as manifested by widespread visible map cracking. The deck surface was treated with a methacrylate (HMWM) in 1995, into which a coarse, rounded sand was broadcast. Figure 35 shows a photograph of the deck surface.

**Figure 35. Treated section on Boron overhead structure over State Route 58 looking east (Boron, CA).**

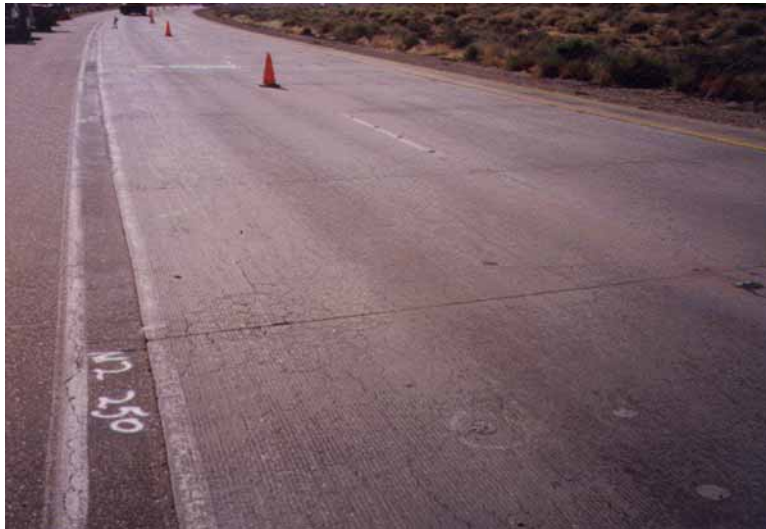
**Figure 36. Photograph showing part of Boron, CA, test site, M2, Station 250.**

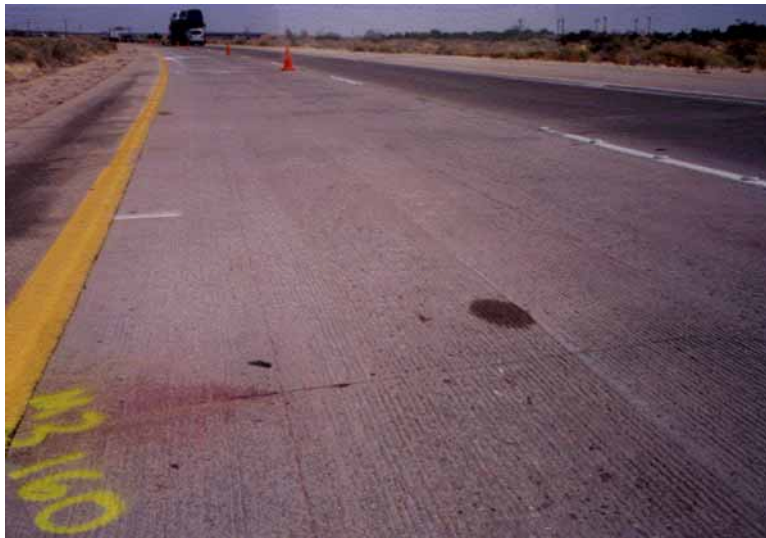
**Figure 37. Photograph showing part of Boron, CA, test site, M3, Station 160.**

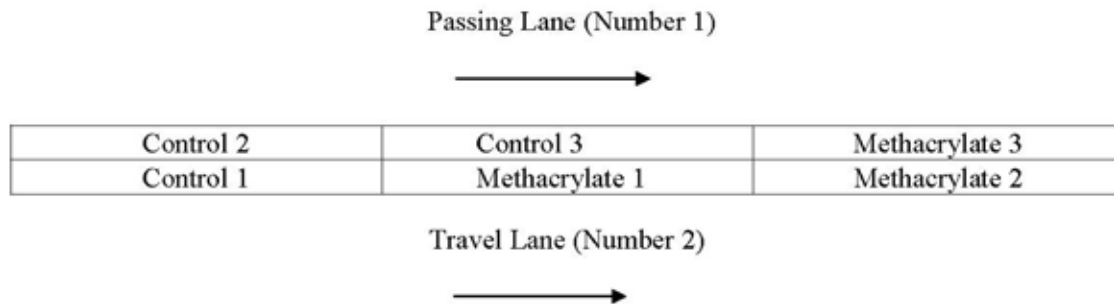
**Figure 38. Plan view of Boron, CA, test site.**

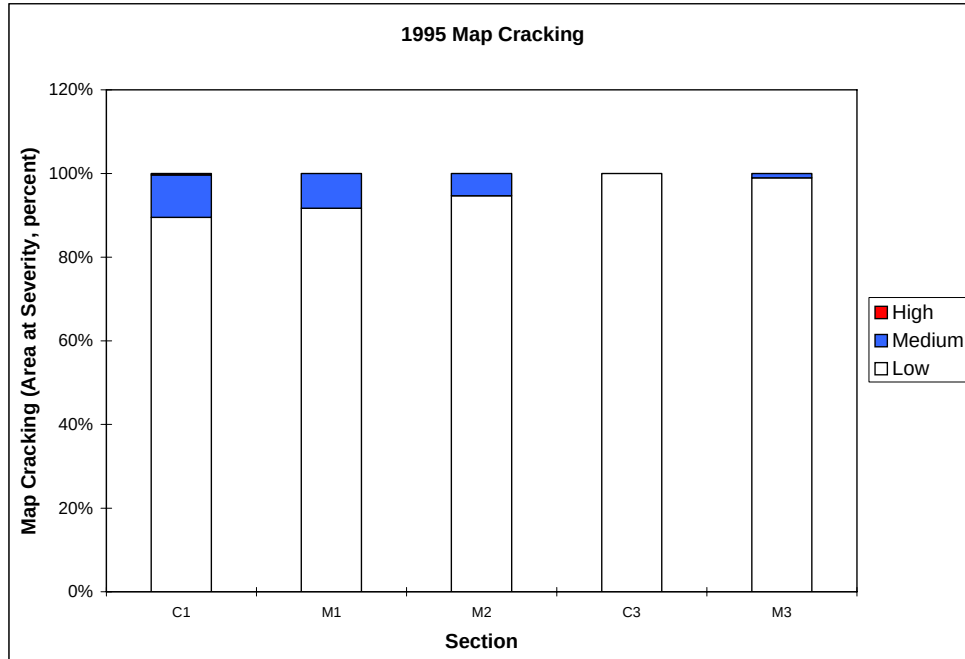
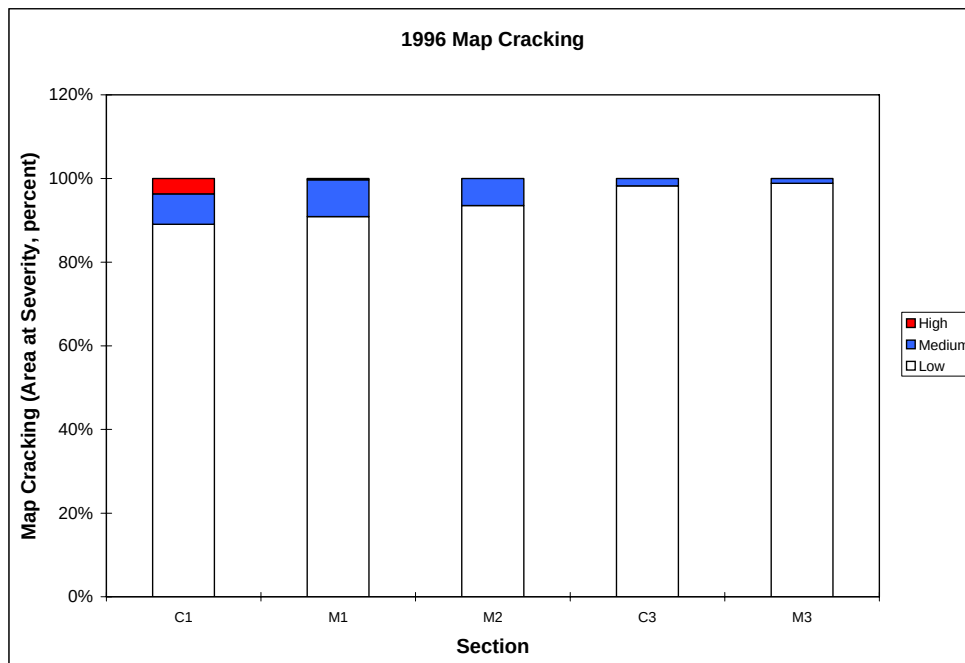
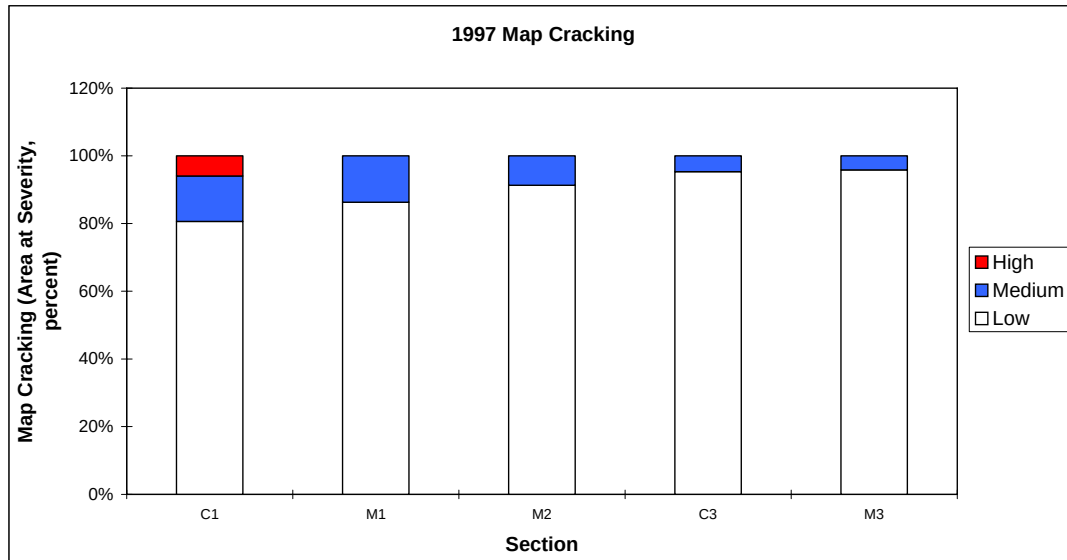
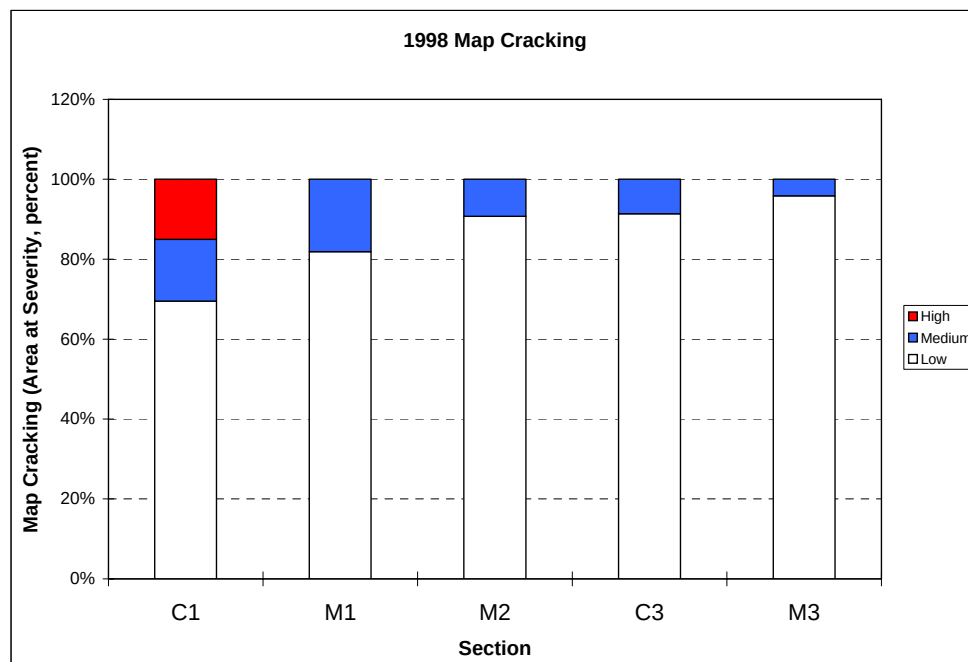
All the sections making up the Boron, CA, test site had map cracking over 100 percent of their area in 1998. Most of the map cracking was of low severity, but there was some medium and high severity also. Figure 39 shows an example of high-severity map cracking. Figure 40 shows a close-up view of typical map cracking at the Boron site. Figures 41 through 44 show the amount of each level of severity as a percentage of the total area for each section for all 5 years of the study. In the travel lane, control section 1 (C1) had more severe map cracking than the methacrylate sections (M1 and M2). The cracking was less severe in M2 than in M1. It appears that the second application of methacrylate to section M2 in 1995 has helped reduce cracking. In the passing lane, methacrylate section 3 (M3) is performing better than control section 3 (C3). Overall, the passing lane sections are performing better than the travel lane sections. A description of the map cracking in each section is as follows:

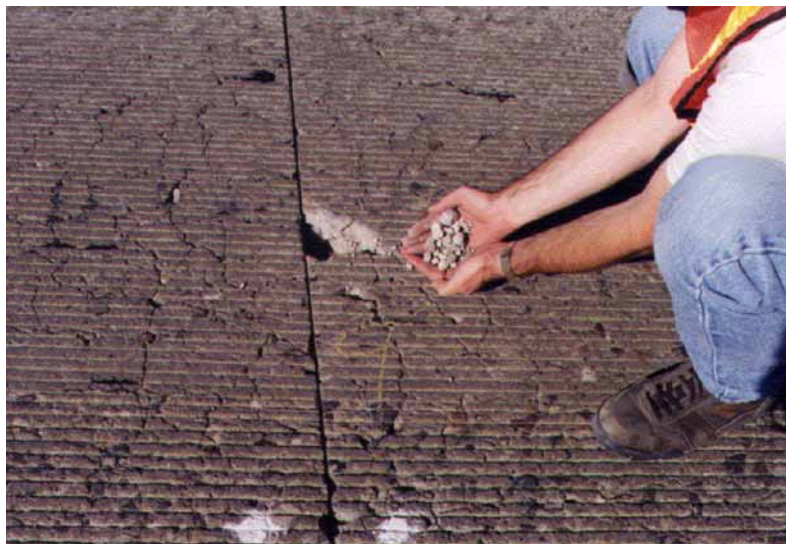
The widespread map cracking in the test sections made exact crack recording impossible. Therefore, only the large, clearly visible cracks were noted. The transverse joints were all completely distressed, with cracks and spalled areas occurring over the entire length of the joints. Figure 45 shows a photograph with an example of medium-severity joint distress. Figure 46

**Figure 46. Photograph showing an example of high-severity joint distress (Boron, CA).**

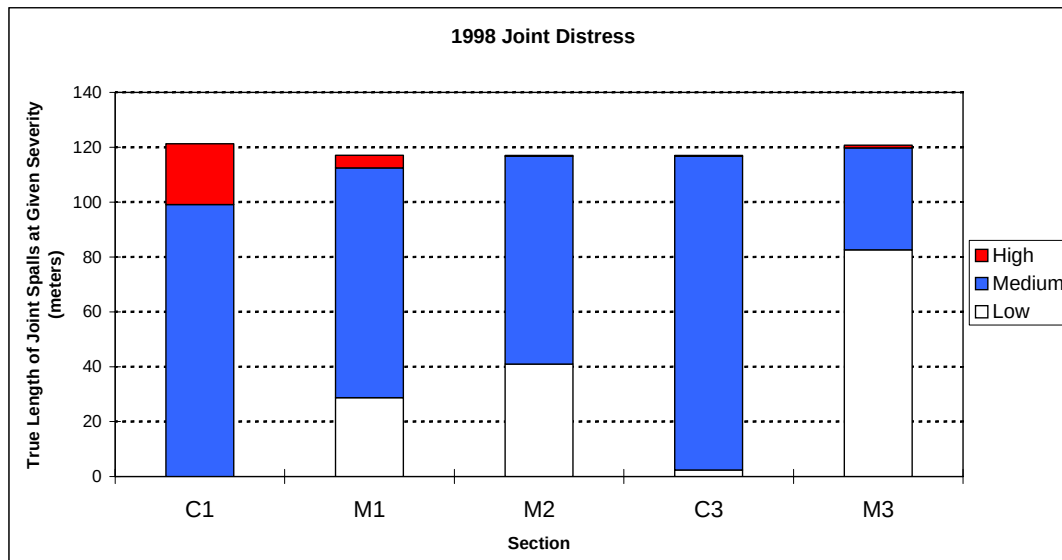
**Figure 54. True length of joint spalls at each level of severity (Boron, CA, 1998).**

- Control 1—the severity of joint distress in section C1 had increased from almost entirely low severity in 1994 to mostly high severity in 1998. This was the worst section of the five. At least 10 percent of the length of almost all joints in this section had at least some high-severity joint distress. The graph of actual length of each distress condition (figure 54) indicates that for 1998 most of the length was of medium severity.
