# Highway Concrete Pavement Technology Development and Testing: Volume I— Field Evaluation of Strategic Highway Research Program (SHRP) C-202 Test Sites (Alkali-Silica Reaction (ASR))

PUBLICATION NO. FHWA-RD-02-082

AUGUST 2006

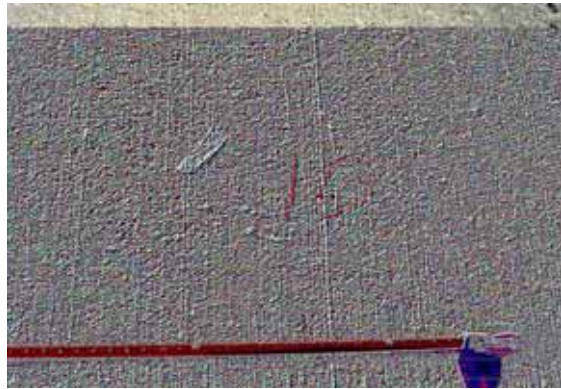
**(j)** 1% LiOH—Grevey

| <b>Test Section</b> | <b>Treatment –Aggregate Source</b> | <b>Observations</b> |
|---|---|---|
| 10 | 1 percent LiOH—Grevey | Very faint map cracking was found but less visible than in section 9. Areas of rough and irregular finish exist. |

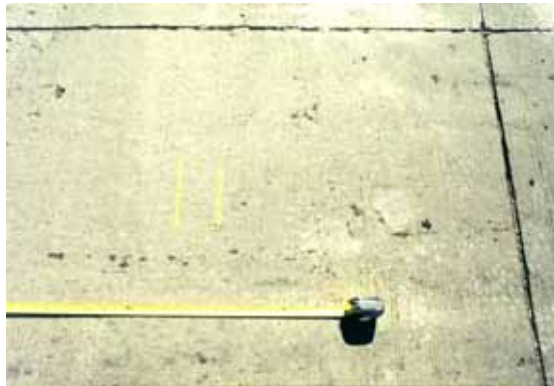
**(k)** Class C Ash—Grevey

| <b>Test Section</b> | <b>Treatment –Aggregate Source</b> | <b>Observations</b> |
|---|---|---|
| 11 | Class C Fly Ash—Grevey | Longitudinal cracks were found in left wheelpath and along centerline, fine wheelpath map cracking and transverse cracks were also developing, and areas of rough and irregular finish exist. Severity of map cracking is between that of sections 9 and 10. |

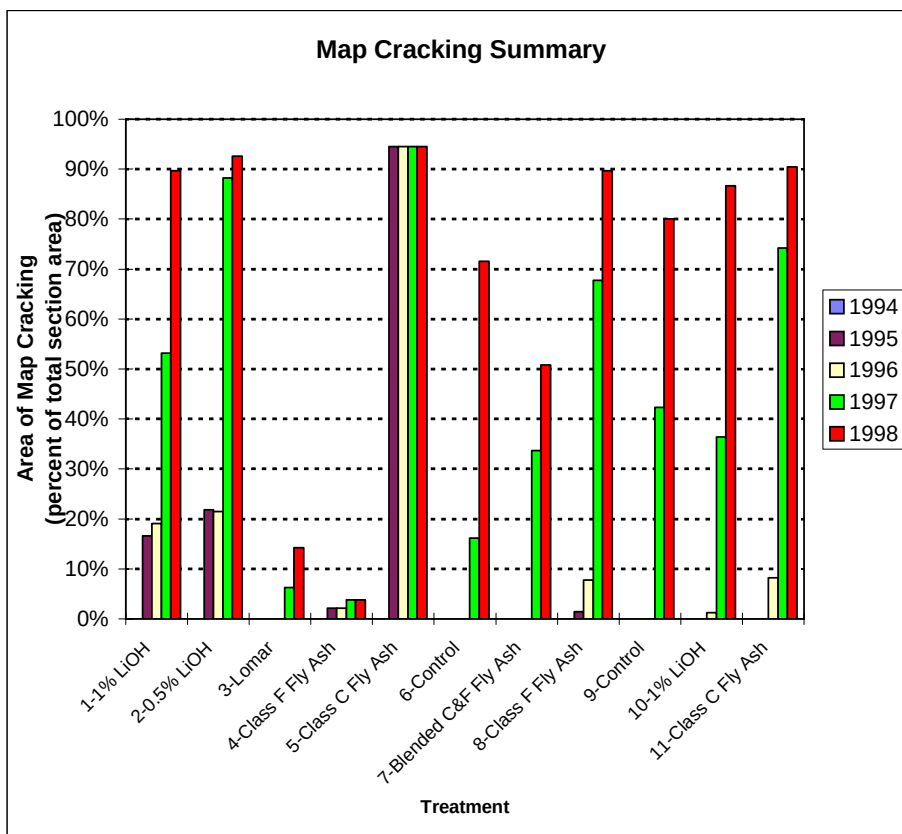
**Figure 58. Area of map cracking as a percentage of the total area (all sections, Albuquerque, NM).**

The amount and severity of map cracking is a good early indicator of the extent of ASR occurring in each section. The area of map cracking as a percent of the total area is shown in figure 58. This figure shows that, for most sections, the area of map cracking had increased substantially between 1996 and 1998. The section with Class C fly ash and Shakespeare aggregate had extensive map cracking over the entire test area in 1995, except for a small area along the curb. The section with Class F fly ash and Shakespeare aggregate was performing the best of all the sections, with less than 10 percent of its area covered by map cracking. The Lomar section was the next best with about 15 percent map cracking. Several sections, especially those with Grevey aggregate, had extensive map cracking appear only within the last 2 years of the study.

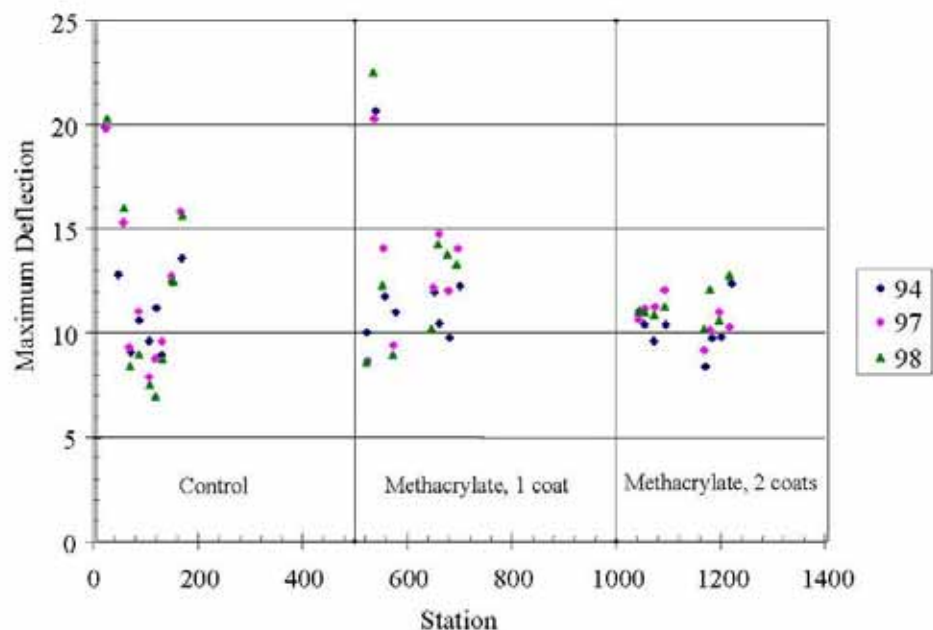
**Figure 78. California test site—D<sub>o</sub> from leave side.**

An analysis of the maximum joint deflection data shown in figure 78 showed that the  $D_o$  values have a slight increasing trend over time. However, the differences were relatively slight and are

not proportional to the increase in the amount of observed joint distress data. Overall, the levels of maximum joint deflection were about double the maximum interior deflection (mid-slab values), which is as expected. An examination of the average values for each section revealed that the methacrylate 1 section had the highest deflection, followed by the control and the methacrylate 2 sections. It is difficult to postulate what the expected joint deflection over time is expected on jointed pavement having ASR distress. In jointed pavements, without dowels, joint deflection and curling can be large. As ASR develops, the concrete expands reducing joint openings and increasing aggregate interlock across the joint. Joint curling is essentially eliminated and the ride (smoothness) is improved.

As ASR deterioration continues, spalling and loss of integrity at the joints occurs. However, even though the concrete is disintegrating, the joints remain very tight.

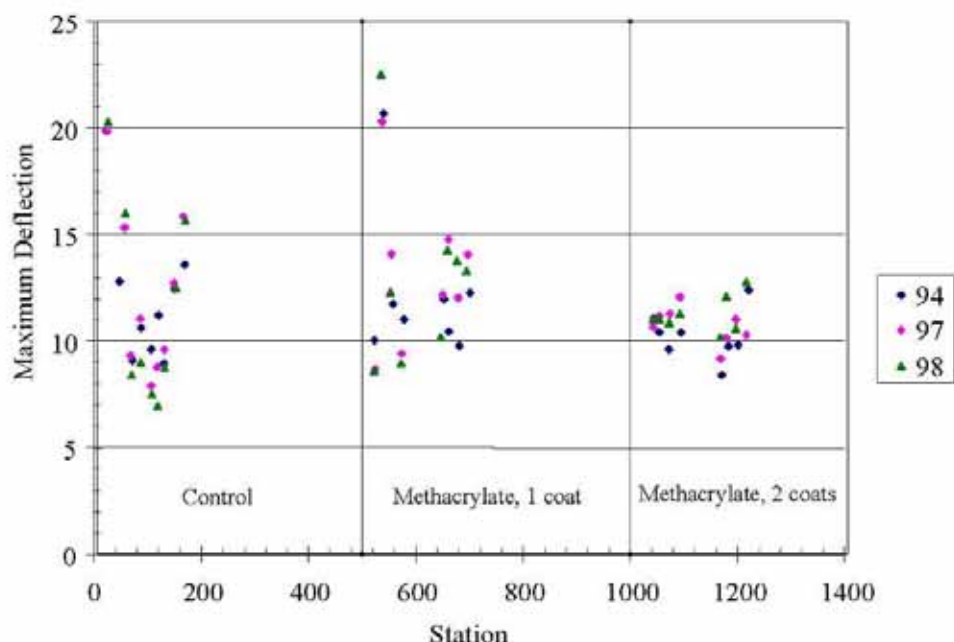
**Figure 79. California test site—LTE.**

The variation of the LTE along the project is shown in figure 79. Although the load transfer efficiencies are relatively high, the LTE has the best correlation with the observed joint distress data. The average values for each section decrease substantially from 1994 through 1997. There is a slight increase in the LTE from 1997 to 1998 in the methacrylate 1 and control sections, but this is expected given the temperature at the time of testing. For these sections, the test temperature in 1998 was approximately 10 degrees higher than in 1997. For the methacrylate 2 section, the 1997 and 1998 test temperatures were approximately equal, and the LTE continued to decrease. Ranking the average LTE for each section shows the expected correlation with the joint distress data. The methacrylate 2 section has the highest average LTE, followed by the methacrylate 1 section, followed by the control section. A statistical analysis was performed to

determine if the difference in LTE between the treatment types was significantly different. This analysis consisted of a Duncan grouping at an alpha level of 0.05. This analysis confirmed that the LTE for the methacrylate-treated sections was significantly higher than the LTE for the control section. The results of the Duncan grouping are shown in table 49.

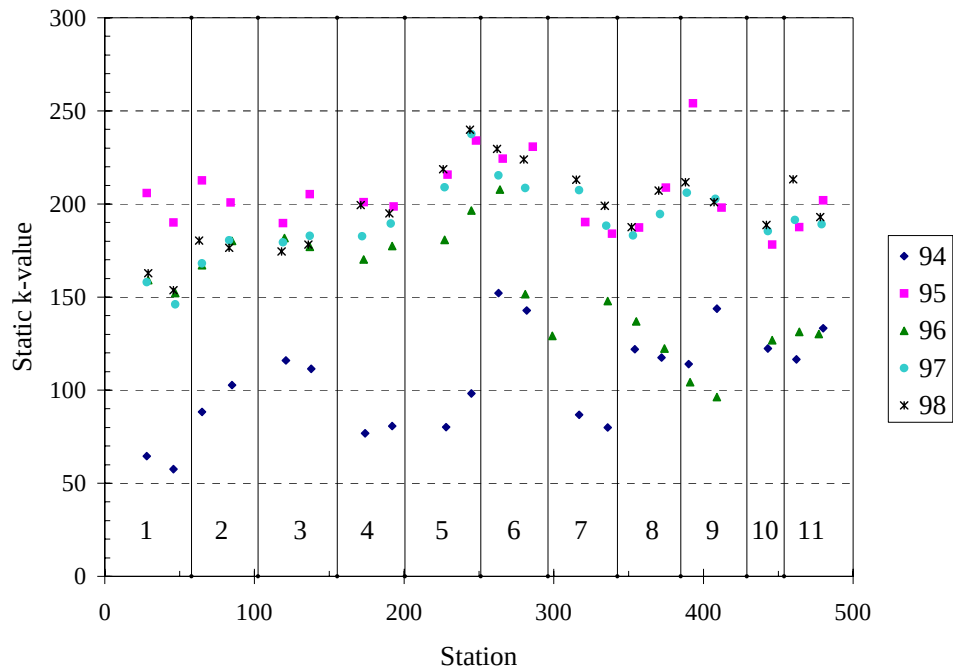
**Figure 80. Static k-value for New Mexico test.**

A plot of the variation of the backcalculated subgrade support value along the project is presented in figure 80 for each year the data was collected. The subgrade support value is relatively constant within each visit and between visits for the years 1995, 1997, and 1998. The mean k-value for the various sections based on this data is 1,379 kPa/2.54 cm (200 psi/inch). The k-value is quite variable in 1994 and 1996, with the lowest k-values being recorded in the former year. The type of subgrade soils present at the site location and the saturation state of the soils during the time at which the FWD testing was conducted could likely explain these findings. For example, an intense rainfall event a few days prior to the testing in combination with a moisture-sensitive subgrade soil and poor drainage conditions could lead to a weak subgrade support condition. However, actual occurrence of this event could not be ascertained from the data collected.

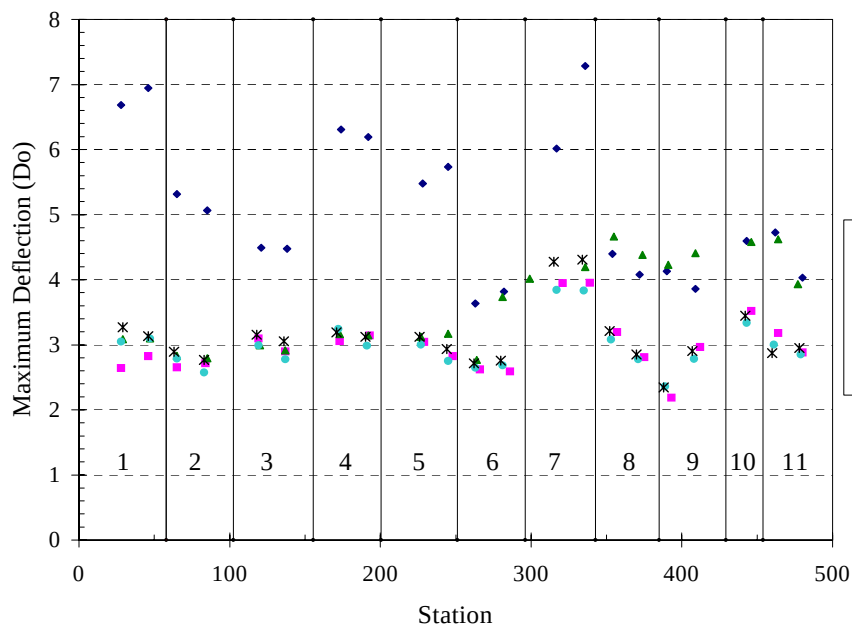
**Figure 81. New Mexico test site—Do from center slab.**

In figure 81, the project variation of  $D_o$  is presented for the multiple years in which data was collected. From this figure it can be seen that  $D_o$  varies greatly, especially for the 1994 data. The  $D_o$  values follow the expected trends based on the subgrade support conditions shown in figure 80. It seems likely that saturated subgrade conditions were present during the 1994 data collection. This would explain the substantially higher  $D_o$  values obtained for that year.

An examination of the data on a section-by-section basis and on a year-to-year basis did not indicate any clear trend regarding  $D_o$ . There does not appear to be any apparent correlation between  $D_o$  and map cracking for this section. Recall that map cracking has been reported to increase in all sections between 1994 and 1998, with the exception of sections 3 and 4; with the last 2 years registering a dramatic increase. However, most of the map cracking reported was of low severity, and it is assumed that the FWD test was not sensitive enough to register this distress.

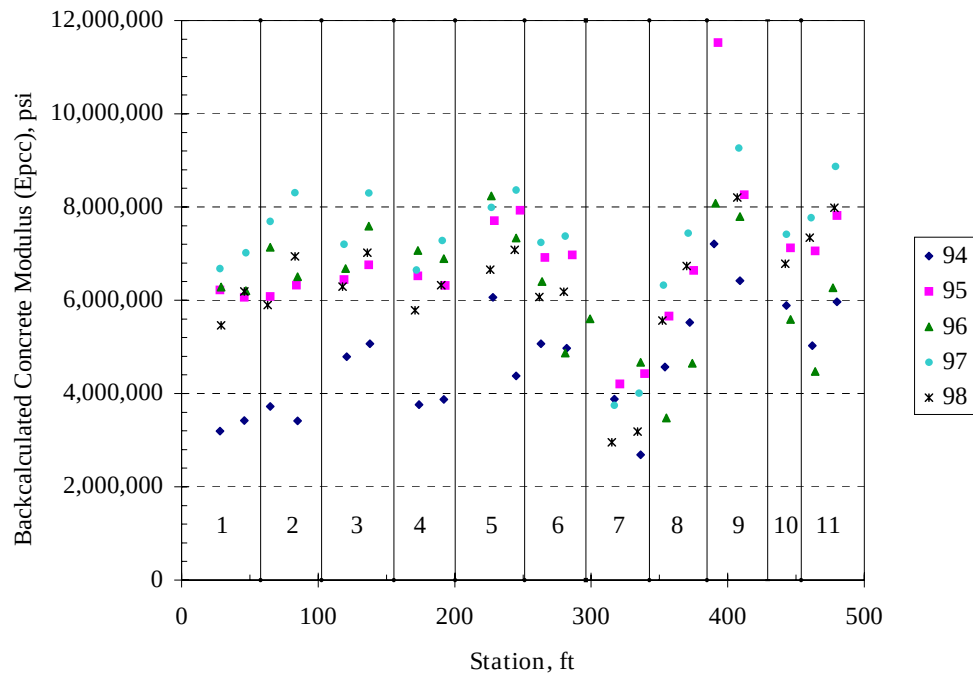
**Figure 82. New Mexico test site—EPCC from center slab.**

In figure 82, the backcalculated  $E_{PCC}$  is plotted for all the treatment sections. Similar to the  $D_0$  pavement response, the backcalculated  $E_{PCC}$  remained relatively constant over time. Based on these results, the  $E_{PCC}$  parameter is not able to corroborate the observed distress data, which shows map cracking to be increasing over time. Thus, the map cracking is not affecting the apparent structural capacity of the pavement, or more likely, the effects of slight variations in layer thickness and subgrade support conditions are interfering with the FWD's ability to distinguish between the different levels of map cracking observed in this section.

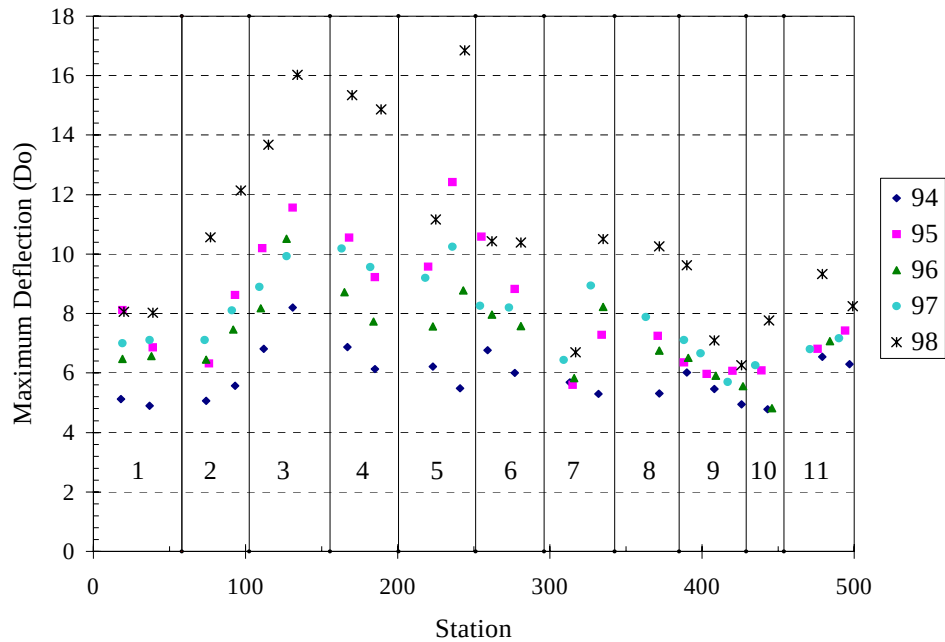
**Figure 83. New Mexico test site— $D_o$  from leave side.**

Figure 83 presents the maximum pavement deflection collected from joint testing. As with the  $D_0$  center slab data, the  $D_0$  data taken from the leave side of the joint showed rather large variability. Overall, the data did show a slight upward trend over time corresponding to increased joint distress. However, this trend was not consistent, as the data was confounded by differences in temperatures at testing between sections during each visit. A pictorial representation of the average temperature at the time of FWD testing for each section is presented in figure 84. Other confounding factors include variations in slab thickness due to construction variability and changing subgrade support conditions.

Because the  $D_o$  data did at least show the expected trend of increasing with time, a statistical analysis was performed. This analysis revealed some differences between the treatment types; however, these differences appear to be more closely related to temperature and subgrade support conditions than to ASR-related deterioration.

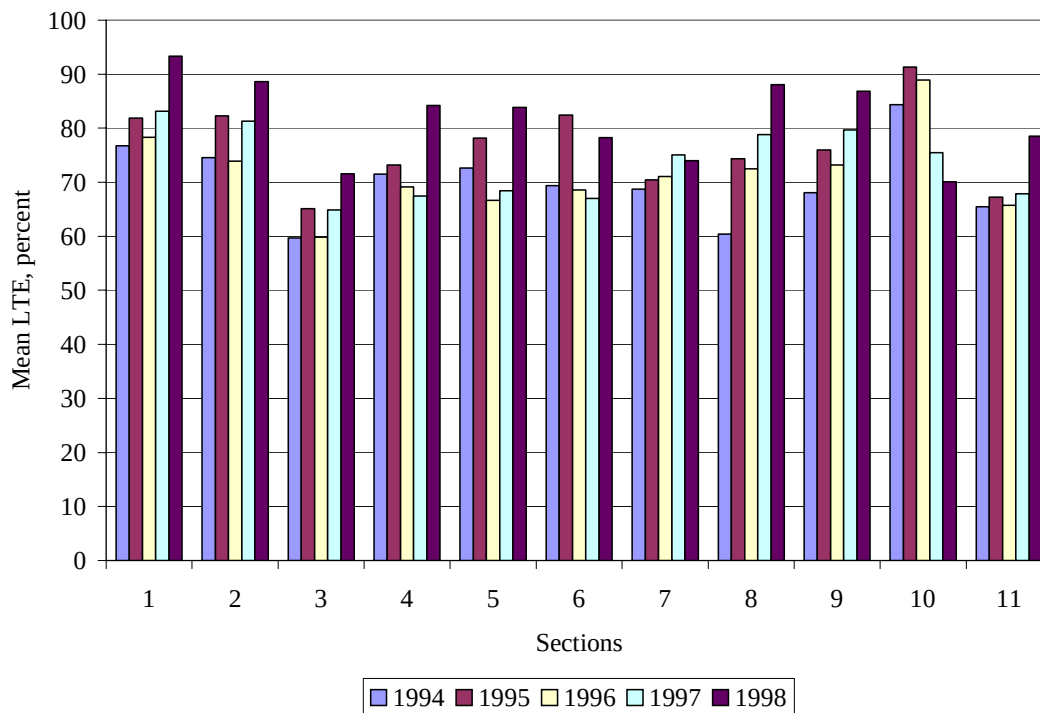
**Figure 85. New Mexico test site—LTE.**

The variation of the LTE along the project is plotted in figure 85. An examination of the LTE data on both a yearly and section-by-section basis revealed that LTE remained relatively constant. The LTE data did not have a significant correlation with the observed joint distress data, and it could not be used to corroborate the benefit of the Class F fly ash treatment. A statistical analysis revealed that the average LTE values for each section belonged to the same group. Thus, no significant differences in LTE values existed between any of the treatment types.

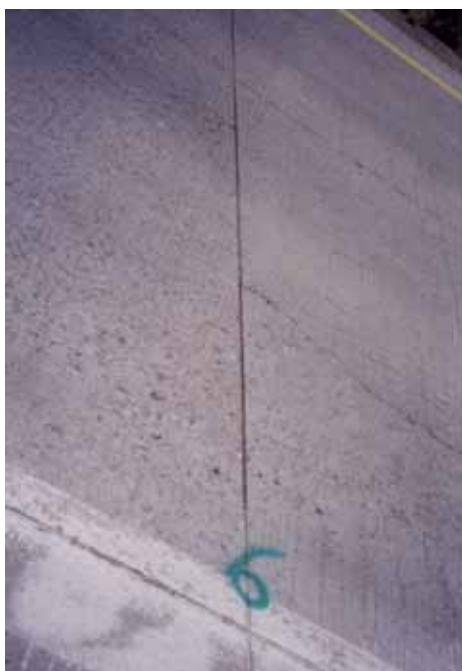
**(b)** Lithium Hydroxide section 2 (L2)

Core 97-L2-B: The core is classified as slightly distressed. The wearing surface is worn, exposing aggregate particles. Twenty cracks and 32 instances of alkali-silica gel were counted. Twenty-two fine aggregate particles showed evidence of distress or reaction. The core is air-entrained with an estimated air content of 6 percent.

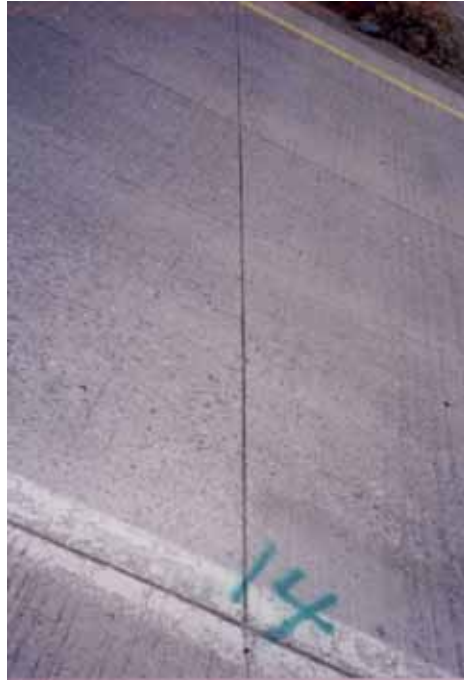
(c) Silane section 2 (S2)

Core 97-S2-A: The core is classified as slightly distressed. The wearing surface is worn; shallow popouts over coarse and fine aggregate particles are frequent; 29 cracks and 40 instances of alkali-silica gel were counted. Fourteen coarse and 53 fine aggregate particles show evidence of reaction or distress. The core is air-entrained with an estimated air content of 6 percent.

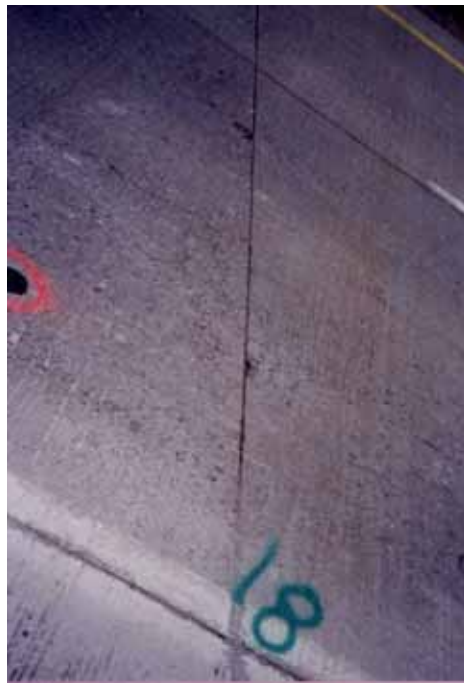
(d) Methacrylate section 2 (M2)

Core 97-M2-B: The core is classified as slightly to moderately distressed. The wearing surface is worn, revealing fine and occasionally coarse aggregate particles; 48 cracks and 75 instances of alkali-silica gel were counted. Five coarse and 27 fine aggregate particles showed evidence of distress or reaction. The core is poorly air-entrained with an estimated air content of 4 percent.

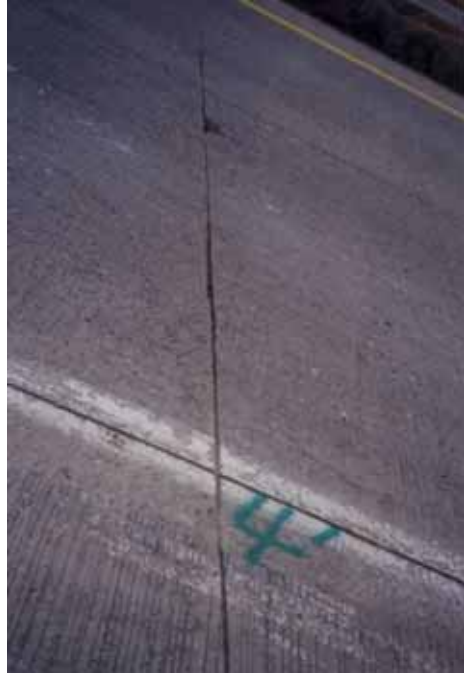
(e) Silane #2 section 1 (SA1)

Core 97-SA1-C: The core is classified as moderately distressed. The wearing surface is worn, and popouts over aggregate particles are present. Seventy-seven cracks and 41 instances of alkali-silica gel were counted. Ten coarse and 64 fine aggregate particles showed evidence of reaction or distress. The core is air-entrained with an estimated air content of 6 percent.

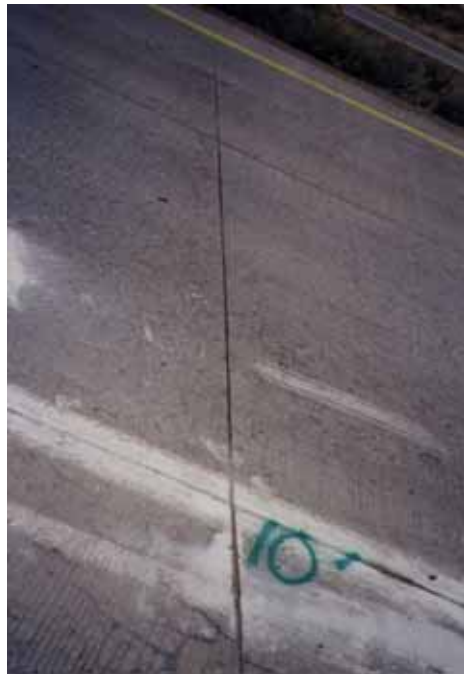
(f) Linseed oil section 1 (LO1)

Core 97-LO1-B: The core is classified as moderately severely distressed. The wearing surface is worn, exposing numerous fine and coarse aggregate particles. Popouts are occasionally evident. Seventy-three cracks and 62 instances of alkali-silica gel were counted. Five coarse and 32 fine aggregate particles showed evidence of distress or reaction. The core is marginally to poorly air-entrained with an estimated air content that varies between 4 and 5 percent.

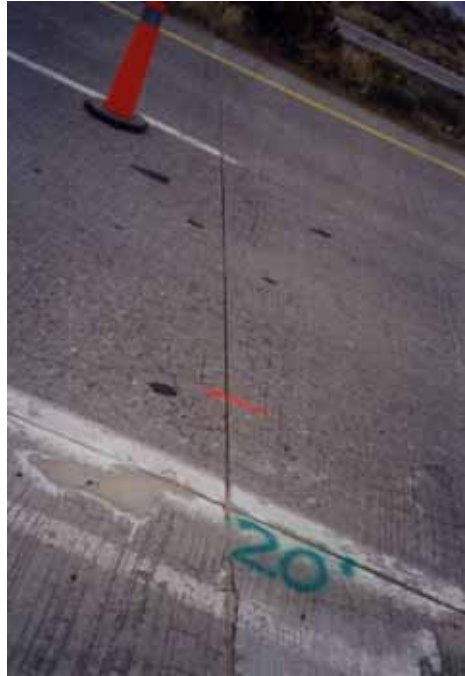
**(g)** Control section 2 (C2)

Core 97-C2-A: The core is classed as slightly distressed. The wearing surface is severely worn, exposing coarse and fine aggregate particles. Popouts are occasionally identifiable. Thirty-four cracks and 58 instances of alkali-silica gel were counted. Nine coarse and 42 fine aggregate particles were distressed or had reacted. The core is well air-entrained with an estimated air content of 6.5 percent.

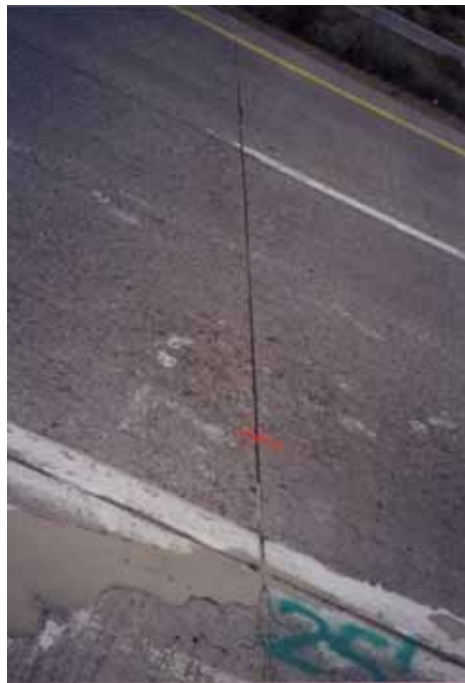
**(h)** Silane section 1 (S1)

Core 97-S1-C: The core is classified as moderately severely distressed. The wearing surface is moderately worn, exposing fine and occasionally coarse aggregate particles. Ninety-seven cracks and 85 instances of alkali-silica gel were counted. Thirteen coarse and 23 fine aggregate particles showed evidence of distress or reaction. The core is air-entrained with an estimated air content of 5.5 percent.

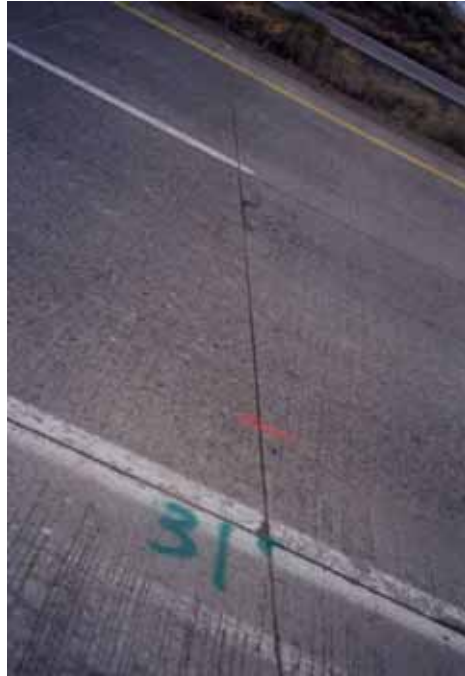
**(i)** Lithium hydroxide section 1 (L1)

Core 97-L1-C: The core is classified as moderately distressed. The wearing surface is severely worn, exposing coarse and fine aggregate particles. Popouts are frequently identifiable. Sixty-five cracks and 39 instances of alkali-silica gel were counted. One coarse and 21 fine aggregate particles show evidence of distress or reaction. The core is air-entrained with an estimated air content of 6 percent.

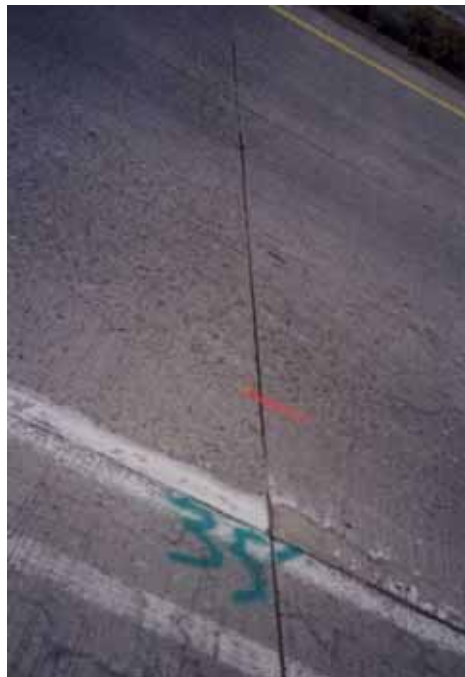
**(j)** Control section 1 (C1)

Core 97-C1-B: The core is classed as slightly to moderately distressed. The wearing surface is severely worn, exposing coarse and fine aggregate particles. Popouts are occasionally identifiable. Sixty-one cracks (chiefly microscopic) and 54 instances of alkali-silica gel were counted. Eight coarse and 22 fine aggregate particles were distressed or had reacted. The core is marginally air-entrained with an estimated air content of 5 percent.

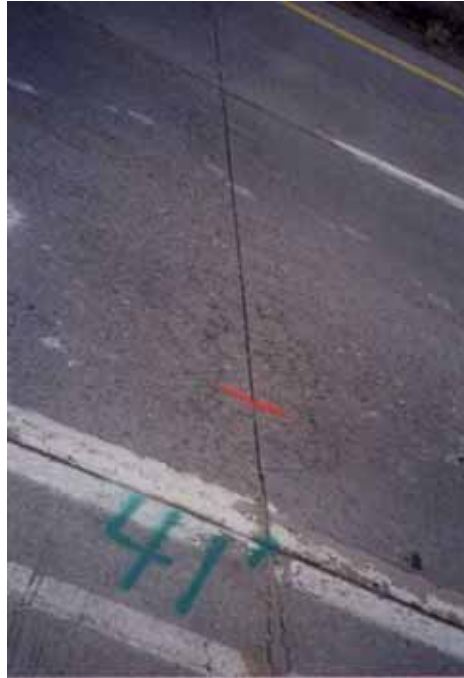
(k) Methacrylate section 1 (M1)

Core 97-M1-C: The core is classed as severely distressed. The wearing surface is worn, exposing coarse and fine aggregate particles. Popouts are occasionally evident. One hundred eighty-five cracks and 81 instances of alkali-silica gel were counted. Several of the cracks are macroscopic. Thirteen coarse and 42 fine aggregate particles showed evidence of distress or reaction. The core is poorly air-entrained with an estimated air content of 4 percent.
