# Highway Concrete Pavement Technology Development and Testing: Volume II— Field Evaluation of Strategic Highway Research Program (SHRP) C-203 Test Sites (Freeze-Thaw Resistance)

PUBLICATION NO. FHWA-RD-02-083

AUGUST 2006

U.S. Department of Transportation  
**Federal Highway Administration**

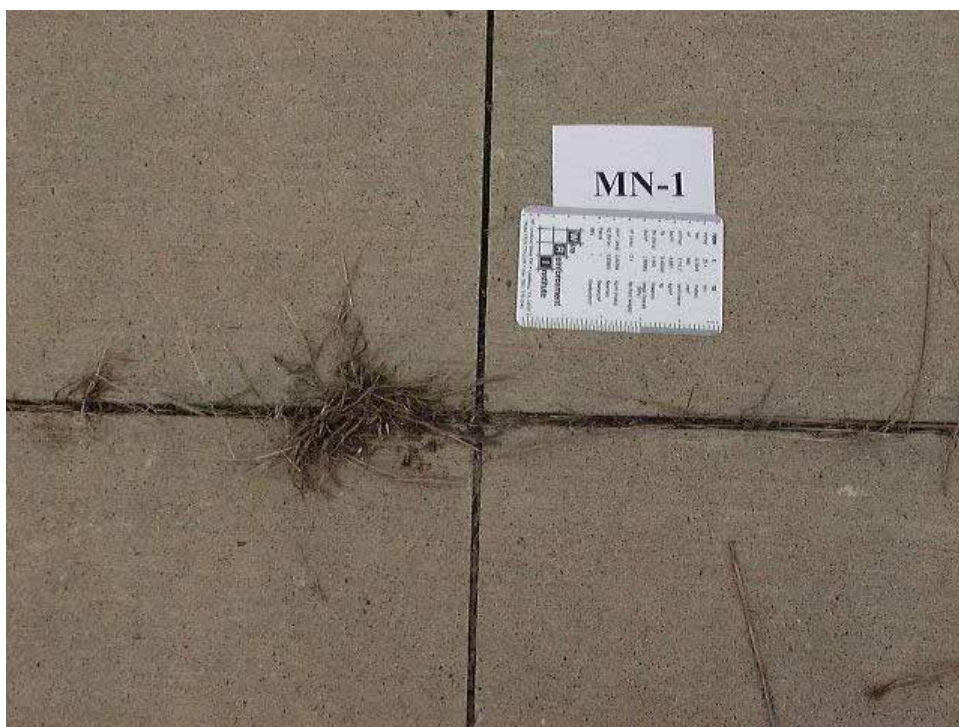
**Figure A2. Section MN1—May 2001.**

**2001:** Very light loss of surface mortar observed throughout the pad—probably consistent with expectations for 9-year-old PCC. There are several skid loader surface scratches present on this pad. Three or four small popouts (< 25.4 mm diameter, < 12.7 mm deep) are present, but there is no significant scaling or spalling. The surface condition is relatively uniform and the pad is generally in excellent condition with respect to durability.

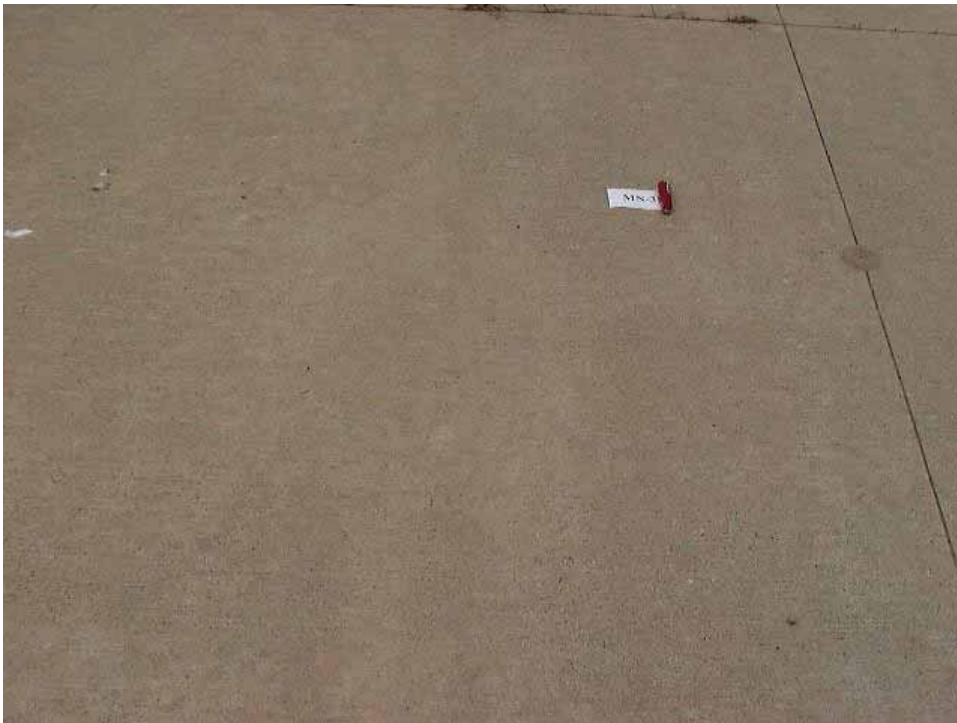
**Figure A6. Section MN3—May 2001.**

**2001:** A few larger popouts are visible on this pad (~38.1 mm in diameter, 12.7 to 19.05 mm deep). More loss of surface mortar is observed throughout the pad, especially at the east end. The surface color and texture of the pad is less uniform, and the original broomed surface texture is difficult to see in some areas of mortar loss. Overall, the surface is in fair to good condition.

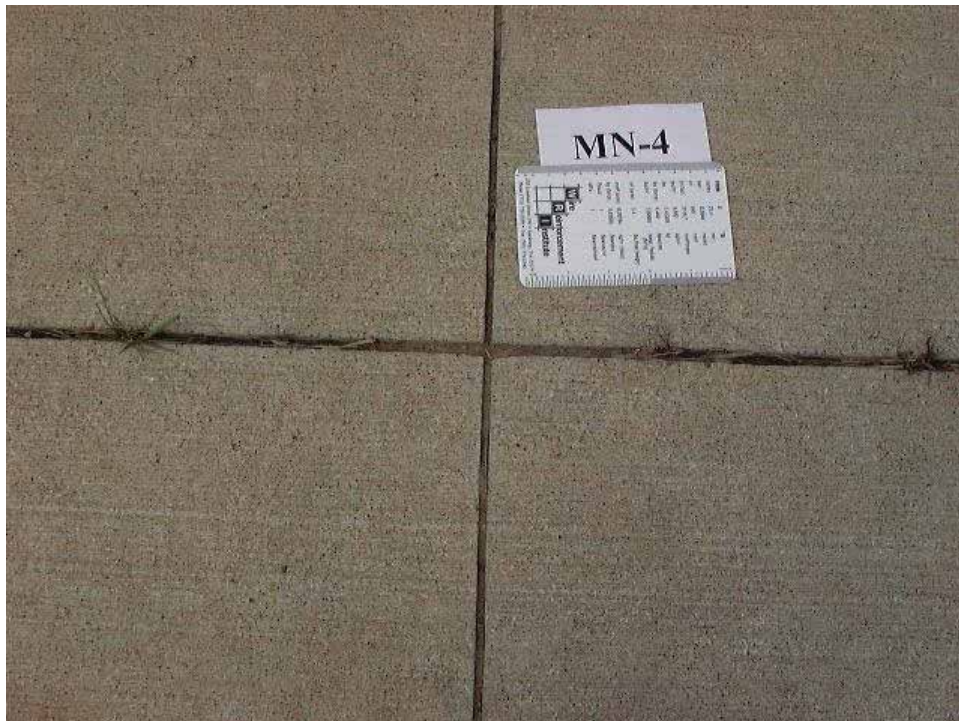
**Figure A8. Section MN4—May 2001.**

**2001:** There is one large popout (50.8+ mm in diameter, 19 mm deep) near the west end of the pad. There is a large spall adjacent to a 101.6-mm core hole at the west end of the slab. There is some loss of surface mortar (and evidence of the same whitish crystalline deposits observed in MN2), but texture is generally good and uniform throughout. No significant spalling or scaling is present. Overall condition is good to very good.

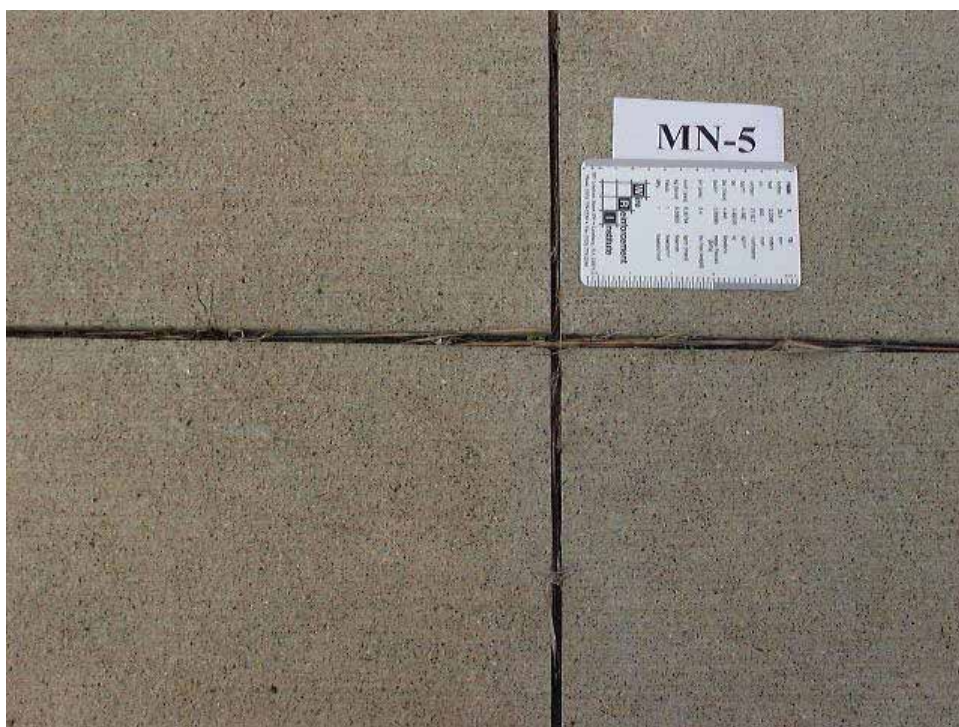
**Figure A10. Section MN5—May 2001.**

**2001:** There is heavier loss of surface mortar throughout, resulting in localized elimination of the broomed surface texture. There is no significant scaling or spalling/fraying of joints. The heaviest loss of mortar and texture is along a .3 m to .6 m band along the south edge of the pad, which is characterized by a darker color. The whitish crystalline deposits are visible in other areas of the pad. There are some skid loader marks oriented in a north-south direction in the southwest quarter of the pad. The overall general condition of the pad is considered good.

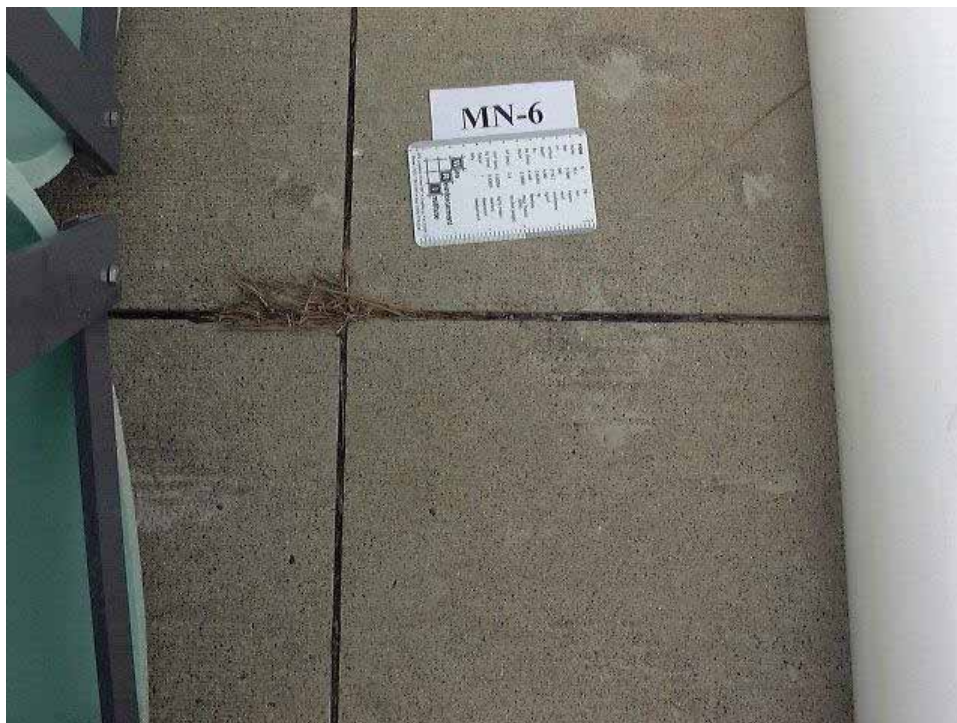
**Figure A12. Section MN6—May 2001.**

**2001:** There is localized heavy loss of mortar and surface discoloration along various lines that suggest localized water problems under plastic curing sheets. There is a large spall at the southeast corner of the pad. A few small popouts are present throughout the pad. No significant spalling or scaling was observed. The pad is in generally good condition with respect to durability except for the presence of the locally heavy mortar loss probably associated with the plastic curing cover.

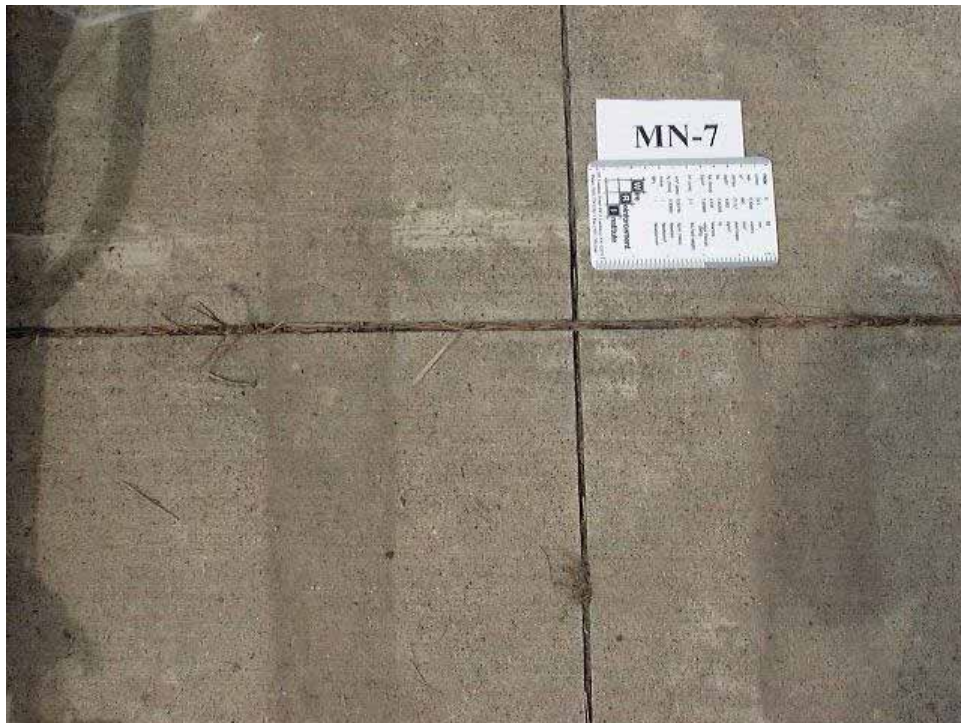
**Figure A14. Section MN7—May 2001.**

**2001:** There is again heavy mortar loss along various “plastic covering” lines in the east half of the pad. The loss is fairly deep (3.18 to 6.35 mm, locally) and the broomed texture is gone in these areas. There are also areas of what appear to be coring slurry or grey epoxy on the pad surface. A few small popouts are present throughout the slab. There is light fraying (25.4 to 50.8 mm long, < 12.7 mm wide) at two joint locations. There is a large spall in the southeast corner of the pad. Slab texture at the west end of the pad is generally good and uniform (no evidence of plastic sheeting problems).

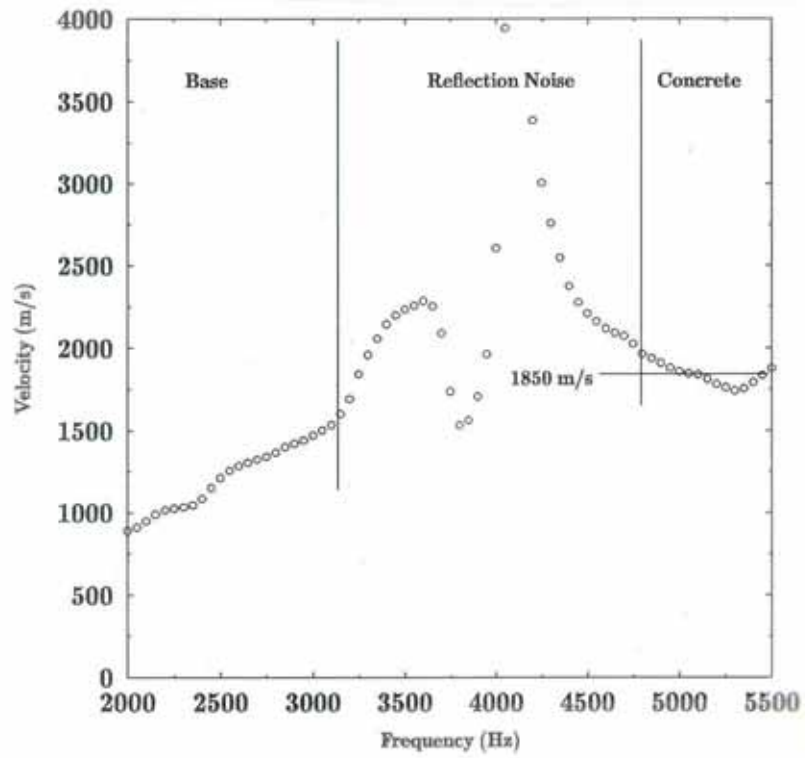
Figure B4 shows a typical R-wave velocity versus vibration frequency plot. The concrete pavement and subbase (base) portion are easily identified. The central section of the graph is dominated by noise resulting from waves reflected by the vertical edge of the pavement. This phenomenon is present in most of the R-wave velocity versus vibration frequency plots from the Ohio testing. Extensive analysis was conducted to filter out this reflection noise from the digital data obtained in Ohio.

**Figure B4. Typical R-wave velocity versus vibration frequency plot.**
