# Highway Concrete Pavement Technology Development and Testing: Volume IV— Field Evaluation of Strategic Highway Research Program (SHRP) C-206 Test Sites (Early Opening of Full-Depth Pavement Repairs)

PUBLICATION NO. FHWA-RD-02-085

AUGUST 2006

U.S. Department of Transportation  
**Federal Highway Administration**

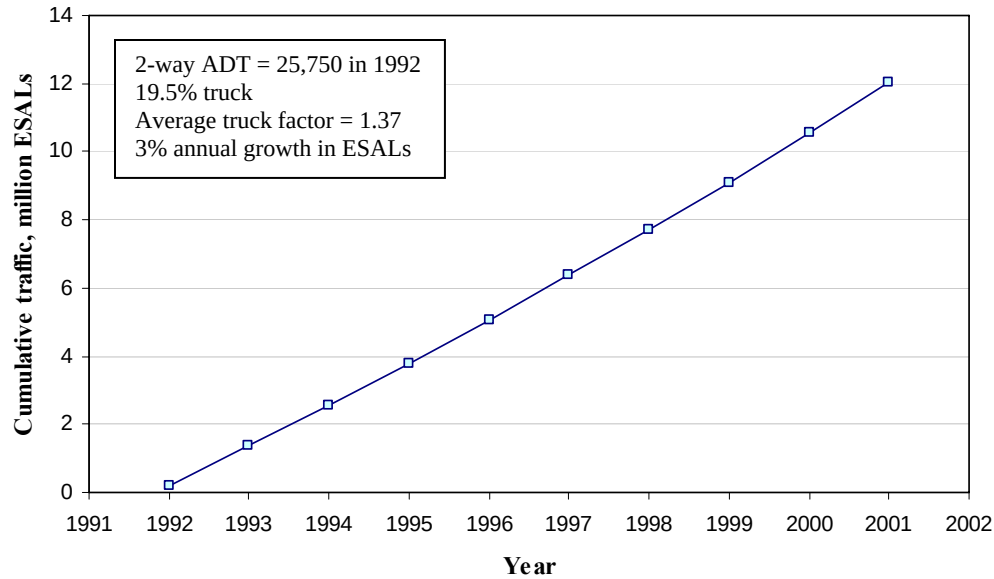
**Figure 1. Estimated traffic on Georgia site.**

The cracking problem was analyzed using the fatigue calculation procedure and model developed by Yu and colleagues (1998). The traffic data needed for the fatigue analysis are shown in figure 1. The traffic on I-20 through the project site is relatively high. The annual traffic is about 1.1 million equivalent single axles (ESALs) in the design lane.

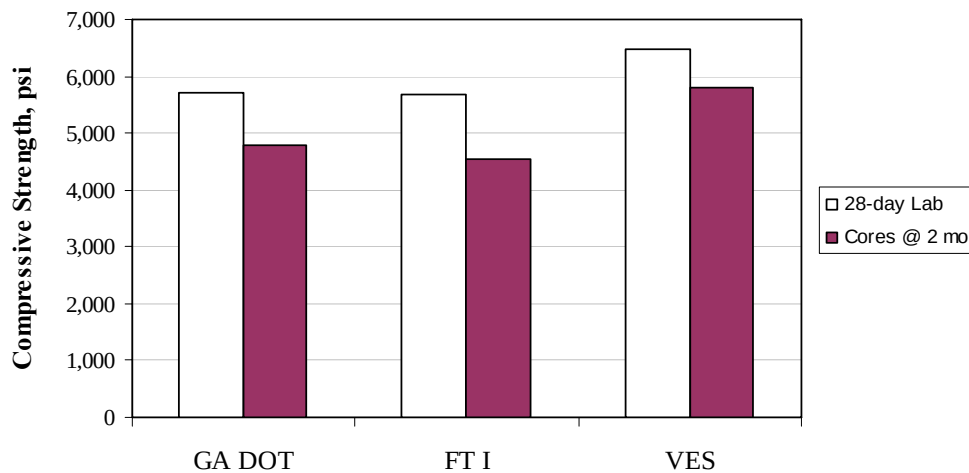
**Figure 2. Available material strength data for the Georgia sections.**

Figure 2 shows lower strength for cores retrieved at 2 months, but this is likely caused by damage during coring or shipping of the cores and testing variability. Extensive material testing was conducted under task C of this project for VES and HES mixes, and the results of those tests showed that the long-term (5-yr) strength of those mixes is up to 18 percent greater than the 28-day strength. A comparison of early-age (up to 90 days) strength-gain characteristics of these mixes suggests that the long-term strength-gain characteristics of the GADOT mix should be similar to those of VES and HES. Based on this assumption, figure 3 was developed to show the long-term strength development of the GADOT mix.

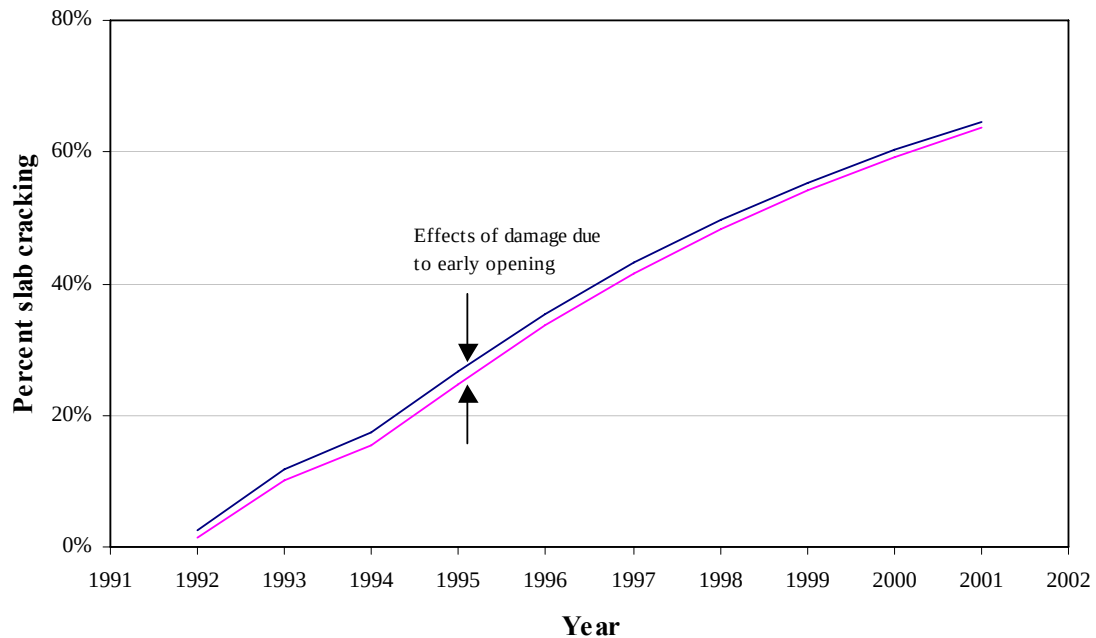
**Figure 5. Illustration of the effects of damage due to early opening.**

The results of fatigue analysis are shown in figure 4, along with the observed slab cracking. The model was run with built-in curling of  $-2.2\text{ }^{\circ}\text{C}$  ( $28.04\text{ }^{\circ}\text{F}$ ), which accounts for differential shrinkage. The effects of damage due to early opening are illustrated in figure 5. As shown in table B1 in appendix B, the amount of fatigue damage attributable to early opening was minimal (Miner's damage of 0 to 0.07, except for 0.10 for the last patch). The damage due to early opening has the effect of shifting the time (or traffic) versus cracking curve upward, as illustrated in figure 5. However, for the Georgia sections, early opening to traffic had a negligible effect on the fatigue life of the repairs, even for the 4.6-m repairs. In fact, the last three 4.6-m repairs placed in the GADOT section (i.e., the repairs that were opened to traffic at the lowest strength) did not crack. For shorter repairs, the effects of early opening (and fatigue damage in general) are inconsequential.

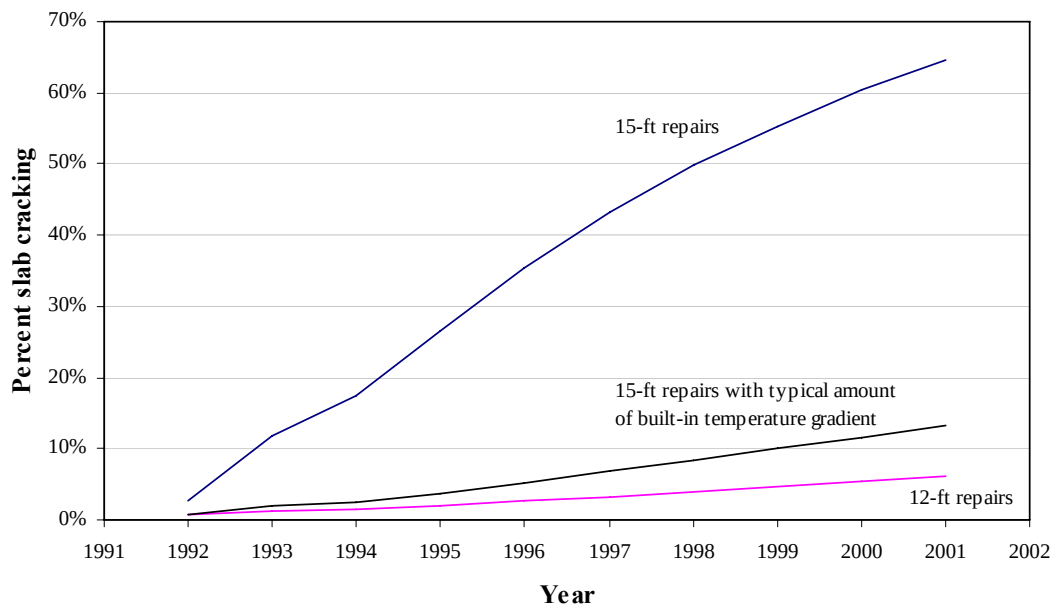
**Figure 6. The effects of repair length and built-in curling on performance of full-depth repairs.**

Figure 6 shows the effects of repair length and built-in curling on the fatigue performance of full-depth repairs. For bottom-up transverse cracking, the GADOT section represents the most adverse condition, because the repairs hardened with zero built-in temperature gradient.

However, even under this condition, the 3.7-m repairs have an expected fatigue life of 10 or more years; shorter repairs should have practically unlimited fatigue life. Figure 6 also shows that if moderate built-in curling were introduced, the fatigue life of the 4.6-m repairs would increase dramatically. In this example, a total effective built-in temperature gradient of  $-5^{\circ}\text{C}$  ( $23^{\circ}\text{F}$ ) was used, including the effects of temperature and differential shrinkage. This is a typical magnitude of built-in curling for PCC pavements in wet-nonfreeze climates. In general, for daytime construction, excessive built-in curling is more of a problem than is an inadequate amount of built-in curling.
