Highway Concrete Pavement Technology Development and Testing: Volume V— Field Evaluation of Strategic Highway Research Program (SHRP) C-206 Test Sites (Bridge Deck Overlays)

PUBLICATION NO. FHWA-RD-02-086

AUGUST 2006

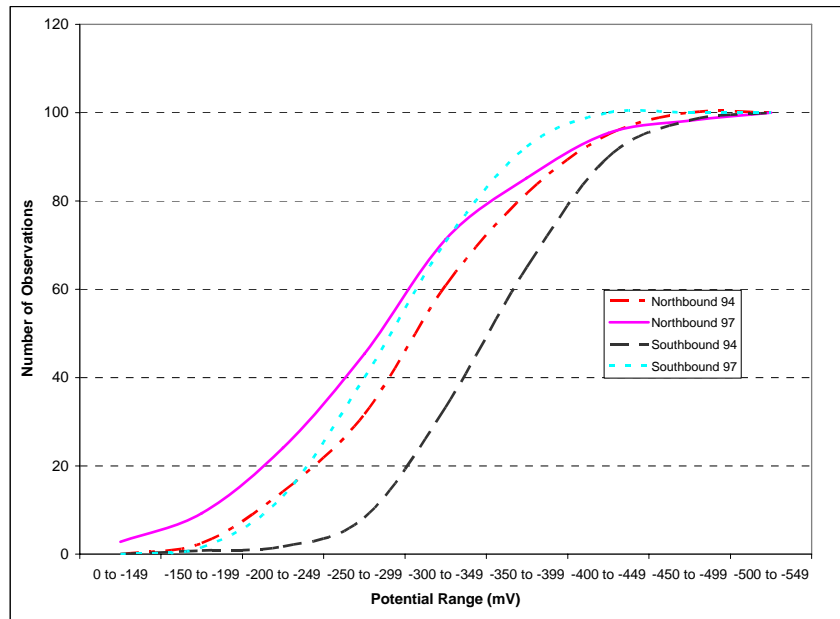
Figure 8. Cumulative frequency diagram for I-270 (NB and SB) for years 1994 and 1997.

Past experience with research performed at the contractor site and published in FHWA report FHWA-RD-86-193, *Protective Systems for New Prestressed and Substructure Concrete*, indicates that corrosion potentials more negative than approximately -230 mV indicate that corrosion is taking place in bridge deck type structures. According to the -230 mV criteria, the majority of the locations surveyed had potentials indicating that corrosion was taking place. Both structures appear to be undergoing corrosion over the majority of their deck area. The ends of the bridges and the areas under cracked delaminations appear to be especially vulnerable. A cumulative frequency diagram of the potentials is shown in figure 8. The curve for both bridge decks is shifted to the left from 1994 to 1997. This indicates a decrease in the overall half-cell potentials. The shift is larger for the southbound lanes which have the latex-modified overlay.

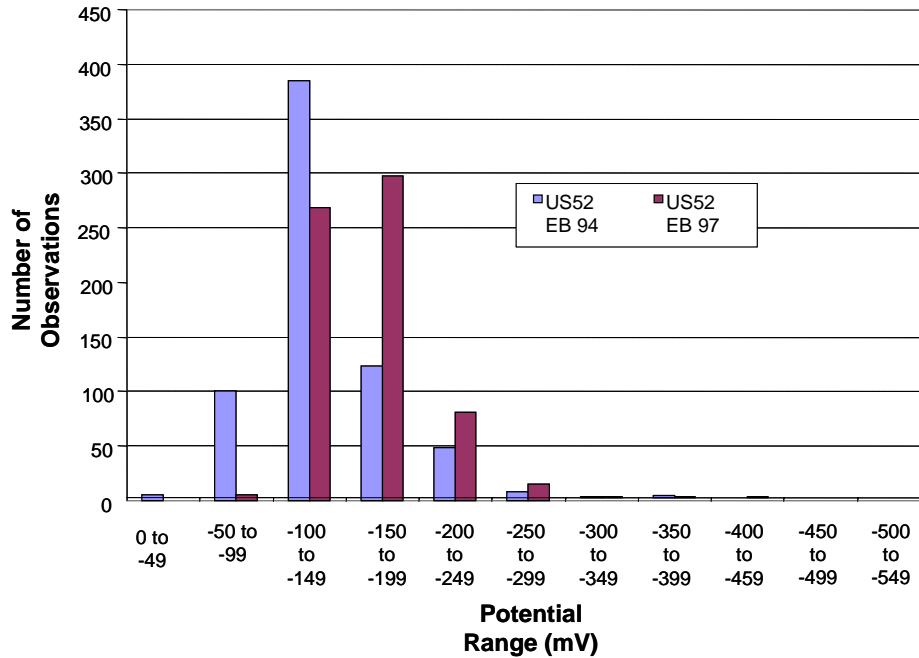
Figure 12. Histogram of half-cell potential readings for U.S. 52 eastbound travel lane LMC in 1994 and 1997.

The readings for the eastbound travel lane in 1997, shown in table 21, range from -0.089 V to -0.412 V. Over 97 percent of the readings are below -0.250 V. A histogram for the eastbound travel lane in 1994 and 1997 is shown in figure 12. The half-cell readings for the westbound travel

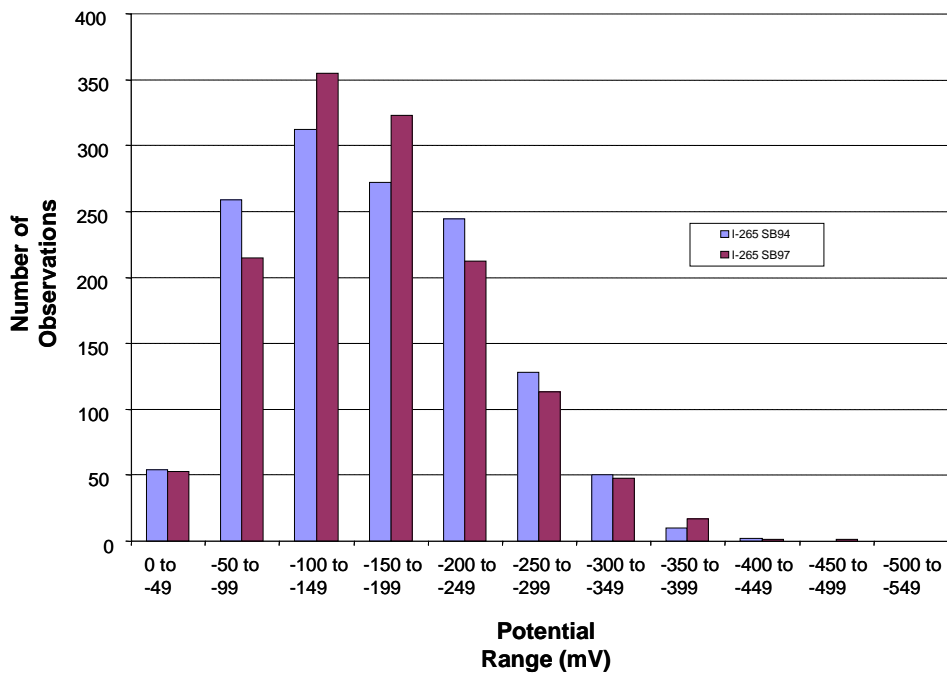
Figure 19. Histogram of half-cell potential readings for I-265 southbound SFC test section.

In 1997, the half-cell potentials ranged from +265 mV to -600 mV. Span 1 again had the highest average potential reading of -207 mV. Span 2 again had the highest potential reading at -600 mV and the lowest average reading at -149 mV. Span 3 had an average potential reading of -160 mV. Tables 35 and 36 give the cumulative frequencies of the half-cell potentials for the southbound test section of I-265 for 1994 and 1997, respectively. In 1994, over 85 percent of the readings were less negative than -250 mV. In 1997, over 86 percent of the readings were less negative than -250 mV. A histogram of the half-cell potential readings for the southbound test section in 1994 and 1997 is shown in figure 19.
