# LTPP Pavement Maintenance Materials: PCC Partial-Depth Spall Repair Experiment, Final Report

PUBLICATION NO. FHWA-RD-99-153

OCTOBER 1999

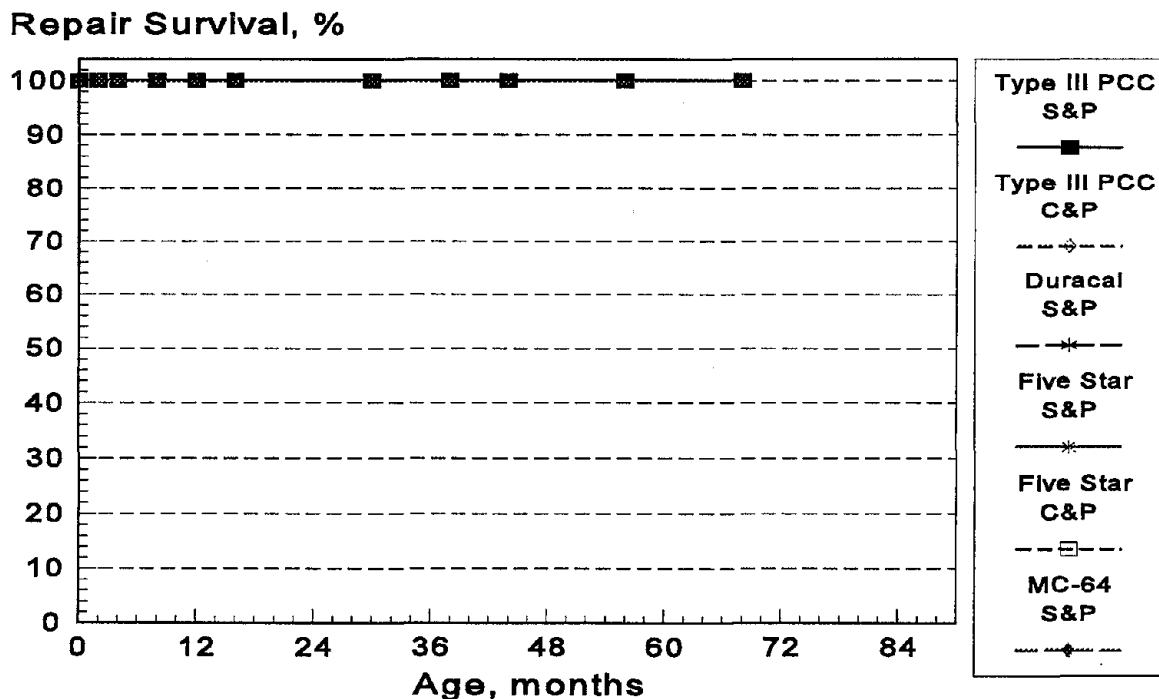
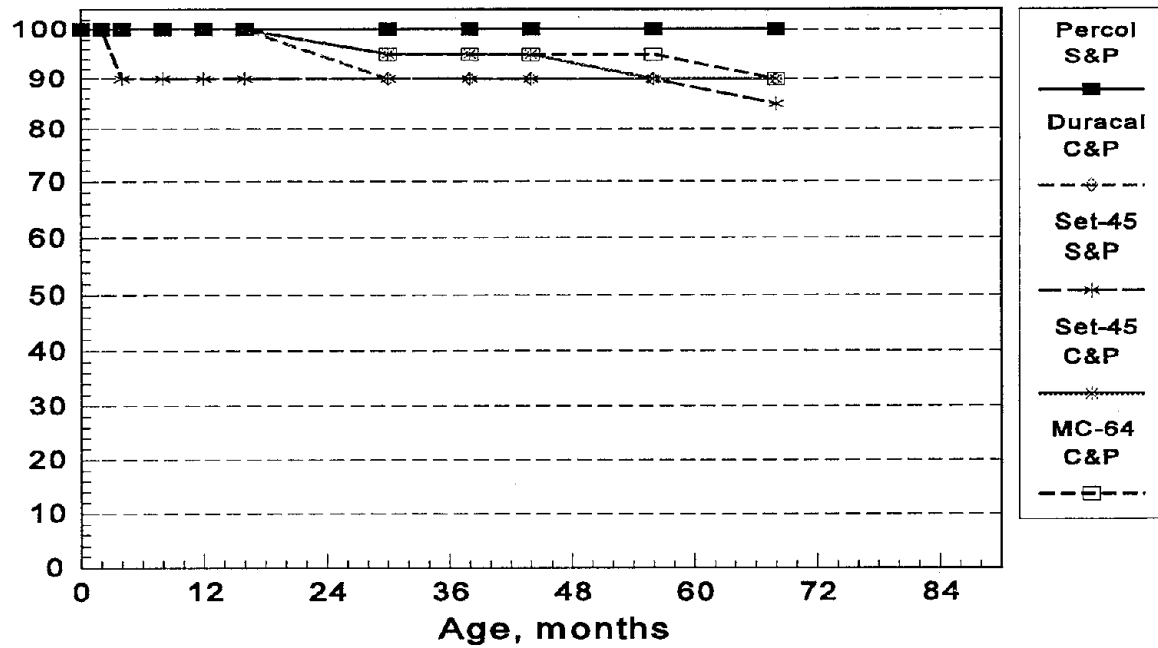
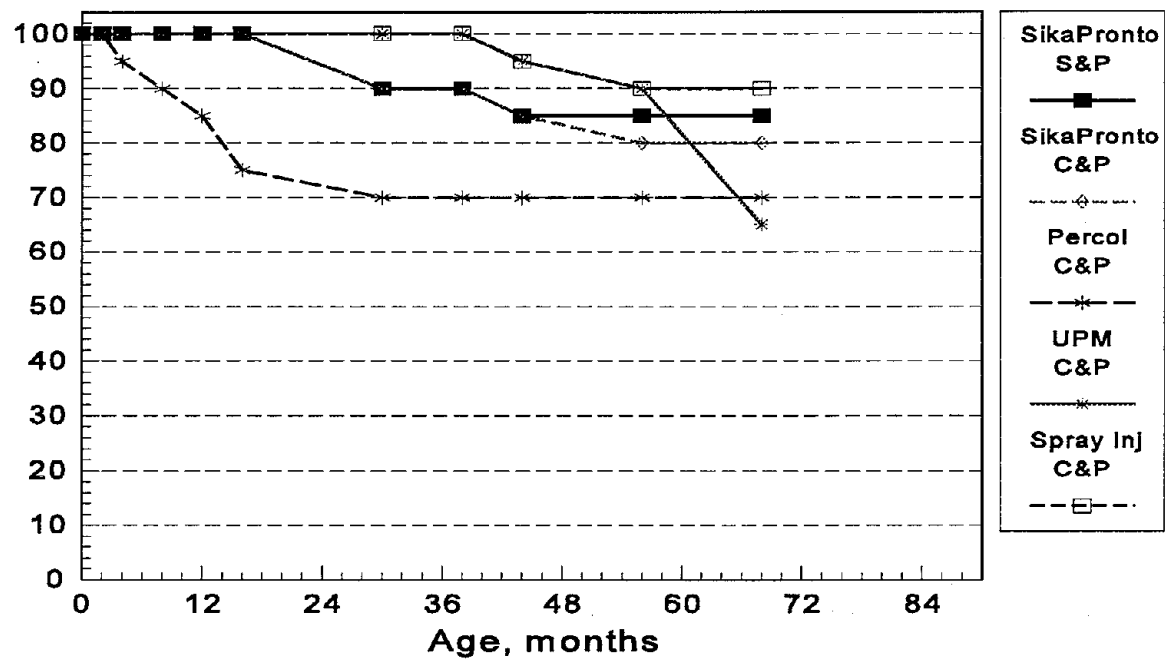
Figure 24. Spall repair survival at South Carolina test site.

Figures 24 through 27 show the survival trends of the various repair types placed at each of the four test sites. These figures indicate that the percentage of repairs surviving after 4 to 7 years is quite variable for the Pennsylvania and Arizona test sites, whereas all but three repair types experienced no failure over 7 years of observation at the Utah test site. The fact that the repairs were all in the passing lane and not subjected to the majority of the truck traffic was one of the factors contributing to the good performance observed at the Utah site. The overall good condition of the pavement, which was better than any of the other spall repair test sites, also provided the repairs with a better opportunity for good performance.

The distresses most often observed during the field inspections of the spall repair test sites consisted of cracking of the patches and delamination of the rigid and two-part epoxy repairs from the underlying PCC material. Deterioration of repair edges, aging and raveling of material, cracking, and loss of material pieces were the predominant distresses observed for the bituminous repairs. In many instances, the distresses developed during the initial year after placement and continued to worsen over time as climate and traffic continued to wear on the repairs.

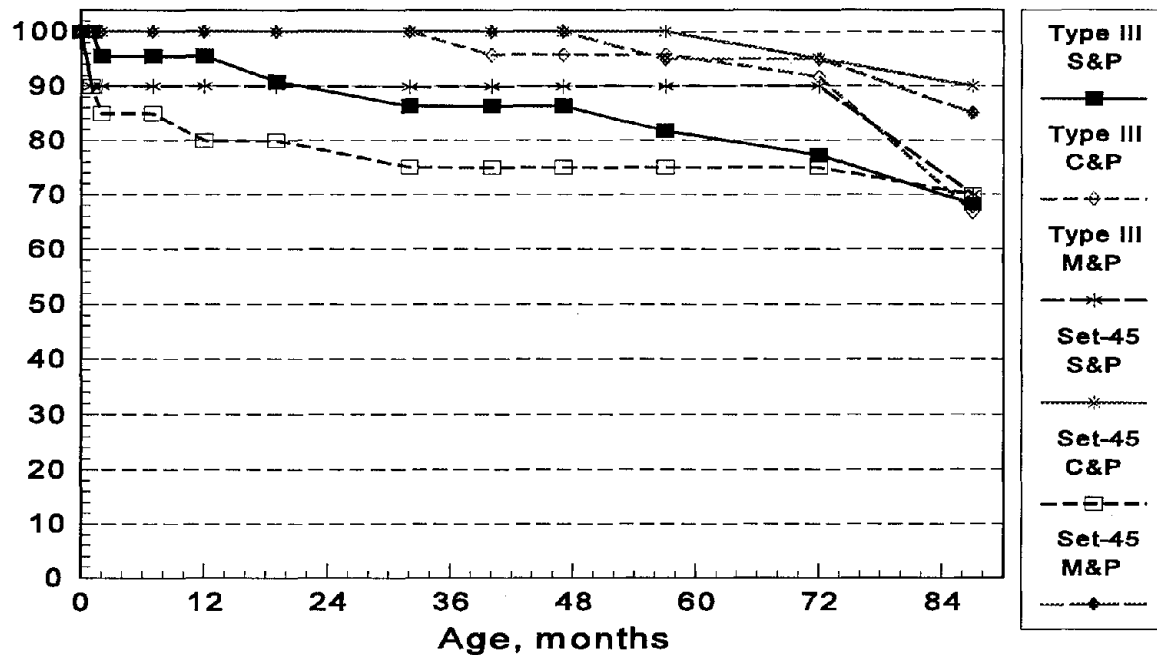
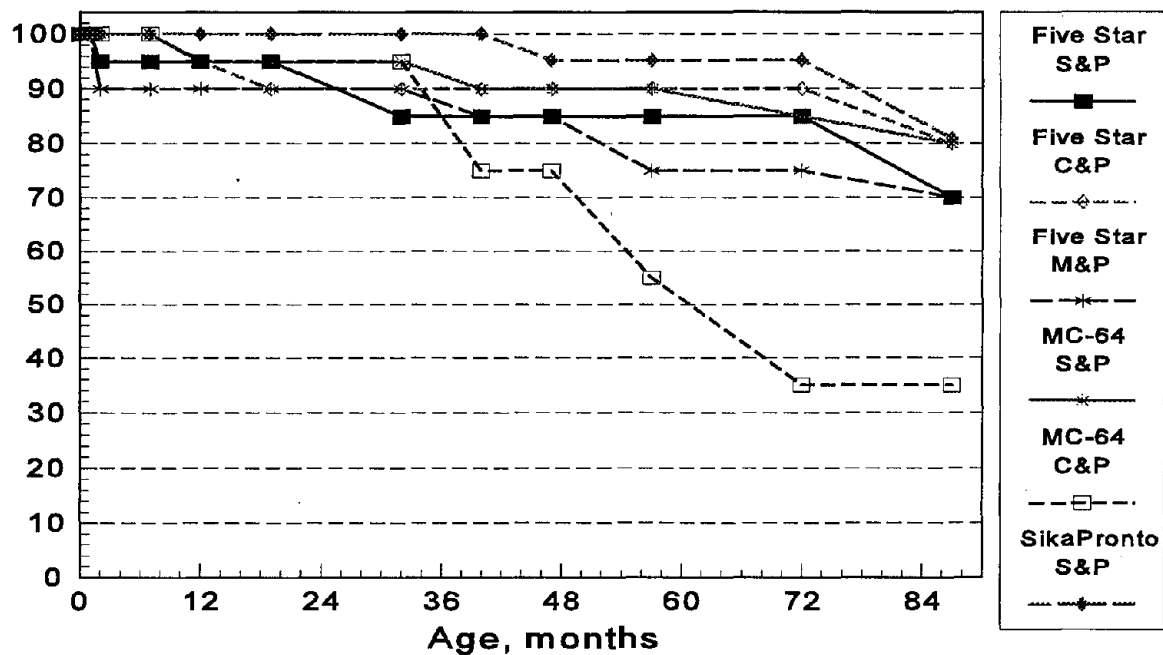
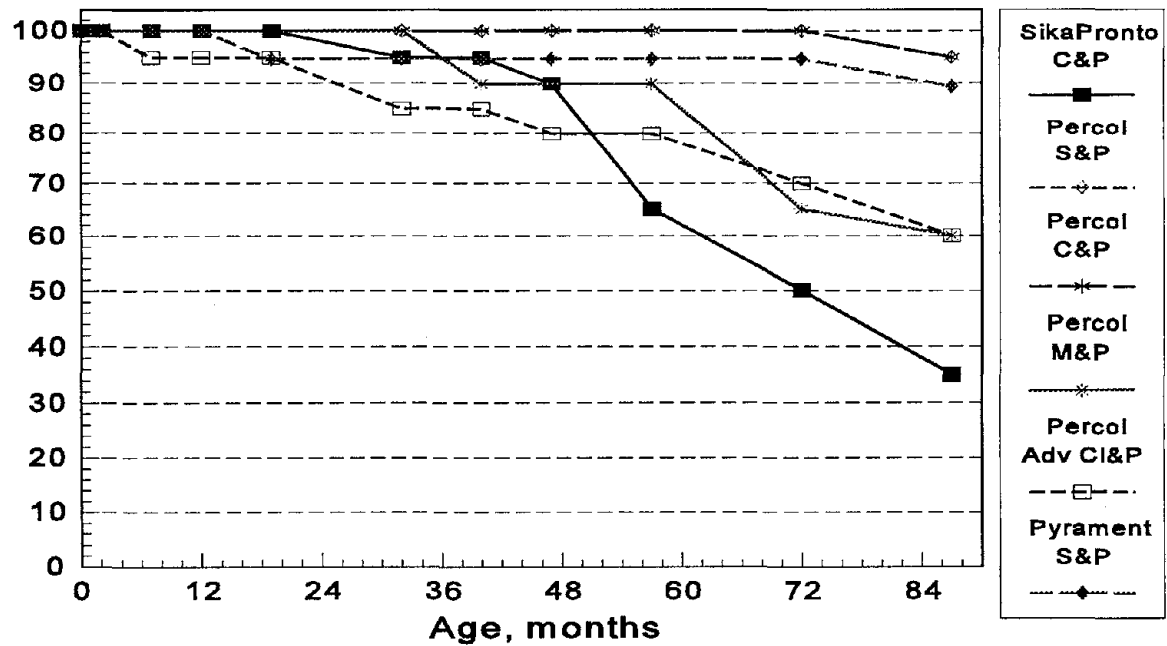
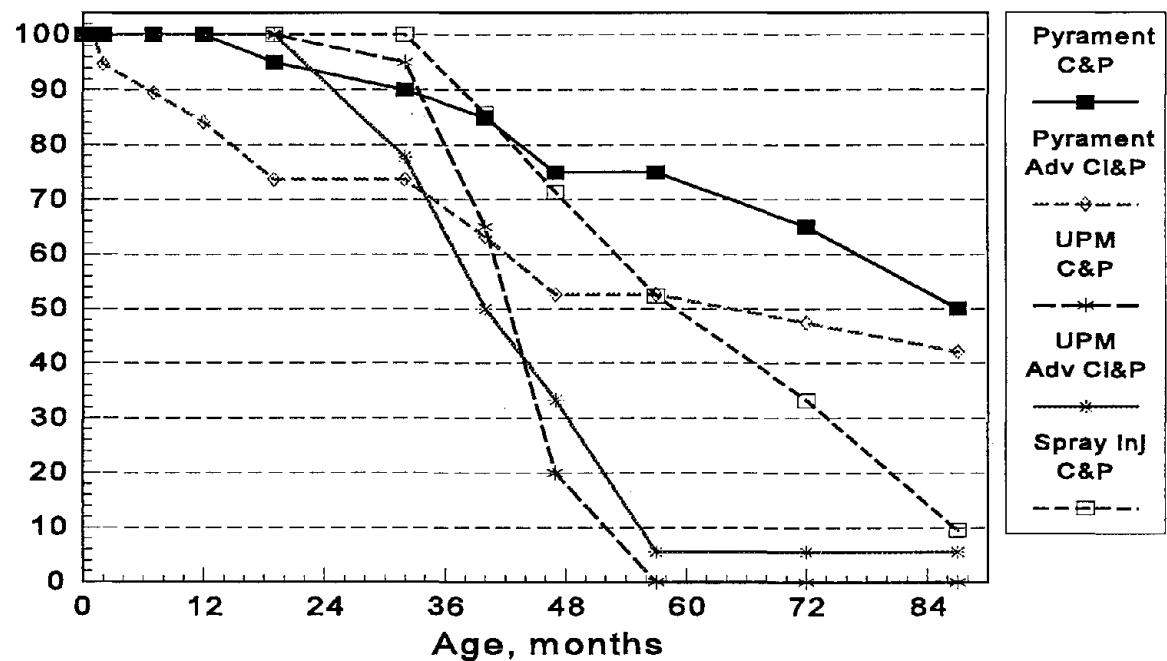
Figure 26. Spall repair survival at Pennsylvania test site.

Although the test sites were carefully screened for their suitability to the demands of the SHRP H-106 project, unexpected pavement conditions were encountered at the Pennsylvania site. Ideally, only spalls that measure less than one-third the pavement thickness in depth are suitable for partial-depth repairs. However, the depth of the deterioration below the spalled area is difficult to determine prior to actually repairing the spall. At the Pennsylvania test site, joint deterioration often was more severe than the surface visual inspection indicated. Many of the spalled areas were deteriorated to the depth of the dowel bars and below. Because of time constraints and the unavailability of proper equipment to perform full-depth repairs, partial-depth repairs were installed and will be evaluated as part of this project.
