# Long-Term Effects of Electrochemical Chloride Extraction on Laboratory Specimens and Concrete Bridge Components

PUBLICATION NO. FHWA-HRT-10-069

SEPTEMBER 2011

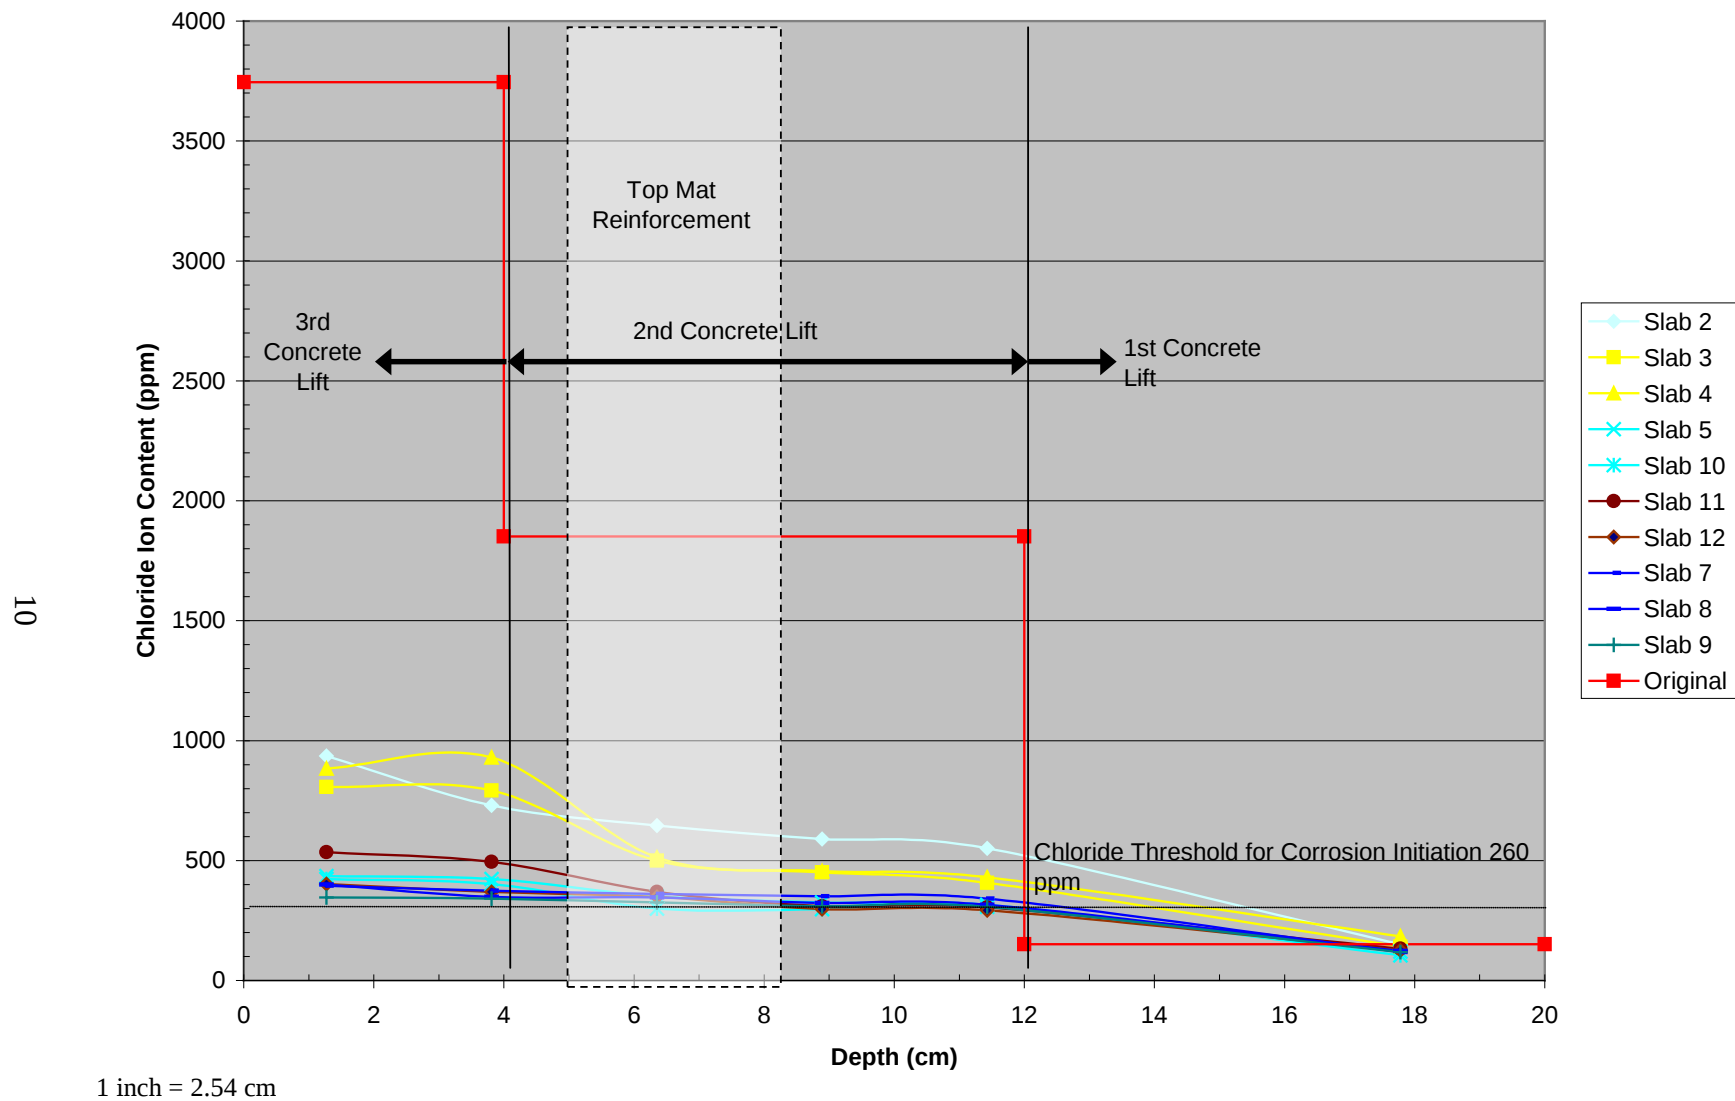
At the end of the study in December 1999 (10.25 years after ECE treatment), one core was collected from each slab, and chloride ion content analyses were performed on powdered samples from the cores. Concrete samples were collected from five nominal depths of 0.50, 1.50, 2.50, 3.50, 4.50, and 7.00 inches (12.7, 38.1, 63.5, 88.9, 114.3, and 177.8 mm). Concrete from 0.50 inches (12.7 mm) above and 0.50 inches (12.7 mm) below each nominal depth was powdered and mixed to prepare a sample representing that nominal depth. The collected powdered samples were analyzed for total chloride ion content, and the results are presented in figure 1.

Prior to the application of ECE, the average chloride ion content measured in the bottom 3.1 inches (78.7 mm) of the slabs (first lift) was 151 ppm. Additionally, the average chloride ion measured in the middle 3.1 inches (78.7 mm) of the slabs (second lift) was 1,851 ppm, while the average chloride ion content measured in the top 1.6 inches (40.6 mm) of the slabs (third lift) was 3,475 ppm (see figure 1 for comparison purposes). Comparison of the chloride profile for slab 2 to the chloride profile for original chloride ion content shows the effect of diffusion at the end of 10.25 years. Over time, the chloride ions in slab 2 were diffused to reach a uniform distribution at all depths. The total quantity of chloride ions in slab 2 was calculated using the profile of chloride distribution assuming that the chlorides were uniformly distributed in the horizontal plane at each depth. Based on this calculation, the total quantity of chloride ions present in the slab after 10.25 years was approximately 3.5 oz (100 g). The calculated quantity (based on initial quantities of chlorides in each lift) of chloride ions added to the slab at construction was 9.38 oz (268 g), and the removal of cores from the slab accounted for 2.38 oz (68 g) of chloride ions. The difference of 3.5 oz (100 g) can be explained by the leaching of chloride ions from cracks and the delaminations along the top mat rebar and in the core holes.

Figure 1. Graph. Chloride ion content versus depth.

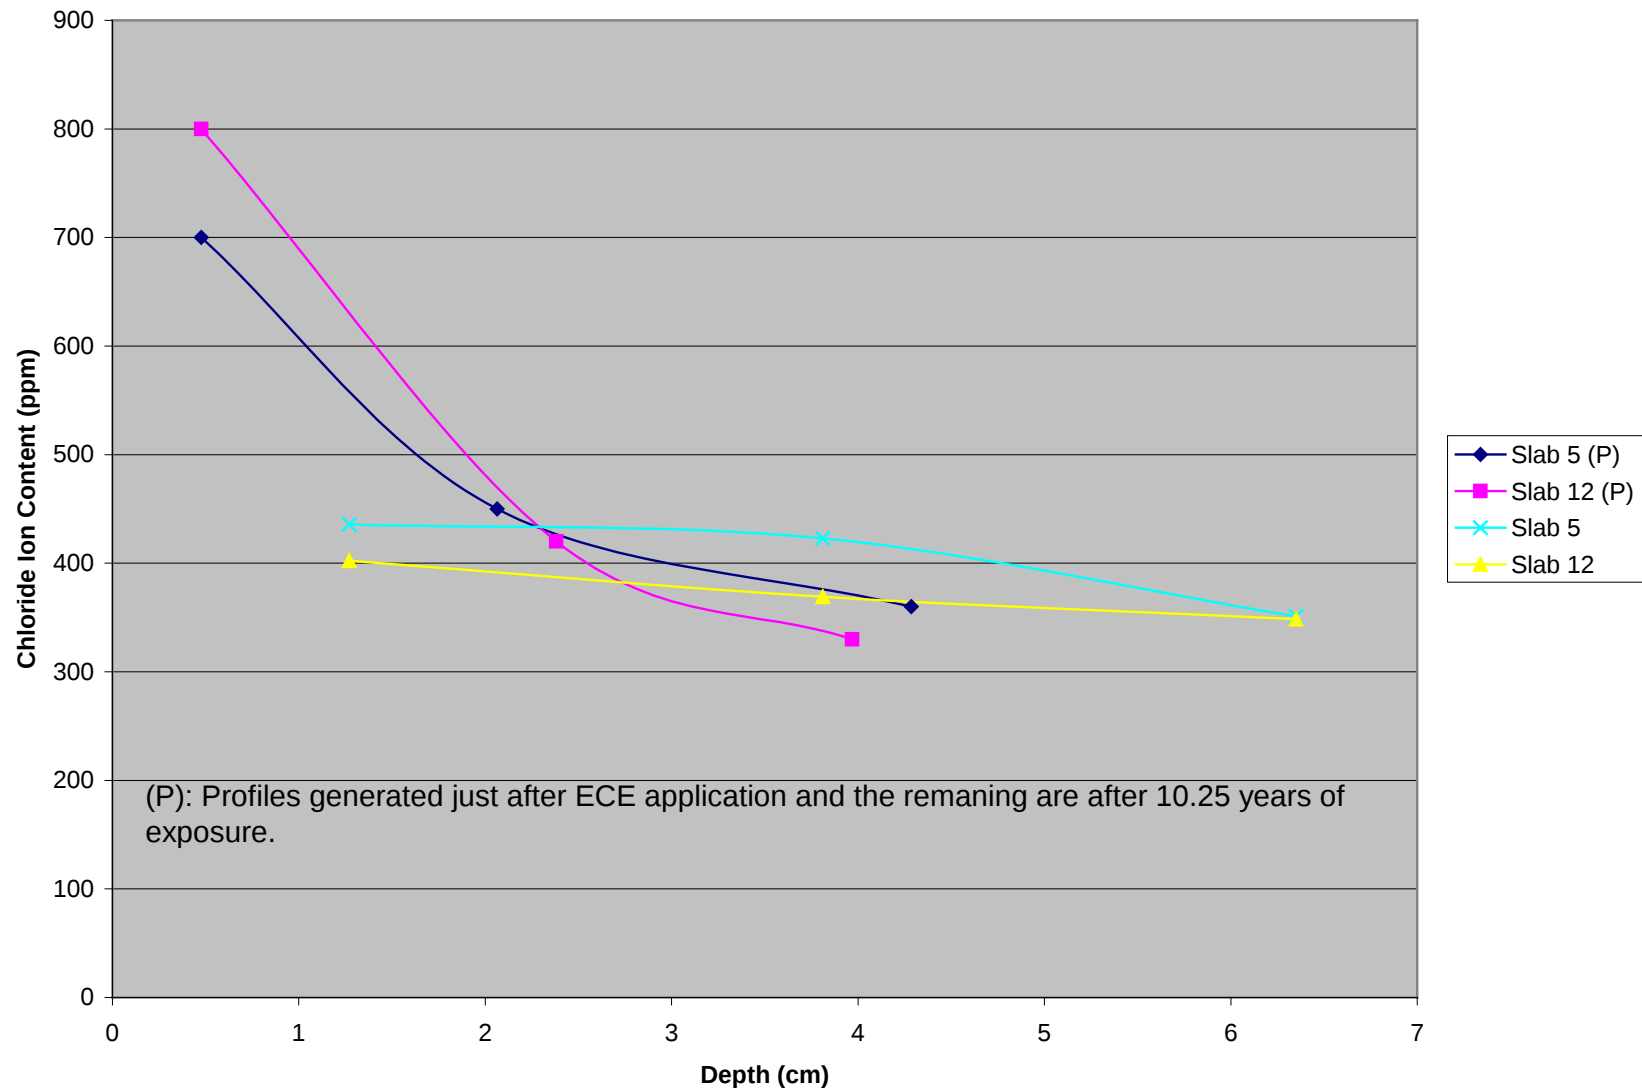
All ECE slabs showed a distribution of chloride ions similar to that of slab 2, albeit at a lower but somewhat uniform concentration. Slabs 3 and 4, which received the least amount of ECE treatment (59.9 A-h/ft<sup>2</sup> (645 A-h/m<sup>2</sup>) compared to over 186 A-h/ft<sup>2</sup> (2,000 A-h/m<sup>2</sup>)) for other slabs), had a higher level of chloride ion concentration than the other ECE slabs at all depths in the second and the third lifts of concrete. To ascertain if this distribution of chloride ions in the ECE slabs resulted from diffusion of chloride ions and/or the application of ECE, chloride profiles from various time periods needed to be compared for each ECE slab. Limited profile data were available. Immediately after ECE application, chloride ion content from several depths of one core from slabs 5 and 12 were analyzed. Comparison of those profiles with profiles after 10.25 years of exposure suggests that some amount of diffusion occurred in the third lift of concrete for these two slabs (see figure 2).

**Figure 2. Graph. Comparison of chloride profiles.**

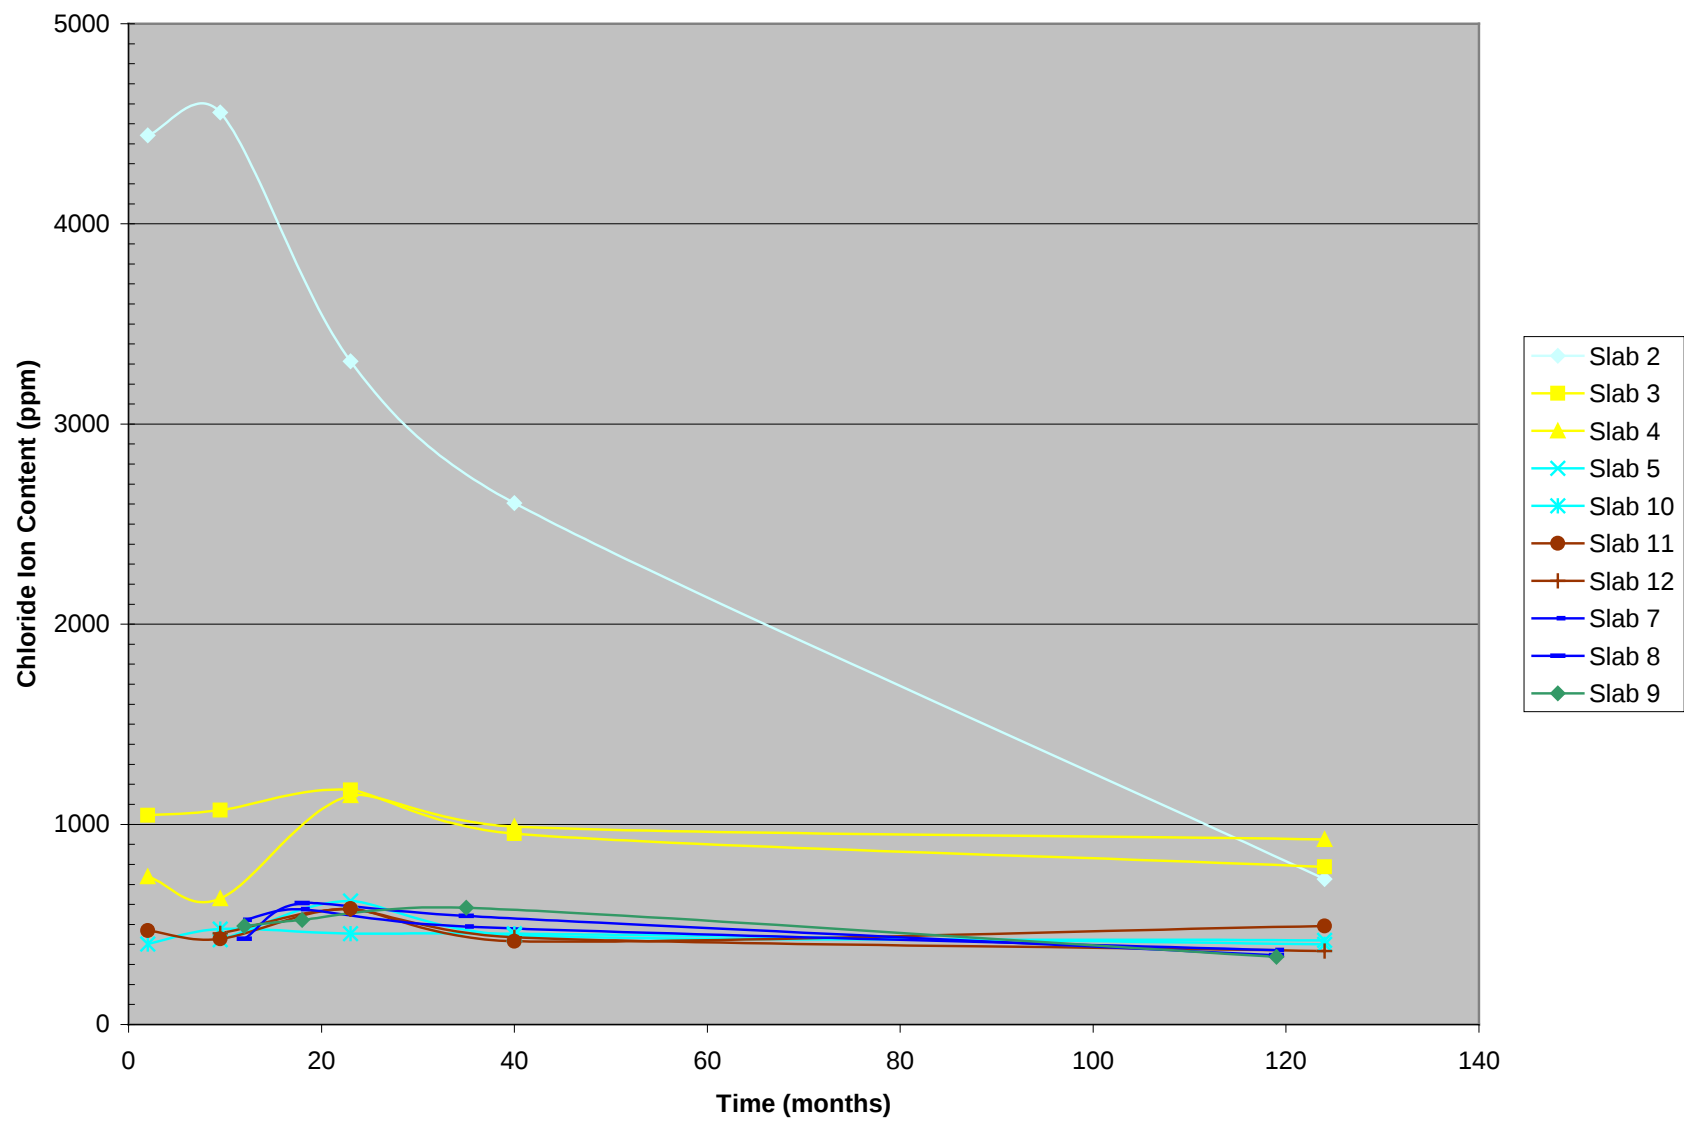
Figure 3 shows the diffusion of chloride ions with time from the top trace of the top mat rebar of slab 2. A similar but much lower magnitude trend is discernable in the ECE slabs, which is in agreement with data presented in figure 2. The chloride ion content above the top rebar trace in slabs 3 and 4 was higher than the other ECE slabs.

Figure 3. Graph. Chloride content versus time.

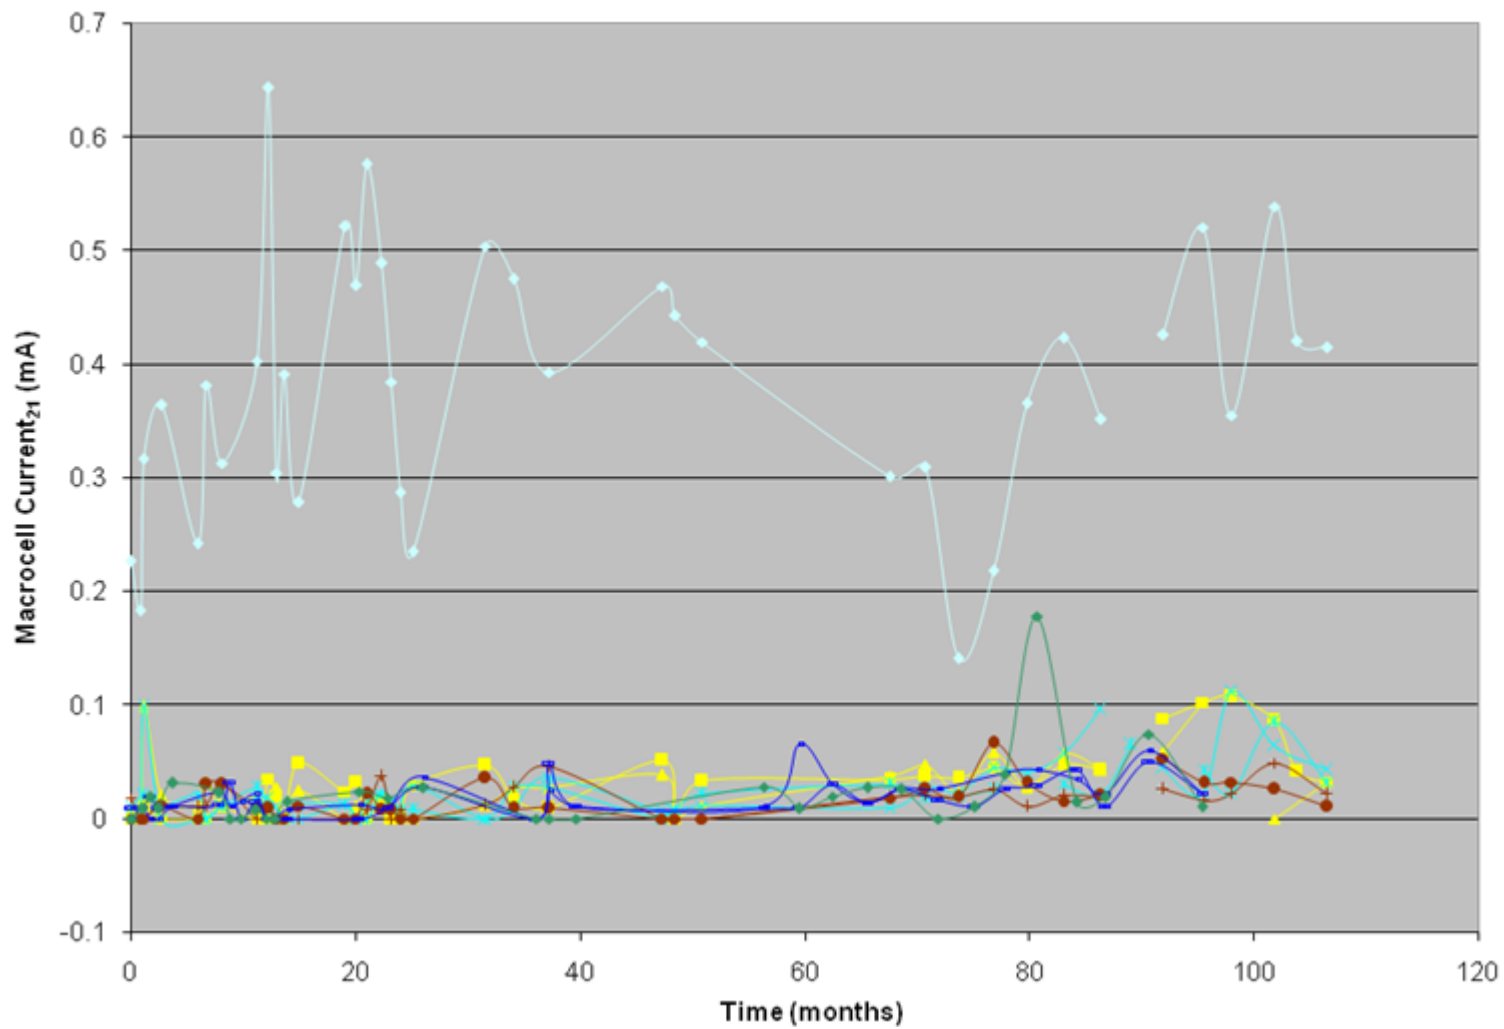
The ECE slabs had much lower macrocell current and driving volts and exhibited lower levels of damage. The driving volts and macrocell currents for the ECE slabs varied within a narrow range, and no specific trend was observed over time. Analysis of variance of the data indicated that the driving volts and macrocell currents for slabs 3 and 4 were statistically different than those of the other ECE slabs. Figure 22 indicated that the driving volts for slabs 3 and 4 were somewhat higher than the volts for the other ECE slabs, especially after 40 months of monitoring. Such a difference was not noticeable in the macrocell data in figure 21. The higher driving volts and macrocell currents for these slabs correlated well with the amount of chlorides at the top mat steel level and the observed damage. The macrocell currents and driving volts for slabs 3 and 4 increased closer to the end of this study.

The macrocell currents and driving voltages of all ECE slabs were significantly lower than those of the control slab, and they indicated the level of reduction in corrosion of the rebars that had resulted from application of ECE. If the time-averaged macrocell current was calculated for each slab from the data in figure 21, the time-average macrocell current for the control slab was a minimum of 13 times larger than the time-average macrocell current of the individual ECE slabs.

Figure 21. Graph. Macrocell current at 69.8 °F (21 °C) versus time.

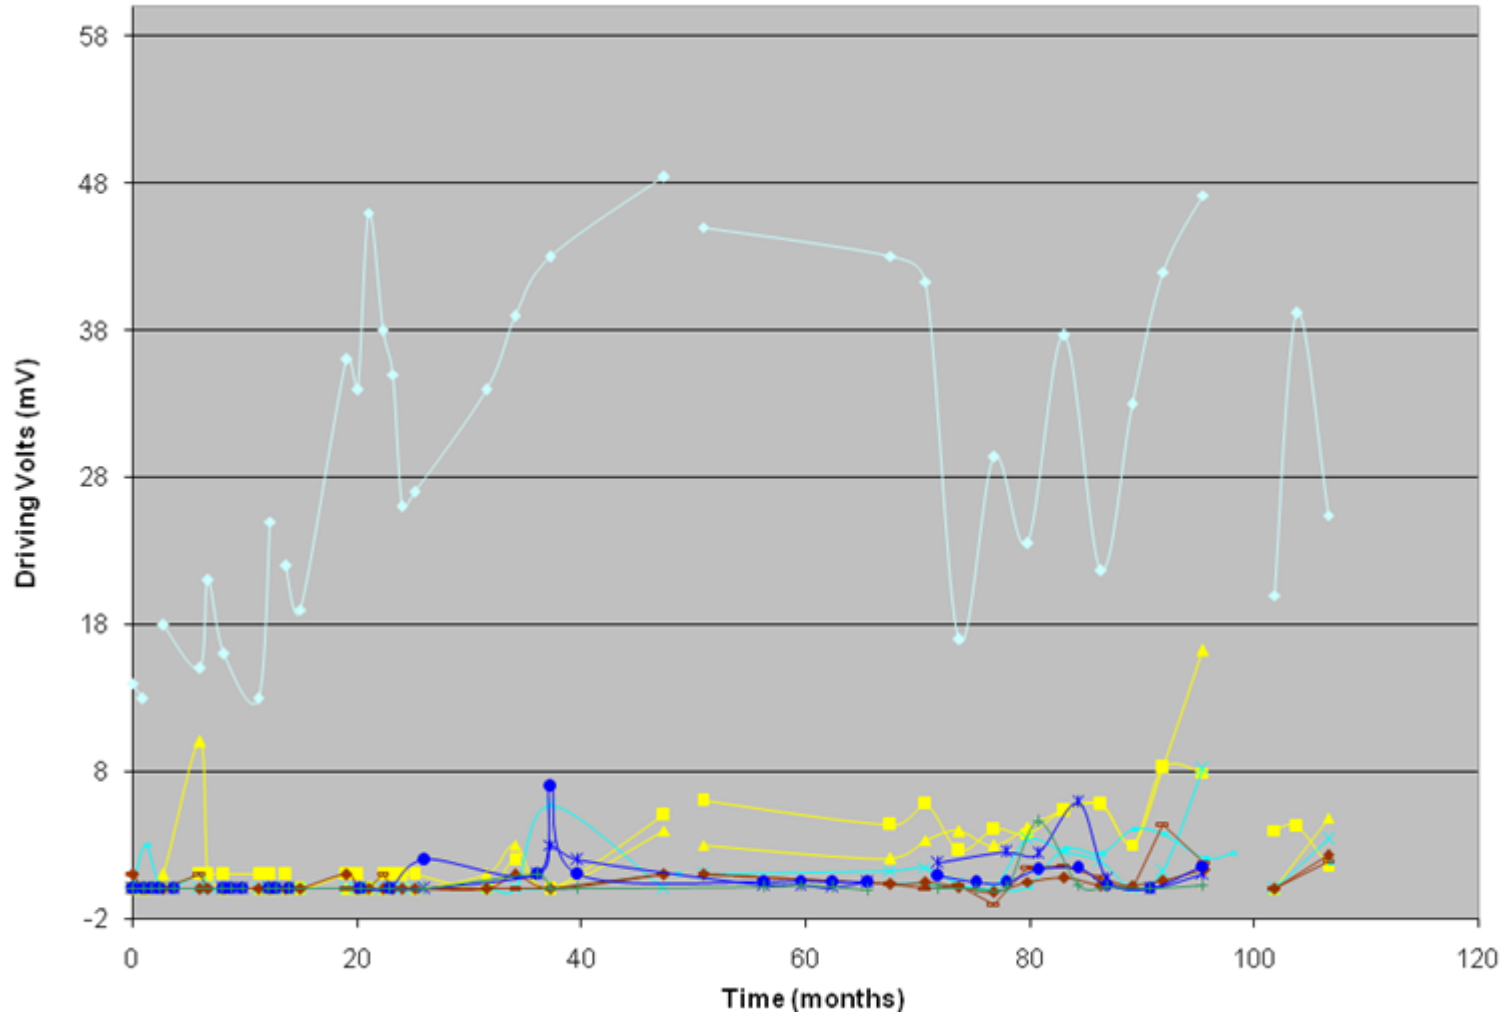
Figure 22. Graph. Driving volts versus time.

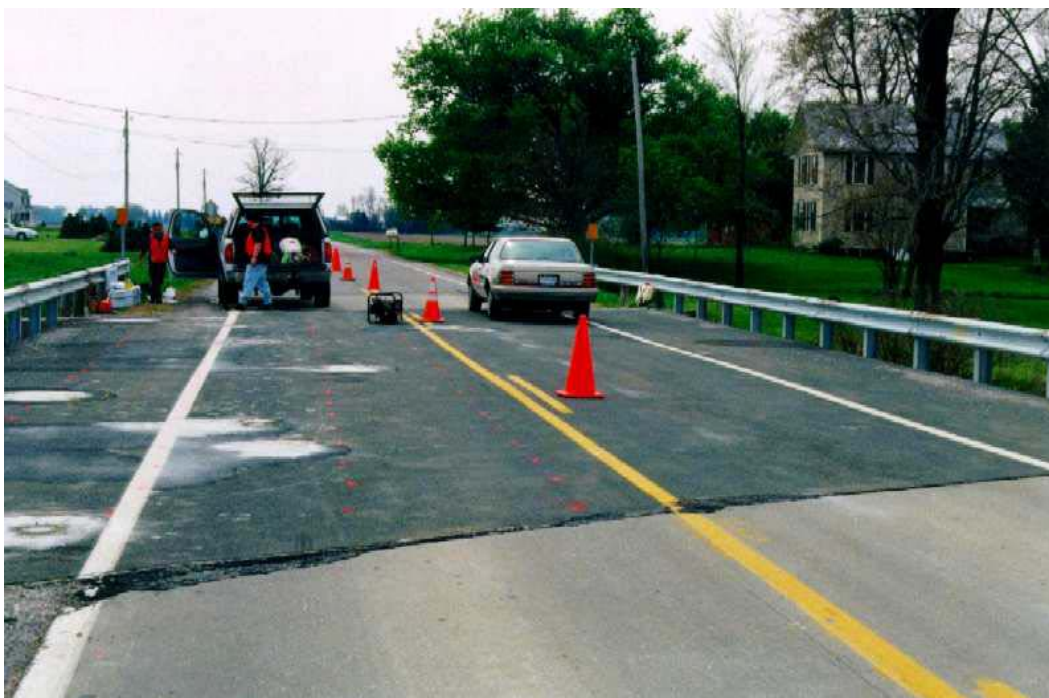
A corrosion condition evaluation of the deck conducted in March 1991 documented a delaminated area of 148.81 inches<sup>2</sup> (93,005.58 mm<sup>2</sup>).<sup>(1)</sup> The average chloride content varied from 5,820 ppm at a nominal depth of 0.55 inches (14 mm) to 860 ppm at a nominal depth of 2.54 inches (65 mm). Corrosion potential mapping identified 18 percent of the deck area to have a 90 percent probability of active corrosion. Corrosion rate measurements taken at four locations on the deck were in the high range (6.90 to 11.4  $\mu\text{A/inches}^2$  (1.07 to 1.78  $\mu\text{A/cm}^2$ )), which are considered to result in concrete damage within 2 to 10 years.<sup>(1)</sup> Petrographic analysis determined that the deck concrete was of excellent quality considering materials, consolidation, air entrainment, water-cement ratio, and cement maturity.

**Figure 27. Photo. Deck surface of bridge carrying SR-295 over Blue Creek in Lucas County, OH.**

In September 1991, an ECE treatment was applied to the eastern half of the bridge deck covering 1,317.6 ft<sup>2</sup> (122 m<sup>2</sup>). The western half was not treated and was designated as a control.

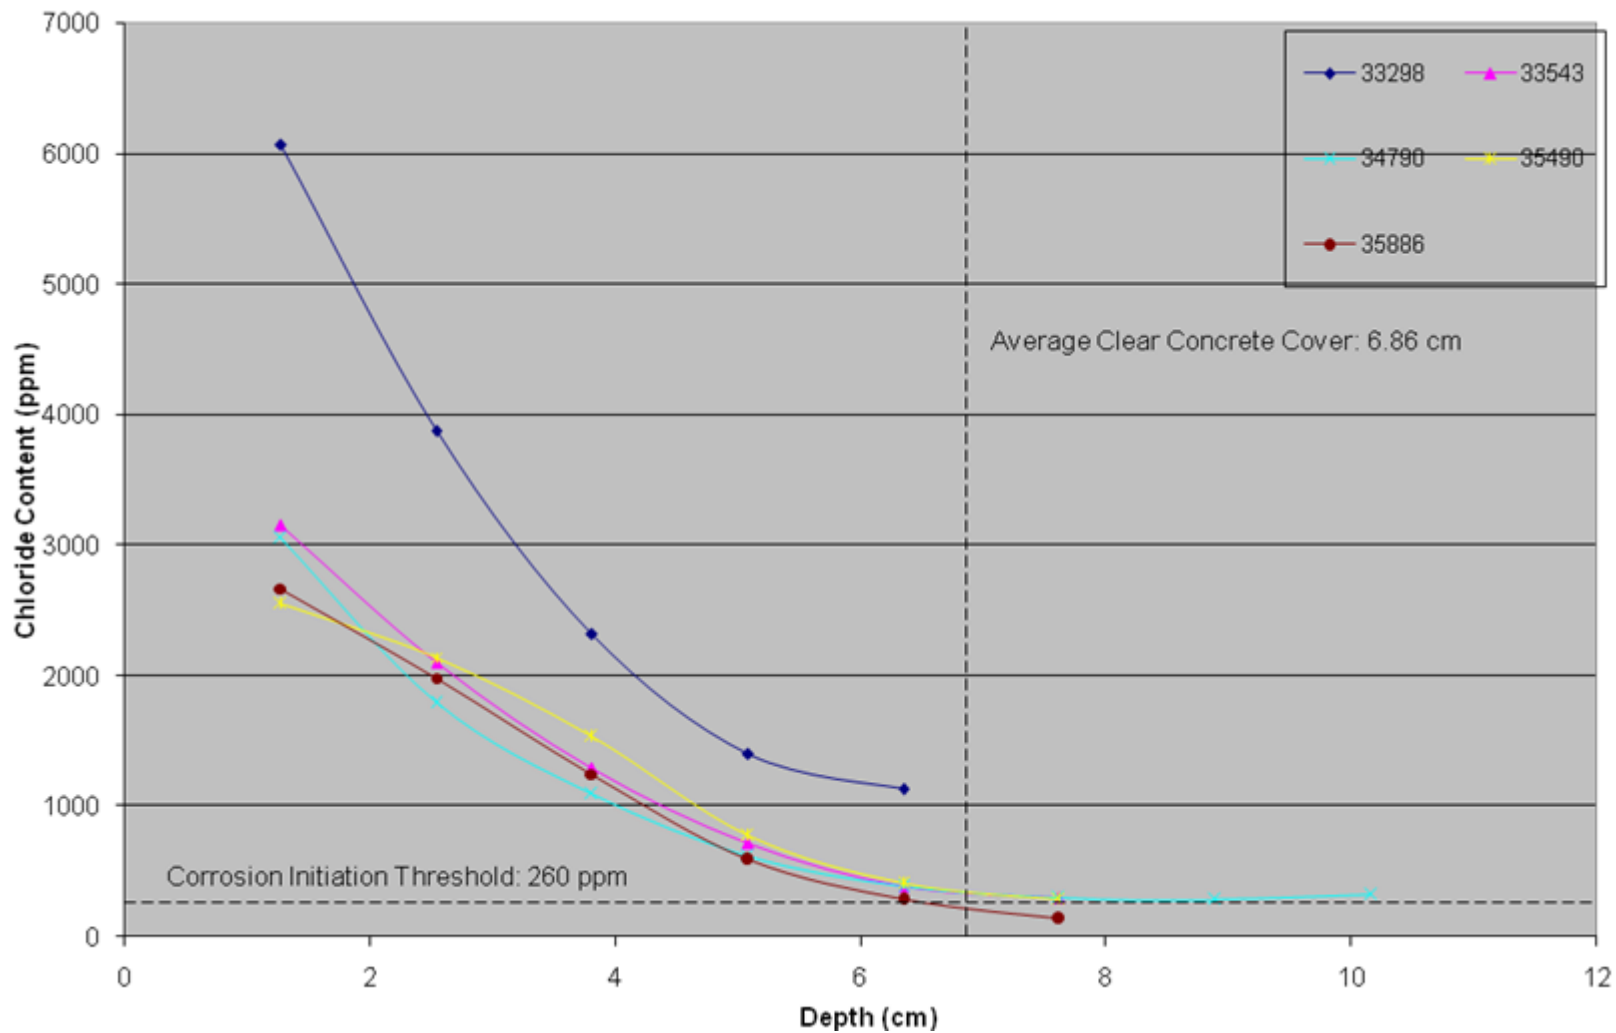
For approximately 7 years after the application of ECE, chloride content at steel depth has remained above the threshold for corrosion initiation by 260 ppm in the treated and the control areas. The chloride ion content at the steel depth in the control area was higher than that of the treated area.

**Figure 30. Graph. Chloride profiles of ECE treated area versus time.**

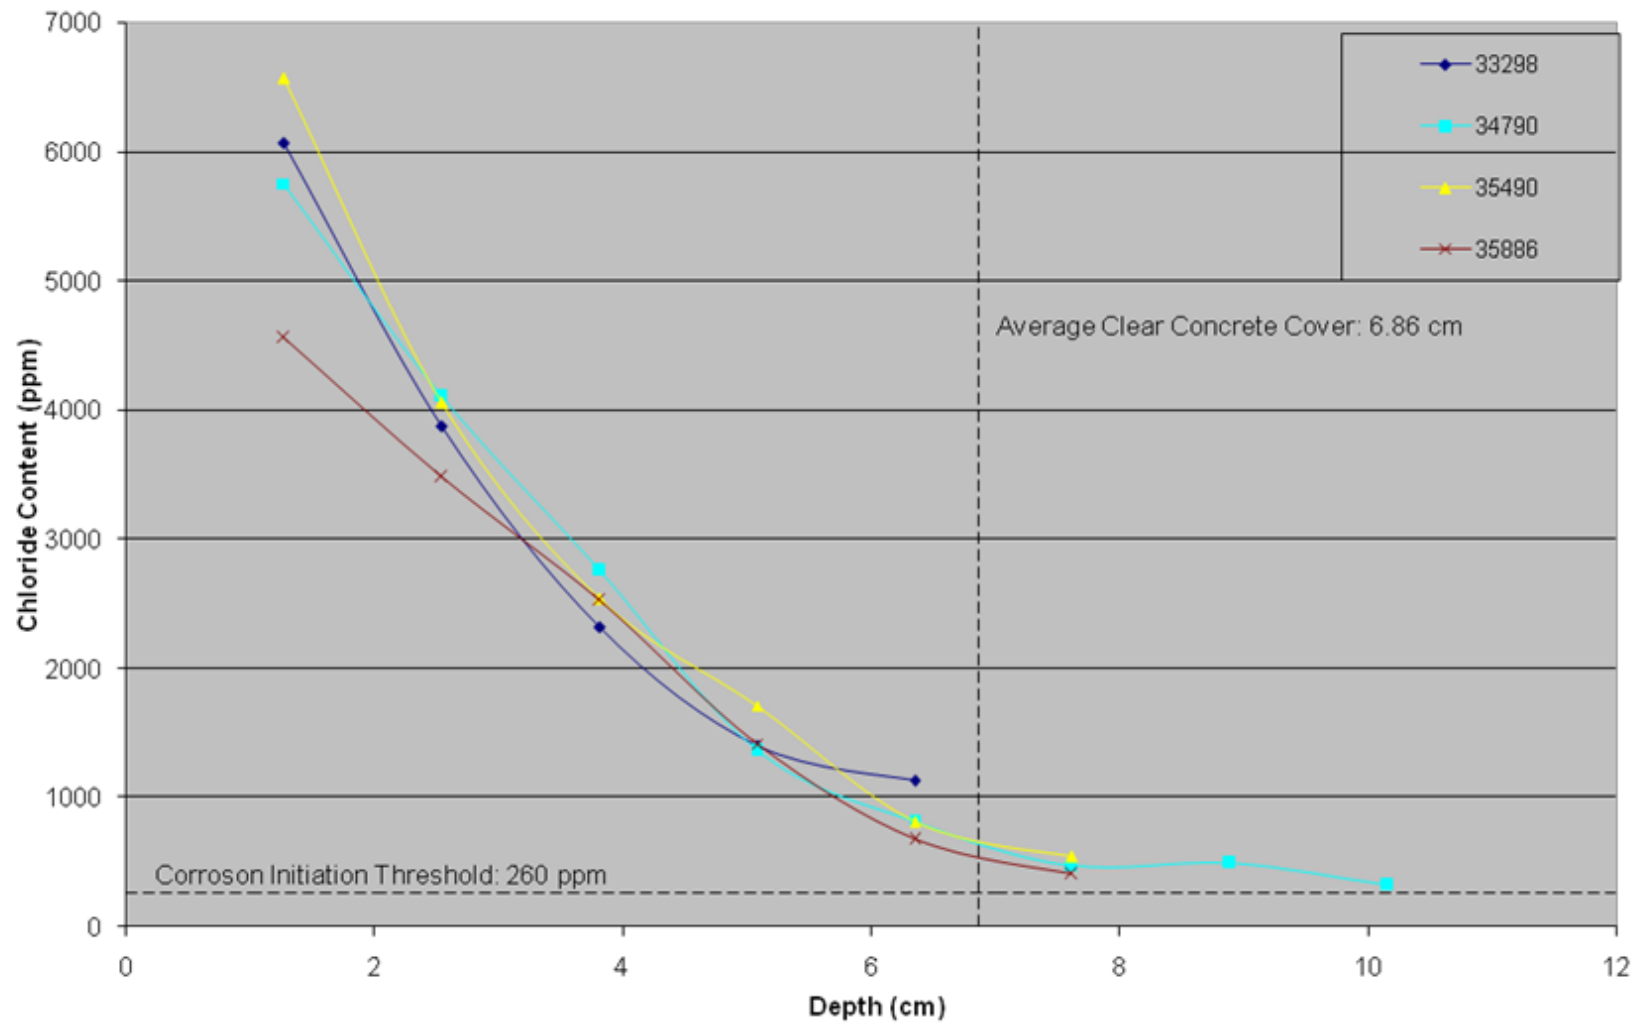
In figure 31, the pre-treatment core and the cores collected from the untreated section of the bridge deck showed similar chloride content profiles, suggesting that some diffusion of chloride ions may have occurred in the top 0.8 inches (20.3 mm) of the concrete.

**Figure 31. Graph. Chloride profiles of control area versus time.**

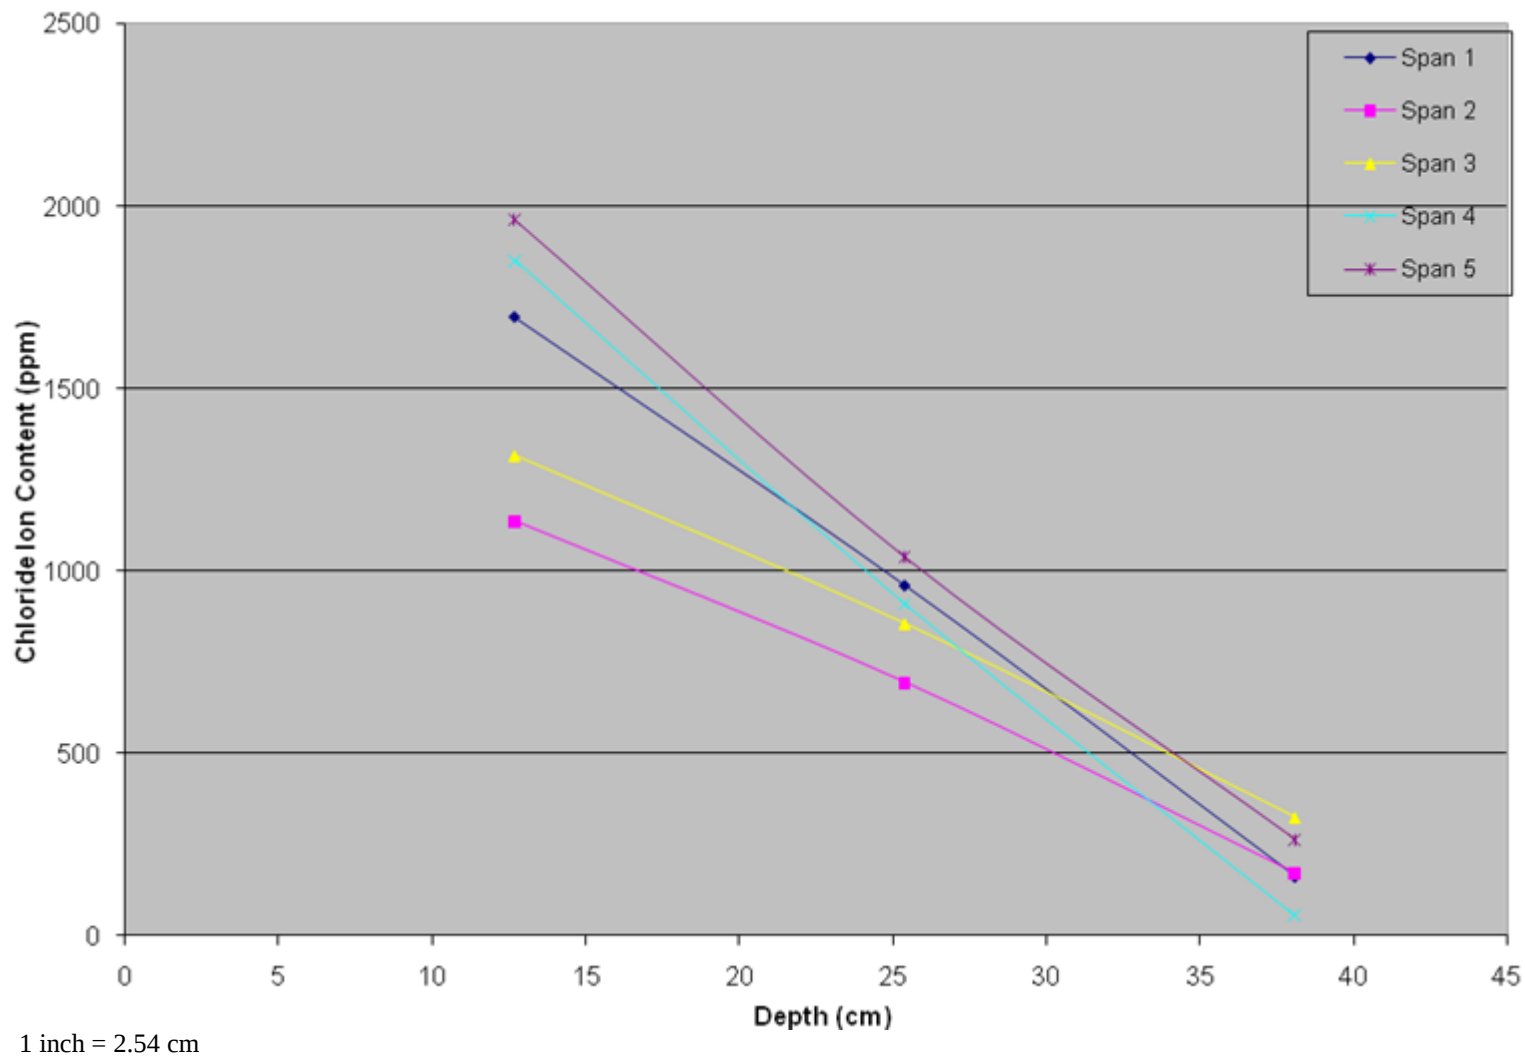
The average clear concrete cover varied from 0.75 to 1.8 inches (19 to 45 mm) and averaged 1.3 inches (33 mm). The average chloride content extrapolated to the average steel depth of 1.3 inches (33 mm) was 971 ppm. Corrosion potential mapping indicated that 78 percent of the deck had a low probability of corrosion activity, and 3 percent had a high probability of corrosion activity. The corrosion status of the remaining 19 percent was uncertain. In total, 48 corrosion rate measurements were made, with 68 percent of these measurements in the passive range and 32 percent in the low to moderate range.

Figure 32. Graph. Pretreatment chloride profiles.

Rehabilitation of the bridge deck was performed between March and September 1995. All unsound concrete was removed and patched with a cementitious material. Budgetary constraints did not allow application of ECE to the entire bridge, and the treatment was limited to spans 4 and 5, totaling 7,776 ft<sup>2</sup> (720 m<sup>2</sup>) of deck surface area. Spans 1–3 were designated as controls. Although spans 4 and 5 had lower levels of corrosion-induced damage, the chloride content interpolated to the average steel depth of 1.3 inches (33 mm) was 649 and 929 ppm compared to 819, 654, and 912 ppm for spans 1–3, respectively. Also, chloride content at lower depths in spans 4 and 5 were generally higher than the other spans (see figure 32). The lower levels of damage on spans 4 and 5 made them more advantageous for ECE application.

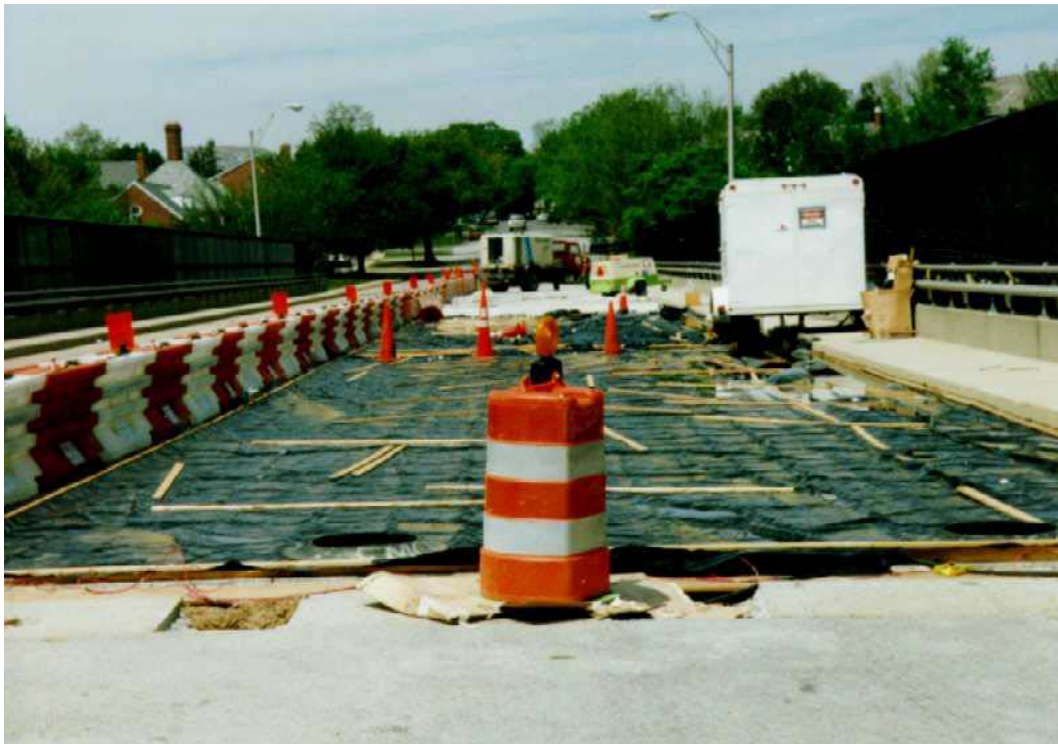
**Figure 33. Photo. Northern half of the eastbound lane of 34th Street bridge in Arlington, VA, during ECE treatment.**

To maintain traffic flow over the structure, one lane was treated at a time.<sup>(3)</sup> The eastbound lane (northern half of the deck) was treated first (see figure 33). Several treatment areas were created, two on the north half of the bridge, one in each span, and two on the south half of the deck of each span. A catalyzed titanium mesh sandwiched between two layers of synthetic felt was used. The anode was placed in a wooden dam built to contain the electrolyte on the surface of the deck. A plastic sheet was used to cover and protect the anode and the electrolyte. Pumps and hoses were used to circulate the electrolyte. Three different electrolytes were used, including lithium borate on the northern half of span 4 and calcium hydroxide on the southern half of both spans. On the northern half of span 5, tetraphenol phosphonium chloride solution ( $((C_6H_5)_4P^+Cl^-)$ ), which is a corrosion inhibitor, was applied on the deck surface prior to the placement of the anode system and lithium borate solution. Post-treatment analysis of powdered concrete samples collected from a depth of 0.75 to 1.25 inches (19 to 32 mm) indicated the presence of lithium borate in concentrations as high as 265 ppm and corrosion inhibitor in concentrations lower than the detectable limit of 25 ppm. Approximately 2 weeks after the ECE treatment, a 1.99-inch (51-mm)-thick silica fume overlay was placed on the entire deck.

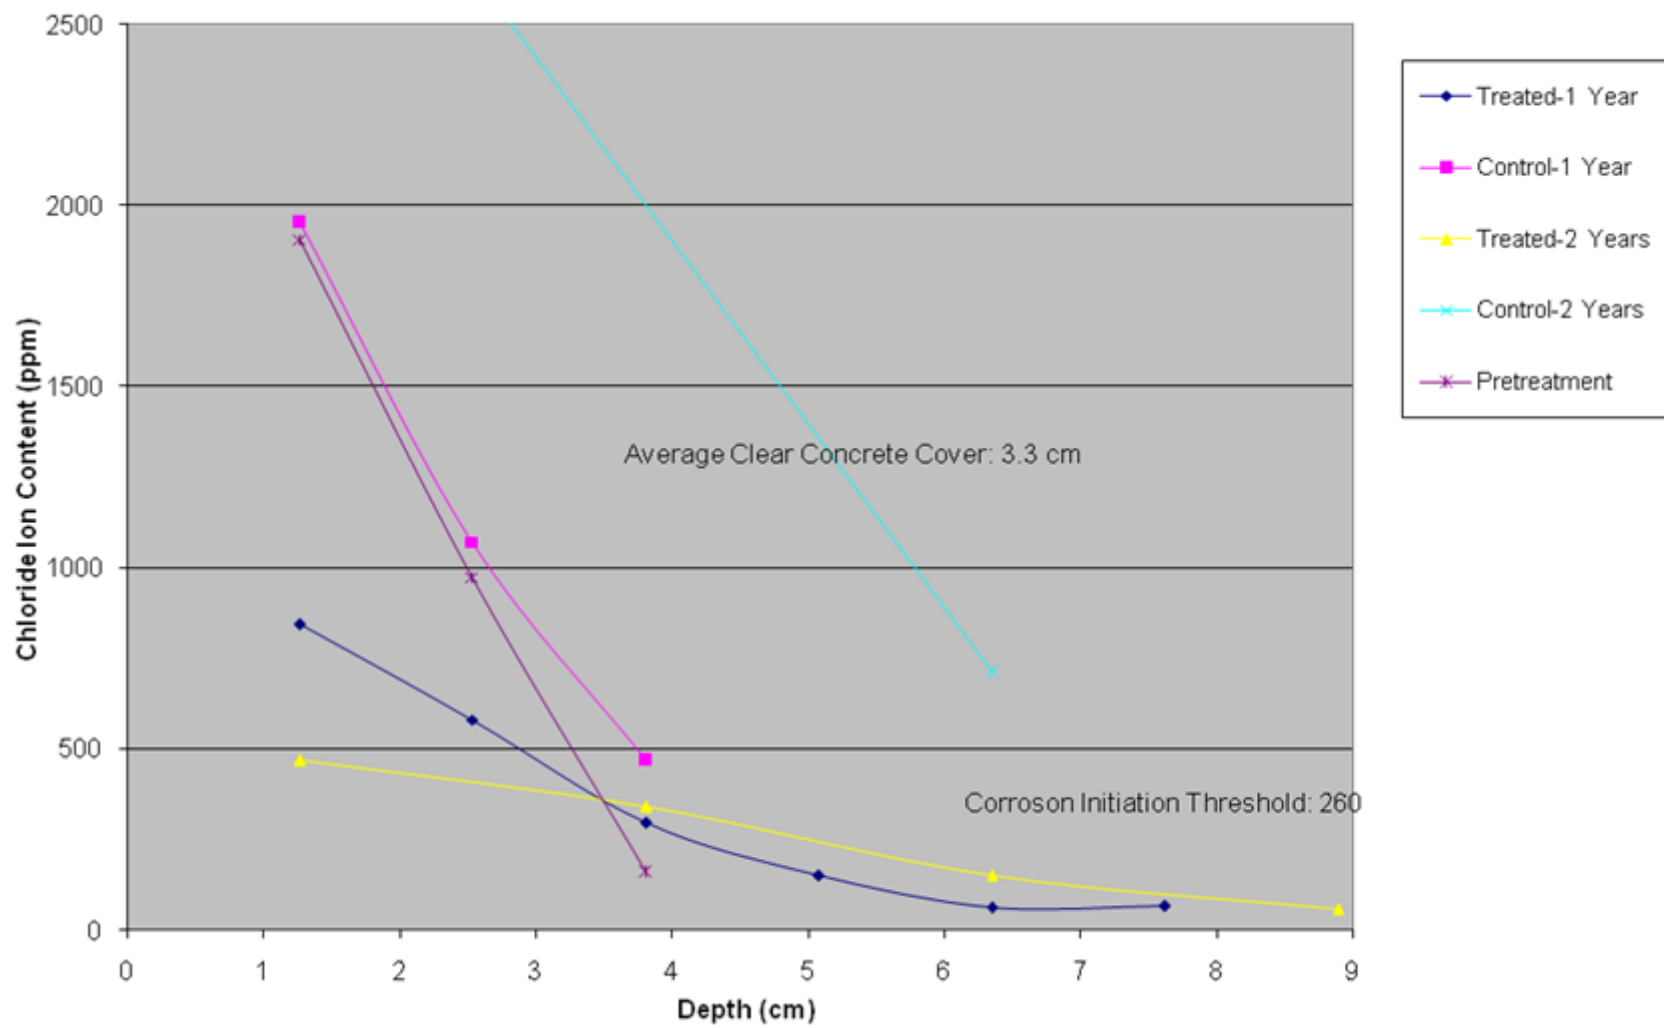
Span 3 suffered the most damage (29 percent delamination in 1993) and thus had the largest amount of repairs. Some of the cores (one from the first evaluation and the remaining from the second) collected from span 3 contained patch repair material. The chloride profile data for these cores was not representative of the actual chloride content of the original deck concrete. Data from cores containing patch material were excluded from the analysis.

Chloride profile data presented in figure 34 indicate that the chloride ion content in span 3 was similar to conditions before 1995, while chloride content in the treated areas was much lower and diffusion of chloride ions occurred over time. The average chloride ion content at the average steel depth of 1.29 inches (33 mm) was in excess of the threshold of 260 ppm required to initiate corrosion.

**Figure 34. Graph. Chloride profiles versus time.**

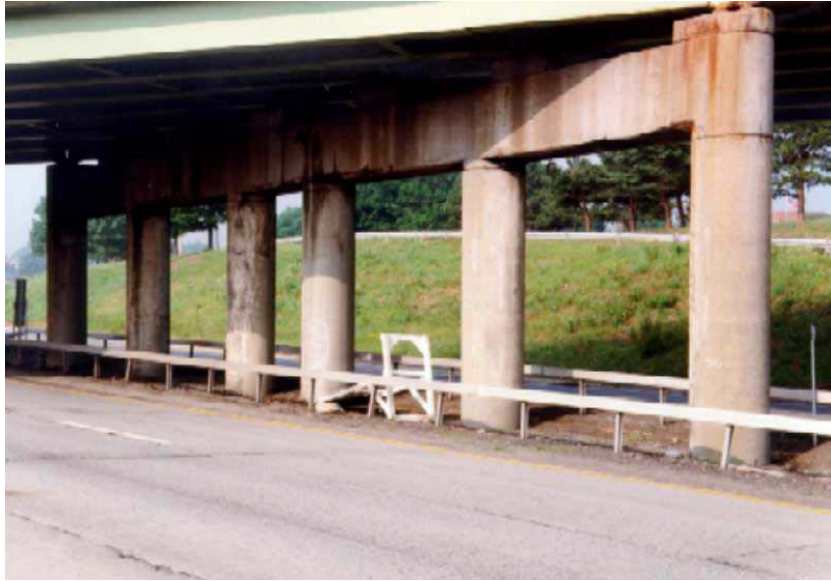
**Figure 36. Photo. Pier 2 of the Campus Loop Bridge in Albany, NY.**

In May 1992, all delaminated concrete from subject columns was removed to the rebar level and repaired by patching with a cementitious material. In June 1992, electrochemical chloride extraction treatment developed under the SHRP program was applied to the six columns on pier 2. The pier cap beams were not treated.

Each column was wrapped by a 10.99-ft (3.35-m)-long anode/blanket composite, which was covered by a plastic film, and a 0.3 M sodium borate buffered electrolyte was used. The anode/blanket composite contained three layers of blanket material and the anode. The first layer was designed to retain the electrolyte and provide contact. A titanium mesh anode was sandwiched between the remaining two layers of blankets. The electrolyte was pumped to the top of the anode/blanket composite and allowed to flow down the column by gravity and collect in a sump. The containment of the electrolyte within the anode/blanket assembly was paramount to the success of the treatment. On columns 1 and 4, the containment could not be accomplished. Because these columns could not be treated, they were designated as untreated controls. For the application of ECE, two electrical zones were established, each containing two columns.<sup>(1)</sup> Zone 1 included columns 2 and 3, and zone 2 contained columns 5 and 6.
