# Long-Term Effects of Electrochemical Chloride Extraction on Laboratory Specimens and Concrete Bridge Components

PUBLICATION NO. FHWA-HRT-10-069

SEPTEMBER 2011

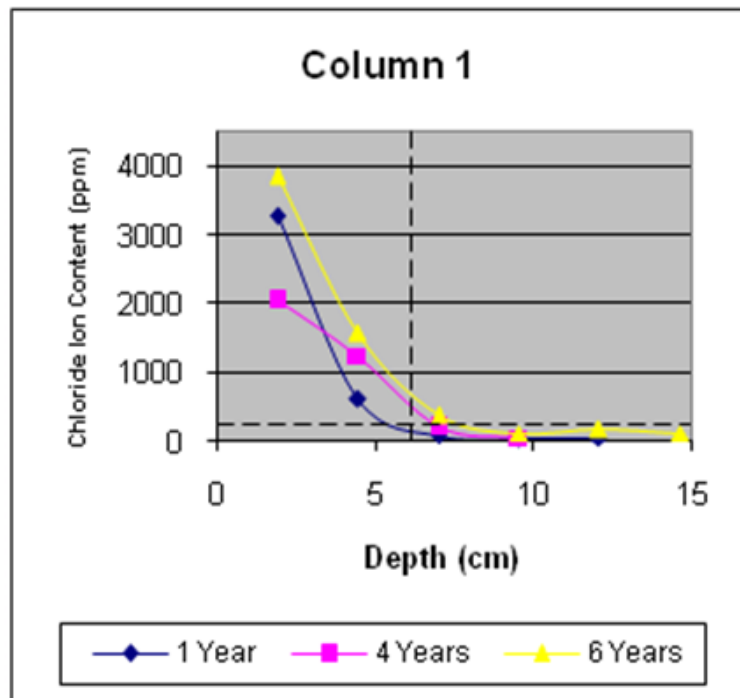
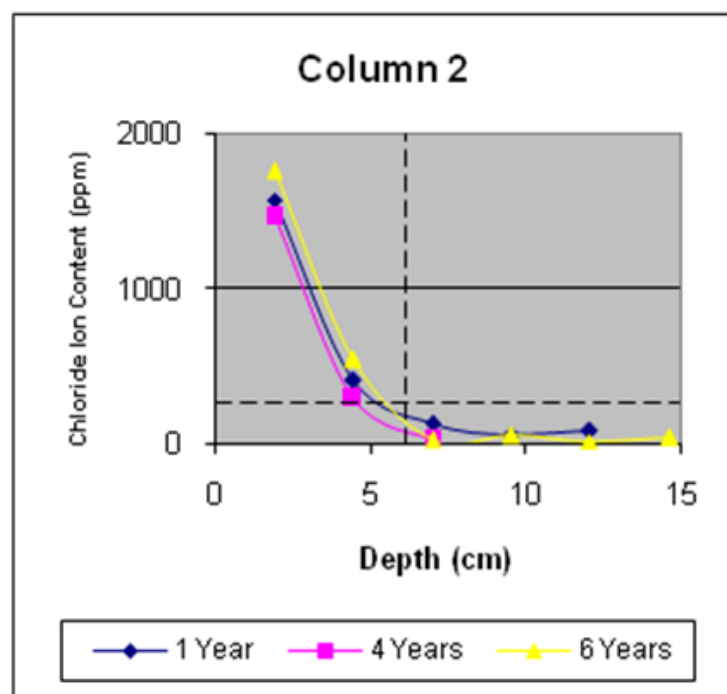
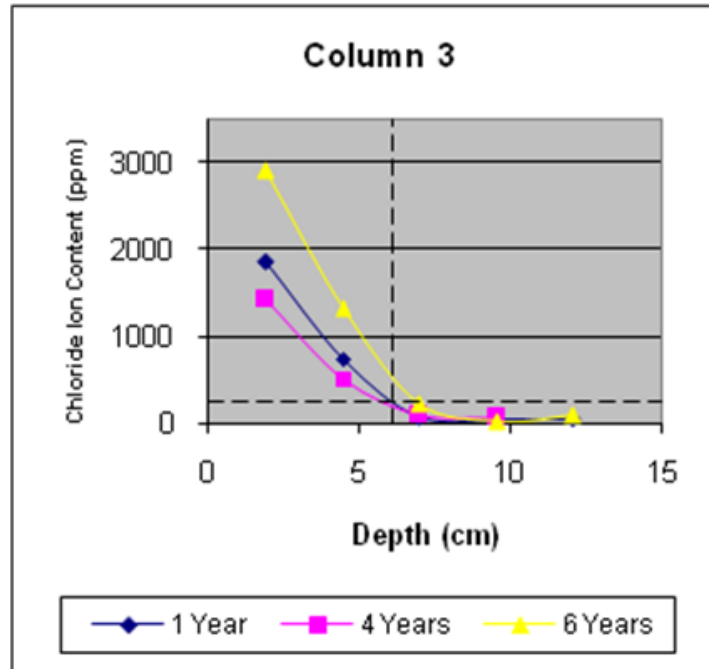
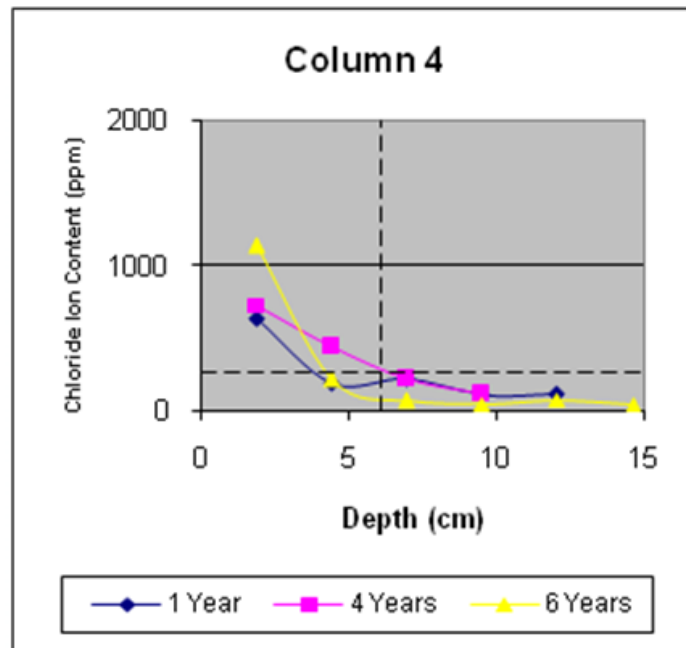
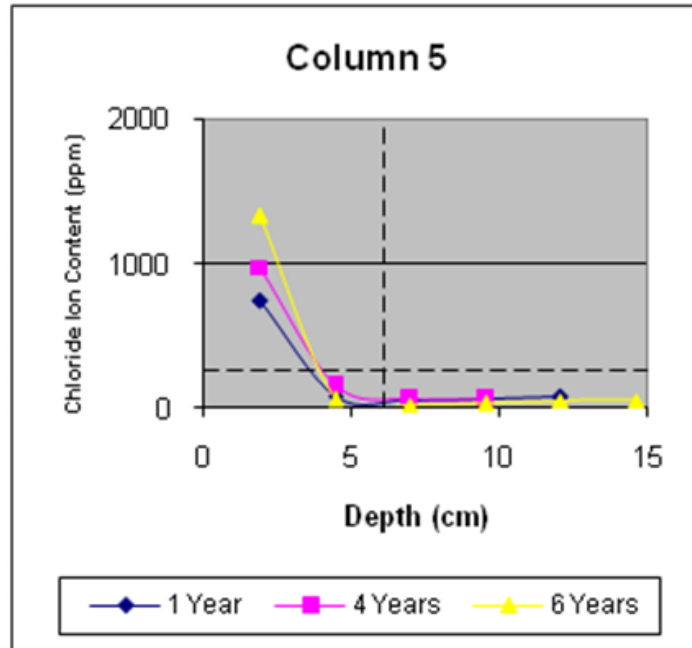
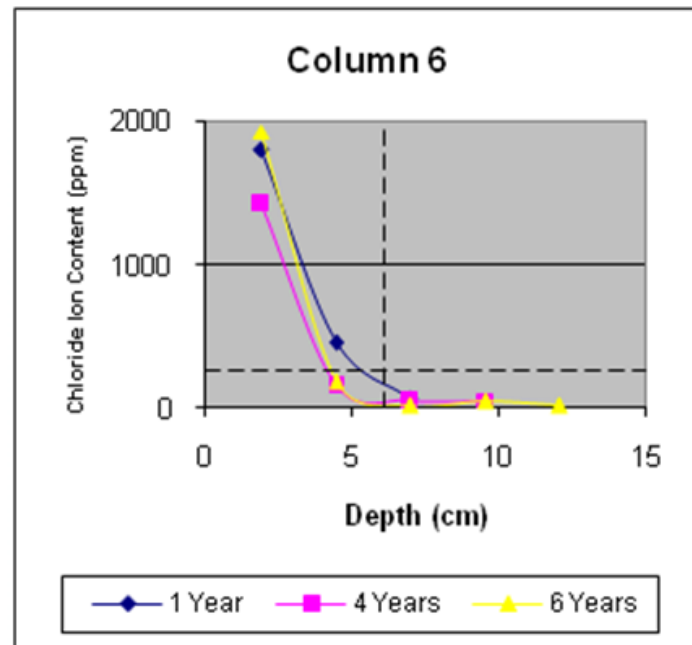
Figure 45 through figure 50 present the average variation of chloride ion content as a function of depth for each column. The data suggest that chloride ion content generally increased with time for all columns. This was expected as columns were exposed to chloride contaminated water runoff and splash. The chloride ions continued to migrate into the column concrete.

The average chloride ion content at the average steel depth was below the corrosion threshold for columns 2 and 4–6 and was above the threshold for the remaining columns. This explains the reduction in rate of increase of delaminations with time. Corrosion-induced damage primarily

occurred in patched areas with cracks and occurred adjacent to cracks in other areas where chloride ions had direct access to the steel.

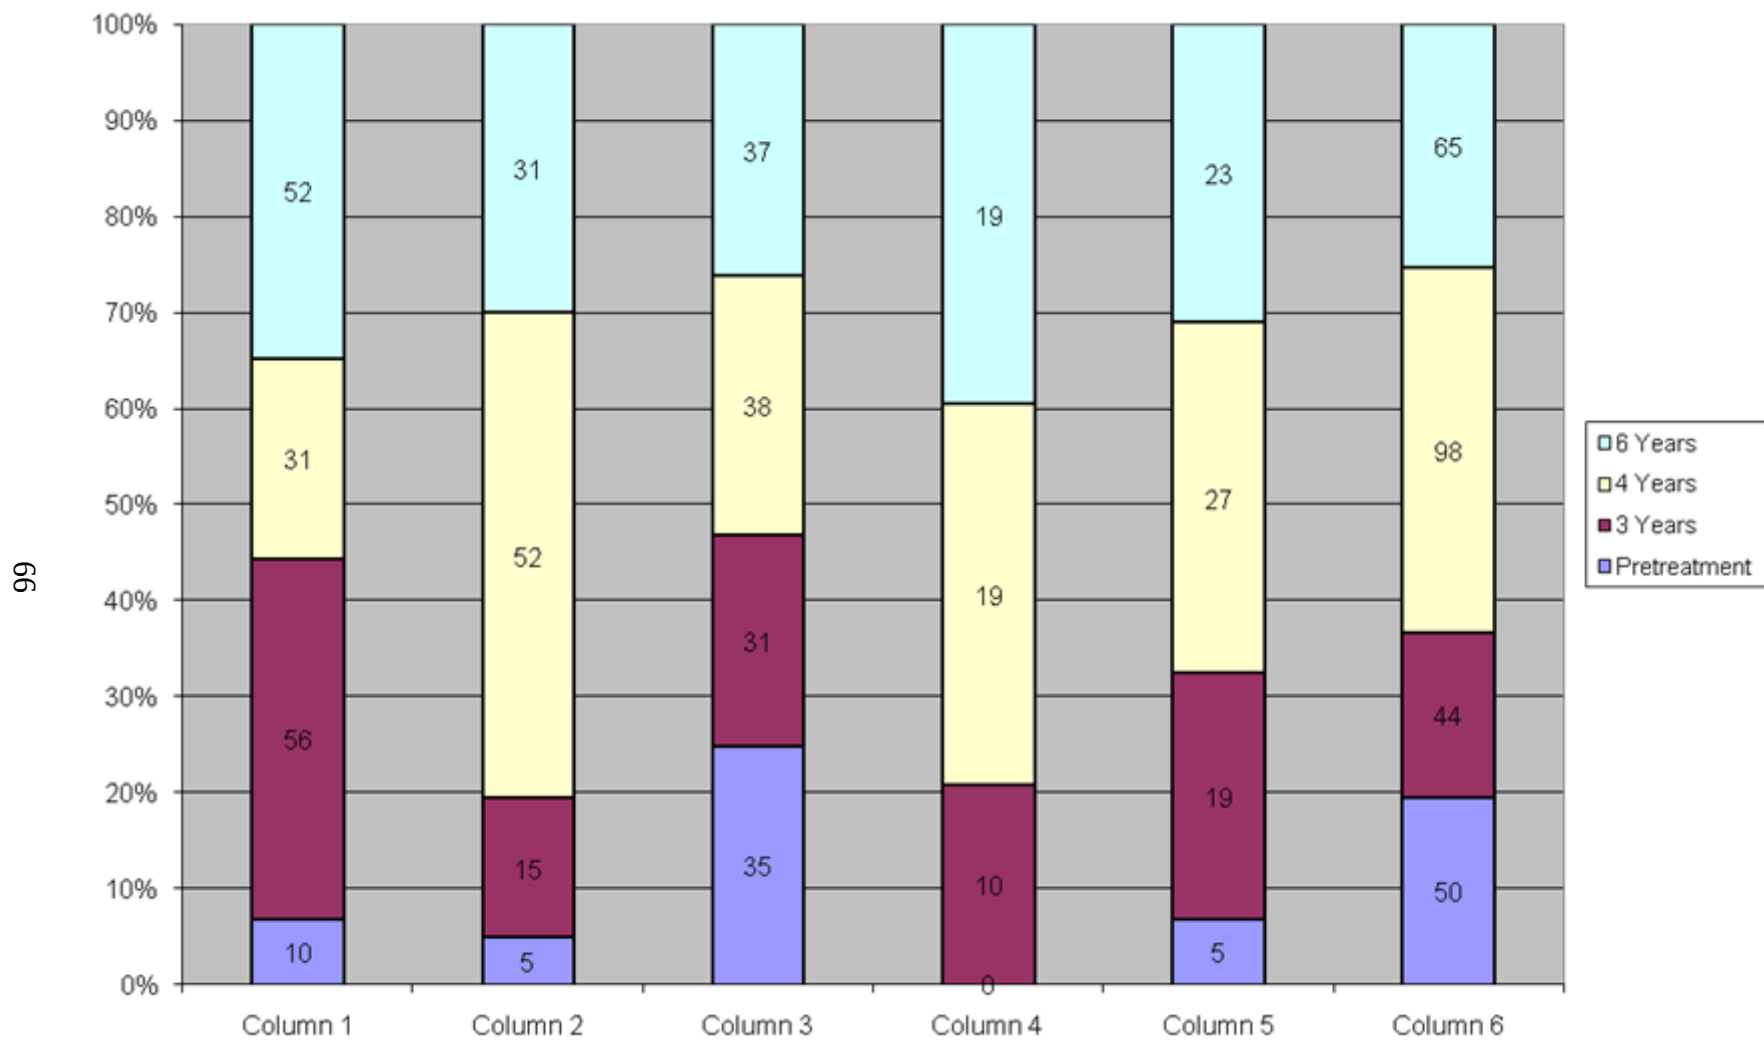
A half-cell potential survey was performed on a 2.00-ft (0.61-m) grid on each column with a copper-copper sulfate half-cell during each evaluation. In five of the six columns, the percentage of active potentials increased with time, and it remained constant in column 3 (see figure 51).

**Figure 51. Graph. Distribution of active potentials versus time.**

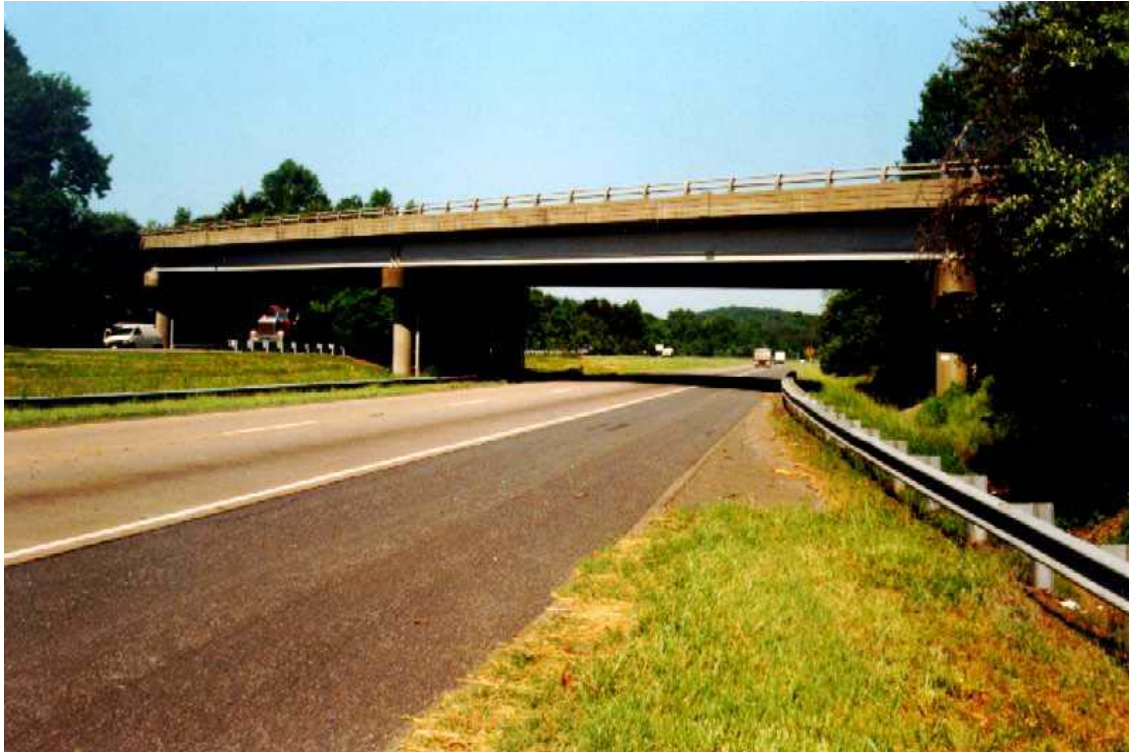
A four span slab-on-stringer bridge was constructed in 1969 to carry two northbound and two southbound lanes of Route 631 over I-64. Two abutments and three piers support the 334.56-ft (102-m)-long and 82-ft (25-m)-wide bridge (see figure 52). Each pier is comprised of two column bents, one on each side of the bridge centerline (see figure 53). The number of columns in a bent varies from three to four, although the total number of columns in each pier is seven. The piers are numbered from south to north. The western bents of piers 1 and 2 and the eastern bent of pier 3 are four-column bents, whereas the eastern bents of piers 1 and 2 and the western bent of pier 3 are three-column bents. The columns are numbered from west to east.

**Figure 52. Photo. Route 631 over I-64 bridge in Charlottesville, VA.**
