FORENSIC EVALUATION

LTPP SPS-5 Project (040500)

*I-8 Eastbound
Casa Grande, Arizona*

DRAFT REPORT

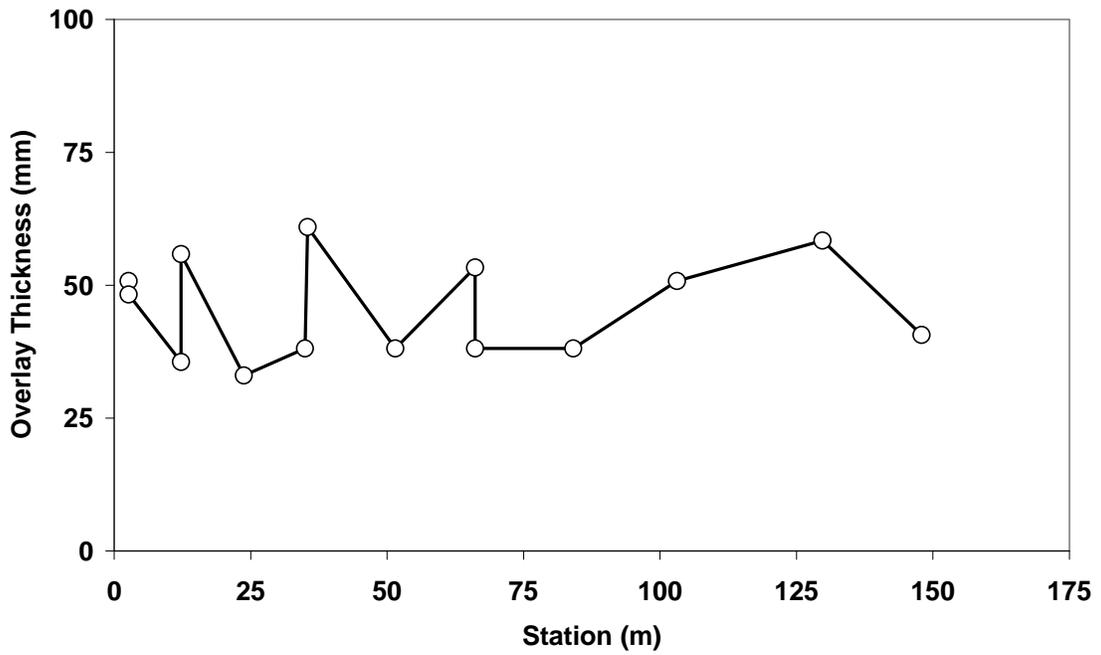
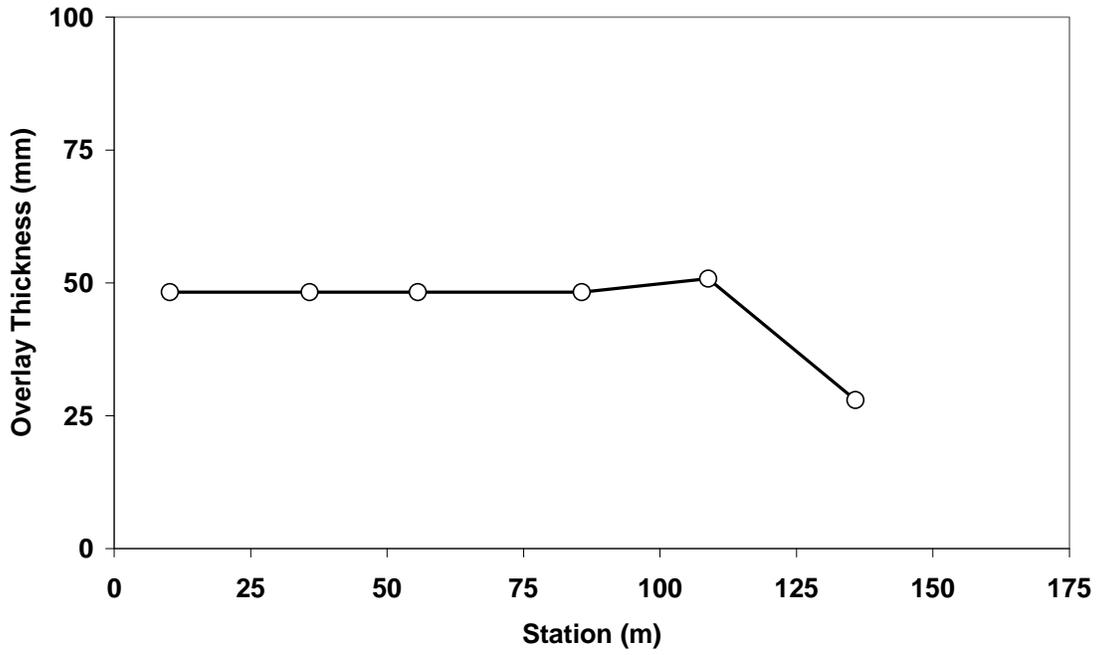
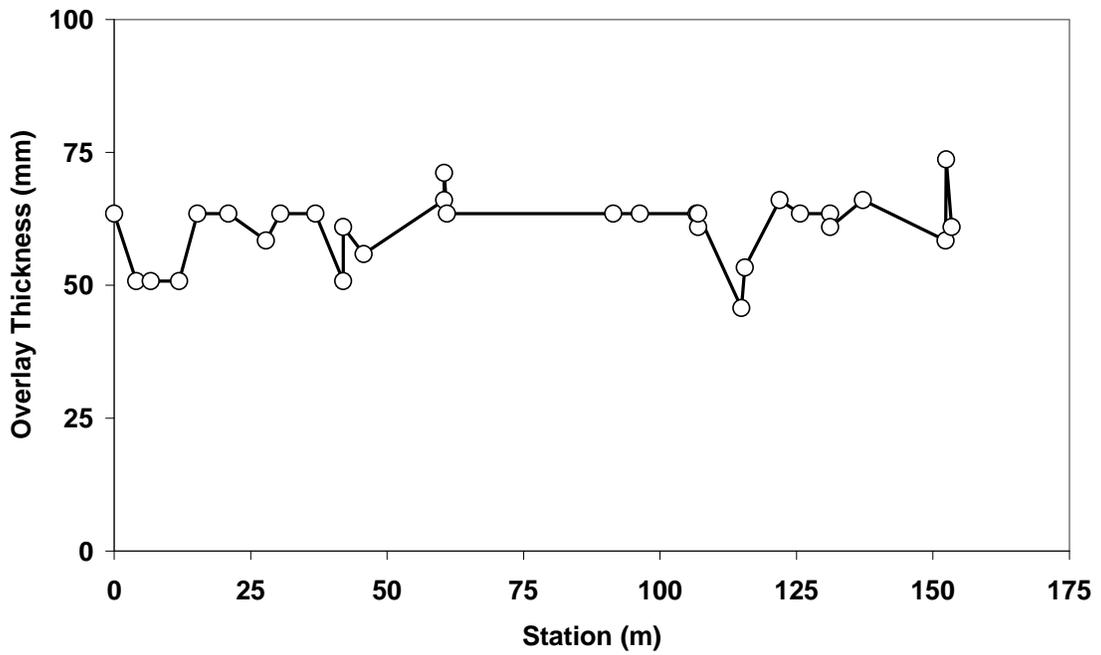
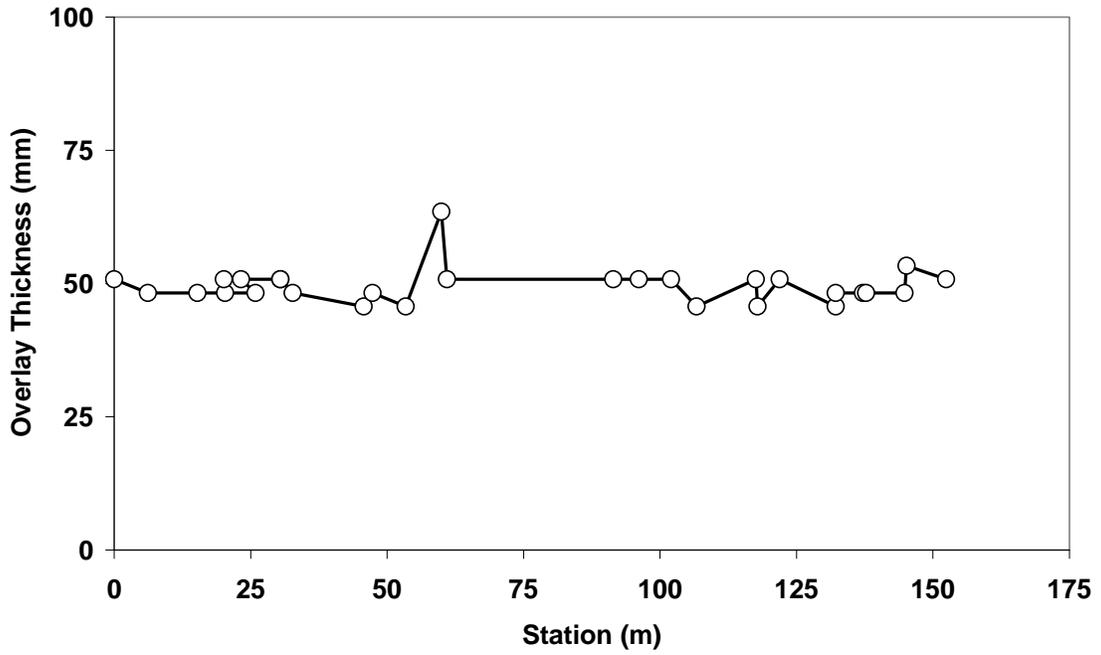
Core thickness measurements were performed to assess construction variability (Figure 4). The AC overlay thicknesses measured from the cores are shown in Figures 5 through 8. The average AC overlay thickness for test sections 0502, 0505, 0506, and 0509 are 1.8, 1.8, 2.4, and 2 inches (44, 44, 60, and 50 mm), respectively. Reduction in AC overlay thickness, i.e., layer densification, is anticipated during the pavement service life due to traffic axle loading.

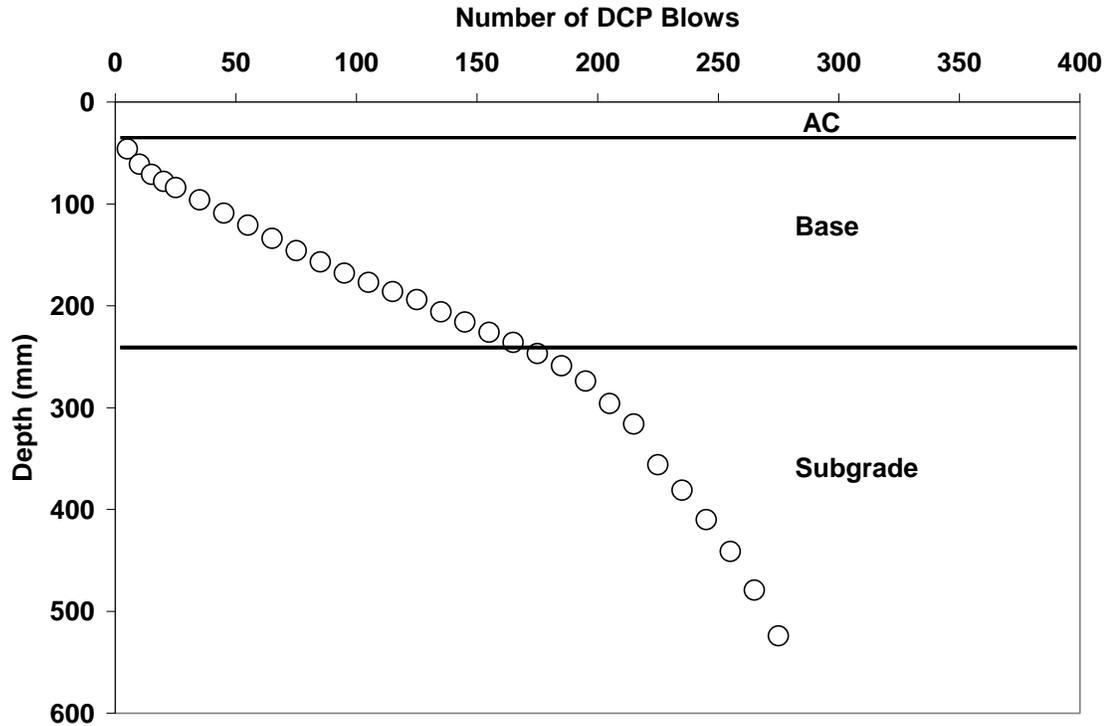
Figure 11. DCP Test Plot; Section 0502, Core No. A 69.

The DCP test locations are shown in Table 7. Six inch diameter cores were used for DCP tests. At least two DCP tests were performed for each of the test sections. Additional DCP tests were conducted prior to trench excavation at test sections 0506 and 0509. A typical DCP plot is presented in Figure 11. The slope of the graph expressed in millimeters per blow yields the DCP Penetration Index (PI) which represents the resistance offered by the material. DCP is also an important tool in determining changes in a material's response with depth. As illustrated in this figure, a change in material response (i.e., from base to subgrade) occurred at about 240 mm in depth. A consistent slope for base and subgrade layers is shown indicating uniform material response. Similar findings were obtained from the other DCP test locations.

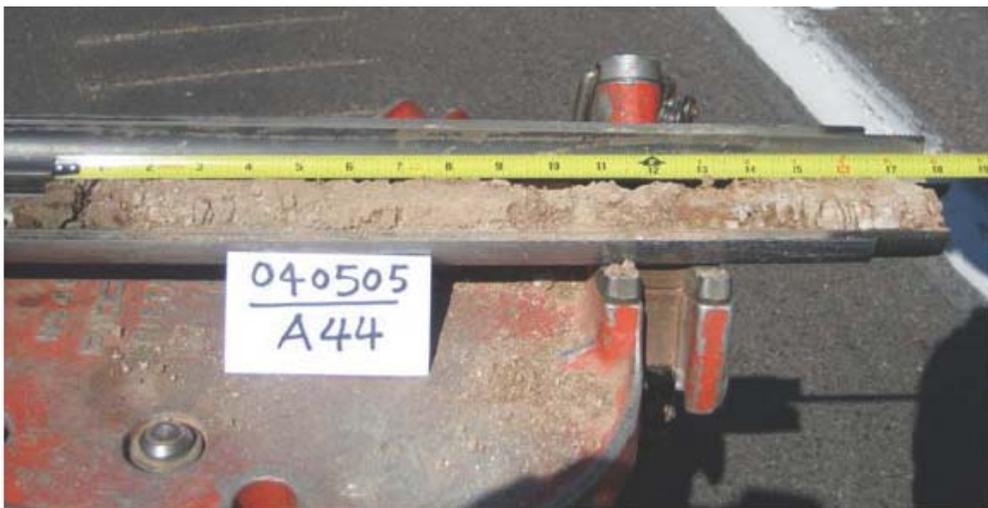
Figure 14. Disturbed SPT Sample; Section 0505, Core No. 44.

The SPT-N values for each of the test sections are presented in Table 10. These values correspond to stiff granular materials. This indicates the pavement subsurface soil materials are in good condition and can resist traffic vehicle loading. The materials extracted from the sample were also visually inspected. The undisturbed and disturbed SPT samples for test section 0505 are shown in Figures 13 and 14, respectively. In general, uniform soil materials were observed for each of the test sections.

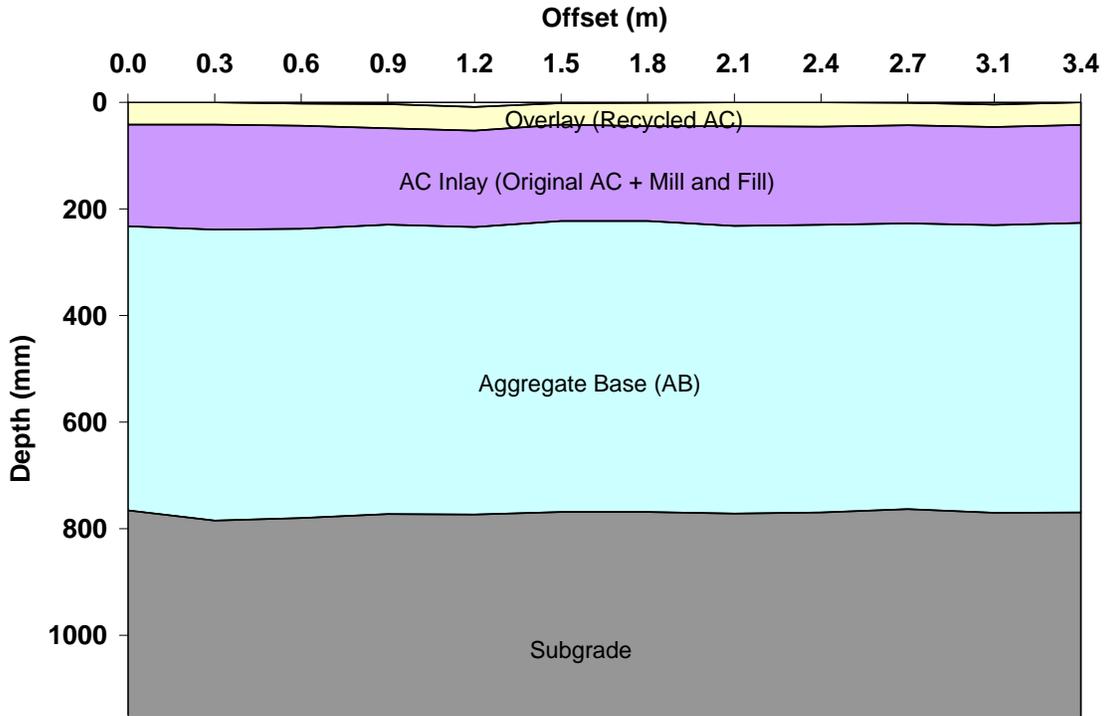
Figure 17. Subsurface Profiles; Section 0509 Uphill.

As per the LTPP recommendation, layer thickness profiles were collected at 1 ft (0.305 m) intervals with a standard tape measure along the length of the trench. For consistency, the same person measured all layer thickness profiles. The layer thickness profiles for test section 0509 and 0506 are presented in Tables 11 and 12, respectively. The subsurface profiles measured in these test sections are shown in Figures 17 and 18, respectively. The layer profiles show the rutting contributed by each layer (Figure 19 and 20). Close-up views of the surface layer along the wheel paths are shown in Figures 21 and 22, respectively. It is clearly shown that rutting was mainly in the top AC layer and virtually no rutting was detected in the lower layers (AC inlay and base layer). Similar observations were found using downhill subsurface profiles.

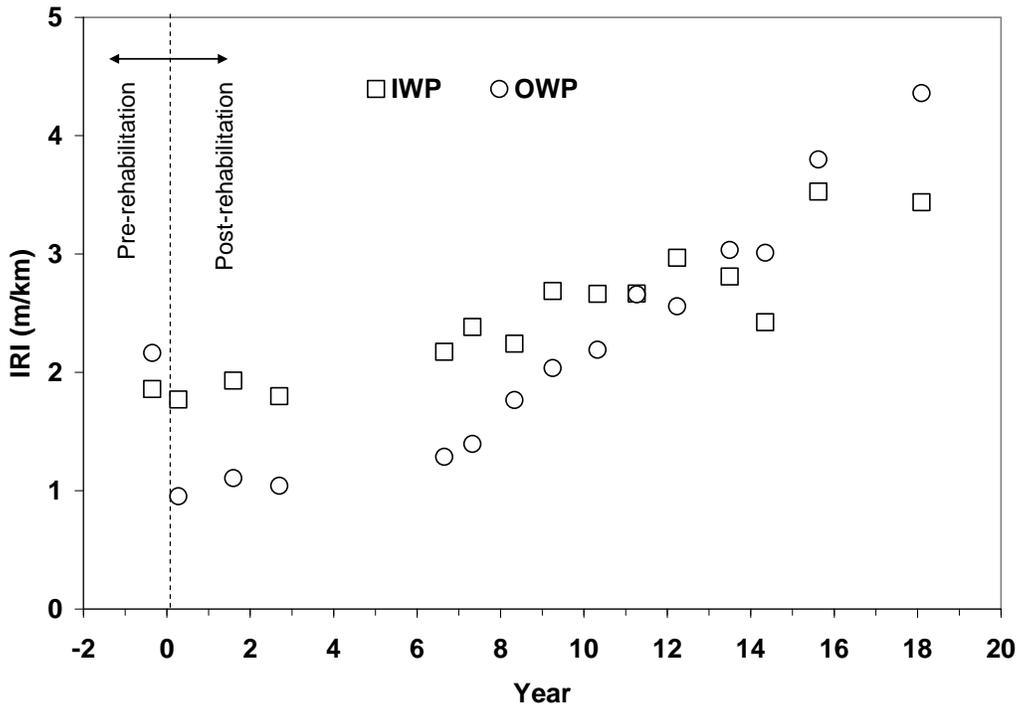
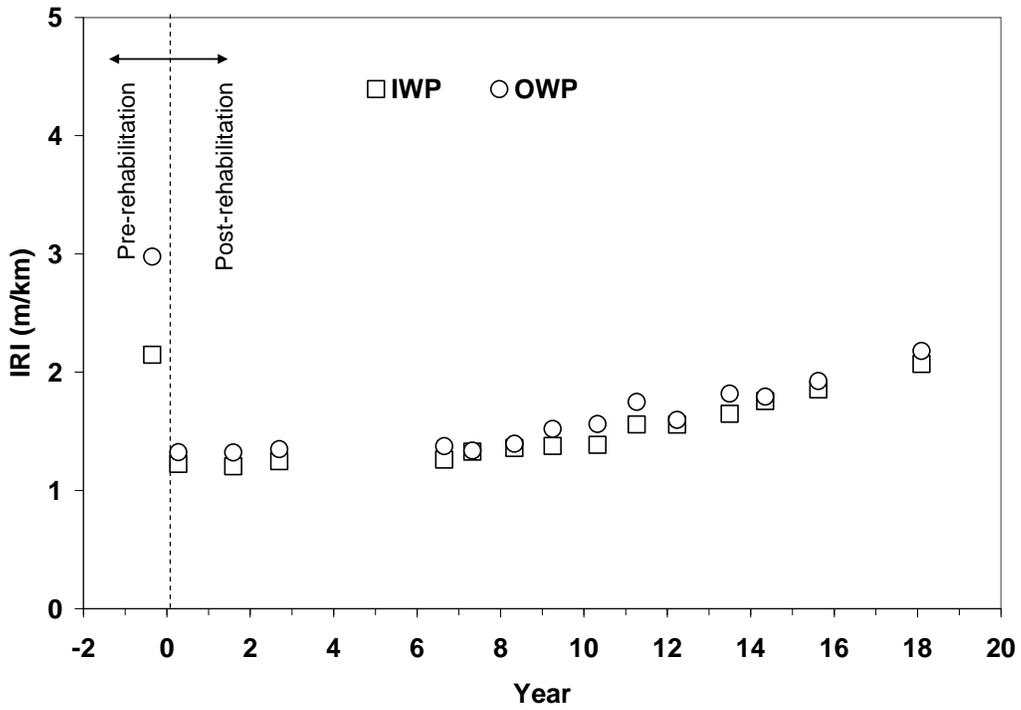
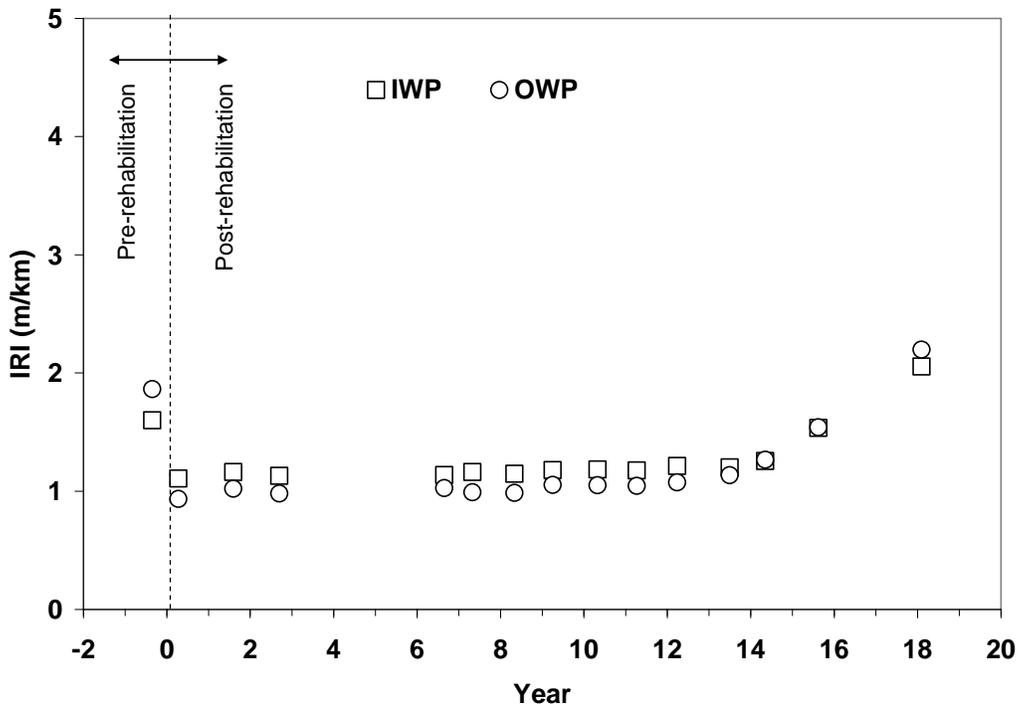
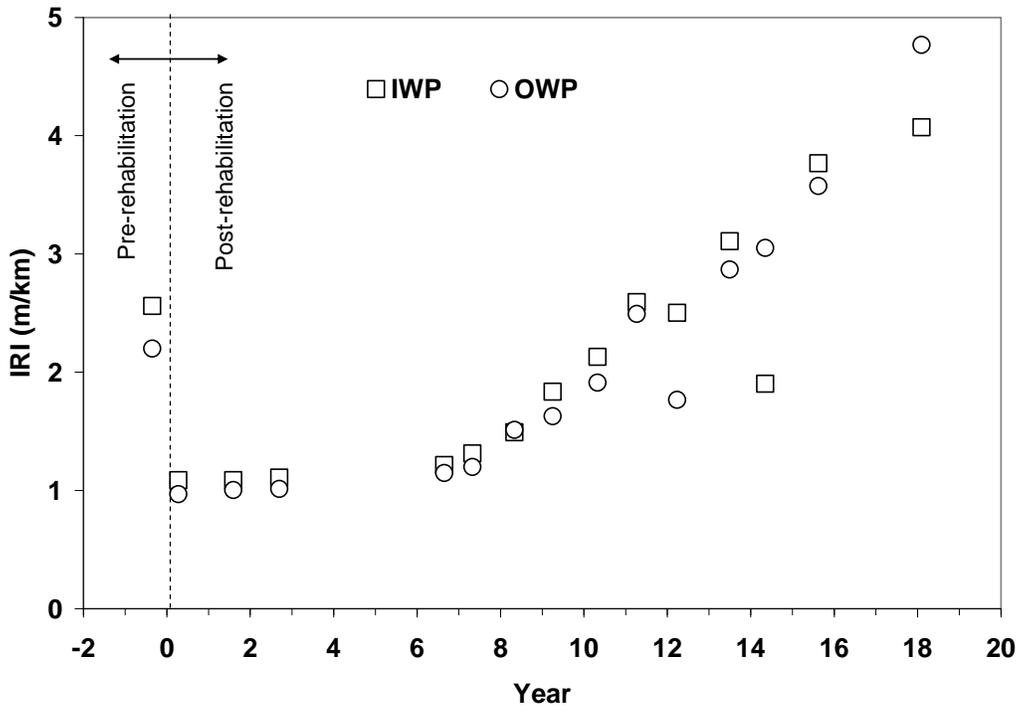
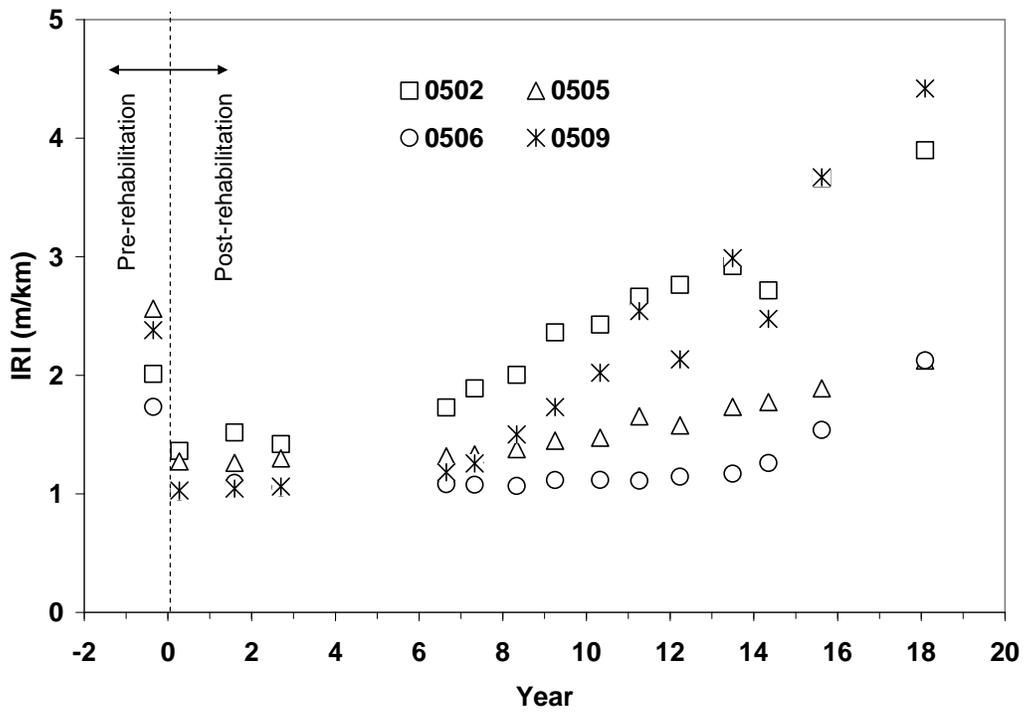
The profile characteristics of each pavement section and the change in the IWP and OWP IRI with time are presented in Figures 36 through 39. The mean IRI values for each of the test sections over their monitored period are given in Figure 40. The historical IRI summary statistics are presented in Table 24. Section 0502 showed improvement in OWP IRI after rehabilitation. In addition, the IWP roughness after rehabilitation was much higher than that of OWP. This was almost certainly caused by the presence of distresses along the IWP. The IWP and OWP IRI values are slightly decreased after the placement of fog seal coats and crack sealing. Sections 0502 and 0509 exhibited significant increase in IRI over their post-rehabilitation monitoring history. The roughness level in 2008 is almost twice the roughness level before rehabilitation in 1990 for each test section. The drastic growth in roughness for these test sections is due primarily to the existence of fatigue cracking and pumping in test section 0502 and transverse cracking in test section 0509. In most cases, the transverse cracks covered the entire width of the lane. Section 0505 also exhibited a large increase in roughness with time. The change in roughness growth at this test section was minimal throughout the post-rehabilitation monitoring history. This section experienced high severity fatigue cracking and transverse cracking with a high level of pumping contributing to an increase in the roughness level. Section 0506 increased in roughness at a steady rate after rehabilitation until 2004. In this section, the roughness increased more rapidly in the last 3 years than over the previous 14 years with the development of high severity transverse cracks.

As discussed previously, each of the test sections received crack sealing and fog seal coats. These rehabilitation activities did not cause an immediate change of the IRI values. In general, based on the longitudinal profile roughness analyses, it was found that recycled overlay test sections 0502 and 0509 exhibited the largest post-rehabilitation increase in roughness IRI over their monitoring history.

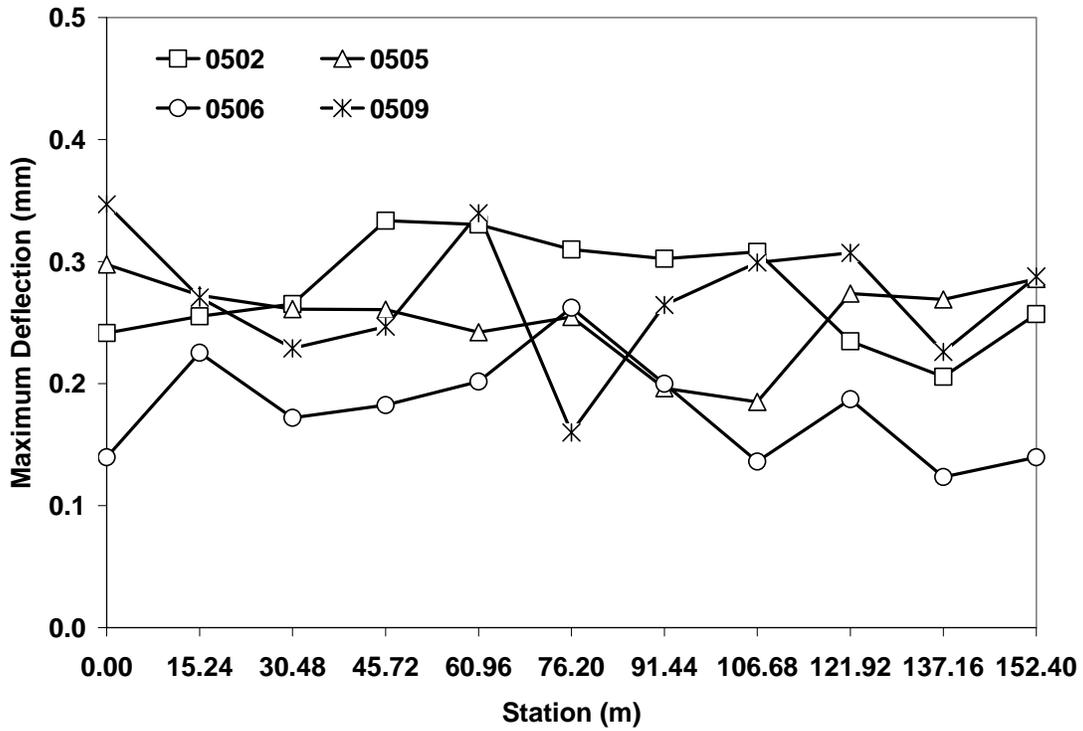
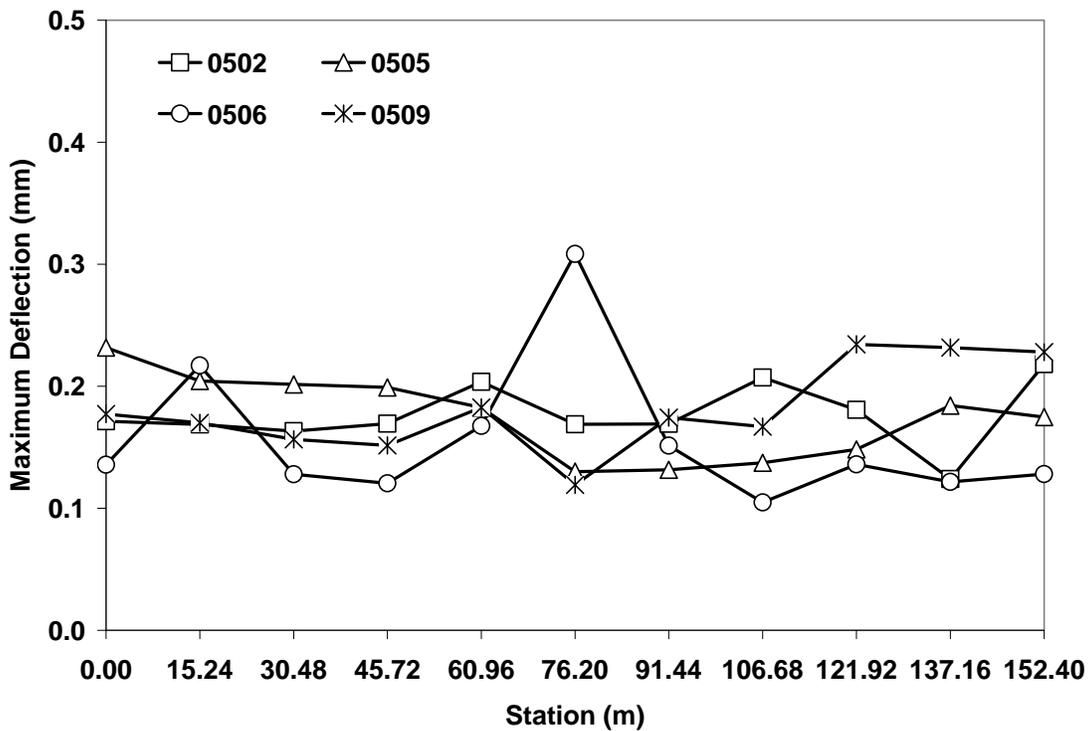
To assess the performance of the AC surface layer, the FWD maximum deflections along the OWP and mid-lane were analyzed and are presented in Figures 42 and 43, respectively. As illustrated in these figures, the FWD maximum deflection value varies from station to station. The OWP has generally higher deflections when compared to the deflection at the mid-lane. Test sections 0502 and 0509, with low rutting resistance performance, measured higher FWD maximum deflections, whereas test sections 0505 and 0506 exhibited lower deflections. This phenomenon is apparent for FWD deflections along the OWP. Referring to Figure 43, the large deflection spike at station 76.20 m (section 0506) is due to the presence of high severity transverse cracking.

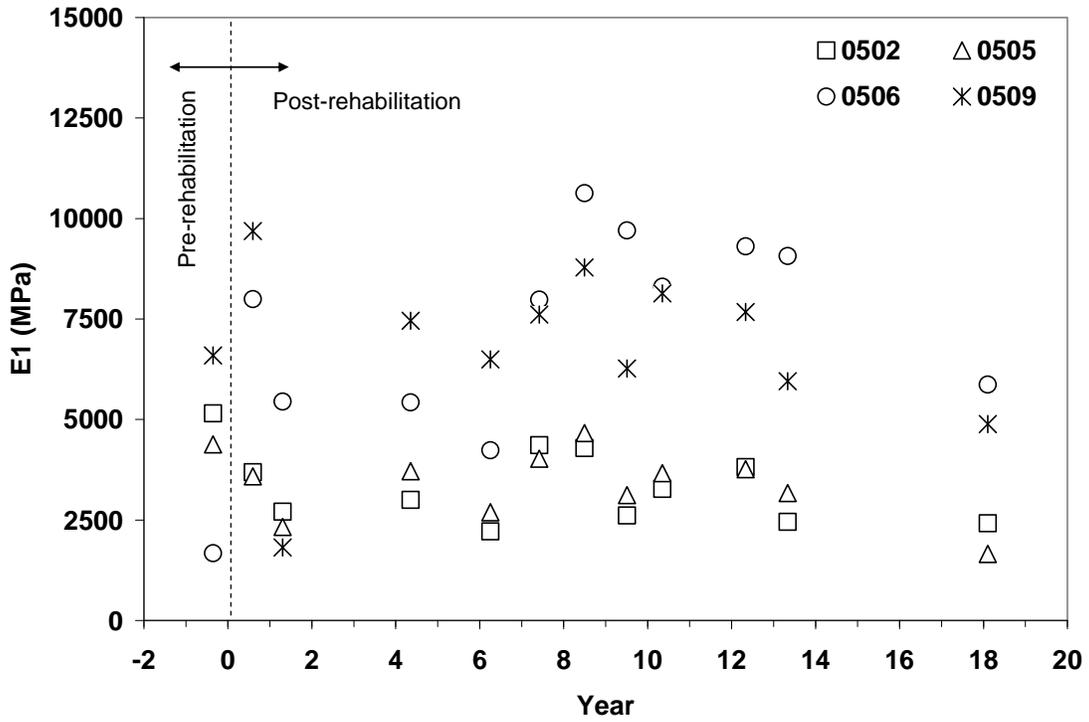
Figure 44. AC Layer Moduli Progression.

Back-calculated AC layer moduli values for the test sections over their monitored history are presented in Figure 44. Stiffer AC responses are observed in test sections 0506 and 0509. The AC layer strength for test sections 0502 and 0505 are almost identical.

In general, reduction in AC layer stiffness with time occurs due to deterioration of the pavement structure. Over time, the test sections received extensive crack sealing and fog seal coats to improve conditions of the surface layer. A slight increase in the AC layer stiffness is shown with these maintenance activities. Periodic maintenance and repairs can provide temporary improvement of the surface condition, but do not typically remedy structural deficiencies associated with the pavement layers. Over time, the AC stiffness in each of the test sections became inadequate to handle the existing traffic volume. Overall, the final structural condition of pavement layers was lower than the pre-rehabilitation strength, indicating the need for immediate pavement rehabilitation activities.

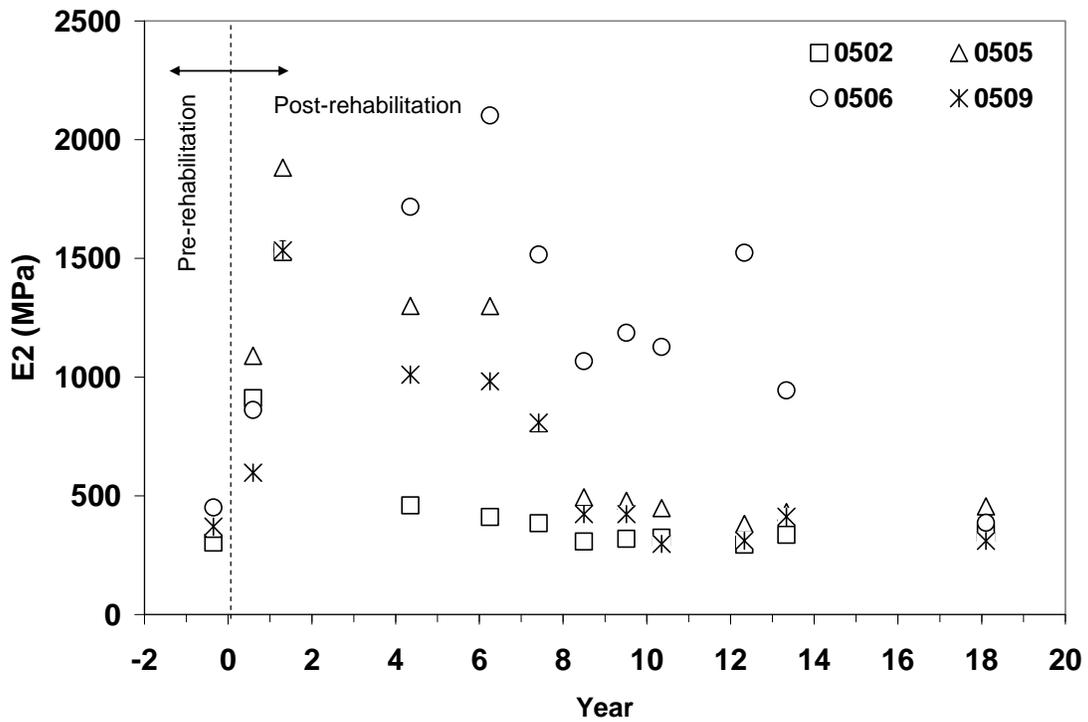
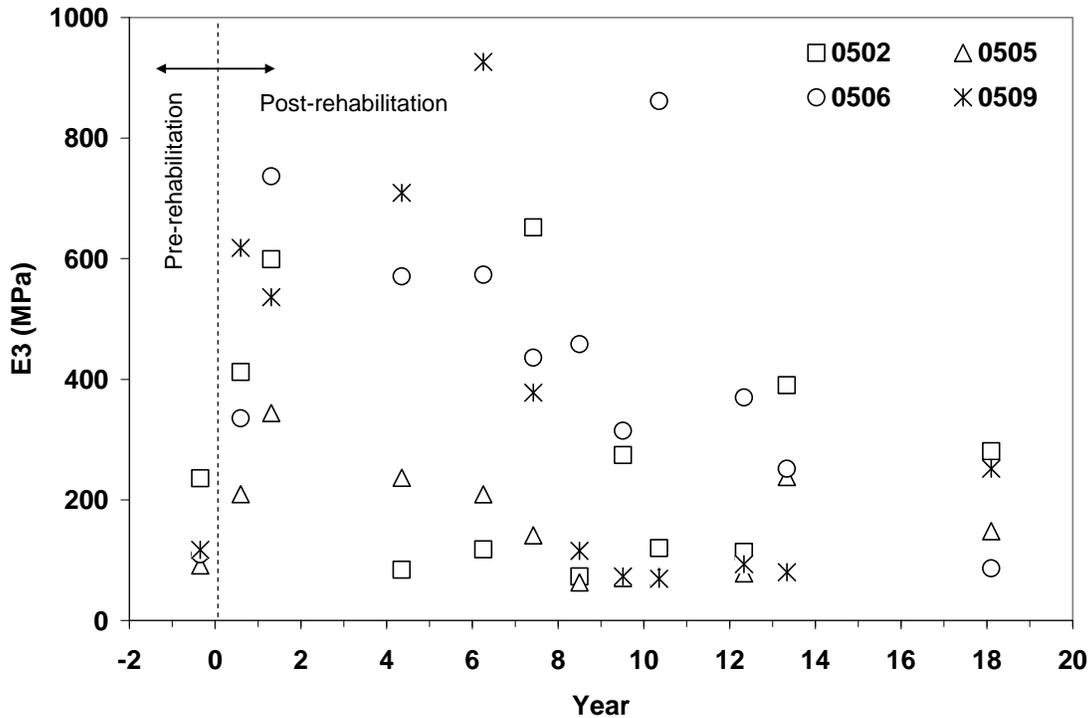
The back-calculated base and subgrade layer moduli values over their monitored period are shown in Figures 45 and 46, respectively. The stiffness of these materials significantly reduced over the past years. Upon degradation of the surface layers, water can easily percolate through cracks. Water damage and loss of materials from pumping may have contributed to the loss of material strength.

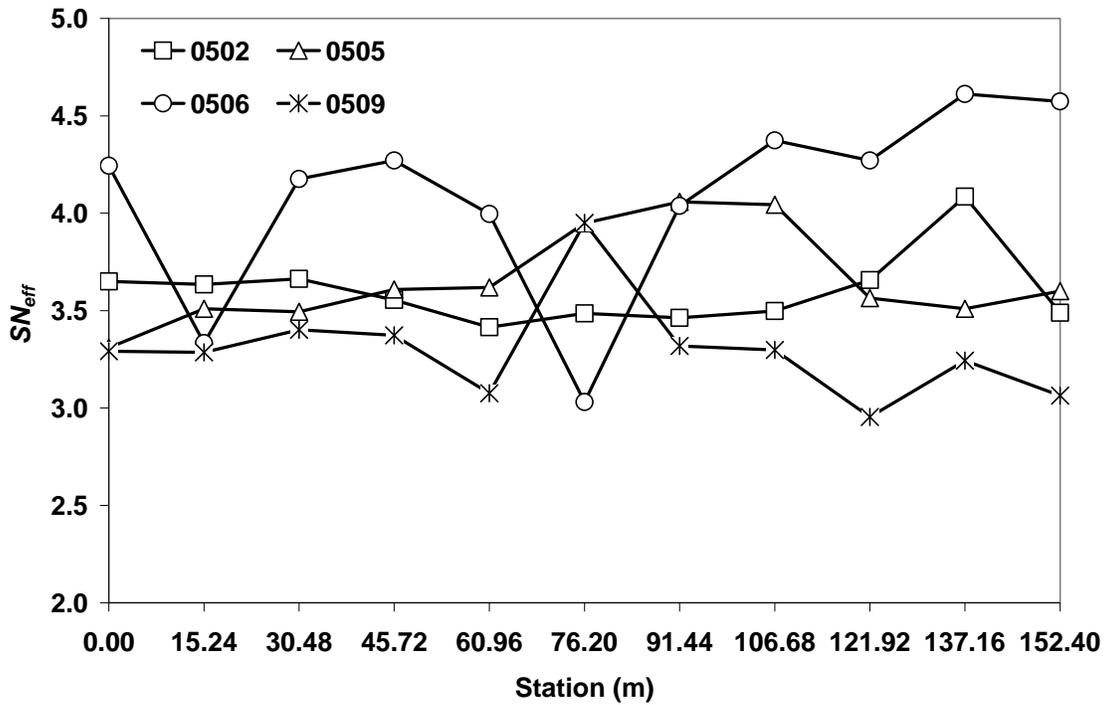
Figure 47. Structural Strength of Test Sections (September 2008).

The structural strength of the test sections using the FWD deflection data measured in September 2008 are given in Figure 47. The average SN_{eff} values for each test sections are presented Table 27. Test section 0506 exhibited higher structural strength than the other test sections.

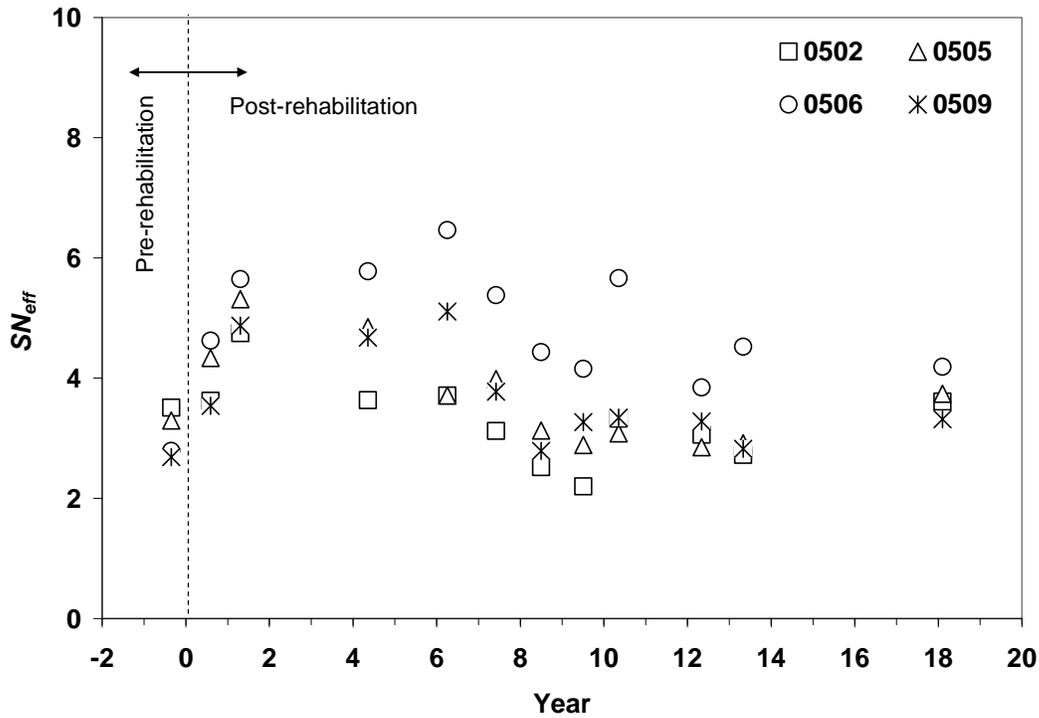
Figure 48. Structural Strength Progression.

The structural strength of each pavement section over their monitored period are presented in Figure 48. As discussed previously, each of the test sections received crack sealing in May 2002 and fog seal coats in May 1998, August 2001, and April 2003. These maintenance activities did not significantly improve the post-rehabilitation structural performance. In general, the pavement structural capacity for each of the test sections deteriorated with time.
