# FORENSIC INVESTIGATION REPORT ON THE LTPP TEXAS SPS-5 PROJECT

Submitted by Fugro Consultants, Inc.  
FHWA-LTPP SPS-5 PROJECT 48A500  
US 175 Eastbound, Kaufman County, Texas  
Date Prepared: July 2009

**FHWA LTPP SPS-5 PROJECT 48A500**  
*US 175 Eastbound Kaufman County, Texas*  
*Date Prepared: July 2009*

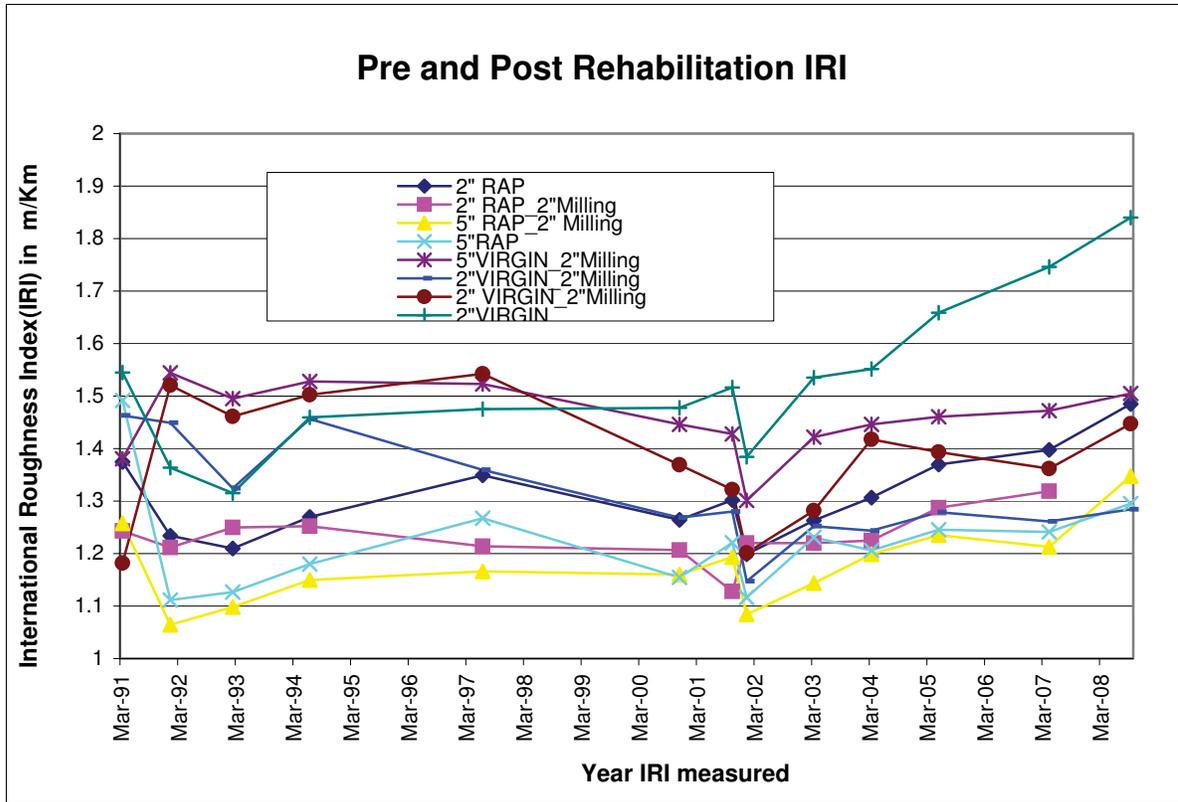
Figure 3: Plot of IRI the Years

Roughness is a measure of ride comfort and a component of pavement performance evaluation. The roughness or rideability of the test section is quantified using the International Roughness Index (IRI). For these test sections, IRI was measured using the LTPP profilometer. It is interesting to note that, even after 17 years of service, all sections but one have a lower IRI than pre-overlay condition (section 48A505). The range of IRI measured is between 1.0-2.0 m/km. A comparative study of the increase in IRI for all sections for 1991, 1992, 1994, 2001, and 2008 was done to see the influence just after treatment, within two years of treatment. It was also done after nine years and after 17 years of treatment. Table 4 summarizes this data and Figure 3 shows the time series plot of IRI over the years.

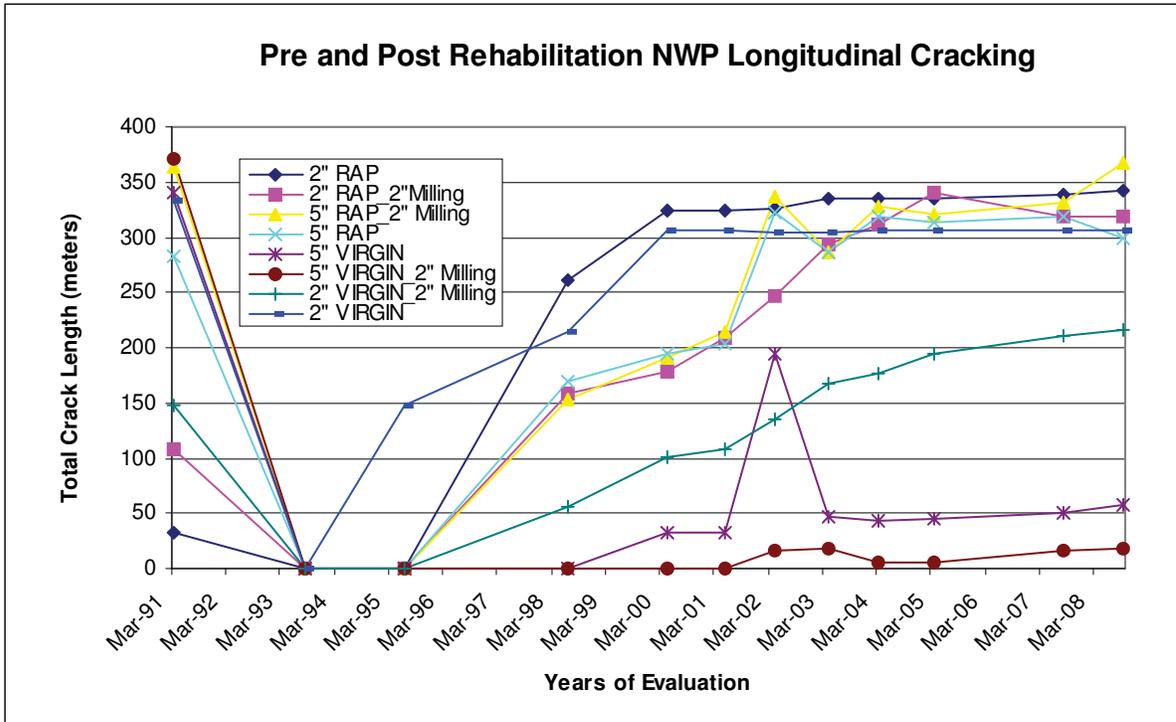
Figure 4: Plot of Longitudinal Non-Wheel Path Cracks Over the Years

Longitudinal cracking (all severity levels) in the wheel path and non-wheel path of each of the eight test sections were plotted against time to evaluate the performance. Only the automated PASCO distress survey was available for pre-overlay distress assessment. Since most of the sections had block cracking, these automated surveys masked other distresses in those areas, and a fair comparison of the longitudinal cracking before and after treatment was not obtained for sections A502 and A509. When comparing the total length of longitudinal non-wheel path (LNWP) cracks available before treatment with the manual distress survey data as shown in Figure 4, it is surprising that even after 17 years of service, none of the sections exhibited the same amount of distress before treatment. The trend of a lower wheel path cracking when compared to the non-wheel path cracking was noted in all sections. Table 5 and 6 show the percentage variation of longitudinal distresses in the wheel path and non-wheel path in 1993, after 7 years (1998), after 12 years (2003) and after 17 years (2008) of surface treatment.

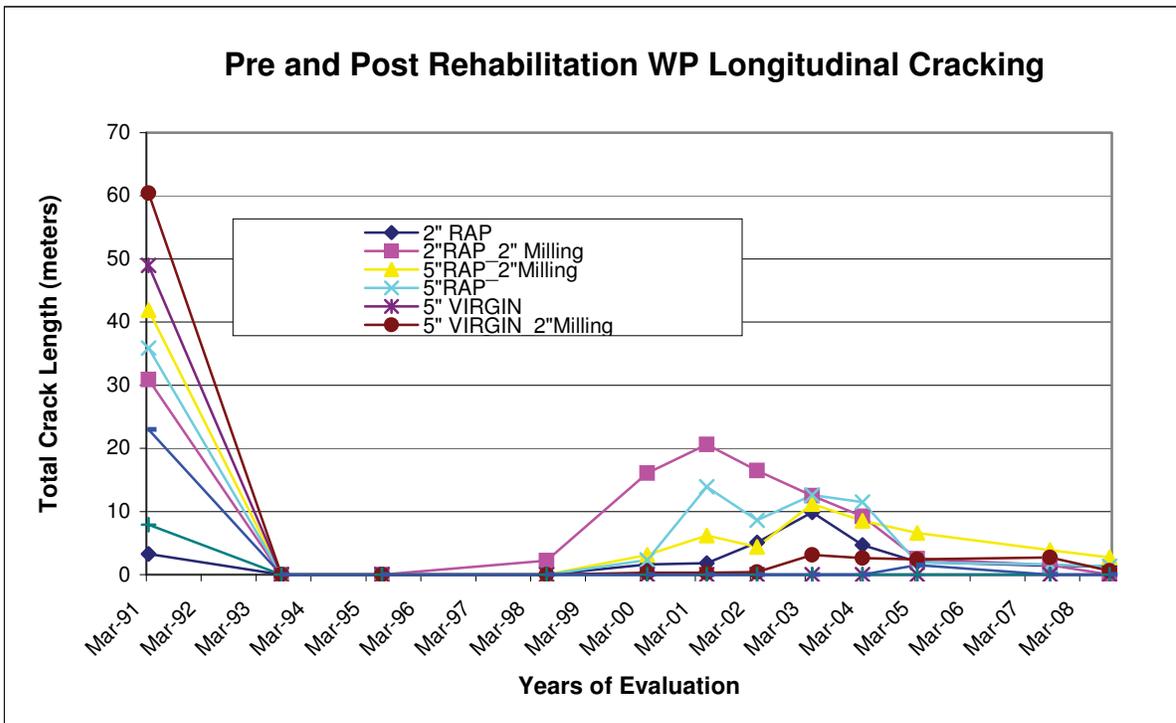
Figure 5: Plot of Longitudinal Wheel Path Cracks Over the Years

All virgin sections except section A507 (99% reduction), showed 100% reduction in wheel path longitudinal cracks. RAP sections also showed a reduction in wheel path longitudinal cracks as noted here for thin non-milled/milled, (60.6% for A502, 100% for A509) thick non-milled /milled sections (93.6% for A508 and 96.4% for A503) respectively. The least reduction was observed in non-milled thin overlay RAP section A502.

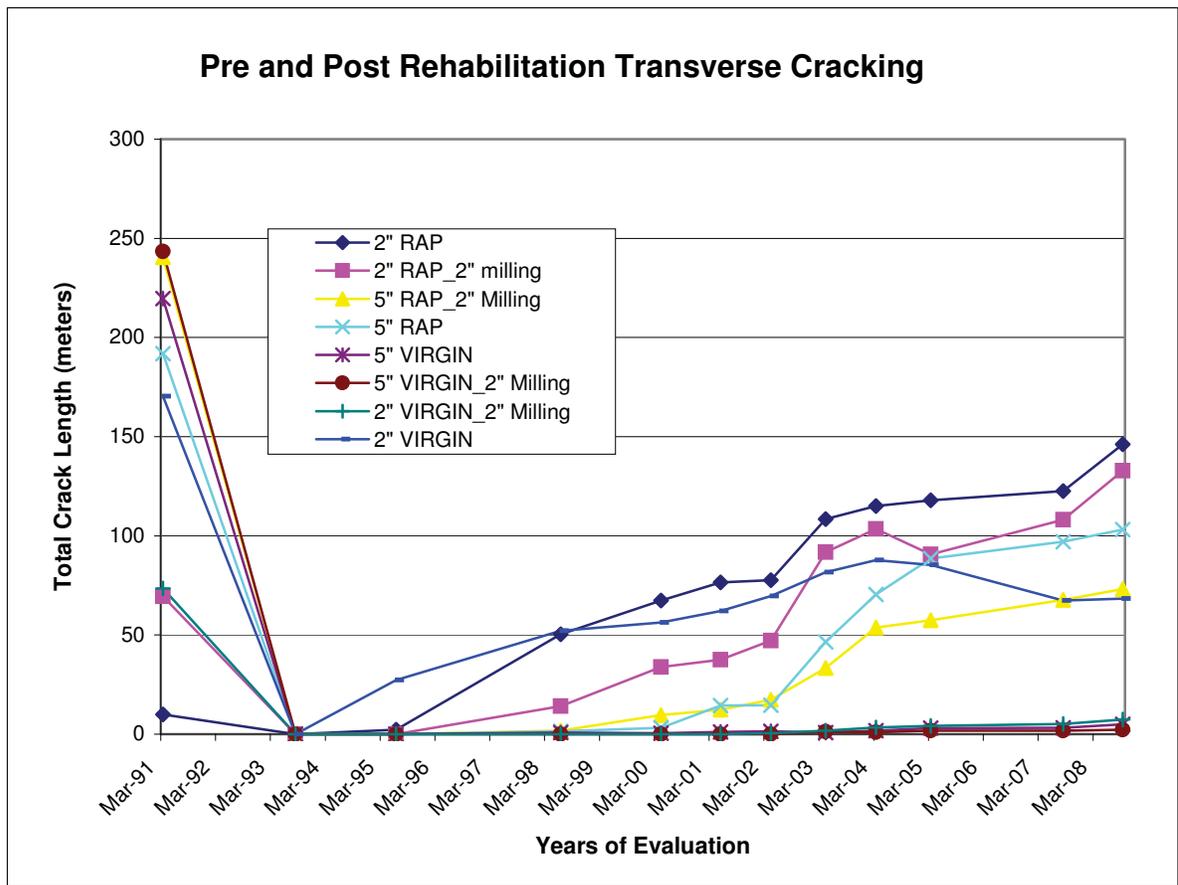
Figure 6: Plot of Transverse Cracks Over the Years

A time series plot of the total length of transverse cracks (all severities) for each test section was prepared to compare the distress before and after rehabilitation treatment, as shown in Figure 6. As noted before, only the automated PASCO distress survey was available before treatment for distress analysis, and in most sections these were reported as block cracking that masked other distresses, including transverse cracks in sections A509 and A502.

Comparing the total number of cracks before rehabilitation to the cracks in 2008, it is noted that resistance to transverse cracks in thick non-milled/milled and thin non-milled/milled of virgin sections was high (97.7% for A504, 99.1% for A507, 89.9% for A506, 59.9% for A505) compared to RAP sections (46.2% for A503, 69.6% for A508, 11.4% for A509, 2.5% for A 502), as may be seen in Table 7.

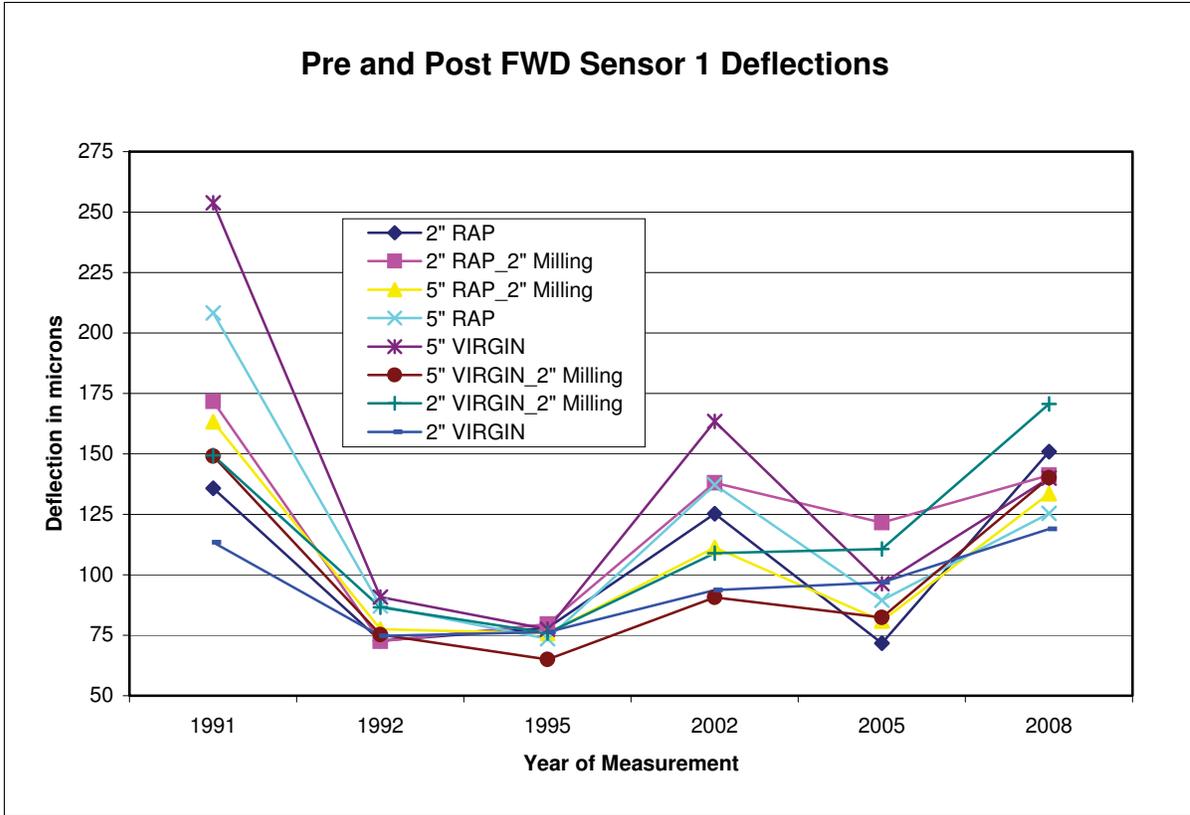
**Figure 7: Plot of Sensor 1 FWD Measurement Over the Years**

Pre and post FWD measurements for sensors 1 and 7 are plotted for each year as shown in Figures 7 and 8 to analyze the structural capacity of each underlying layer. These are deflections without temperature correction average for the project location and normalized for a drop load of 9 kips. Sensor 1 plots show that there is considerable increase in structural capacity for all sections following rehabilitation in 1991. For all sections, the sensor 1 deflections reported were less than 90 microns compared to the deflections in the range of 120 to 250 microns before treatment. Though not significant, the deflection noted in subgrade layers also decreased for all the sections with rehabilitation. The surveys in recent years show that both sensor 1 and sensor 7 deflections started increasing after 7-10 years of service life. According to recent FWD measurements, increases in deflection for the surface and subgrade layers is observed in the non-milled thin overlay RAP section A502 (108%) and the lowest increase in deflection is observed in non-milled 5 inch thick RAP section A503 (44%). Variations in deflections are observed in 2002 and 2005, as the temperature at the time the FWD measurement was taken varied considerably within the two days of successive data collection.

As noted in other distresses, thicker sections of both RAP and virgin mixtures showed increased strength. Milled sections with 7-inch overlay of both RAP and virgin mixtures showed comparably better performance (72% and 86% increase) and thin sections showed 95% and 97% increase respectively. Non-milled thin sections of virgin mixtures showed less deflection (59% increase) compared to 108% increase in RAP section.

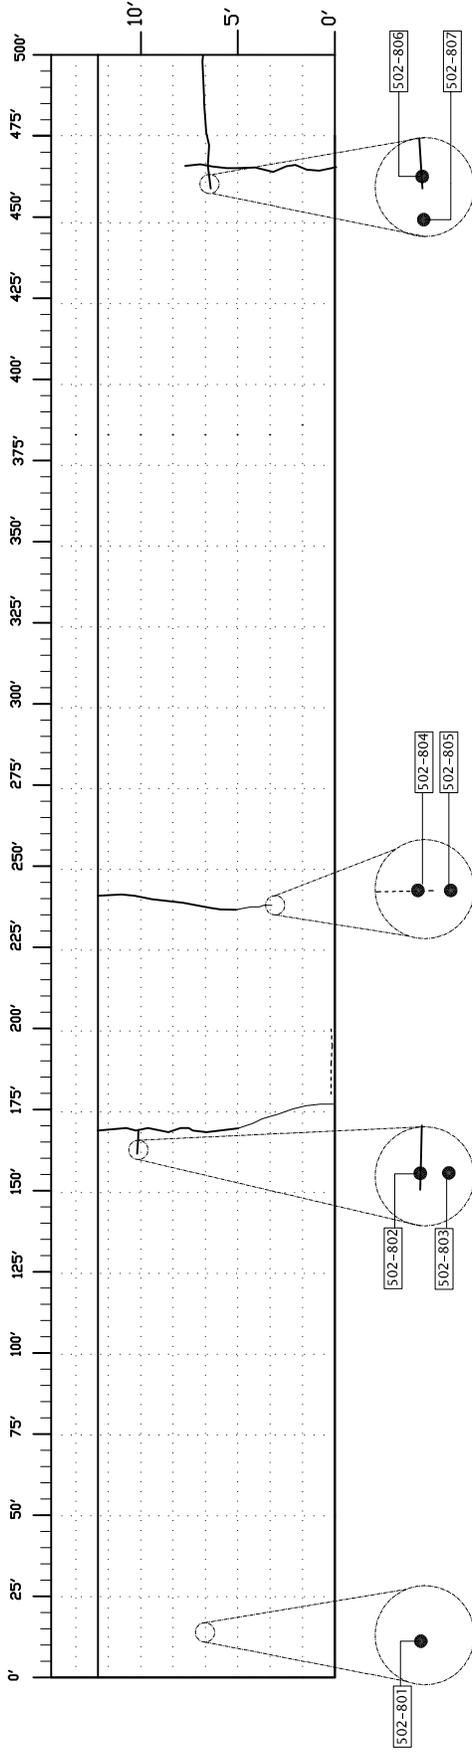
SECTION: 48\_A502

CORE #	REASON INVESTIGATED	CORE DIMENSION	CORE LOCATION
502-801	LONGITUDINAL CRACKING - NOT REFLECTED	4" DIA	15+00, 06+00
502-802	FATIGUE CRACKING	4" DIA	170+20, 03+00
502-803	FATIGUE CRACKING - REPLICATE CORE	4" DIA	170+20, 02+60
502-804	TRANSVERSE CRACKING	4" DIA	248+00, 04+00
502-805	TRANSVERSE CRACKING - REPLICATE CORE	4" DIA	248+00, 03+60
502-806	LONGITUDINAL CRACKING	4" DIA	465+00, 08+00
502-807	LONGITUDINAL CRACKING - REPLICATE CORE	4" DIA	464+60, 08+00

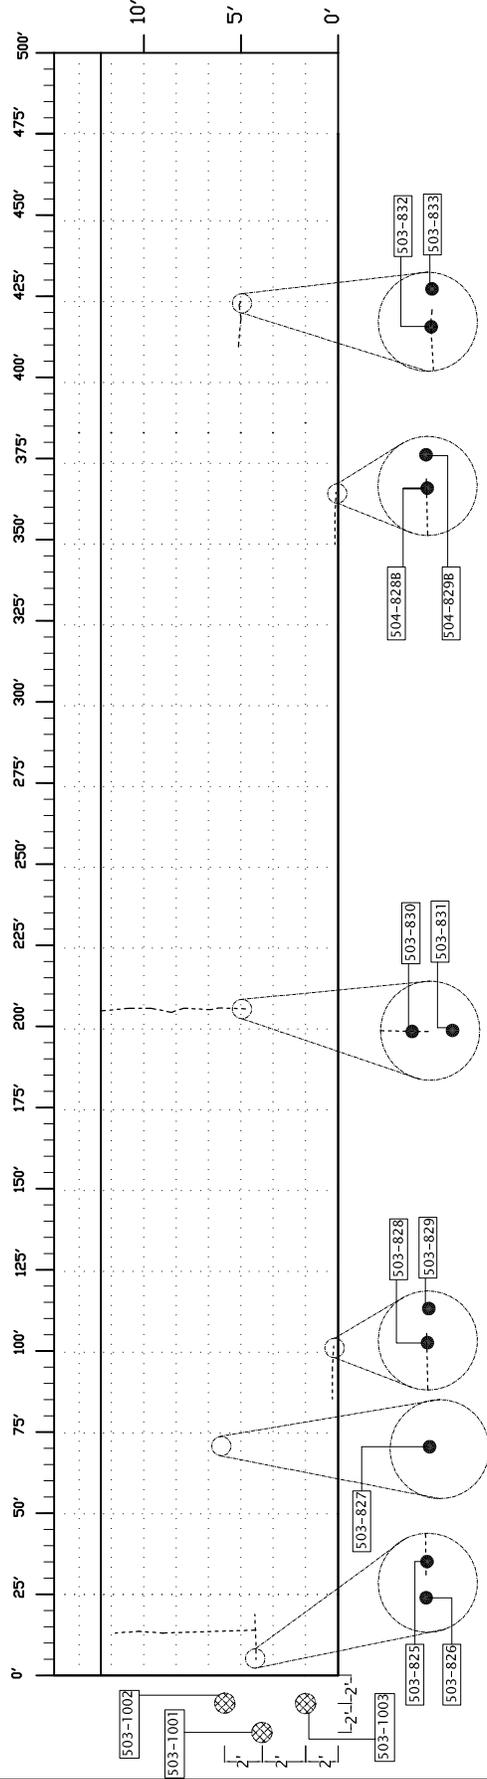
SECTION: 48\_A503

CORE #	REASON INVESTIGATED	CORE DIMENSION	CORE LOCATION
503-825	FATIGUE CRACKING	4" DIA	06+00, 4+00
503-826	FATIGUE CRACKING - REPLICATE CORE	4" DIA	06+40, 04+00
503-827	EXISTING CRACK NOT REFLECTED	4" DIA	74+00, 06+00
503-828 / 8288	REFLECTED LONGITUDINAL CRACKING	4" DIA	100+00, 0+00 / 365+00, 0+00
503-829 / 8298	LONGITUDINAL CRACKING - REPLICATE CORE	4" DIA	100+40, 0+00 / 365+40, 0+00
503-830	REFLECTED TRANSVERSE CRACKING	4" DIA	210+00, 05+00
503-831	TRANSVERSE CRACKING - REPLICATE CORE	4" DIA	210+00, 04+60
503-832	REFLECTED LONGITUDINAL CRACKING	4" DIA	425+00, 05+00
503-833	LONGITUDINAL CRACK - REPLICATE CORE	4" DIA	425+40, 05+00
503-1001 TO 1003	CORES FOR EXTRACTING BINDER FOR BINDER TESTS	12" DIA	3 BULK CORES BEFORE SECTION 48_A503

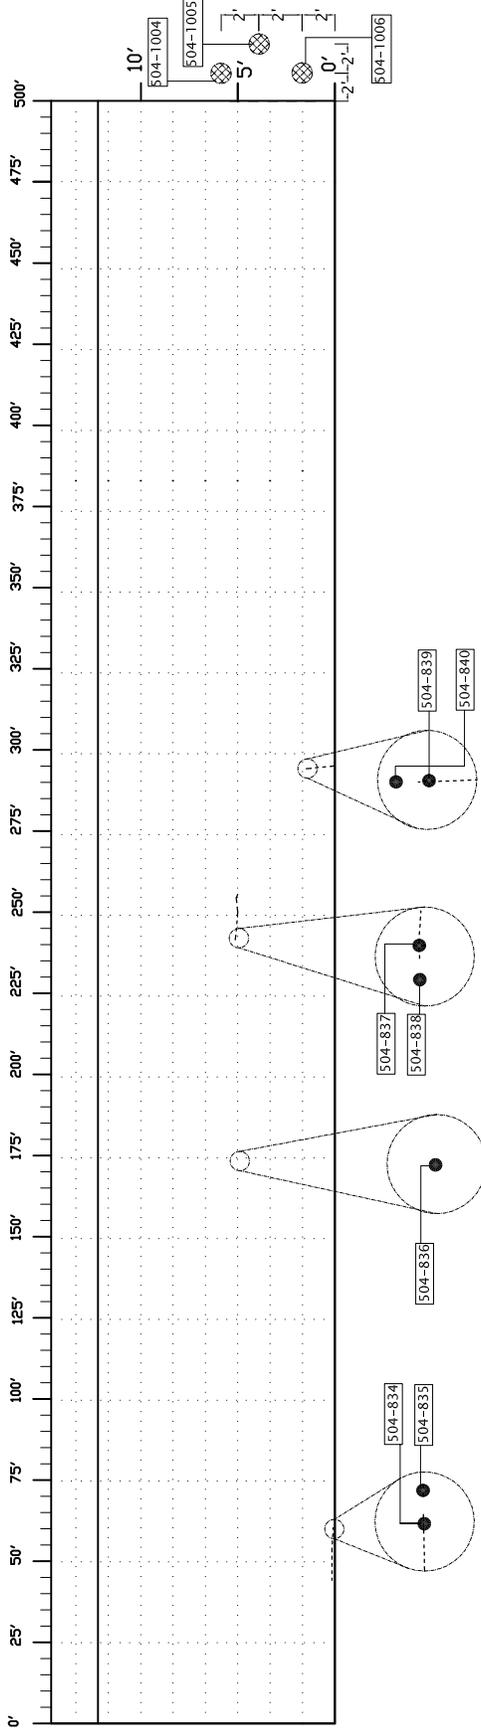
SECTION: 48\_A504

CORE #	REASON INVESTIGATED	CORE DIMENSION	CORE LOCATION
504-834	LONGITUDINAL CRACKING	4" DIA	65+00, 0+00
504-835	LONGITUDINAL CRACKING - REPLICATE CORE	4" DIA	65+00, 0+00
504-836	CRACKING NOT REFLECTED	4" DIA	175+00, 05+00
504-837	RAVELING	4" DIA	230+00, 05+00
504-838	RAVELING - REPLICATE CORE	4" DIA	229+60, 05+00
504-839	REFLECTED TRANSVERSE CRACKING	4" DIA	299+00, 02+00
504-840	CRACKING NOT REFLECTED - REPLICATE CORE	4" DIA	299+00, 02+40
504-1004 TO 1006	CORES FOR EXTRACTING BINDER FOR BINDER TESTS	12" DIA	3 BULK CORES AFTER SECTION 48_A504

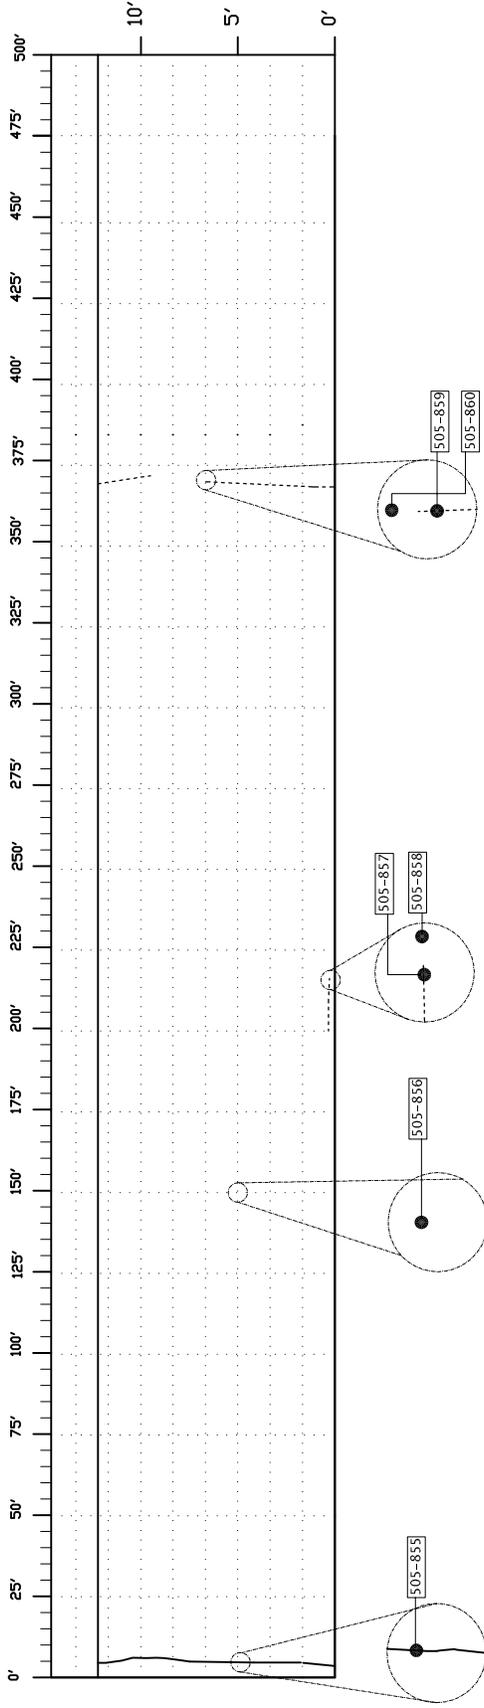
SECTION: 48\_A505

CORE #	REASON INVESTIGATED	CORE DIMENSION	CORE LOCATION
505-855	TRANSVERSE CRACKING	4" DIA	05+60, 05+00
505-855	TRANSVERSE CRACKING - REPLICATE CORE	4" DIA	06+00, 05+00
505-856	EXISTING CRACK NOT REFLECTED	4" DIA	150+00, 05+00
505-857	LONGITUDINAL CRACKING	4" DIA	220+00, 05+00
505-858	LONGITUDINAL CRACKING - REPLICATE CORE	4" DIA	220+40, 0+00
505-859	REFLECTED TRANSVERSE CRACKING	4" DIA	360+00, 06+00
505-860	TRANSVERSE CRACKING - REPLICATE CORE	4" DIA	360+00, 06+40

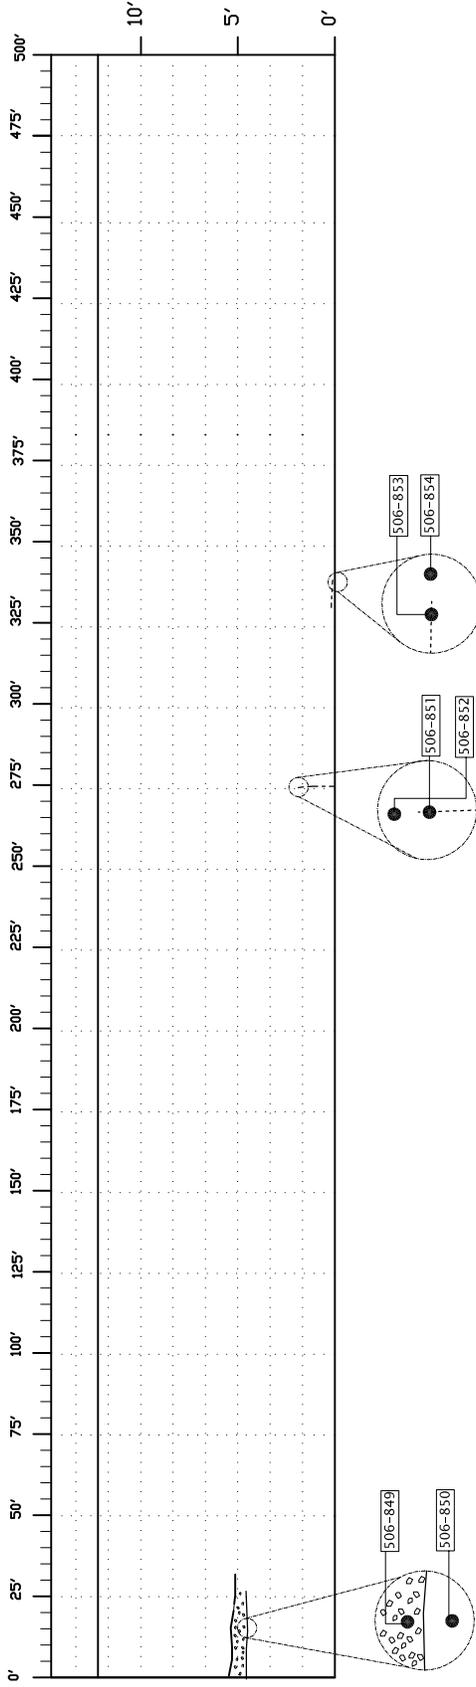
SECTION: 48\_A506

CORE #	REASON INVESTIGATED	CORE DIMENSION	CORE LOCATION
506-849	RAVELING	4" DIA	15+00, 06+00
506-850	REPLICATE CORE NEAR RAVELING	4" DIA	15+00, 05+60
506-851	REFLECTED TRANSVERSE CRACKING	4" DIA	275+00, 02+00
506-852	REPLICATE CORE NEAR TRANSVERSE CRACKING	4" DIA	275+00, 02+40
506-853	REFLECTED LONGITUDINAL CRACKING	4" DIA	344+00, 0+00
506-854	REPLICATE CORE NEAR LONGITUDINAL CRACKING	4" DIA	344+40, 0+00

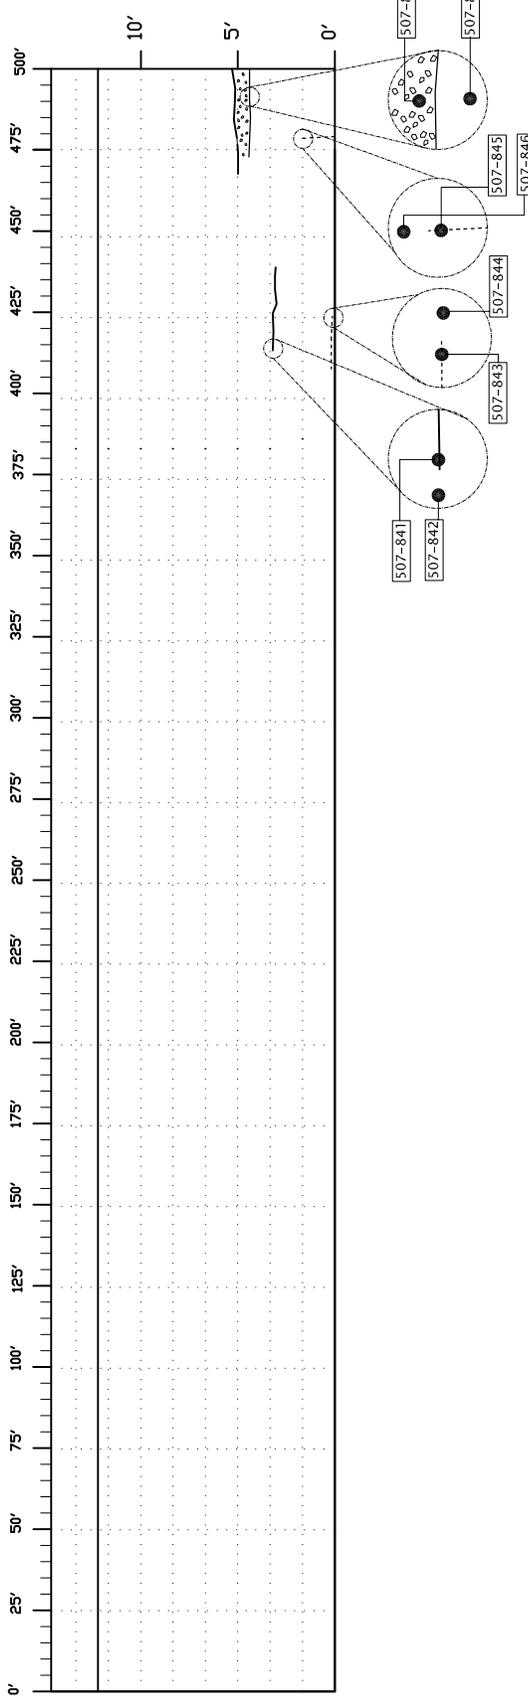
SECTION: 48\_A507

CORE #	REASON INVESTIGATED	CORE DIMENSION	CORE LOCATION
507-841	FATIGUE CRACKING	4" DIA	415+00, 03+00
507-842	REPLICATE CORE NEAR FATIGUE CRACKING	4" DIA	415+00, 03+00
507-843	REFLECTED LONGITUDINAL CRACKING	4" DIA	425+00, 0+00
507-844	REPLICATE CORE NEAR LONGITUDINAL CRACKING	4" DIA	425+40, 0+00
507-845	REFLECTED TRANSVERSE CRACKING	4" DIA	450+00, 02+00
507-846	REPLICATE CORE NEAR TRANSVERSE CRACKING	4" DIA	450+00, 01+60
507-847	RAVELING	4" DIA	495+00, 05+00
507-848	REPLICATE CORE NEAR RAVELING	4" DIA	490+40, 04+60

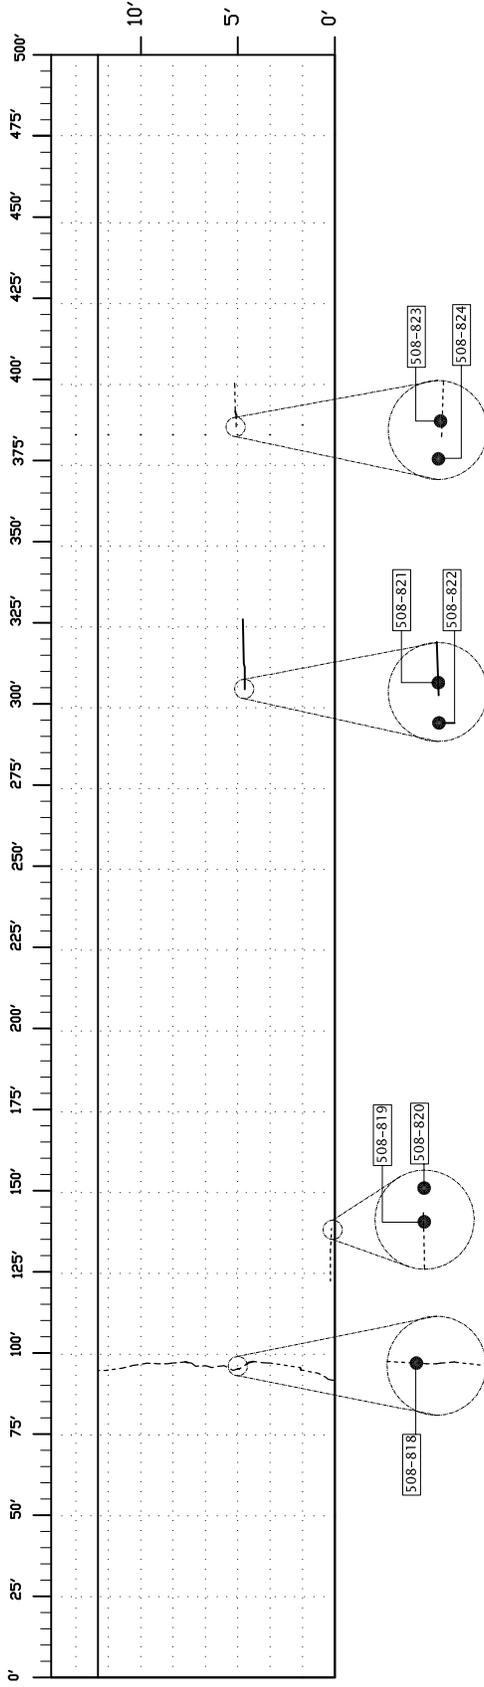
SECTION: 48\_A508

CORE #	REASON INVESTIGATED	CORE DIMENSION	CORE LOCATION
508-818	REFLECTED TRANSVERSE CRACKING	4" DIA	95+00, 05+00
508-819	REFLECTED LONGITUDINAL CRACKING	4" DIA	375+00, 0+00
508-820	REPLICATE CORE NEAR THE LONGITUDINAL CRACKING	4" DIA	375+50, 0+00
508-821	FATIGUE CRACKING	4" DIA	310+00, 05+00
508-822	REPLICATE CORE NEAR FATIGUE CRACKING	4" DIA	309+50, 05+00
508-823	REFLECTIVE LONGITUDINAL CRACKING	4" DIA	385+00, 05+00
508-824	REPLICATE CORE NEAR LONGITUDINAL CRACKING	4" DIA	384+50, 05+00

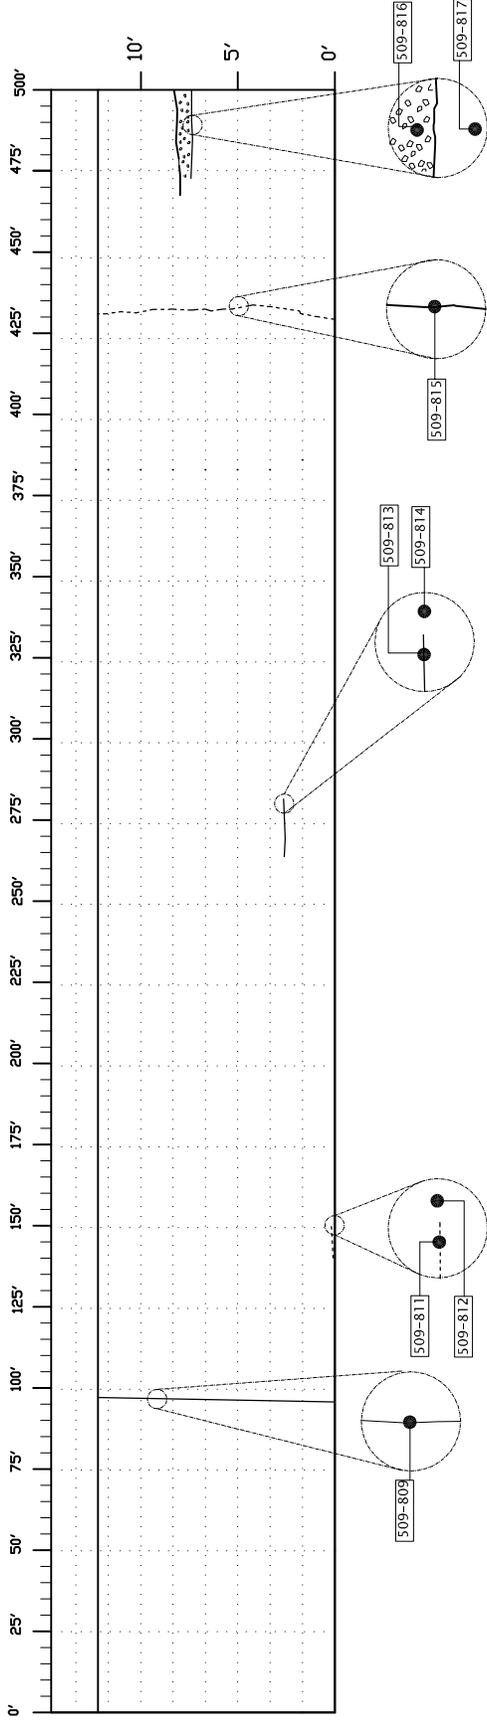
SECTION: 48\_A509

CORE #	REASON INVESTIGATED	CORE DIMENSION	CORE LOCATION
509-809	TRANSVERSE CRACKING REFLECTED	4" DIA	100+00, 06+00
509-811	REFLECTED LONGITUDINAL CRACKING	4" DIA	150+00, 0+00
509-812	REPLICATE CORE NEAR LONGITUDINAL CRACKING	4" DIA	150+50, 0+00
509-813	FATIGUE CRACKING	4" DIA	310+00, 05+00
509-814	REPLICATE CORE NEAR FATIGUE CRACKING	4" DIA	310+50, 5+00
509-815	REFLECTED TRANSVERSE CRACKING	4" DIA	430+00, 05+00
509-816	RAVELING	4" DIA	480+00, 08+00
509-817	REPLICATE CORE NEAR RAVELING	4" DIA	490+00, 05+00

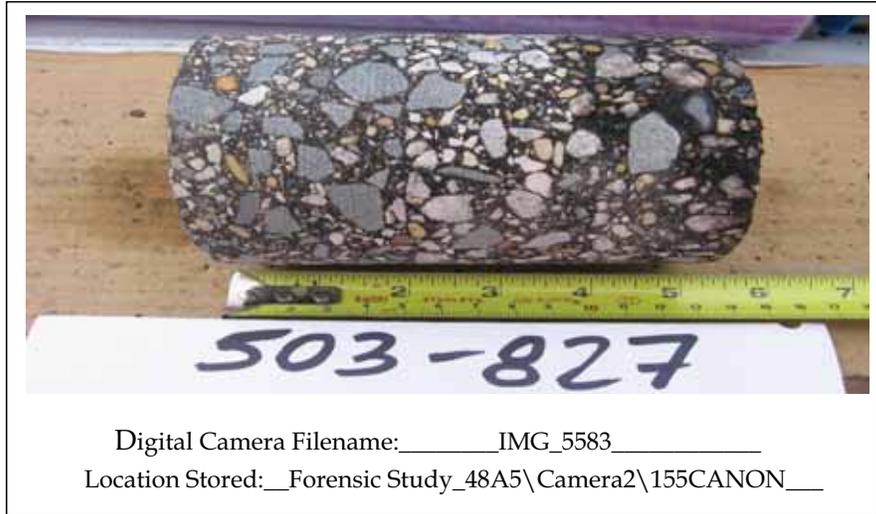
STATE CODE 48  
 SHRP ID A503  
 HIGHWAY US 175  
 LANE DIRECTION EAST  
 BORE HOLE NO 503-827  
 BORE LOCATION CODE CA-827  
 CORING DATE 10-Sep-08  
 CORE BARREL SIZE (in) 4"

Cracked Full Depth  Yes  No  
 Cracked through  Aggregate  Binder  Both  
 Crack Direction  Inclined  Perpendicular  No Pattern or multiple direction  
 Crack Mechanism  Bottom Up  Top Down  Hairline cracks only on top <1/3 depth  
 Layer of Crack Origin \_\_\_\_\_ If Applicable, Layer where cracking stopped \_\_\_\_\_  
 Crack Depth (inches) \_\_\_\_\_ Crack Width (inches) \_\_\_\_\_ Distress Type (Table A.22) \_\_\_\_\_  
 Other Notes : Original AC Base (layer D) and Surface (Layer E) are not recovered at this location where there is both transverse and longitudinal crack reported in PASCO survey. It is noted that these crackings are not reflected through the overlay

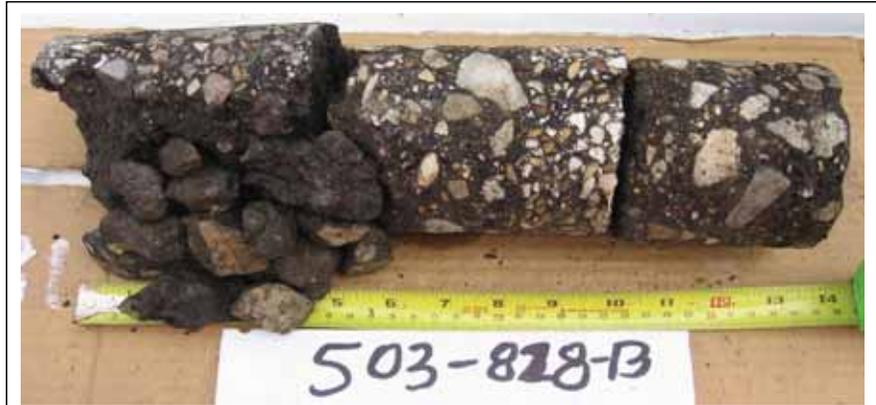
Digital Camera Filename: IMG\_5592  
 Location Stored: Forensic Study\_48A5\Camera2\155CANON

Cracked Full Depth  Yes  No  
 Cracked through  Aggregate  Binder  Both  
 Crack Direction  Inclined  Perpendicular  No Pattern or multiple direction  
 Crack Mechanism  Bottom Up  Top Down  Hairline cracks only on top <1/3 depth  
 Layer of Crack Origin Top of Layer G If Applicable, Layer where cracking stopped Bottom of Layer F  
 Crack Depth (inches) 5.0 Crack Width (inches) 1/8 Distress Type (Table A.22) Longitudinal  
 Other Notes : Longitudinal crack located at this location was found to be extending from the pavement edge marking  
General deterioration of Original AC Base (Layer D) observed

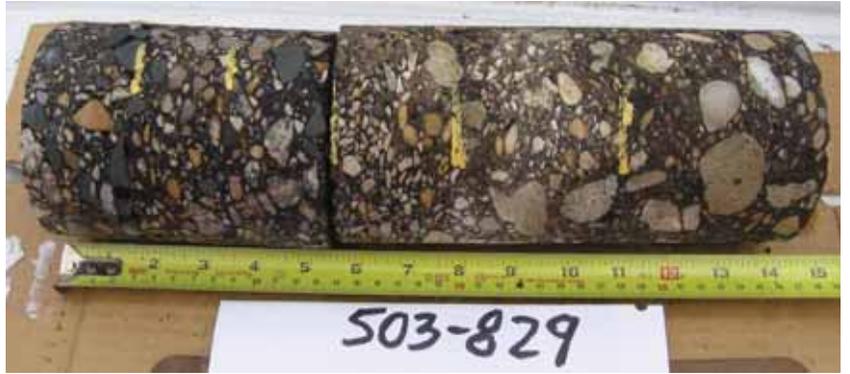
Digital Camera Filename: IMG\_5587  
 Location Stored: Forensic Study\_48A5\Camera2\155CANON

Cracked Full Depth  Yes  No  
 Cracked through  Aggregate  Binder  Both  
 Crack Direction  Inclined  Perpendicular  No Pattern or multiple direction  
 Crack Mechanism  Bottom Up  Top Down  Hairline cracks only on top <1/3 depth  
 Layer of Crack Origin Top of Layer G If Applicable, Layer where cracking stopped Layer G  
 Crack Depth (inches) 0.25 Crack Width (inches) 1/16 Distress Type (Table A.22) Longitudinal  
 Other Notes : Replicate core for 503\_828 for longitudinal crack was found to follow the trend of developing a crack at the top surface  
General deterioration of Original AC Base (Layer D) observed

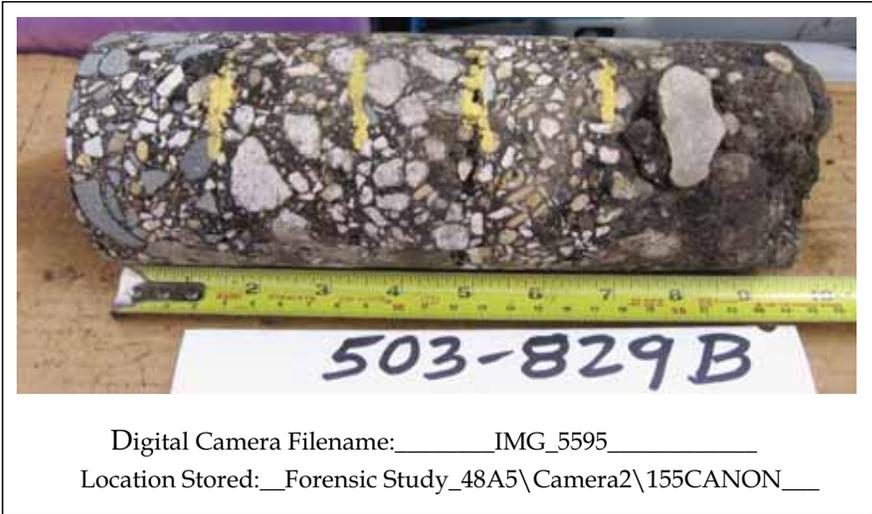
STATE CODE 48  
 SHRP ID A503  
 HIGHWAY US 175  
 LANE DIRECTION EAST  
 BORE HOLE NO 503-829B  
 BORE LOCATION CODE CA-829B  
 CORING DATE 10-Sep-08  
 CORE BARREL SIZE (in) 4"

Cracked Full Depth  Yes  No  
 Cracked through  Aggregate  Binder  Both  
 Crack Direction  Inclined  Perpendicular  No Pattern or multiple direction  
 Crack Mechanism  Bottom Up  Top Down  Hairline cracks only on top <1/3 depth  
 Layer of Crack Origin \_\_\_\_\_ If Applicable, Layer where cracking stopped \_\_\_\_\_  
 Crack Depth (inches) \_\_\_\_\_ Crack Width (inches) \_\_\_\_\_ Distress Type (Table A.22) \_\_\_\_\_  
 Other Notes : Replicate core for 503\_828 for longitudinal crack didn't show development of cracks in any layer:

General deterioration of Original AC Base (Layer D) observed

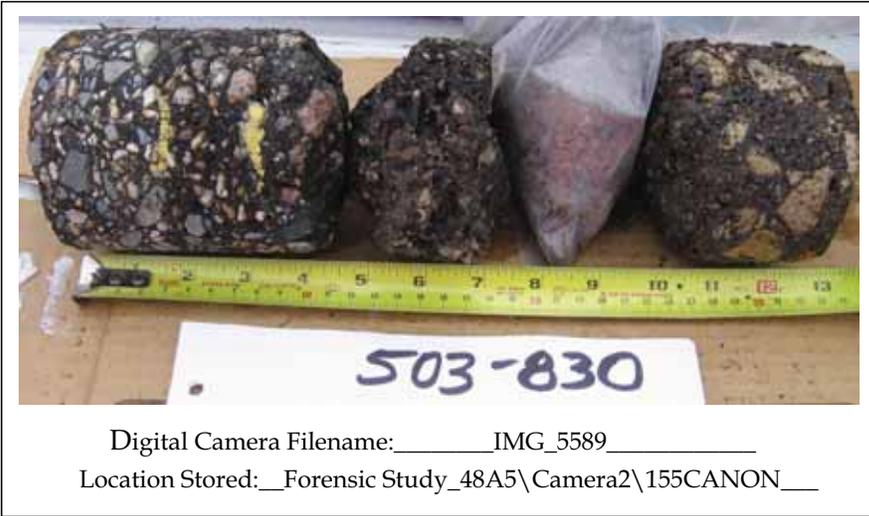
Digital Camera Filename: IMG\_5589  
 Location Stored: Forensic Study\_48A5\Camera2\155CANON

Cracked Full Depth  Yes  No  
 Cracked through  Aggregate  Binder  Both  
 Crack Direction  Inclined  Perpendicular  No Pattern or multiple direction  
 Crack Mechanism  Bottom Up  Top Down  Hairline cracks only on top <1/3 depth \_\_\_\_\_  
 Layer of Crack Origin \_\_\_\_\_ If Applicable, Layer where cracking stopped \_\_\_\_\_  
 Crack Depth (inches) \_\_\_\_\_ Crack Width (inches) \_\_\_\_\_ Distress Type (Table A.22) Transverse  
 Other Notes : Transverse crack at this location was noted on existing pavement in the 1991 PASCO survey and not reflected through the overlay Binder and Surface. Since the portion of Original Surface (Layer E) and Base (Layer D) was highly deteriorated this portion could not be recovered

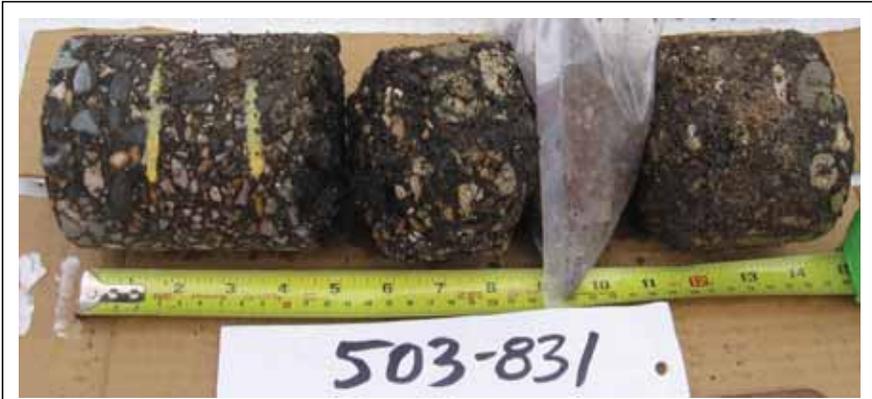
Digital Camera Filename: IMG\_5591  
 Location Stored: Forensic Study\_48A5\Camera2\155CANON

Cracked Full Depth  Yes  No  
 Cracked through  Aggregate  Binder  Both  
 Crack Direction  Inclined  Perpendicular  No Pattern or multiple direction  
 Crack Mechanism  Bottom Up  Top Down  Hairline cracks only on top <1/3 depth \_\_\_\_\_  
 Layer of Crack Origin \_\_\_\_\_ If Applicable, Layer where cracking stopped \_\_\_\_\_  
 Crack Depth (inches) \_\_\_\_\_ Crack Width (inches) \_\_\_\_\_ Distress Type (Table A.22) Transverse  
 Other Notes : Replicate core for 503\_830 indicate the deteriorated original AC surface (Layer E) and Base (layer D).

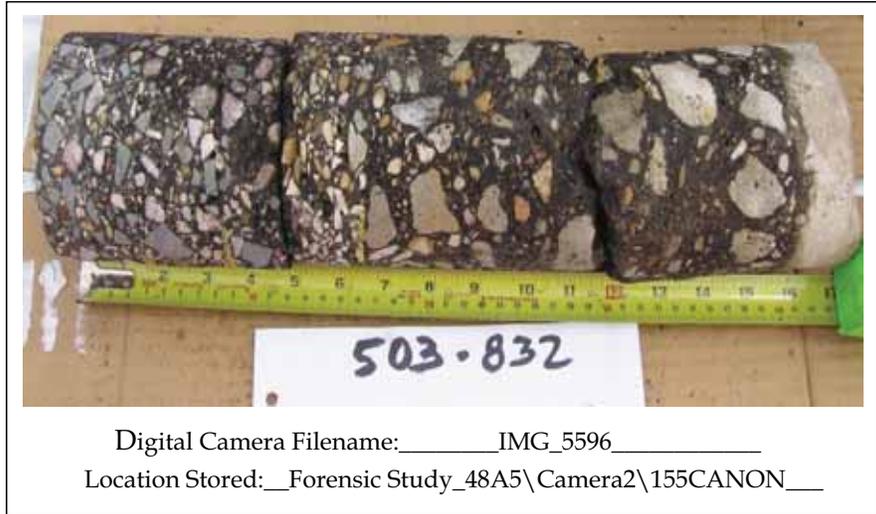
STATE CODE 48  
 SHRP ID A503  
 HIGHWAY US 175  
 LANE DIRECTION EAST  
 BORE HOLE NO 503-832  
 BORE LOCATION CODE CA-832  
 CORING DATE 10-Sep-08  
 CORE BARREL SIZE (in) 4"

Layer of Crack Origin Top of Layer G If Applicable, Layer where cracking stopped Bottom of Layer G

Crack Depth (inches) 2.00 Crack Width (inches) 1/8 Distress Type (Table A.22) Longitudinal

Other Notes : Longitudinal crack located at this location was found to be developed at the surface layer

General deterioration of Original AC Base (Layer D) observed

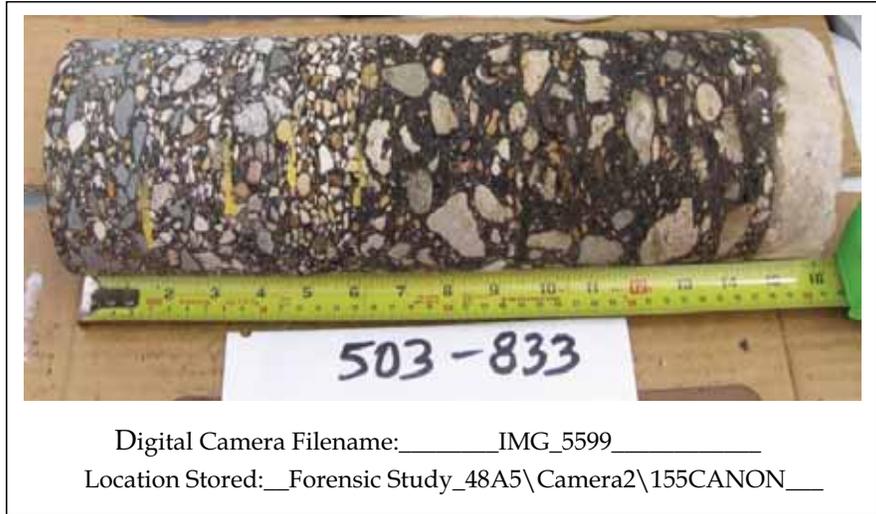
STATE CODE 48  
 SHRP ID A503  
 HIGHWAY US 175  
 LANE DIRECTION EAST  
 BORE HOLE NO 503-833  
 BORE LOCATION CODE CA-833  
 CORING DATE 10-Sep-08  
 CORE BARREL SIZE (in) 4"

Cracked Full Depth  Yes  No  
 Cracked through  Aggregate  Binder  Both  
 Crack Direction  Inclined  Perpendicular  No Pattern or multiple direction  
 Crack Mechanism  Bottom Up  Top Down  Hairline cracks only on top <1/3 depth  
 Layer of Crack Origin \_\_\_\_\_ If Applicable, Layer where cracking stopped \_\_\_\_\_  
 Crack Depth (inches) \_\_\_\_\_ Crack Width (inches) \_\_\_\_\_ Distress Type (Table A.22) \_\_\_\_\_  
 Other Notes : Replicate core for 503\_832 doesn't show crack development in any of the layers.

But it is observed that the cracks in the deterioration of Original AC Surface (layer E) and Base (Layer D) is not reflected to through the overlay

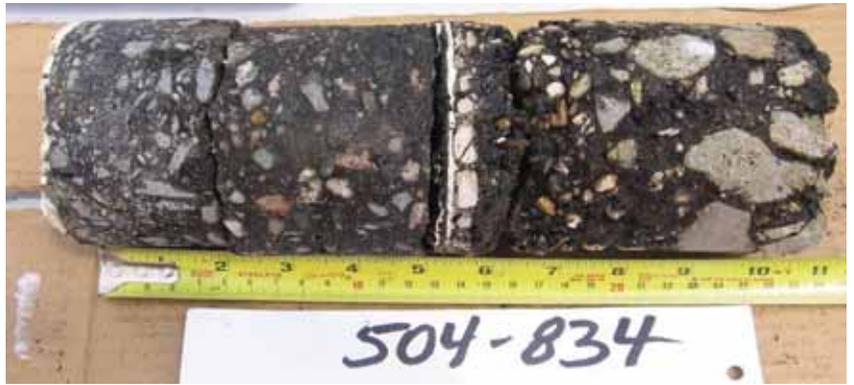
Digital Camera Filename: IMG\_5600  
 Location Stored: Forensic Study\_48A5\Camera2\155CANON

Cracked Full Depth  Yes  No  
 Cracked through  Aggregate  Binder  Both  
 Crack Direction  Inclined  Perpendicular  No Pattern or multiple direction  
 Crack Mechanism  Bottom Up  Top Down  Hairline cracks only on top <1/3 depth  
 Layer of Crack Origin Top of layer I If Applicable, Layer where cracking stopped Layer I bottom  
 Crack Depth (inches) 2.0 Crack Width (inches) 1/8 Distress Type (Table A.22) Longitudinal  
 Other Notes : \_\_\_\_\_

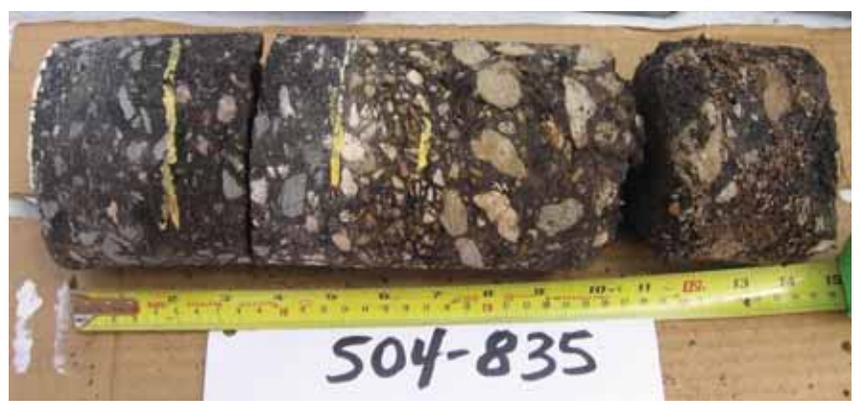
Digital Camera Filename: IMG\_5602  
 Location Stored: Forensic Study\_48A5\Camera2\156CANON

Cracked Full Depth  Yes  No  
 Cracked through  Aggregate  Binder  Both  
 Crack Direction  Inclined  Perpendicular  No Pattern or multiple direction  
 Crack Mechanism  Bottom Up  Top Down  Hairline cracks only on top <1/3 depth  
 Layer of Crack Origin Top of Layer I If Applicable, Layer where cracking stopped Layer I  
 Crack Depth (inches) 0.25 Crack Width (inches) 1/8 Distress Type (Table A.22) Longitudinal  
 Other Notes : Replicate core for 504\_834 show similar crack pattern of top down cracking and it is observed that the existing cracks in Original AC Base and Surface is not reflected through the overlay  
General deterioration of the Original Base (Layer D) and Surface (Layer E) is obvious

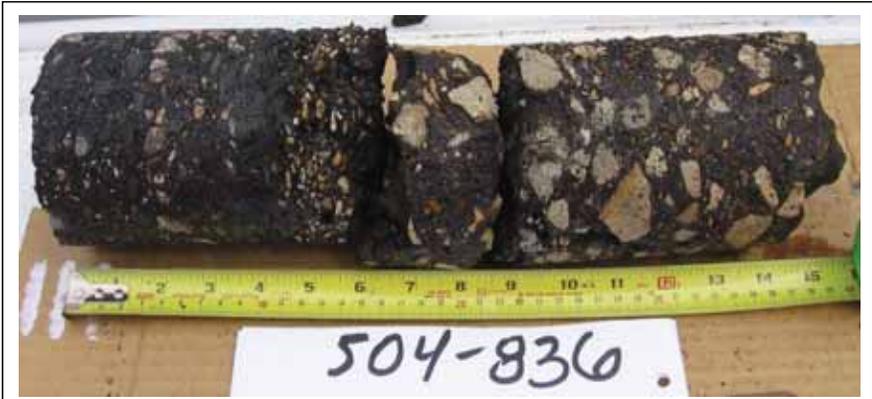
Digital Camera Filename: IMG\_5605  
 Location Stored: Forensic Study\_48A5\Camera2\156CANON

Cracked Full Depth  Yes  No  
 Cracked through  Aggregate  Binder  Both  
 Crack Direction  Inclined  Perpendicular  No Pattern or multiple direction  
 Crack Mechanism  Bottom Up  Top Down  Hairline cracks only on top <1/3 depth  
 Layer of Crack Origin Mid of Layer D If Applicable, Layer where cracking stopped Top of Layer D  
 Crack Depth (inches) 2.5 Crack Width (inches) 1/2 Distress Type (Table A.22) Longitudinal  
 Other Notes : Crack identified on the original AC surface and base is not reflected through the overlay binder and surface layer  
General deterioration of the Original Base (Layer D) and Surface (Layer E) is obvious

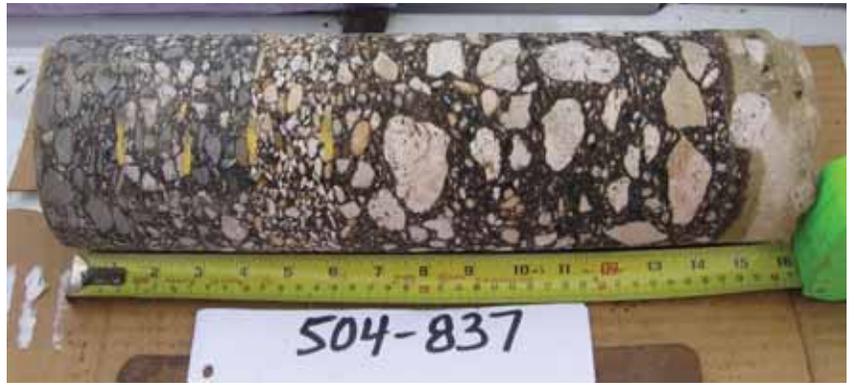
Digital Camera Filename: IMG\_5609  
 Location Stored: Forensic Study\_48A5\Camera2\156CANON

Cracked Full Depth  Yes  No  
 Cracked through  Aggregate  Binder  Both  
 Crack Direction  Inclined  Perpendicular  No Pattern or multiple direction  
 Crack Mechanism  Bottom Up  Top Down  Hairline cracks only on top <1/3 depth  
 Layer of Crack Origin \_\_\_\_\_ If Applicable, Layer where cracking stopped \_\_\_\_\_  
 Crack Depth (inches) \_\_\_\_\_ Crack Width (inches) \_\_\_\_\_ Distress Type (Table A.22) \_\_\_\_\_  
 Other Notes : Crack identified on the original AC surface and base is not reflected through the overlay binder and surface layer  
General deterioration of the Original Base (Layer D) and Surface (Layer E) is obvious

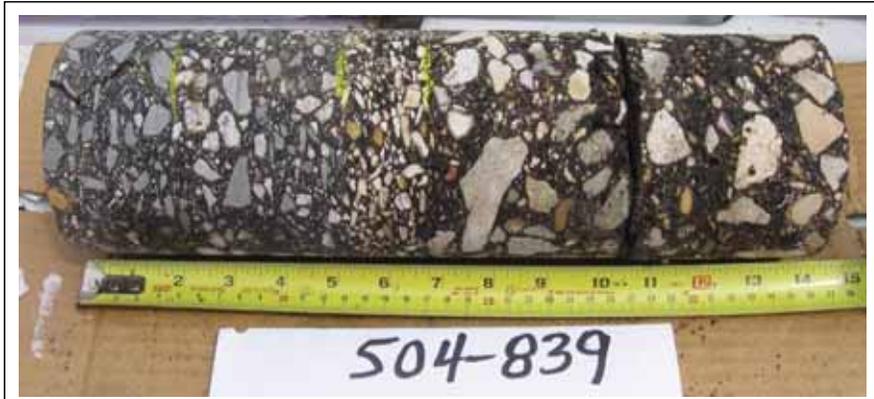
Digital Camera Filename: IMG\_5611  
 Location Stored: Forensic Study\_48A5\Camera2\156CANON

But transverse crack observed on the overlay surface is noted to develop recently at the surface layer and extending down.

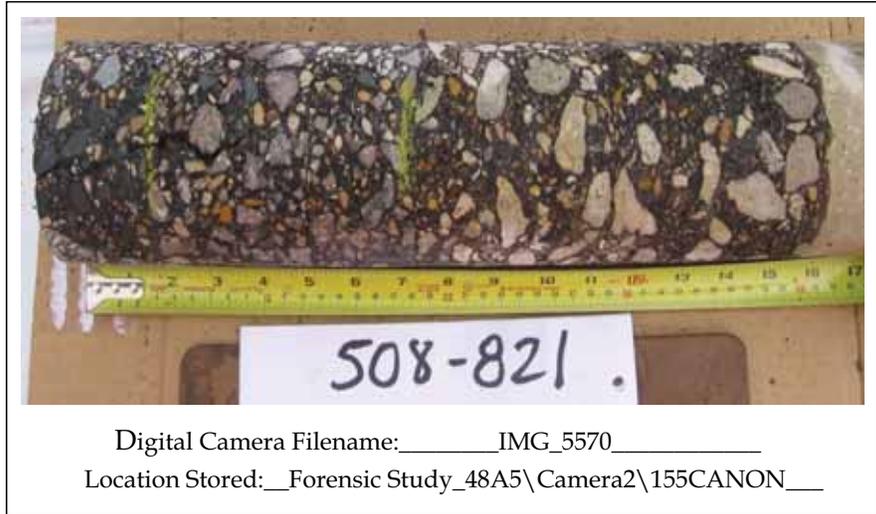
STATE CODE 48  
 SHRP ID A508  
 HIGHWAY US 175  
 LANE DIRECTION EAST  
 BORE HOLE NO 508-821  
 BORE LOCATION CODE CA-821  
 CORING DATE 10-Sep-08  
 CORE BARREL SIZE (in) 4"

Cracked Full Depth  Yes  No  
 Cracked through  Aggregate  Binder  Both  
 Crack Direction  Inclined  Perpendicular  No Pattern or multiple direction  
 Crack Mechanism  Bottom Up  Top Down  Hairline cracks only on top <1/3 depth  
 Layer of Crack Origin Top of Layer G If Applicable, Layer where cracking stopped Mid Layer F  
 Crack Depth (inches) 4.5 Crack Width (inches) 1/8 Distress Type (Table A.22) Longitudinal  
 Other Notes : Longitudinal Crack observed at this location originated on the Overlay AC Surface (layer G) extended till mid Overlay AC Binder (layer F)  
General deterioration and segregation of coarse aggregates noted for Original AC Base (layer D)

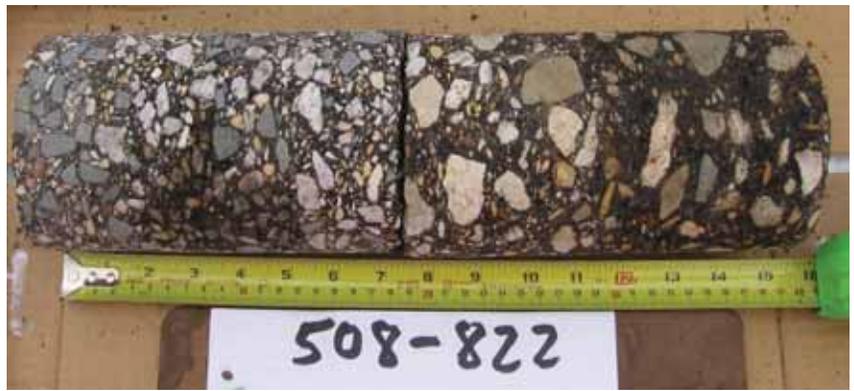
Digital Camera Filename: IMG\_5568  
 Location Stored: Forensic Study\_48A5\Camera2\155CANON

NA  
 Cracked Full Depth  Yes  No  
 Cracked through  Aggregate  Binder  Both  
 Crack Direction  Inclined  Perpendicular  No Pattern or multiple direction  
 Crack Mechanism  Bottom Up  Top Down  Hairline cracks only on top <1/3 depth  
 Layer of Crack Origin \_\_\_\_\_ If Applicable, Layer where cracking stopped \_\_\_\_\_  
 Crack Depth (inches) \_\_\_\_\_ Crack Width (inches) \_\_\_\_\_ Distress Type (Table A.22) \_\_\_\_\_  
 Other Notes : Compared to replicate core 508-821, there is no identification of cracks developing in any of the layers

General deterioration and segregation of coarse aggregates noted for Original AC Base (layer D)
