# FORENSIC INVESTIGATION REPORT ON THE LTPP TEXAS SPS-5 PROJECT

Submitted by Fugro Consultants, Inc.  
FHWA-LTPP SPS-5 PROJECT 48A500  
US 175 Eastbound, Kaufman County, Texas  
Date Prepared: July 2009

**FHWA LTPP SPS-5 PROJECT 48A500**  
*US 175 Eastbound Kaufman County, Texas*  
*Date Prepared: July 2009*

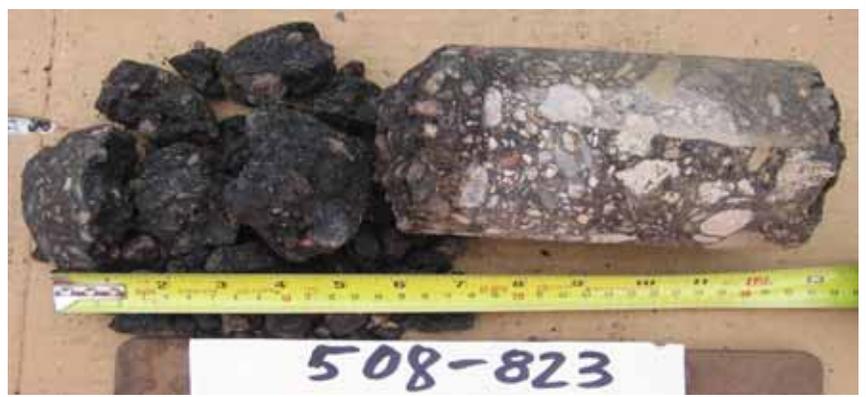
Digital Camera Filename: IMG\_5575  
 Location Stored: Forensic Study\_48A5\Camera2\155CANON

Cracked Full Depth  Yes  No  
 Cracked through  Aggregate  Binder  Both  
 Crack Direction  Inclined  Perpendicular  No Pattern or multiple direction  
 Crack Mechanism  Bottom Up  Top Down  Hairline cracks only on top <1/3 depth  
 Layer of Crack Origin Top of Layer G If Applicable, Layer where cracking stopped \_\_\_\_\_ Bottom of layer F  
 Crack Depth (inches) 5.0 Crack Width (inches) 1/8 Distress Type (Table A.22) Longitudinal  
 Other Notes : Longitudinal Crack observed at this location is assumed to be originated on the Overlay AC Surface (layer G) extended till bottom of Overlay AC Binder (layer F) since there is no cracks observed in the deteriorated Original AC Base (layer D)

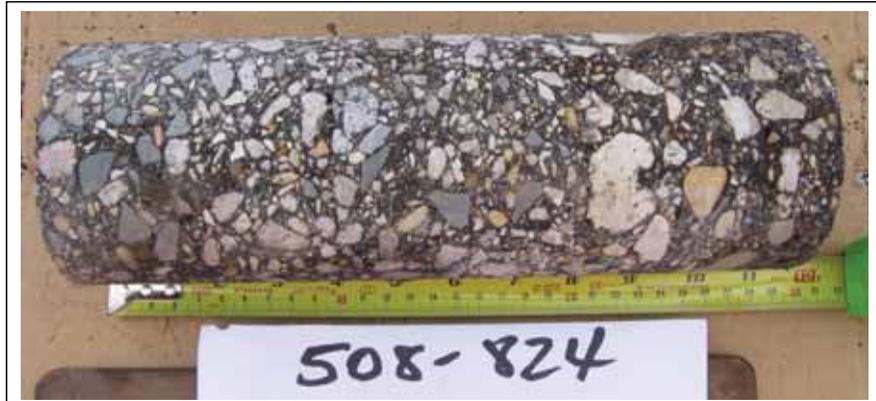
Digital Camera Filename: IMG\_5572  
 Location Stored: Forensic Study\_48A5\Camera2\155CANON

Cracked Full Depth  Yes  No  
 Cracked through  Aggregate  Binder  Both  
 Crack Direction  Inclined  Perpendicular  No Pattern or multiple direction  
 Crack Mechanism  Bottom Up  Top Down  Hairline cracks only on top <1/3 depth  
 Layer of Crack Origin Top of Layer G If Applicable, Layer where cracking stopped Layer G  
 Crack Depth (inches) 0.25 Crack Width (inches) 1/16 Distress Type (Table A.22) Longitudinal  
 Other Notes : Compared to replicate core 508-823, there is some indication of cracks developing on the top of Overlay AC Surface (Layer G  
General deterioration and segregation of coarse aggregates noted for Original AC Base (layer D

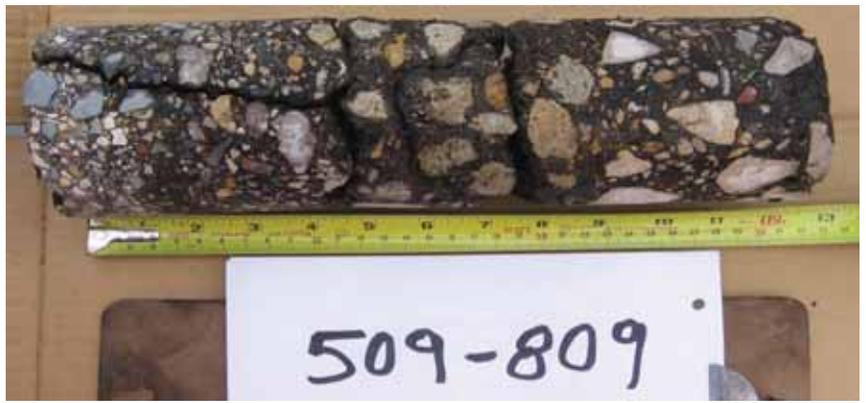
Digital Camera Filename: IMG\_5551  
 Location Stored: Forensic Study\_48A5\Camera2\155CANON

Cracked Full Depth  Yes  No  
 Cracked through  Aggregate  Binder  Both  
 Crack Direction  Inclined  Perpendicular  No Pattern or multiple direction  
 Crack Mechanism  Bottom Up  Top Down  Hairline cracks only on top <1/3 depth  
 Layer of Crack Origin Layer F bottom If Applicable, Layer where cracking stopped Layer G top  
 Crack Depth (inches) 4" Crack Width (inches) 2/8 Distress Type (Table A.22) Longitudinal  
 Other Notes : Longitudinal crack seemed to be developed from top and continued till bottom of the Overlay AC Binder (Layer F)  
Segregation of the aggregates at the Original AC Base (Layer D) has caused the core to crumble at the point where there is dense coarse aggregate

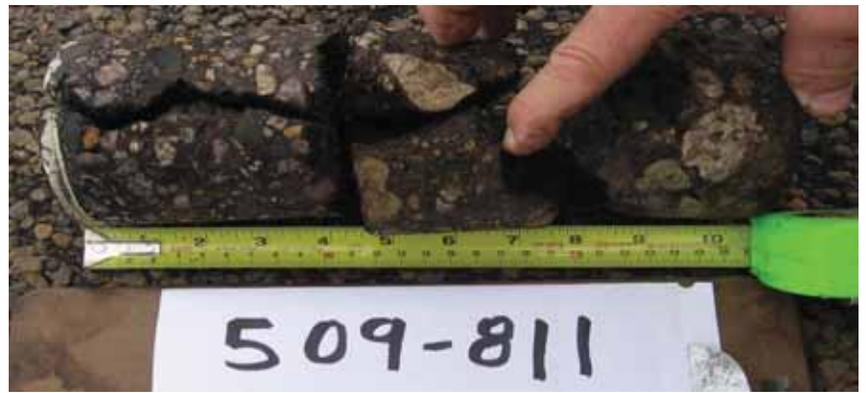
Digital Camera Filename: IMG\_5554  
 Location Stored: Forensic Study\_48A5\Camera2\155CANON

Cracked Full Depth  Yes  No  
 Cracked through  Aggregate  Binder  Both  
 Crack Direction  Inclined  Perpendicular  No Pattern or multiple direction  
 Crack Mechanism  Bottom Up  Top Down  Hairline cracks only on top <1/3 depth  
 Layer of Crack Origin Mid of Layer D If Applicable, Layer where cracking stopped Top of Layer G  
 Crack Depth (inches) 9.0 Crack Width (inches) 1/2 Distress Type (Table A.22) Longitudinal  
 Other Notes : Segregation noted in the deteriorated Original AC Base (layer D)

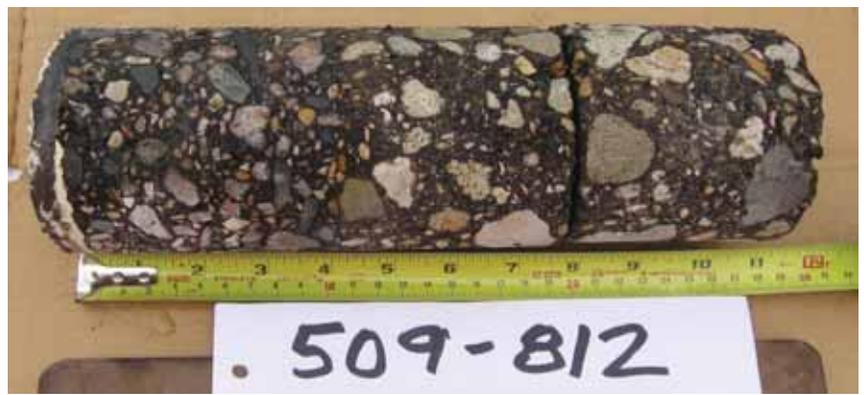
Digital Camera Filename: IMG\_5555  
 Location Stored: Forensic Study\_48A5\Camera2\155CANON

Cracked Full Depth  Yes  No  
 Cracked through  Aggregate  Binder  Both  
 Crack Direction  Inclined  Perpendicular  No Pattern or multiple direction  
 Crack Mechanism  Bottom Up  Top Down  Hairline cracks only on top <1/3 depth  
 Layer of Crack Origin Bottom of Layer F If Applicable, Layer where cracking stopped Top of Layer G  
 Crack Depth (inches) 4.3 Crack Width (inches) 1/8 Distress Type (Table A.22) Longitudinal  
 Other Notes : General deterioration and segregation noted in the Original AC Base (layer D) and crack development noted in bottom of layer F to top of layer G that correlates with the replicate core 509-811 where there is severe crack originated from Original AC Base (Layer D)

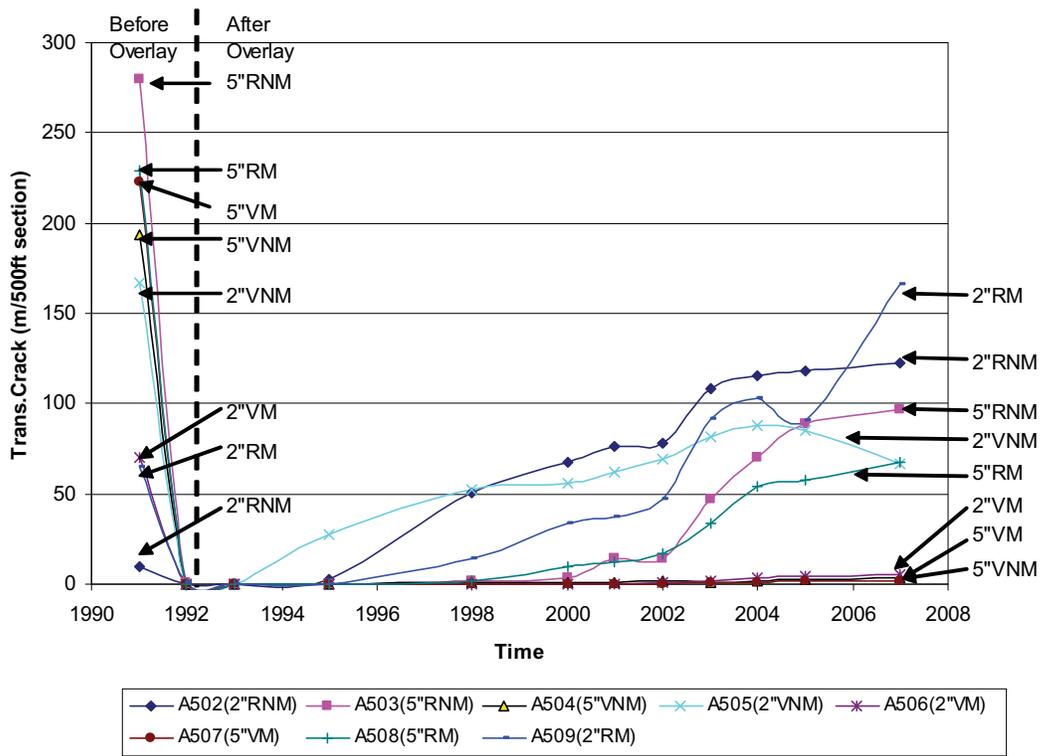
Fig. 5 shows comparisons of the transverse cracks among the 8 sections after 16 years of service. Only the '2007' (after 16 years of service) data are available at the time of this study and thus they were used in the analyses. The ranking of the sections, with most to least transverse cracks, are 2RM, 2RNM, 5RNM, 2VNM, 5RM, 2VM, 5VM, and 5VNM.

Fig. 5 Comparisons of the Transverse Cracks Among Different Treatments

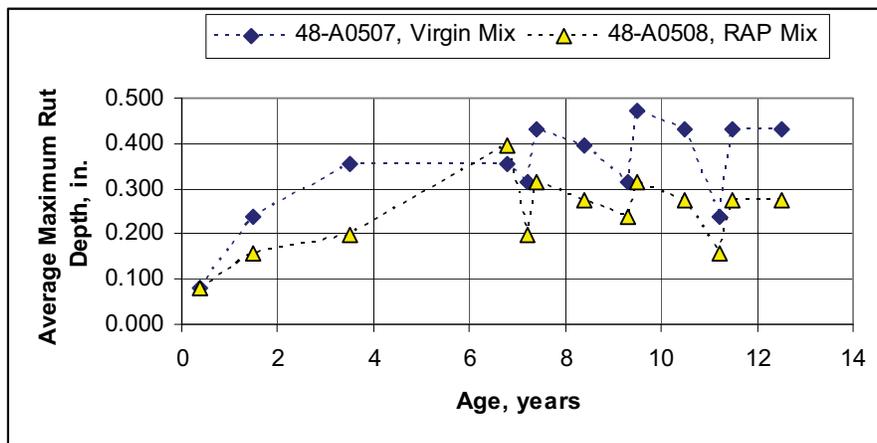
Figure TX-1 shows the measured rut depths as a function of time for the two sections that were trenched, while figure TX-2 shows the measured rut depths as a function of time for all test sections within the SPS-5 project. As shown, mixture type (RAP versus virgin mixes) has a definite effect on the magnitude of the measured rut depths. Another important observation from this time-series data is the amount of variability in the measured rut depths for an individual test section.

**Figure TX-1. Average Maximum Rut Depths Measured with Time for Sections 48-A0507 and A0508**

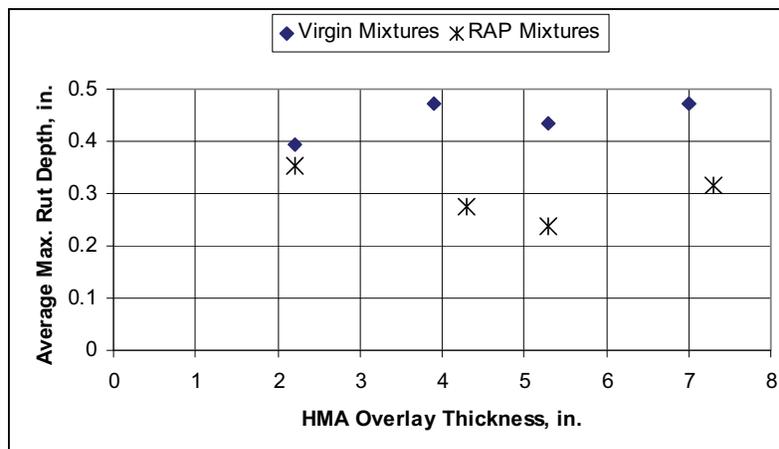
Figure TX-3 shows the effect of HMA overlay thickness and mixture type on the maximum rut depth measured along each of the SPS-5 test sections. As shown, the test sections with the RAP mixtures have rut depths consistently less than those measured along the sections with the virgin mixtures. HMA overlay thickness has no impact or systematic effect on the rut depths for this SPS-5 project. As noted above, the asphalt viscosities and penetration values recorded in the LTPP database for the virgin mixture suggest that this mixture is brittle and hard or stiff. The rut depths should be as low, if not lower than the RAP mixture, which is not the case. Thus, the Texas SPS-5 project was selected for the detailed forensic investigation.

**Figure TX-3. Effect of HMA Overlay Thickness and Mixture Type on Maximum Rut Depth**

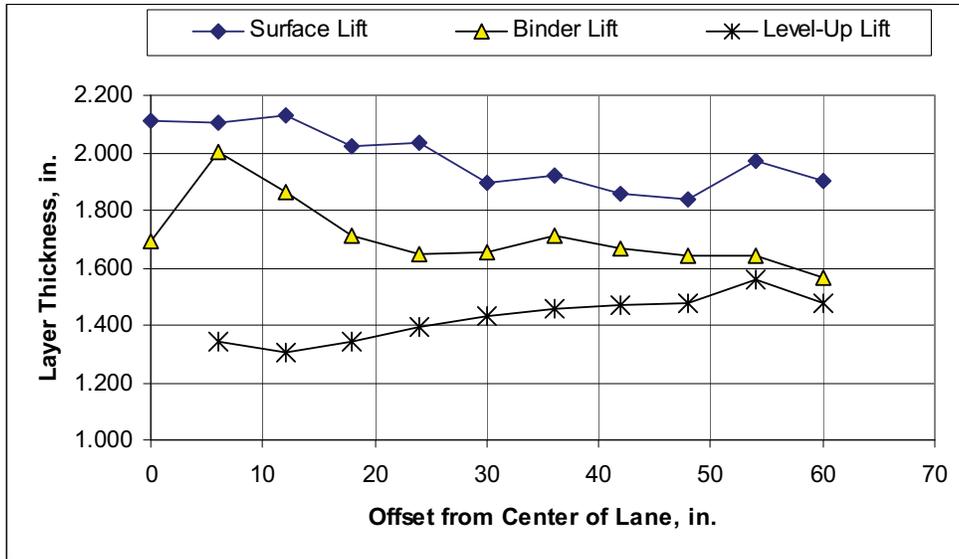
**Figure TX-13. Layer or Lift Thickness Measurements Taken Along the Cut Face of the Trench Excavated for Section 48-A0508 with the RAP Mixture**

In summary, most of the rutting has occurred within the HMA overlay wearing surface. It is difficult to determine the actual magnitude of rutting within each of the HMA overlay lifts for these two sections. Three lifts were placed for the overlay; the wearing surface, the binder layer and a leveling course. Table TX-1 excludes the leveling course that was placed prior to overlay.
