FHWA/LTPP Monitoring Program

**Forensic Study - Specific Pavement Study
(SPS) Sections 360801 and 360802, Lake
Ontario State Parkway, Hamlin, NY**

Report No. FHWA-TS-09-36-01

November 2009

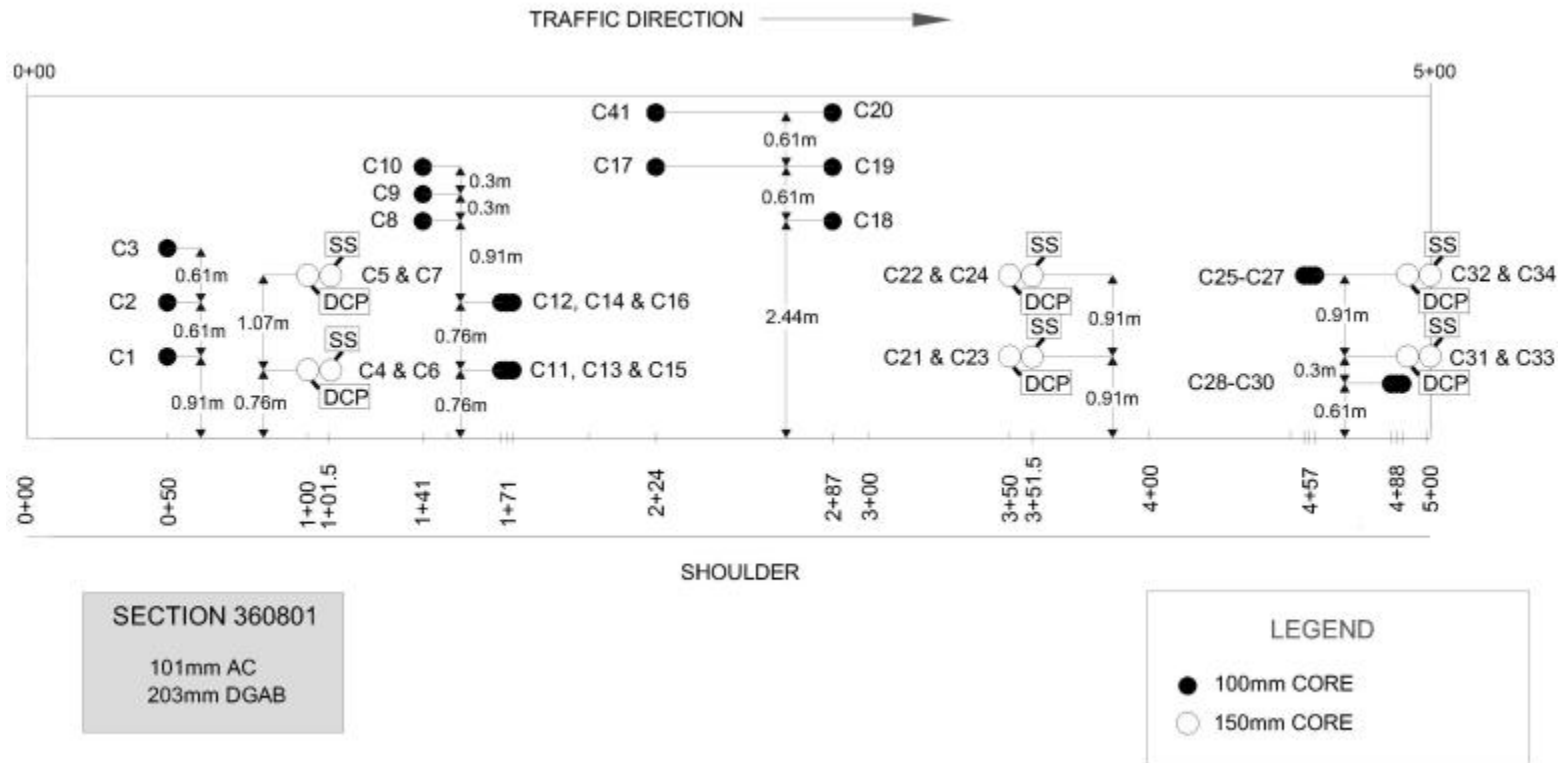
Figure 2: Layout of Sampling and Test Locations (May 21, 2008)

Figure 2 shows the layout of sampling and test locations for the thirty-six 100mm cores that would be used to examine the asphalt layers and associated cracking, as well as the twelve 150mm cores that would be retrieved for laboratory samples, and to provide access for DCP and split-spoon testing. Figure 3 shows the layout of the sampling and testing locations for the eight 150mm replacement cores that were collected on October 7, 2008.

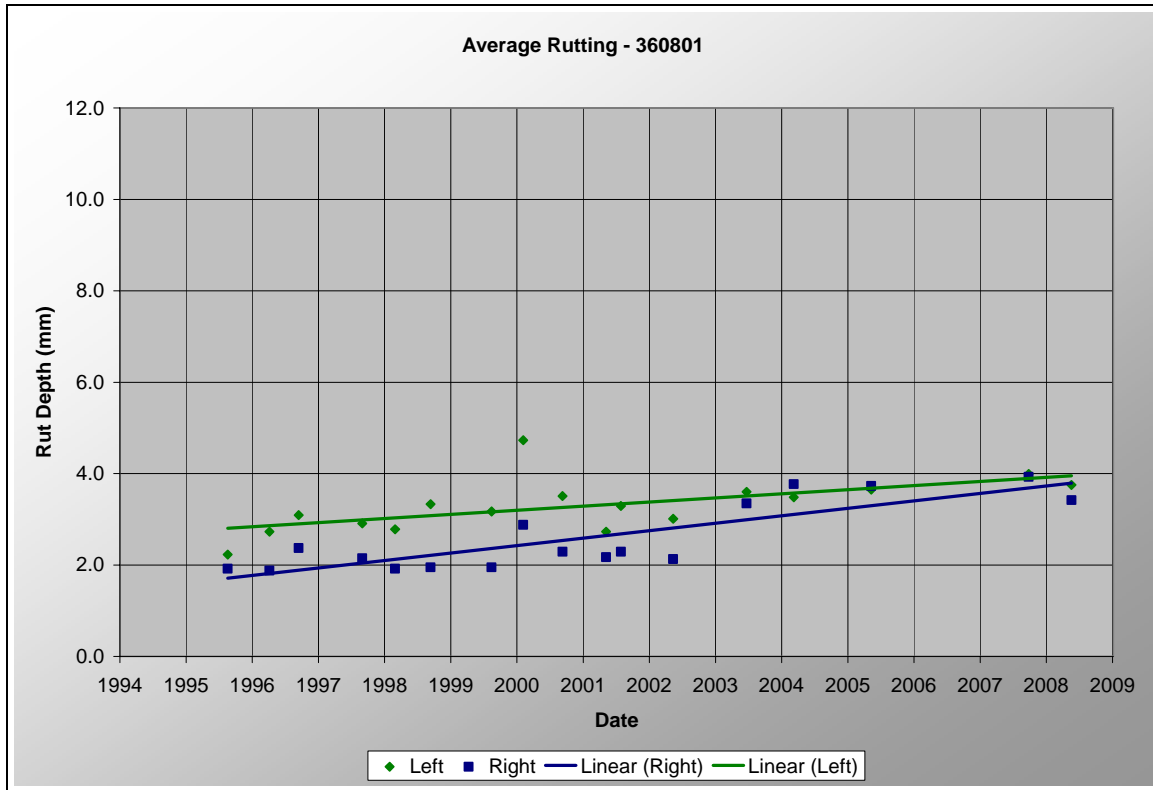
Figure 5: Graphical Presentation of Rut Depth

The historical trends in rut depth from the Dipstick® transverse profiles are provided in Table 20. The average results are also provided in graphical format in Figure 5. These results indicate a very slight progression in rut depth over time with the left rut in most cases being slightly deeper than the right. The average rut depth for the survey on May 20, 2008 was 3.4mm in the right wheelpath and 3.8mm in the left wheelpath. Typically the rut formations in the right wheelpath are deeper than the left as there is less lateral support, but the differences are so small in this instance that they could be considered the same. The rut depth has increased from the first survey in 1995 but not to any great extent. The variations in rut depths from the surveys could be attributed to seasonal changes. It is odd that the deepest rut depth appeared during the survey in February 2000.

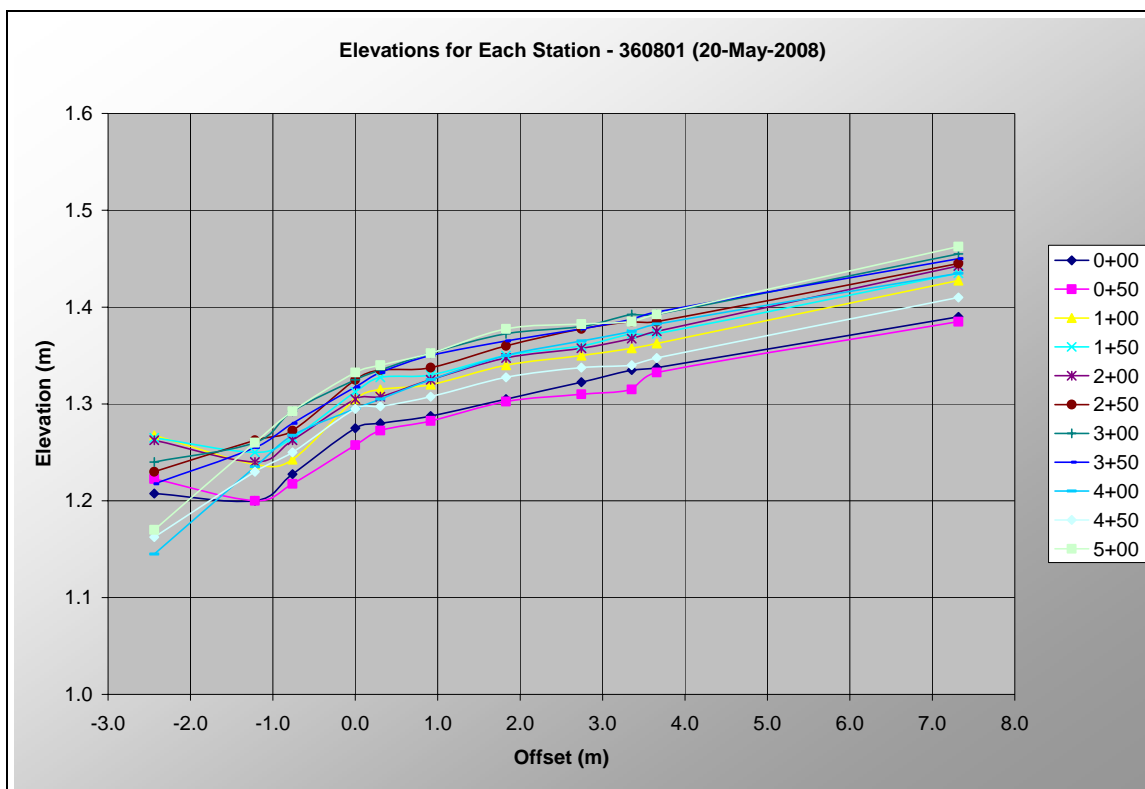
Figure 6: Results of Elevation Survey

The results of the elevation survey are provided in Figure 6. The results show a slight deviation in elevation at the wheelpath location with a 1.7% slope for the pavement (both lanes) and a 3.6% slope from edge to just off the paved shoulder. These results would indicate sufficient slope for water runoff from the pavement surface but a slightly greater

slope for the right lane could accelerate the runoff. Between the shoulder edge and just off the shoulder there is an increase in elevation for a portion of the section which could impede the runoff of the moisture from the pavement. These results are consistent with those observed during the site review and as evident in the photo provided in Figure E-11 and E-12, Appendix E.

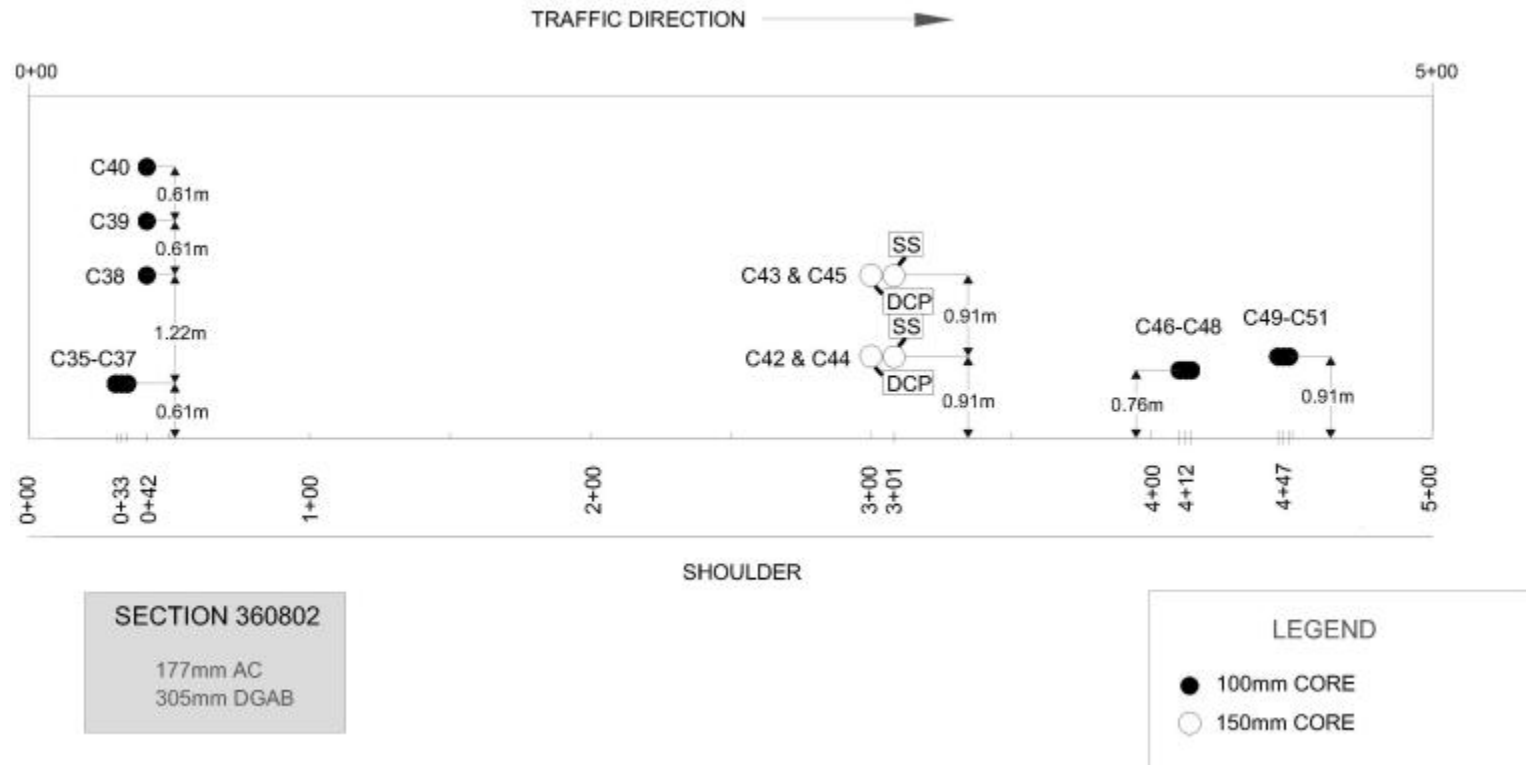
Figure 7: Layout of Sampling and Test Locations (May 21, 2008)

Figure 7 shows the layout of sampling and testing locations for the twelve 100mm cores that would be used to examine the asphalt layers and associated cracking, and the four 150mm cores that would be retrieved for laboratory samples, and to provide access for DCP and split-spoon testing. Figure 8 shows the layout of the sampling and test locations for the eight 150mm replacement cores that were collected on October 7, 2008.

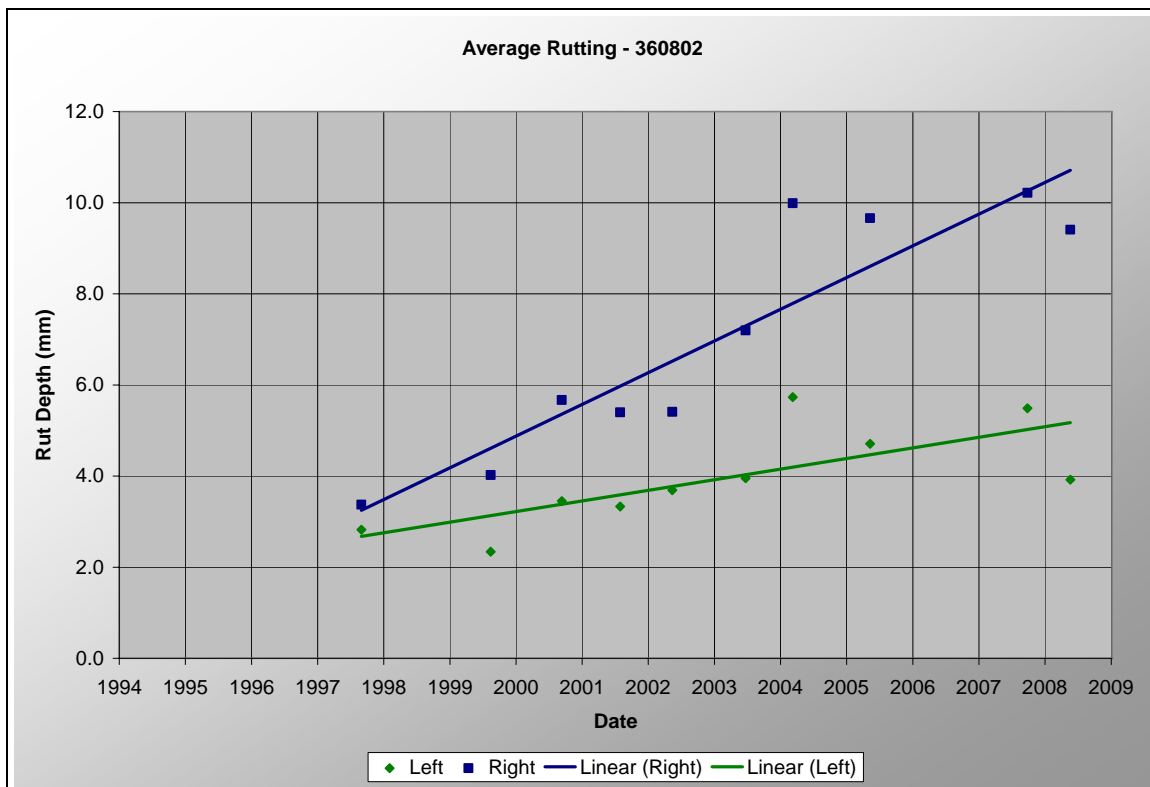
Figure 10: Graphical Presentation of Rut Depth

The historical trends in rut depth from the Dipstick® transverse profiles are provided in Table 39. The average results are also provided in graphical format in Figure 10. These

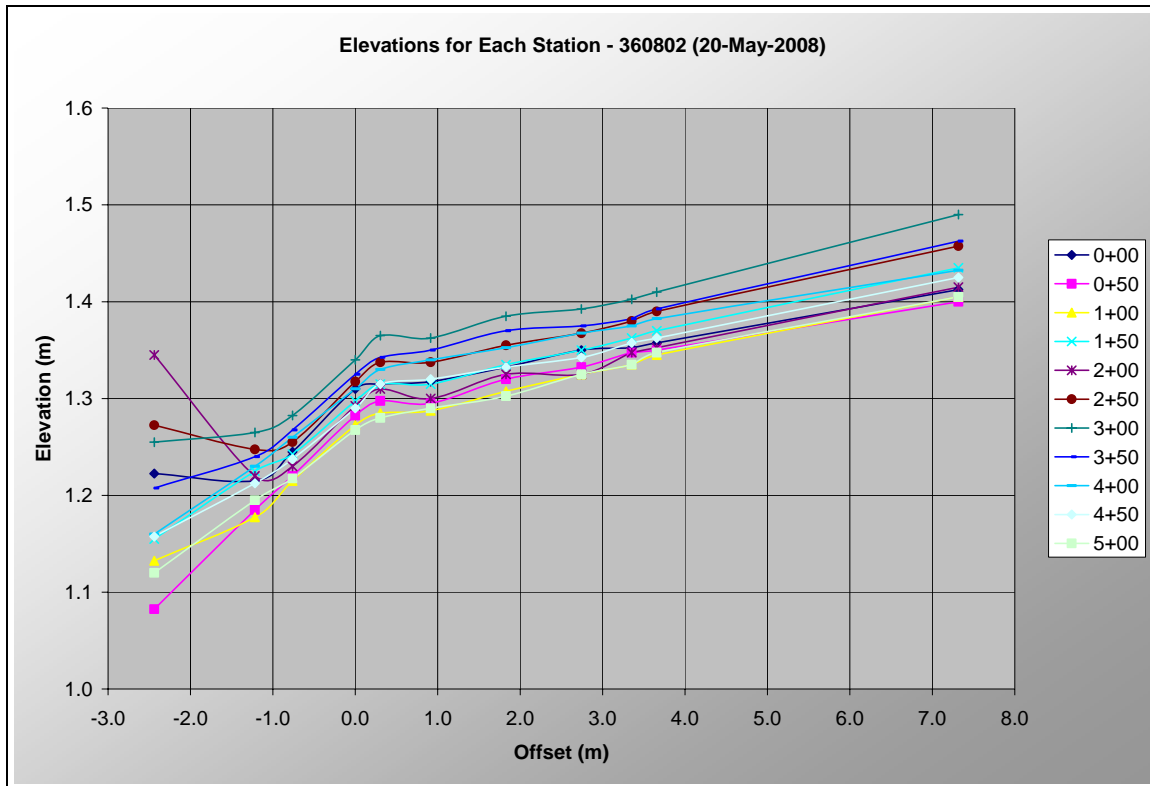
Figure 11: Results of Elevation Survey

The results of the elevation survey are provided in Figure 11. The results show a slight deviation in elevation at the wheelpath location with a 1.8% slope for the pavement (both lanes) and a 4.5% slope from edge to just off the paved shoulder. These results would indicate sufficient slope for water runoff from the pavement surface. Between the shoulder edge and just off the shoulder there is an increase in elevation for a portion of the section which could impede the runoff of the moisture from the pavement. These results would indicate sufficient slope for water runoff from the pavement surface but improvements could be considered for the abutting turf embankment area. These results are consistent with those observed during the site review.

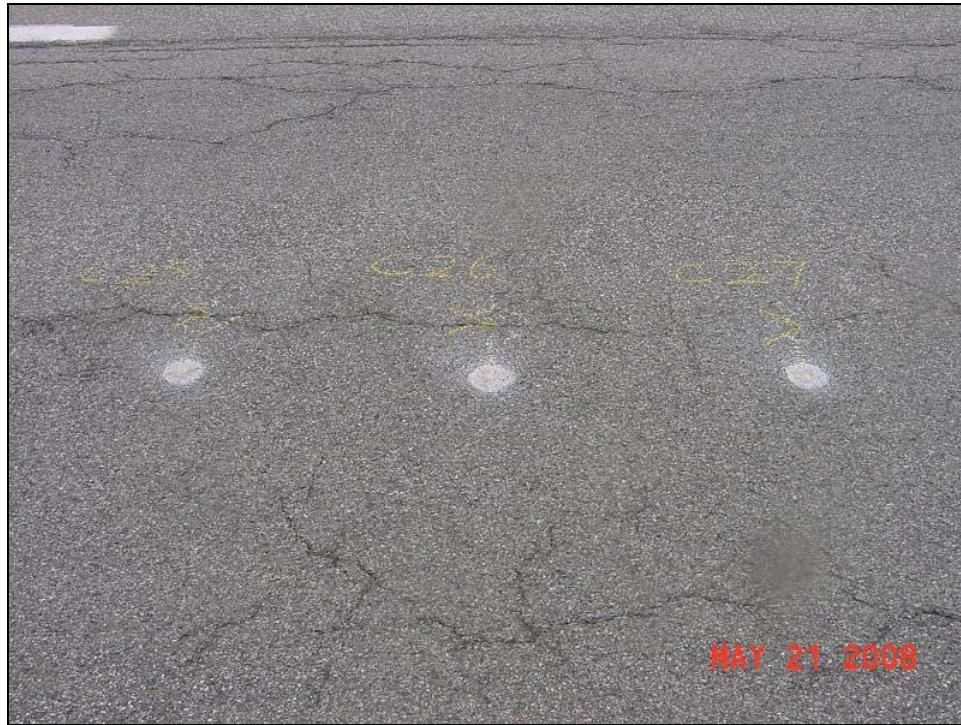
Figure F-1: Core Location Marking at a Midlane Longitudinal Crack (360801)

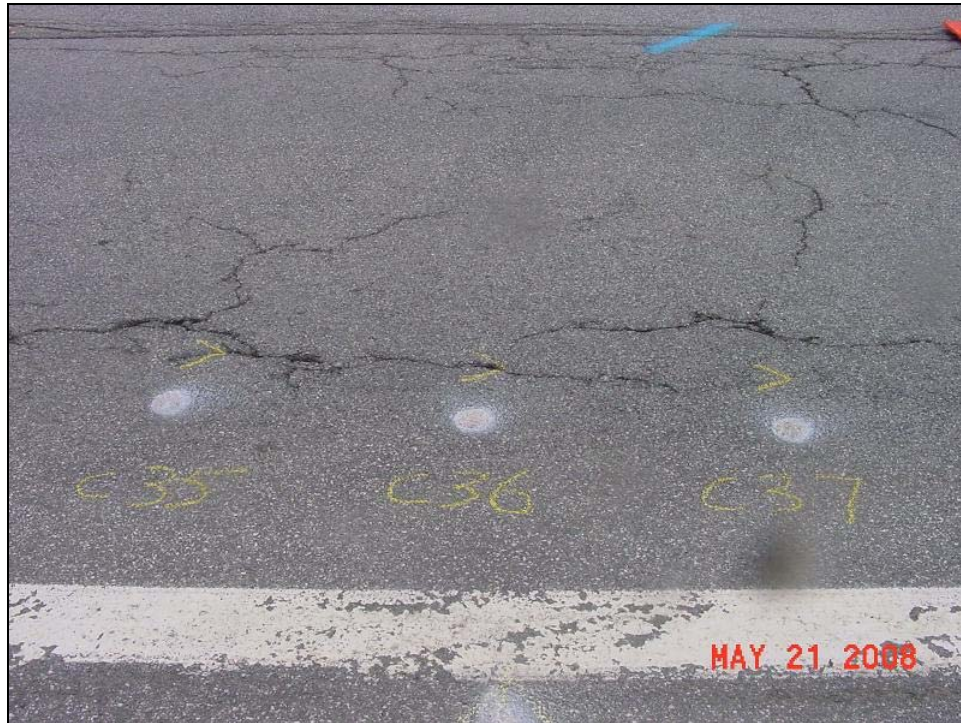
The core sampling, handling, measurement and marking followed the same procedure as for section 360801. The photo in Figure F-9, Appendix F shows the marks to locate the cores at the location of fatigue cracking in the outer wheelpath. A photo of the cores, taken in this location is provided in Figure F-10, Appendix F showing the top-down cracking and variable depth and condition of the cores. The crack depths ranged from 2.5 mm to 66mm within the surface and binder layer with no visible distress in the AC base layer. The cores taken at a partial transverse crack branching from the centerline longitudinal crack had top-down cracking through the surface and binder layer which diminished to the surface layer at the edge of the crack as evident in the photo in Figure F-11, Appendix F. Two sets of cores were taken at the longitudinal crack in the area of the outer wheel path. The low severity longitudinal crack penetrated the surface with the moderate severity crack in both the surface and binder layers with some stripping as evident in Figure F-12, Appendix F. All cracks were top-down as evident in the photos mentioned above. There was no lack of bond issues between layers or stripping at the bottom of the cores. The detailed measurements and core examination results for the 100mm cores are provided in Table 24. The stationing and sample number for each core is provided to cross reference with the location as provided in the core layout diagram in Figures 7 and 8.

Figure F-9: Marks Identifying Location for Cores in Outer Wheel Path (360802)
