LTPP Seasonal Monitoring Program

Site Monitoring Suspension Status Draft Final Report for GPS Section 204054 (20A) Enterprise, Kansas

September 1996

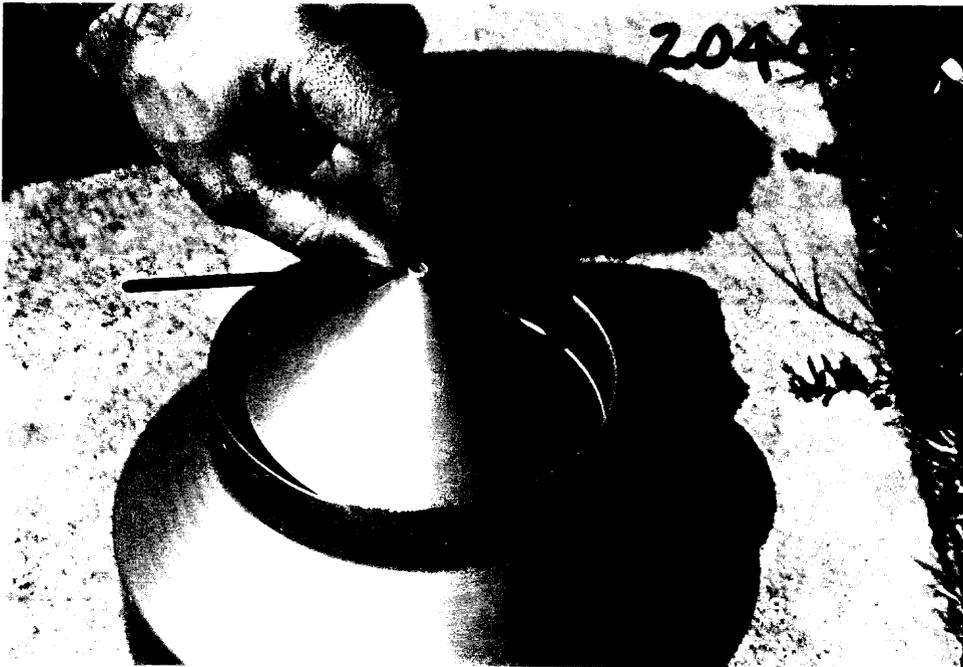
Photograph #1

As shown in photograph number 1 in appendix E, the collector unit (funnel) of the rain guage was detached from the weather station system probably by strong winds. Note the clips expected to hold the collector unit in place in the photograph are intact. The collector unit was found in the ditch along the eastbound lane, approximately 50 to 70 meters from its original location. Photographs 2 through 5 in appendix E show the damage to the collector unit. Note in photograph number 5 that the sieve in the collector unit is missing. Discussions with the local Kansas DOT staff in Abeline indicate that there were strong winds from July 23 through August 5, 1995, which most likely caused the collector unit to be detached from the weather station system. It is therefore recommended that the rainfall data from July 23 through August 5, 1996 not be entered into the IMS database.
