U.S. Department
of Transportation
**Federal Highway
Administration**

**LTPP Seasonal Monitoring
Program**
Site Monitoring Suspension
Status Report
Section 501002
New Haven, Vermont

SEASONAL MONITORING PROGRAM SUSPENSION STATUS REPORT VERMONT SECTION 501002

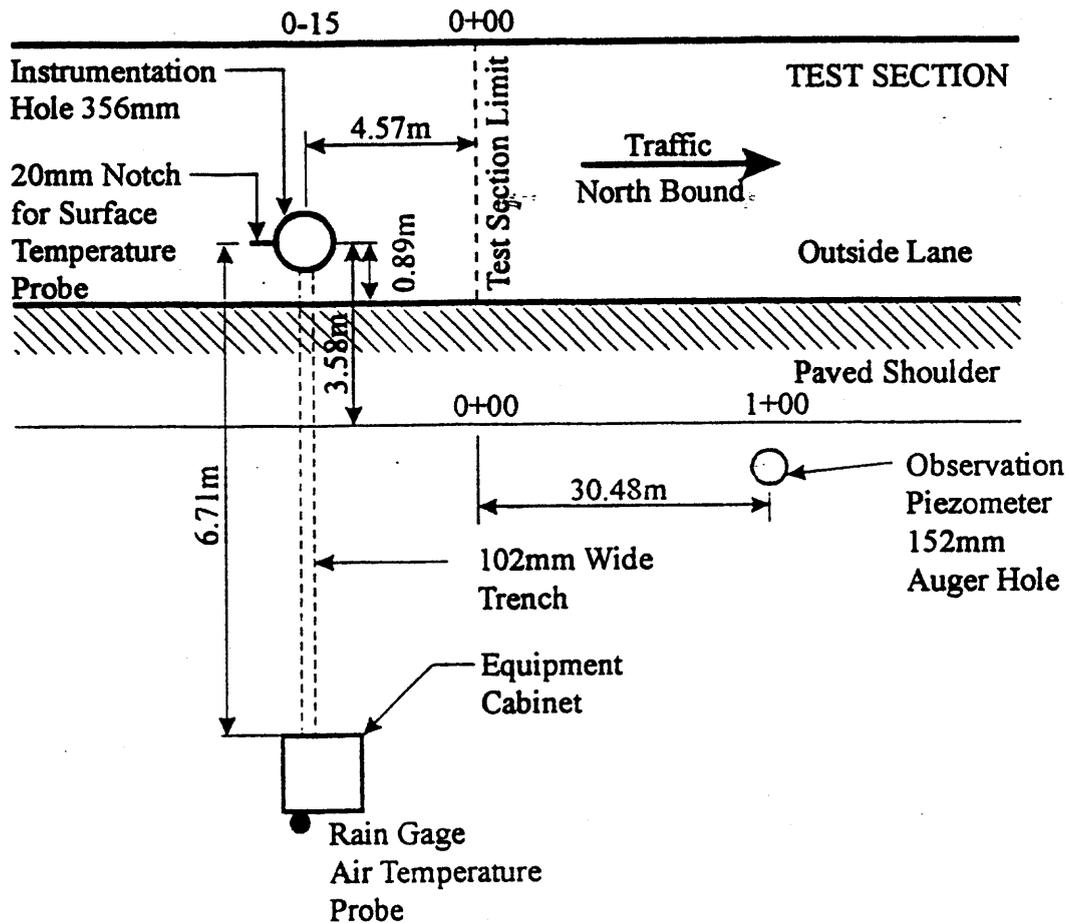
Figure 1. Location for Seasonal Monitoring Instrumentation Installed at GPS 501002

Figure 1 shows the locations of the installed instrumentation at the site. The instrumentation hole is at Station 0-15 and the piezometer is at Station 1+00. Table 2 gives the elevations of the portion of test section 501002 that was used for elevation measurements. All offsets are from the PK nails found at the outside pavement edge.
