LTPP Pavement Maintenance Materials: SHRP Joint Reseal

Experiment, Final-Report

PUBLICATION NO. PHWA RD 99-142

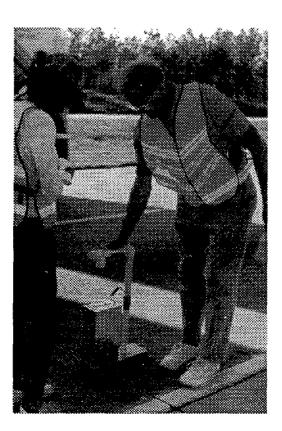
Figure 9. Fault measurement.

The initial faulting condition at each pavement joint of each test site was determined using a digital readout fault-measuring device developed at the Georgia Department of Transportation (DOT). Two readings were recorded at each joint at 305 to 508 mm from the inside shoulder edge. Figure 9 shows the fault measurement device in use. Deeply tined or milled pavement caused minor problems with the precision of the fault measurements; however, the readings indicated that no significant faulting was present.

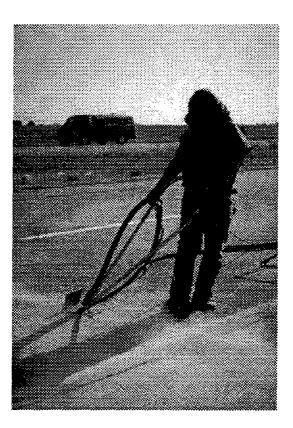
Figure 13. Sandblasting operation.

A more elaborate method of sandblasting was used at the Iowa site. A stainless steel plate was attached to a handle. The hose and nozzle were fixed to the plate and handle at the desired angle and position, and the guide was pulled through each joint held in position by a centering pin in the steel plate. Two sandblast units were used for this operation, one for each joint face. This sandblast apparatus is shown in figure 13.

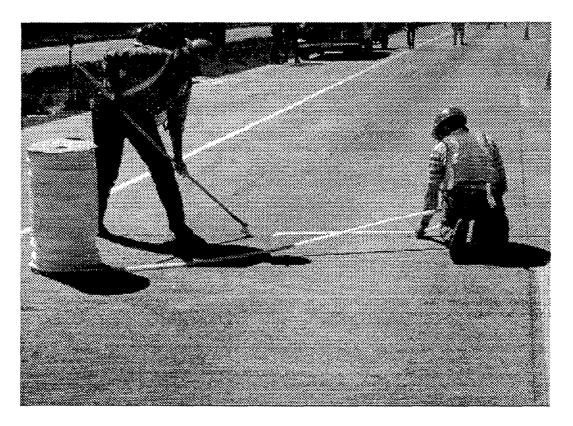
Figure 15. Backer rod installation.

Airblasting, shown in figure 14, was accomplished using an air compressor with the cleanest, driest airstream available. After the sandblasting operation had progressed at least 10 joints ahead, the sand and dust in the joints were removed by airblasting the reservoir. Sand and dust from the sawing and the sandblasting operations were also blown from the pavement surface to the adjacent shoulder or gutter. When the airblasting operation had progressed at least five joints ahead, a crew of two or three persons installed backer rod in the joints to be sealed. An adjustable backer rod placement roller was used to recess the rod to the required depths. Typically, backer rod was cut slightly longer than the length of the joint, and one end of the rod was placed in the joint at the lane edge nearest the shoulder. Then, the person unrolling the backer rod would move to the opposite end of the joint and slightly stretch the backer rod as it was recessed, thus easing the rolling procedure. This is shown in figure 15. When the rolling was nearly complete, the backer rod was cut to the exact length required for providing a tight seal, and the entire length was rolled a second time.

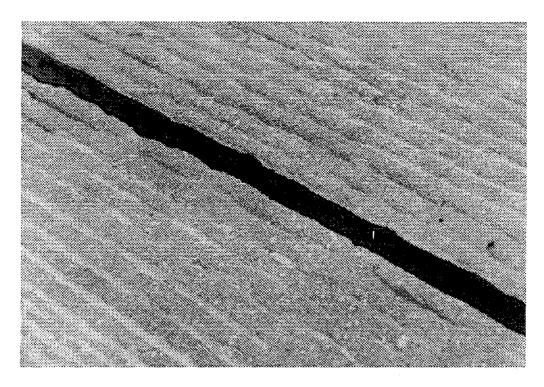
Figure 17. Installed flush-filled sealant.

Hot-applied, rubberized asphalt sealants were installed using configuration 1 according to manufacturers' recommendations, filling from the bottom up and keeping the sealant surface 3.2 to 6.4 mm below the pavement surface. Application in South Carolina is shown in figure 16. Using the configuration 4 method, the sealant was placed from the bottom up to just even with the pavement surface. Flush-filled, hot-applied sealant is shown in figure 17. The average sealant thickness was 13 mm.

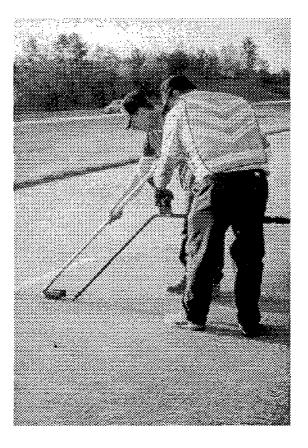
Figure 18. Overbanded sealant installation.

Hot-applied sealants were installed using the overbanded configurations according to manufacturers' recommendations, filling from the bottom up and slightly overfilling the joints. The average sealant thickness was 13 mm for configuration 2 and 9.5 mm for configuration 3. A squeegee followed the applicator wand at a distance of 152 to 610 mm, striking off the surface and leaving an overband about 2 mm thick and 34 mm wide, with a total wipe zone width of about 89 mm. The overband installation process is shown in figure 18, and a recently installed overband is shown in figure 19. Traffic was kept off the sealant until it had sufficiently cooled.

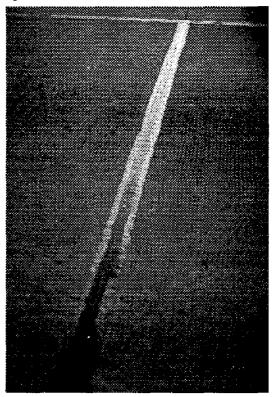
Figure 19. Installed overbanded sealant.

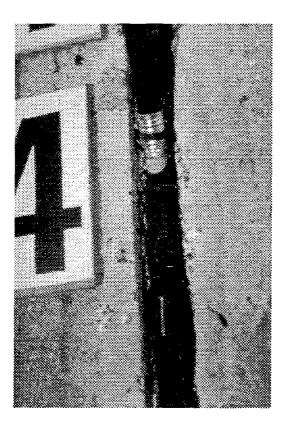
Figure 24. Partial-depth adhesion loss.
