SHRP-P-642

Distress Interpretation from 35mm Film for the LTPP Experiments

PCS/Law Engineering

Strategic Highway Research Program
National Research Council
Washington, DC 1993

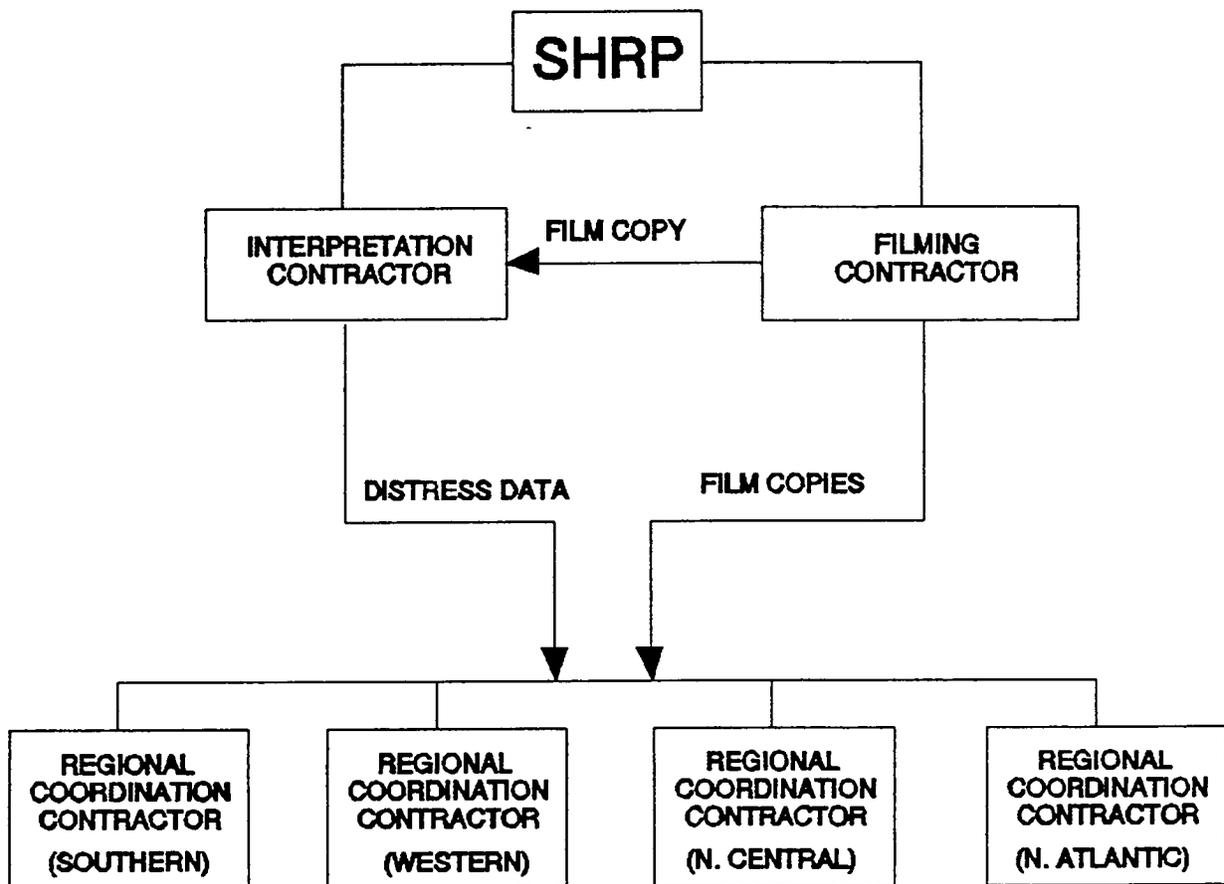
Figure 1. Organization Chart for Distress Data

The organization chart shown in Figure 1 provides a general outline of the distress monitoring program. The filming contractor is directed by SHRP to film certain sections during the contract period, process the film and forward one copy to the interpretation (PADIAS) contractor and state copies to the appropriate Regional Coordination Office Contractors (RCOC's). A flow diagram of the distress interpretation procedure is illustrated in Figure 2. After receipt of the film, the PADIAS operator performs a quality review of each film roll to establish whether or not the images are satisfactory. The operator records the results of the review in designated film logs. Any irregularities in the pavement test sections noted during the review of the film are brought to the attention of the responsible personnel for resolution. A copy of the film logs is then forwarded to SHRP.

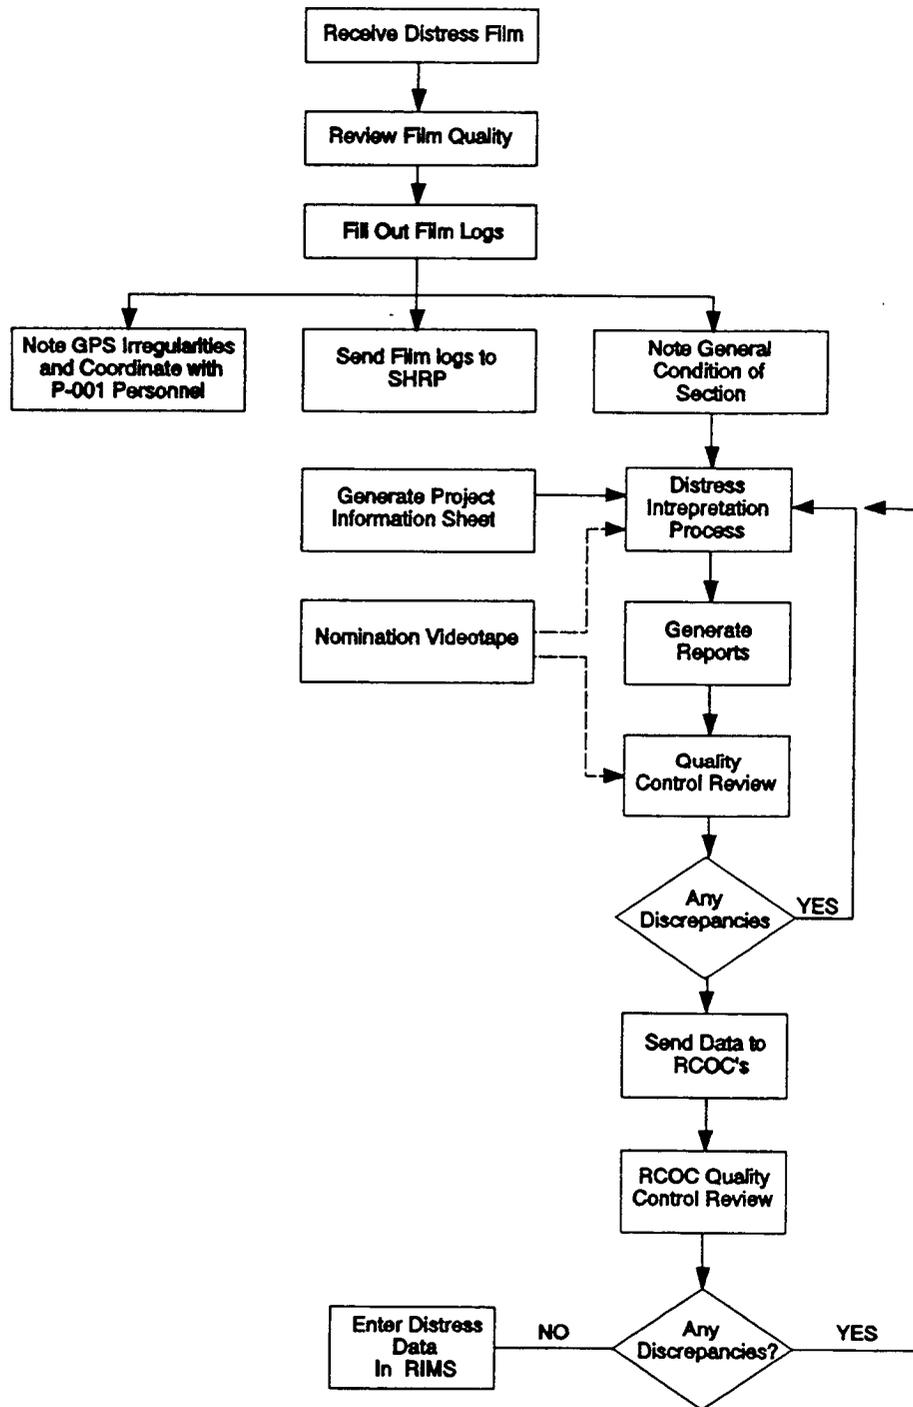
Figure 2. Distress Interpretation Process

handling. This results in interpretations being completed on a state by state (province by province) basis, as one state (province) is typically contained on a single roll of film. Data from the LTPP nomination database are reviewed to provide pertinent information on pavement type, lane width, underlying layers, etc. LTPP section site verification videos are also reviewed, as needed, to enhance the interpretation process. Upon completion of the interpretation process, the operator generates reports summarizing type, amount, and severity level of the distresses found in the section. This process is repeated for each section included on a state (province) film roll.

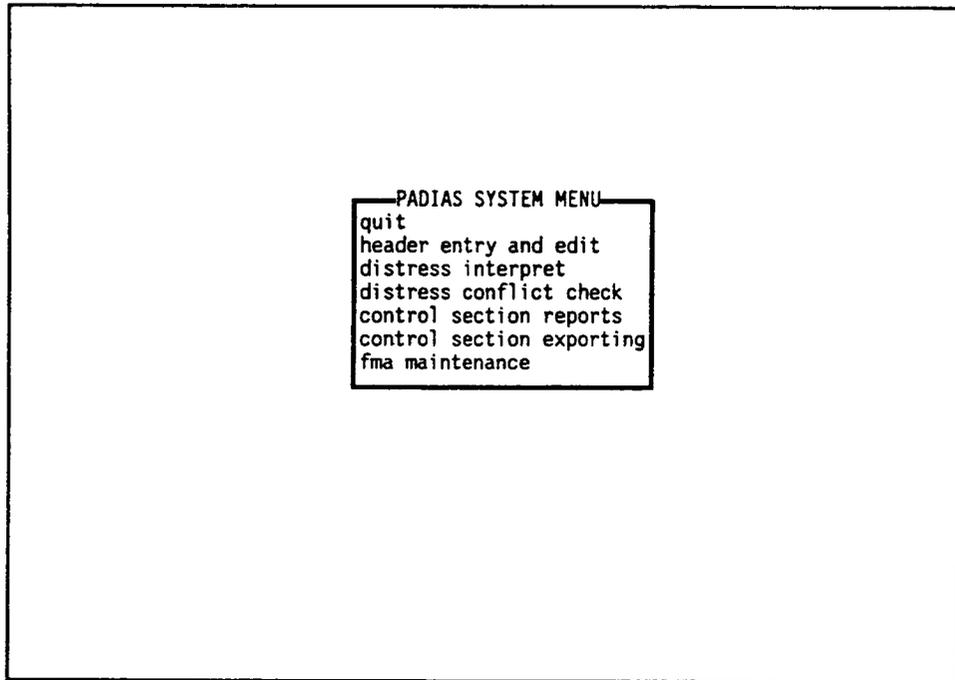
Figure 4. PADIAS Main Menu

The main menu screen for PADIAS is illustrated in Figure 4. The Header Entry and Edit field of the PADIAS program is accessed from the main menu and is illustrated in Figure 5. When this step is undertaken, the operator should have the following documents and information available to correctly complete the header information field of the PADIAS program.

After the header file has been completed, the DISTRESS INTERPRET function is selected from the main menu (Figure 4). Before the actual interpretation can begin, the road width and frame alignment must be defined on the FMA screen using the cursor. After the frame is aligned, the starting point is defined using the "START PT" command in the "frame control menu" accessed via the bar menu in the bottom window of the interpretation screen, shown in Figure 11. This starting point corresponds to the starting mark of the LTPP section.

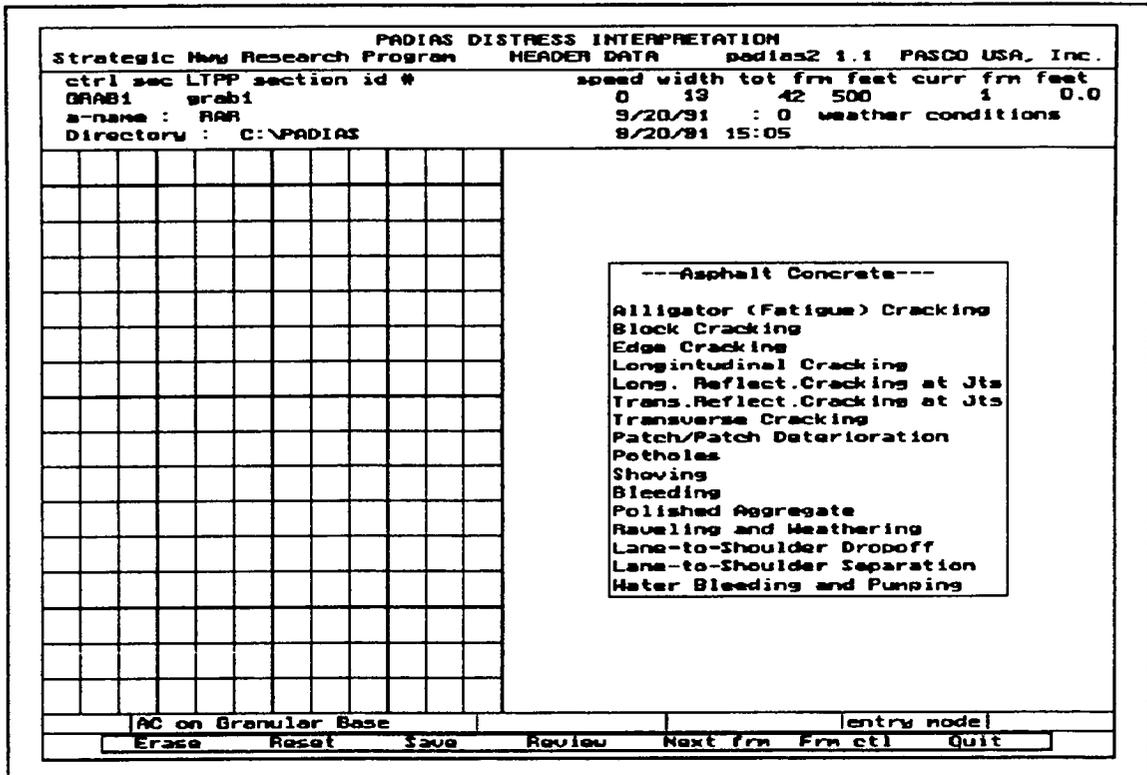
Figure 11. PADIAS Interpretation Screen Configuration

the distress occurs. The distress is represented in the grid area on the monitor by blackened grid cells.

The program formats the monitor into the five following areas (Figure 11):

The distress data consists of three basic parts: (1) the distress type; (2) the severity level; and (3) the area location. The distress type identifies the distress based on the pavement type and film interpretation. The distress menu for each pavement type appears in the work area when the cursor (in the entry mode) is moved to the right side of the screen. The severity level is established by a message window in the work area after the distress is identified. The "Low," "Moderate," "High," and "Unknown" levels are offered with check boxes and one must be selected. If no severity level is necessary, the program recognizes this situation and prompts for a cursor button "press" to continue. Following the severity level selection, the operator will record the grid cell location of the distress by positioning the cursor over the FMA screen where
