# LTPP Pavement Maintenance Materials: SHRP Joint Reseal Experiment, Final Report

PUBLICATION NO. FHWA-RD-99-142

This report provides information to pavement engineers and maintenance personnel on the results of the H-106 joint reseal experiment. It presents the performance and cost-effectiveness of various joint sealant materials and procedures for sealing joints on portland cement concrete pavements.

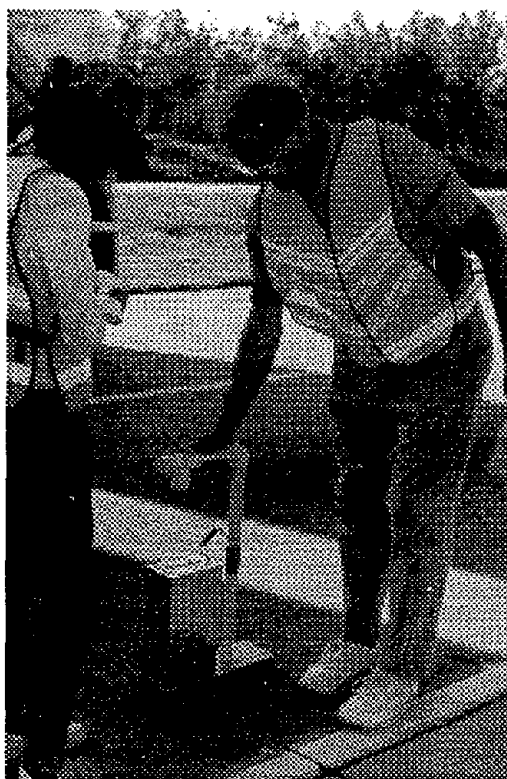
Figure 9. Fault measurement.

The initial faulting condition at each pavement joint of each test site was determined using a digital readout fault-measuring device developed at the Georgia Department of Transportation (DOT). Two readings were recorded at each joint at 305 to 508 mm from the inside shoulder edge. Figure 9 shows the fault measurement device in use. Deeply tined or milled pavement caused minor problems with the precision of the fault measurements; however, the readings indicated that no significant faulting was present.

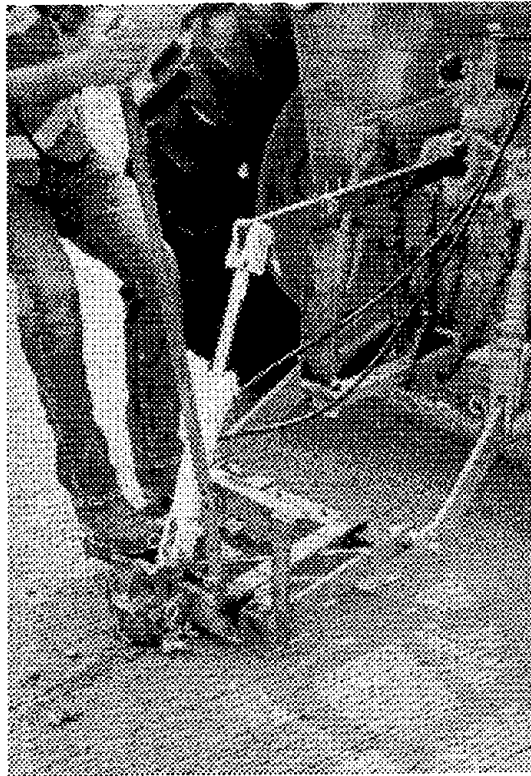
Figure 10. Joint plowing operation.

Joints for configuration 3 were plowed in South Carolina, Iowa, and Kentucky. An 8-year-old silicone joint seal in excellent condition was removed in South Carolina, a 6-year-old failed silicone sealant was removed in Iowa, and a failed asphalt-based sealant of unknown age was removed in Kentucky. The plowing operation in Iowa is shown in figure 11.

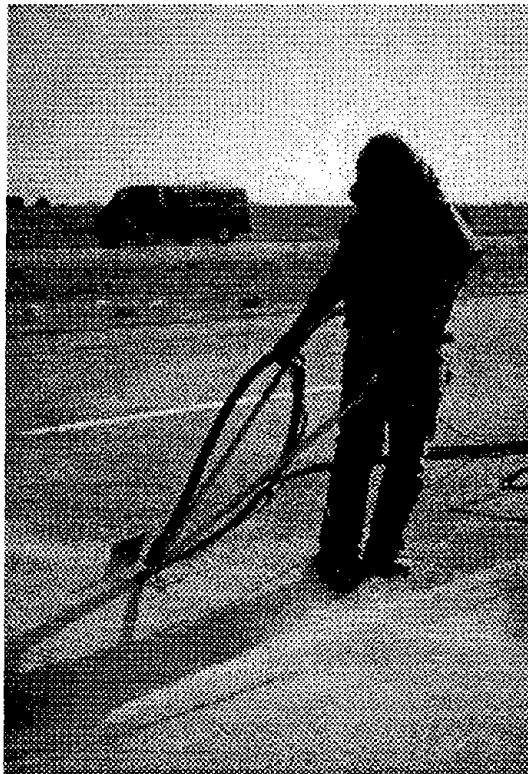
Figure 13. Sandblasting operation.

A more elaborate method of sandblasting was used at the Iowa site. A stainless steel plate was attached to a handle. The hose and nozzle were fixed to the plate and handle at the desired angle and position, and the guide was pulled through each joint held in position by a centering pin in the steel plate. Two sandblast units were used for this operation, one for each joint face. This sandblast apparatus is shown in figure 13.

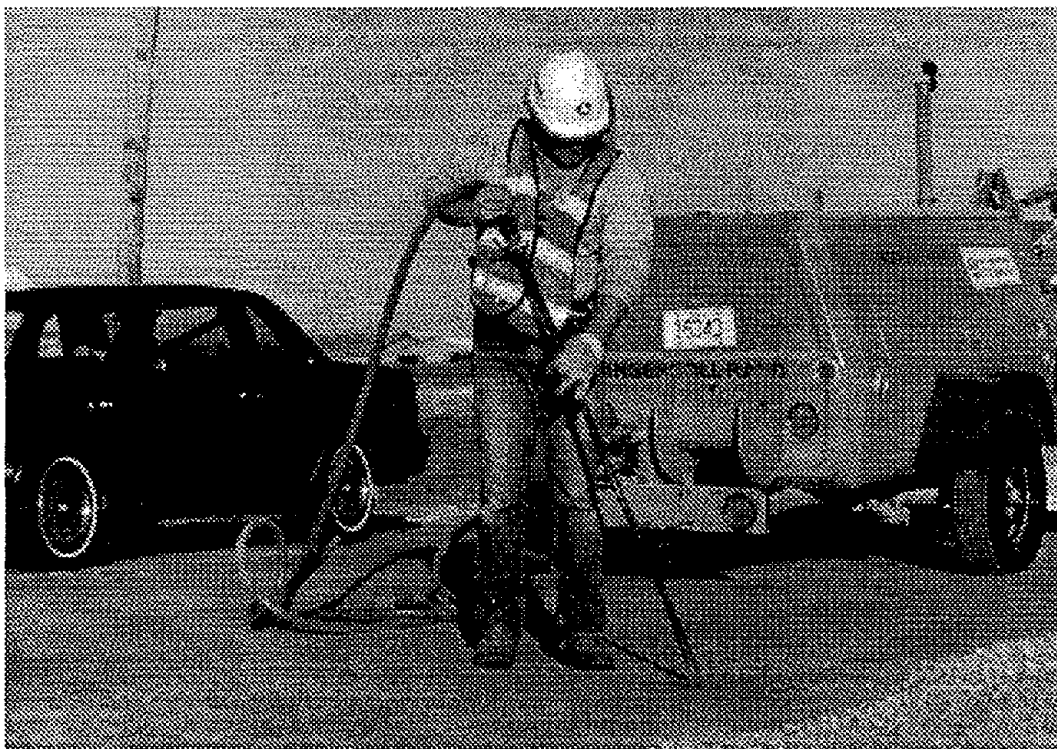
Figure 14. Airblasting operation.

Airblasting, shown in figure 14, was accomplished using an air compressor with the cleanest, driest airstream available. After the sandblasting operation had progressed at least 10 joints ahead, the sand and dust in the joints were removed by airblasting the reservoir. Sand and dust from the sawing and the sandblasting operations were also blown from the pavement surface to the adjacent shoulder or gutter. When the airblasting operation had progressed at least five joints ahead, a crew of two or three persons installed backer rod in the joints to be sealed. An adjustable backer rod placement roller was used to recess the rod to the required depths. Typically, backer rod was cut slightly longer than the length of the joint, and one end of the rod was placed in the joint at the lane edge nearest the shoulder. Then, the person unrolling the backer rod would move to the opposite end of the joint and slightly stretch the backer rod as it was recessed, thus easing the rolling procedure. This is shown in figure 15. When the rolling was nearly complete, the backer rod was cut to the exact length required for providing a tight seal, and the entire length was rolled a second time.

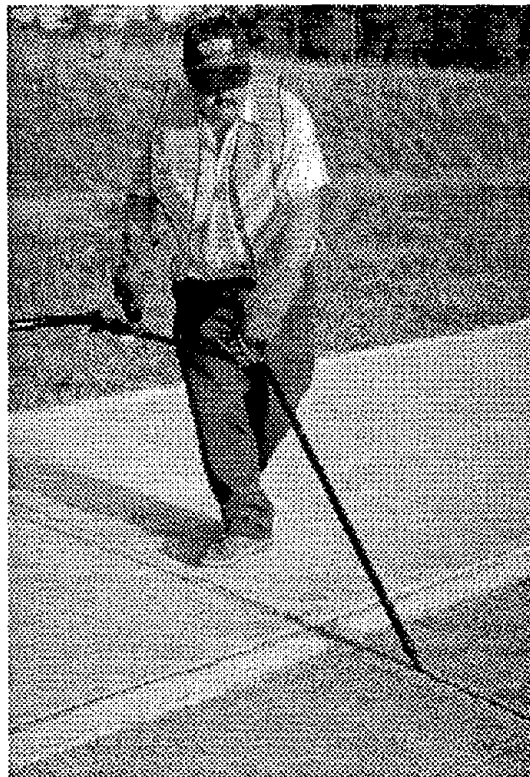
Figure 16. Recessed sealant installation.

Hot-applied, rubberized asphalt sealants were installed using configuration 1 according to manufacturers' recommendations, filling from the bottom up and keeping the sealant surface 3.2 to 6.4 mm below the pavement surface. Application in South Carolina is shown in figure 16. Using the configuration 4 method, the sealant was placed from the bottom up to just even with the pavement surface. Flush-filled, hot-applied sealant is shown in figure 17. The average sealant thickness was 13 mm.

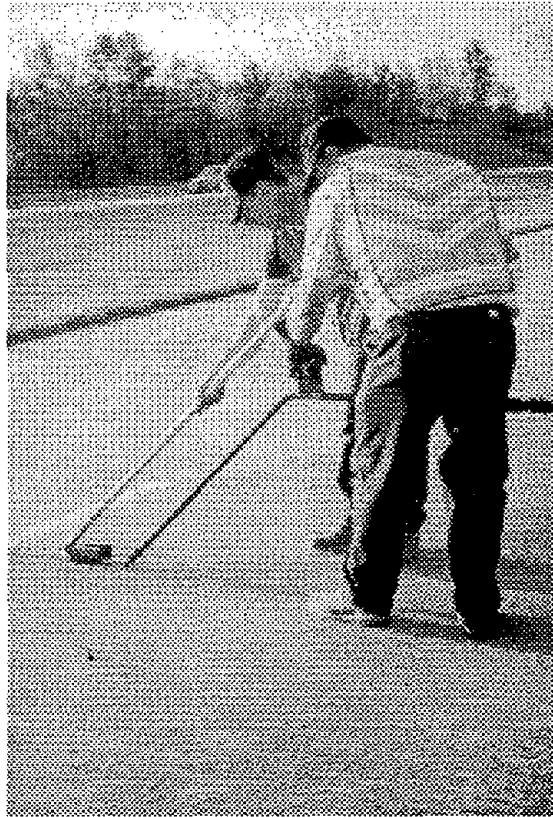
Figure 18. Overbanded sealant installation.

Hot-applied sealants were installed using the overbanded configurations according to manufacturers' recommendations, filling from the bottom up and slightly overfilling the joints. The average sealant thickness was 13 mm for configuration 2 and 9.5 mm for configuration 3. A squeegee followed the applicator wand at a distance of 152 to 610 mm, striking off the surface and leaving an overband about 2 mm thick and 34 mm wide, with a total wipe zone width of about 89 mm. The overband installation process is shown in figure 18, and a recently installed overband is shown in figure 19. Traffic was kept off the sealant until it had sufficiently cooled.
