## TECHBRIEF

# Reducing Roughness in Rehabilitated Asphalt Concrete (AC) Pavements

PUBLICATION NO. FHWA-RD-98-149

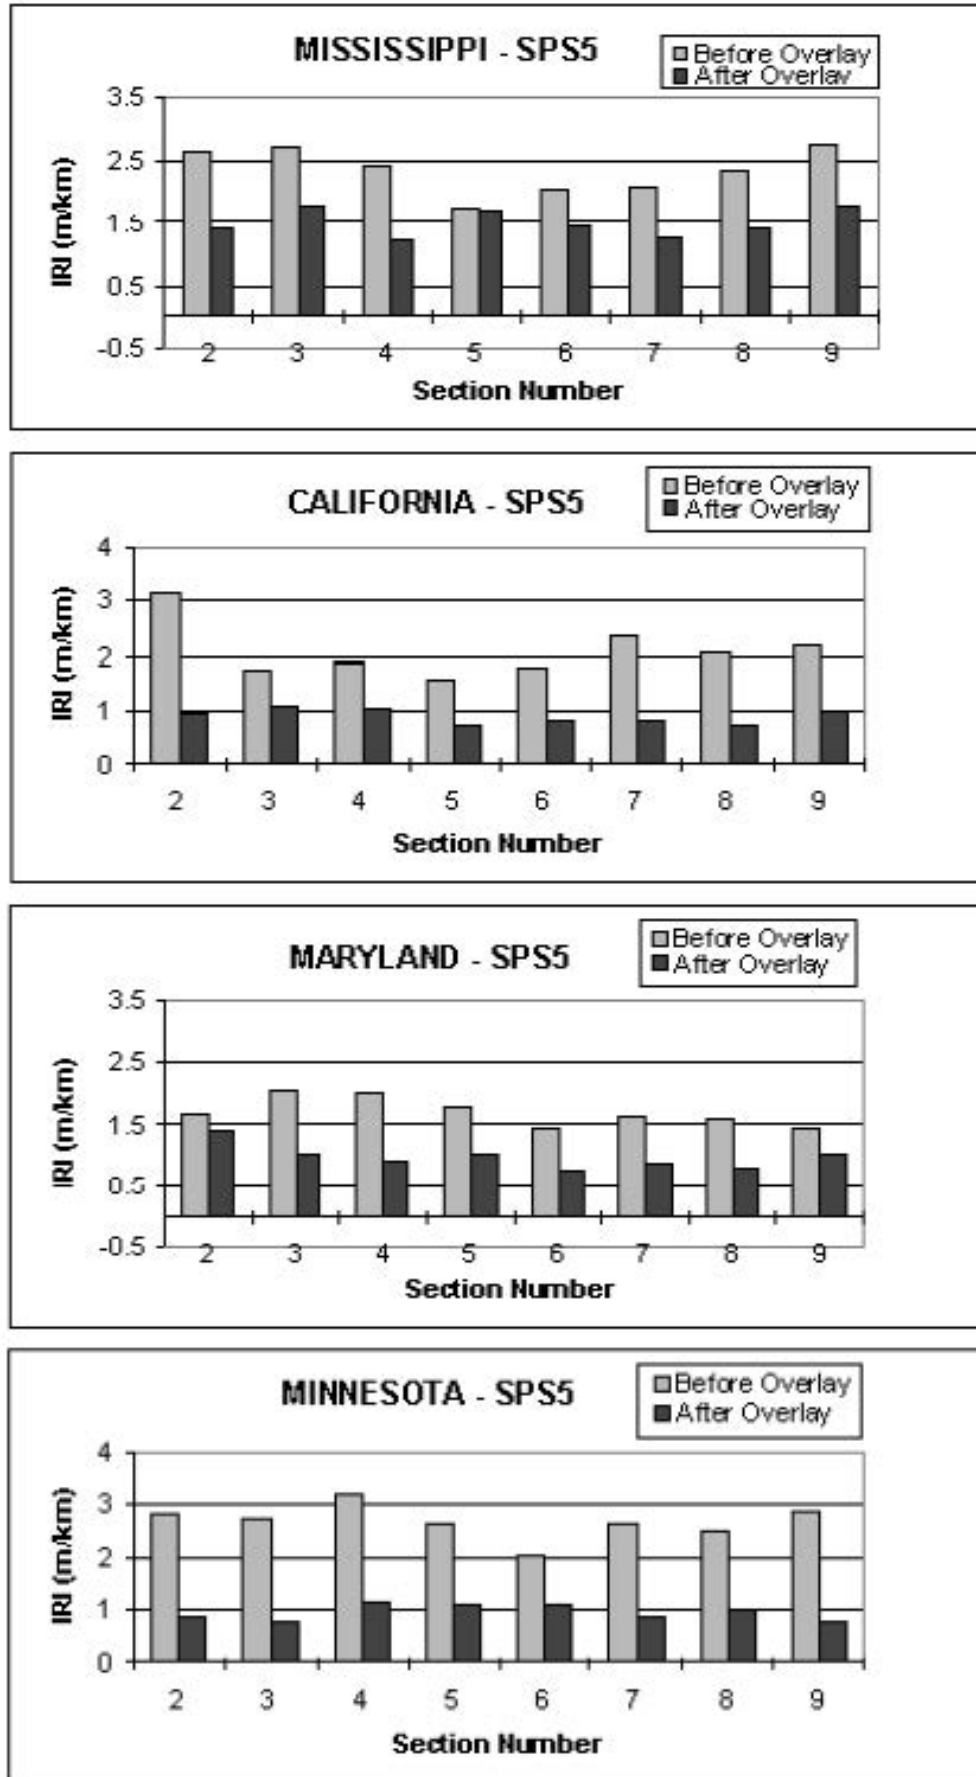
Figure 1 (on the following page) shows the roughness before and after rehabilitation for four Special Pavement Study (SPS)-5 projects. As you will note, regardless of the roughness before the overlay of a section, the roughness after the overlay for all treatments fell within a narrow band, which varied from project to project. Factors that could determine the range of this band include construction procedures, contractor capabil-

Figure 1. IRI before and after overlay for four SPS-5 projects.

ity, and the predominant wavelengths that contribute to roughness and are present in the pavement prior to overlay.

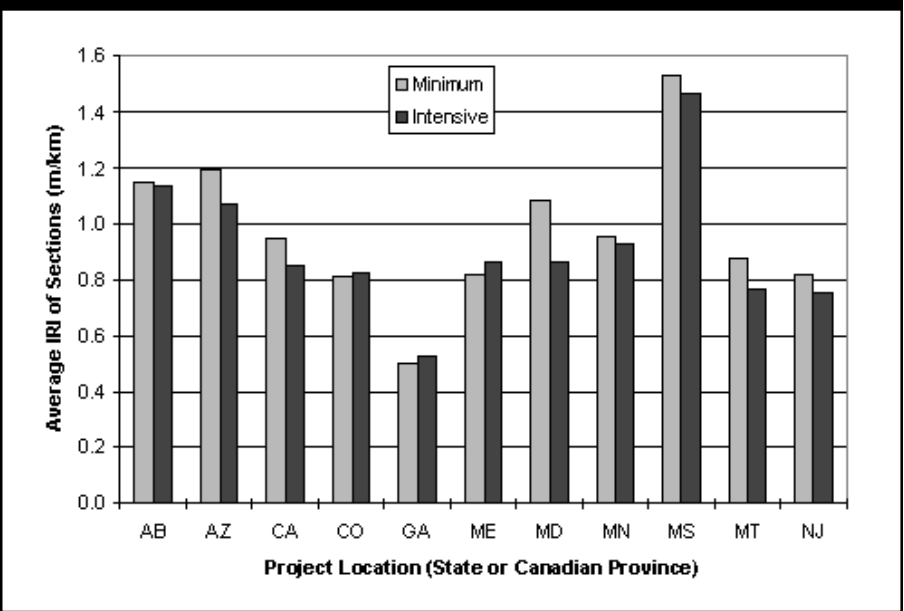
A comparison of the roughness after overlay for the test sections that received minimum and intensive surface preparation prior to overlay is shown in figure 2. The roughness values presented in this figure for each category of surface preparation is the average roughness computed from four test sections that are in each category. Overall, the average IRI values for the minimum and intensive surface preparation sections were close to each other, with the intensive surface preparation sections having a slightly lower IRI value for a majority of the sections.

**Figure 2. Average IRI after overlay for sections receiving minimum and intensive surface preparation prior to overlay.**

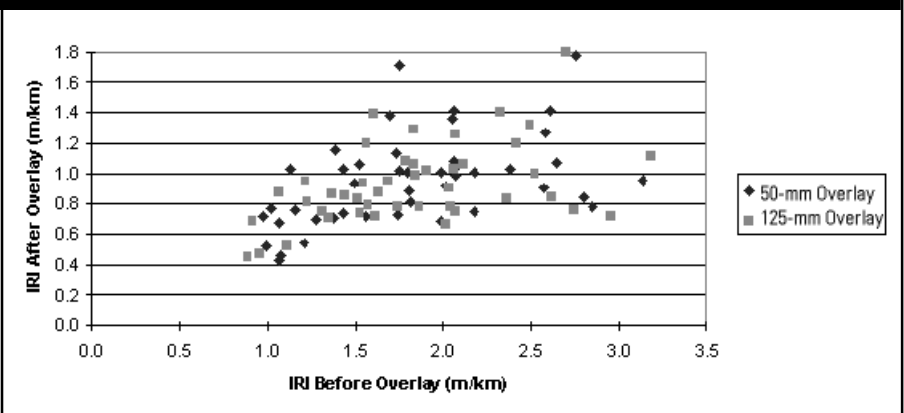
Figure 3 shows the relationship between roughness before and after overlay for all sections. The sections that have an IRI before overlay of less than 1.4 m/km are from two projects. If the sections in these two projects are not considered, and only the sections that have an IRI greater than 1.4 m/km before overlay are considered, data in figure 3 show that there is no relationship between the IRI before and after the overlay. Thin overlays are seen to be capable of reducing the roughness of a pavement by a substantial amount in some cases. For example, figure 3 shows that in three sections that had IRI between 2.5 and 3 m/km, a 50-mm-thick overlay reduced the IRI to approximately 0.8 m/km.

**Figure 3. IRI before and after overlay.**

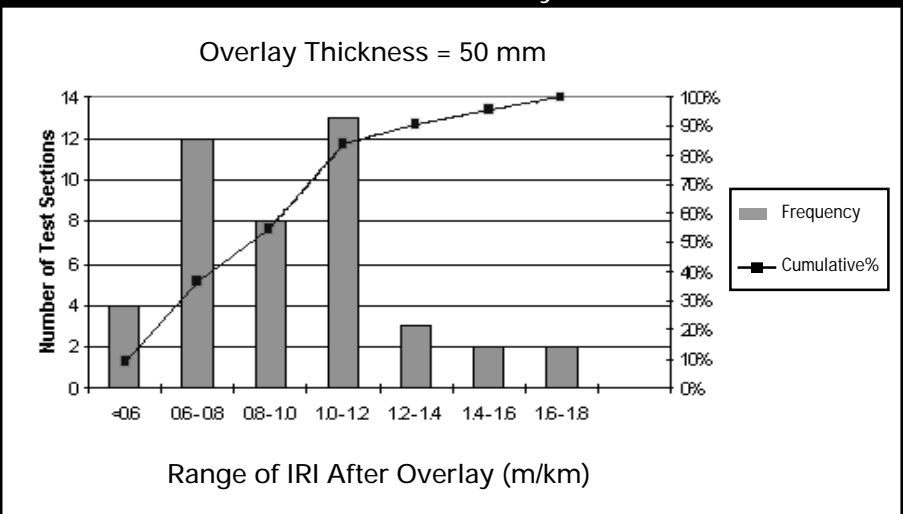
**Figure 4. Frequency distribution of IRI after overlay for sections that received a 50-mm overlay.**

that received a 50-mm overlay are shown in figure 4. This figure also presents the cumulative frequency curve, and shows that approximately 55 percent of the test sections had an IRI value of less than 1 m/km, while 85 percent of the test sections had an IRI value of less than 1.2 m/km.

A frequency distribution of the IRI after overlay for the test sections

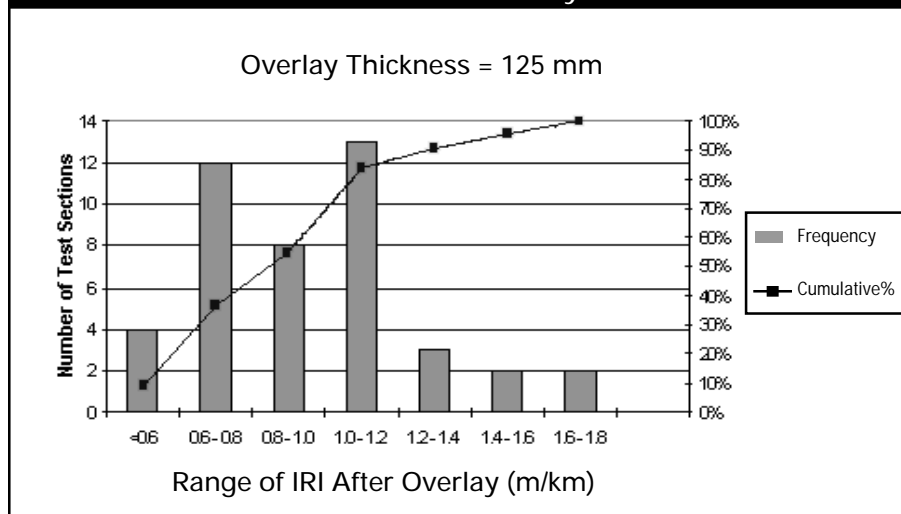
**Figure 5. Frequency distribution of IRI after overlay for sections that received a 125-mm overlay.**

A frequency distribution of the IRI after overlay of the test sections that received a 125-mm overlay is shown in figure 5. The frequency distribution curve in this figure shows that approximately 65 percent of the test sections had an IRI after overlay of less than 1 m/km, while 85 percent of the test sections had

an IRI after overlay of less than 1.2 m/km. These data indicate that in 85 percent of the cases the IRI of an overlaid pavement would be less than 1.2 m/km.
