## TECHBRIEF

# Investigation of Increase in Roughness Due to Environmental Factors in Flexible Pavements Using Profile Data From Long-Term Pavement Performance Specific Pavement Studies 1 Experiment

FHWA Publication No.: FHWA-HRT-17-120

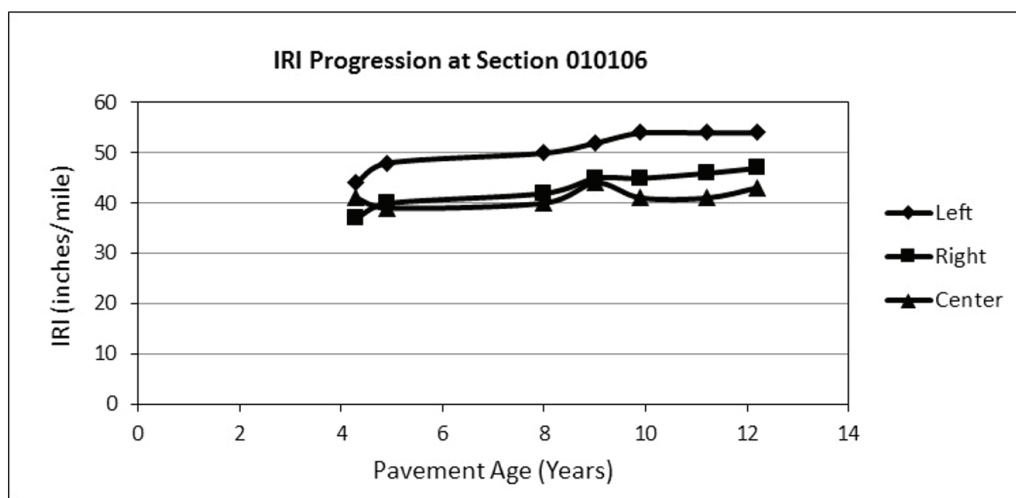
IRI versus pavement age plots were developed for each test section to evaluate how the IRI of the left wheelpath, right wheelpath, and center of the lane changed over time. Figure 1 shows an example of such a plot for section

010106. The horizontal axis of this plot represents the pavement age, with the pavement age being assigned a value of 0 for the traffic open date. The first IRI value shown in this plot corresponds to the date when center of the lane profile data were first collected at this section. The time series IRI values at each test section were visually examined to evaluate the changes in IRI over time. The IRI values before and after a change in construction number were reviewed to evaluate if the activity impacted the IRI. If the activity had an impact on IRI, a sharp change in IRI would be noticed between the IRI before and after the activity. If a sharp increase or decrease in IRI occurred between visits and there was no maintenance or rehabilitation activity indicated in the PPDB table, such data points were closely evaluated to determine the cause for the sharp increase or decrease in IRI. When investigating the cause for the change in IRI, in addition to evaluating the profile data, distress data, cracks maps, photographs, and videos obtained during the distress surveys were used as appropriate to determine the cause for the sudden change in IRI.

Figure 1. Graph. IRI progression at section 010106.<sup>(3)</sup>

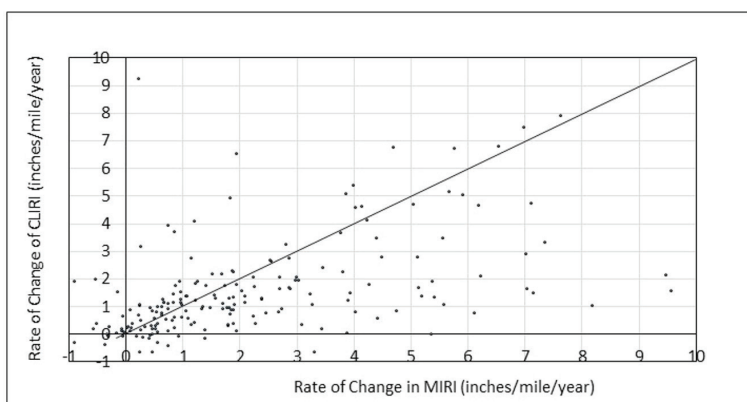
Figure 2 shows the relationship between the rate of change of MIRI and CLIRI at the SPS-1 test sections. When all SPS-1 test sections were considered, the median value of the rate of change of MIRI and CLIRI was 1.56 and 1.05 inches/mi/yr, respectively, while the third quartile values for these parameters were 3.22 and 1.19 inches/mi/yr, respectively. The rate of change of MIRI was greater than the rate of change of CLIRI at 62 percent of the test sections.

Figure 2. Graph. Relationship between the rate of change of CLIRI and MIRI.<sup>(3)</sup>

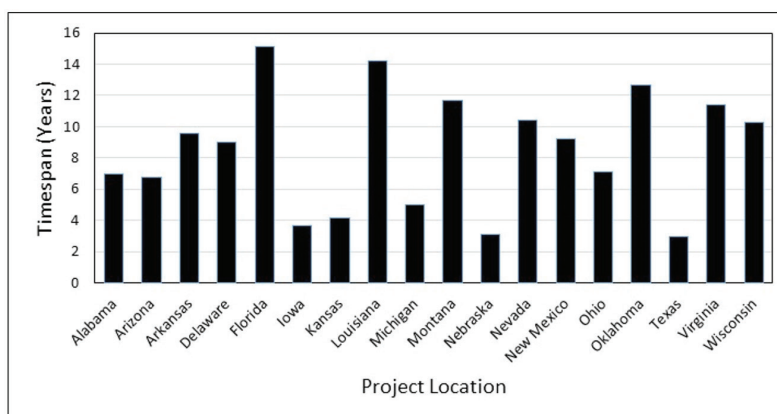
Figure 3 shows the average timespan over which IRI data were collected at the test sections

in each SPS-1 project. The average timespan was computed by averaging the timespan over which data were collected at each test section in the SPS-1 project. Figure 4 and figure 5 show box plots of the rate of change of MIRI and CLIRI at the sections in each SPS-1 project, respectively. A box plot is a simple graphical representation that shows the distribution of data. For each SPS-1 project, the box plot shows the distribution of the change in IRI values for the test sections located in the SPS-1 project. The horizontal line located within the box shows the median of the data. The bottom of the box shows the value of the first quartile of the data (i.e., 25th-percentile value), while the top of the

Figure 3. Bar graph. Average timespan over which CLIRI data were available for test sections in SPS-1 projects.<sup>(3)</sup>

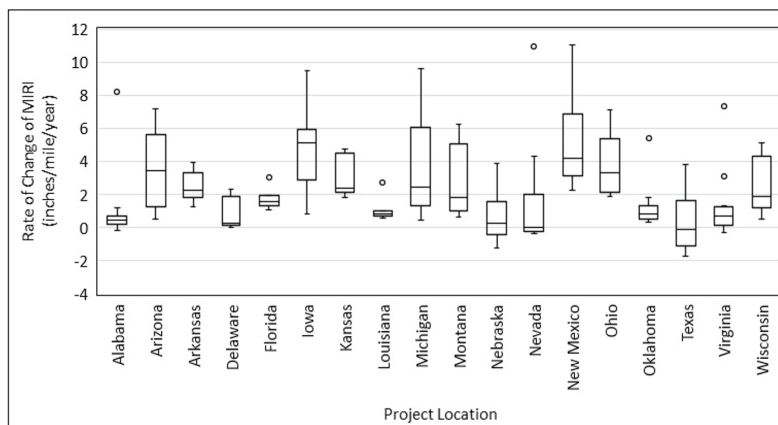
Figure 4. Box plots. Rate of change of MIRI at test sections in each SPS 1 project.<sup>(3)</sup>

box shows the value of the third quartile of the data (i.e., 75th-percentile value). The whiskers (i.e., the horizontal lines) in the plot at the top and the bottom show the range of the data. An outlier is shown as a circle above or below the whiskers. The magnitude of the rate of change of MIRI as well as CLIRI at test sections in a project varied from project to project. In some projects, the rate of change of CLIRI fell within a narrow range, while in others, the range was wider.

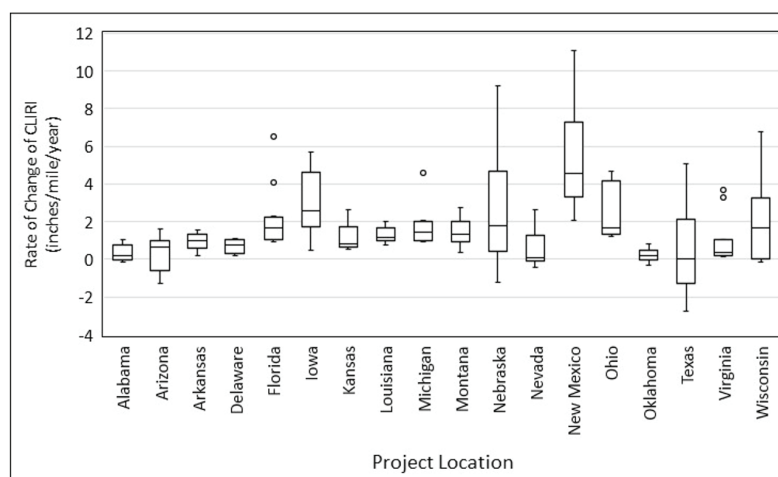
Figure 5. Box plots. Rate of change of CLIRI at test sections in each SPS-1 project.<sup>(3)</sup>

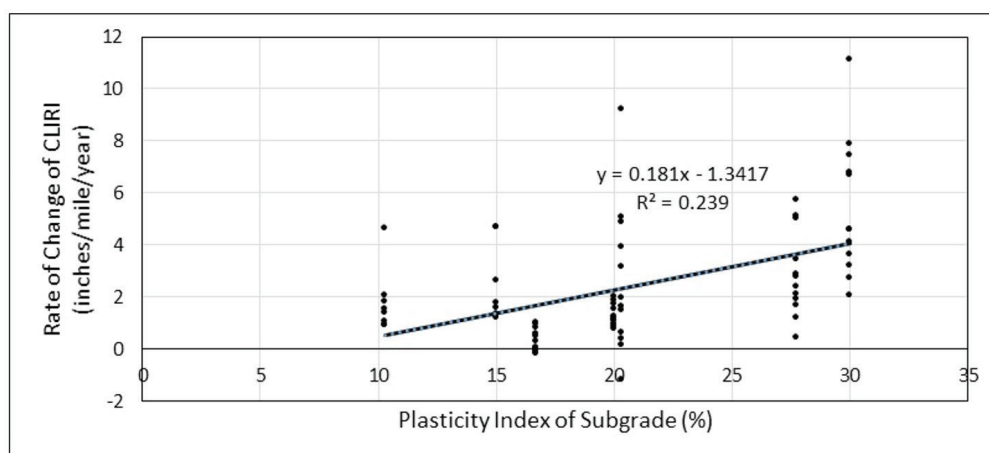
For sections on fine-grained subgrade, the rate of increase of CLIRI and MRI showed an increasing trend with the increase in PI values of the subgrade. Figure 6 shows the rate of change of CLIRI of test sections plotted with the PI of the subgrade for the SPS-1 projects located on fine-

grained subgrade. The rate of change of CLIRI values shown vertically for a specific value of PI are those for the various test sections in that SPS-1 project.

Figure 6. Graph. Rate of change of CLIRI of test sections located on fine-grained subgrade versus the PI of the subgrade.<sup>(3)</sup>
