Subject: **ACTION:** LTPP Directive D-44
Distress Survey Photographs

Directive Number: D-44

Subject: Distress Survey Photographs

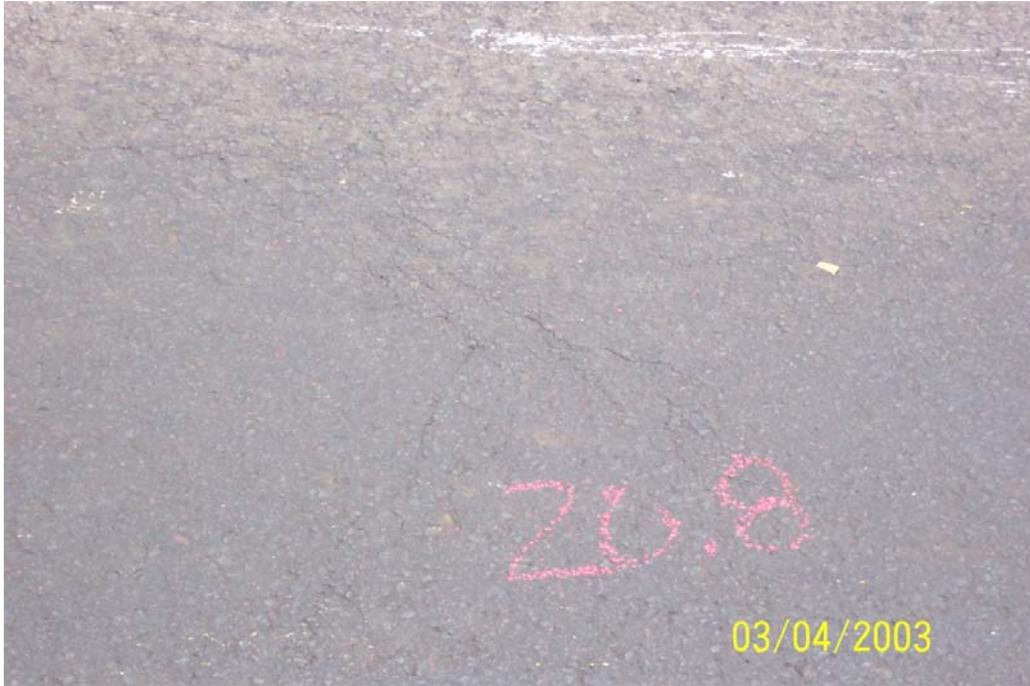
Image 1

This photo has nothing to indicate scale or direction. When such a photo is taken, these need to be included within the description. An example of a good description is provided below.

Description: “Non-standard photo - AC surface with several unusual low severity cracks running transverse to lane.”

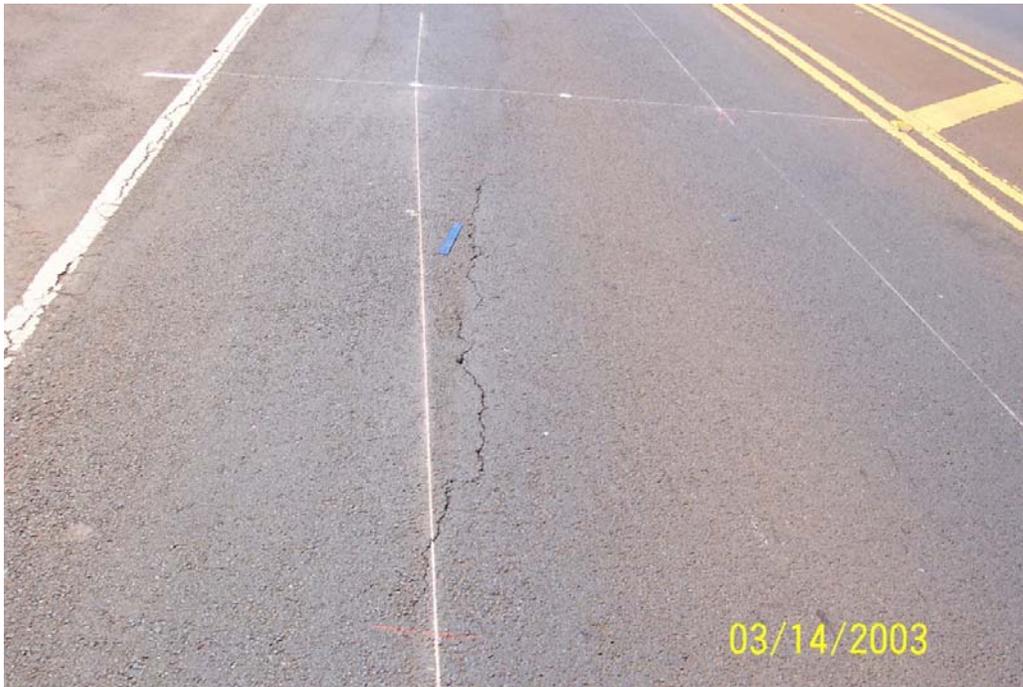
Image 2

Description: “Non-standard photo - a crack in the AC surface developing along an unconventional longitudinal paving seam.”

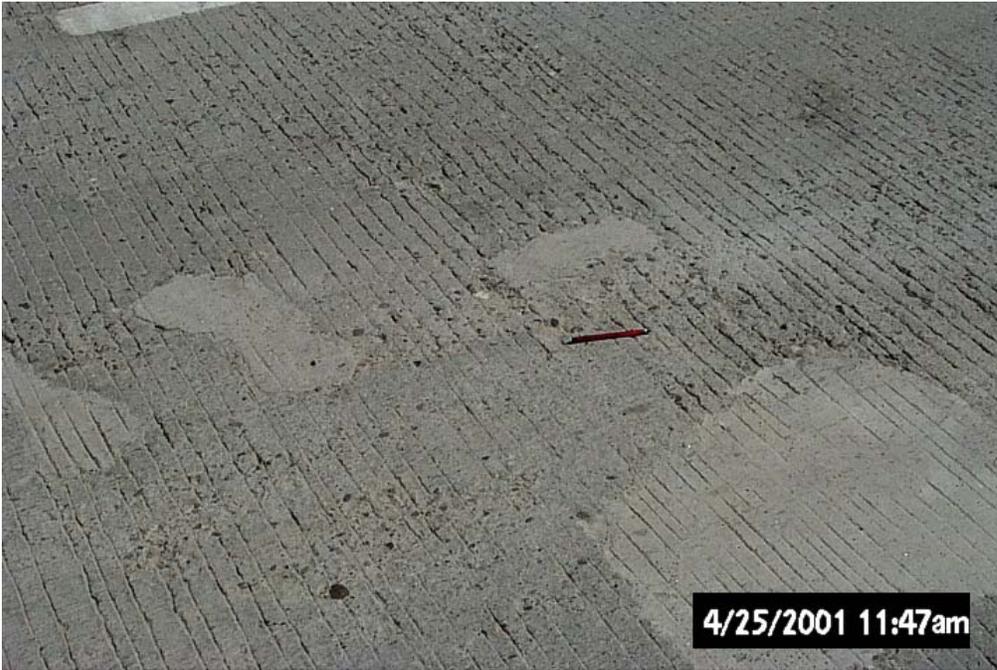
Image 3

The Portland cement concrete patches in this image will have been noted on the survey maps and forms. There does not appear to be a reason why this photo is necessary and thus it may be omitted unless the surveyor feels that it is noteworthy in some other respect. Nonetheless, a possible description is provided below.

Description: "Non-standard photo - small closely spaced PCC surface patches."

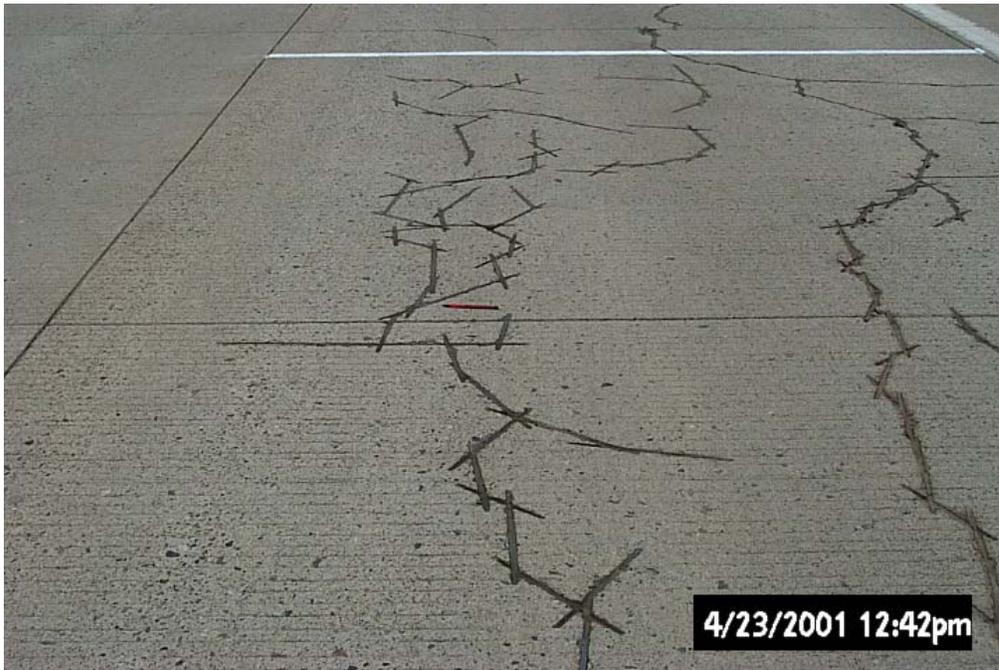
Image 4

Description: “Non-standard photo - PCC pavement with a series of short interconnected cracks that have been saw-cut and sealed.”

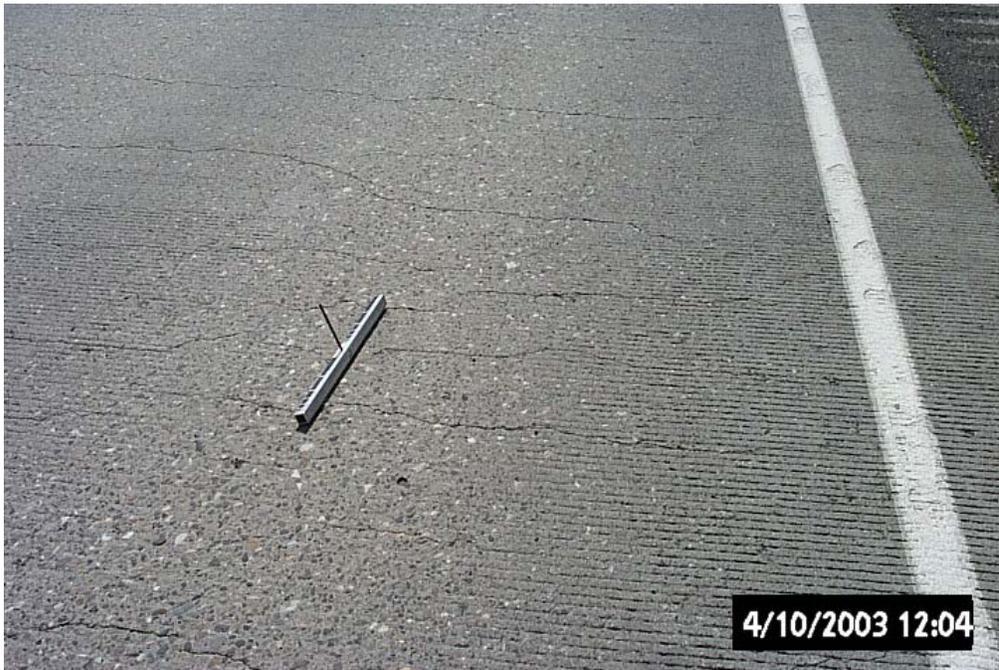
Image 5

These transverse cracks will have been noted on the survey forms and maps. A non-standard photo is not warranted unless the surveyor feels that this photo is noteworthy for another reason. If this was the case, the reason should be included in the description of the photo. A possible description is provided below.

Description: “Non-standard photo - transverse cracks on CRCP pavement lacking apparent interconnection between adjacent cracks or extension to the outer pavement edge.”

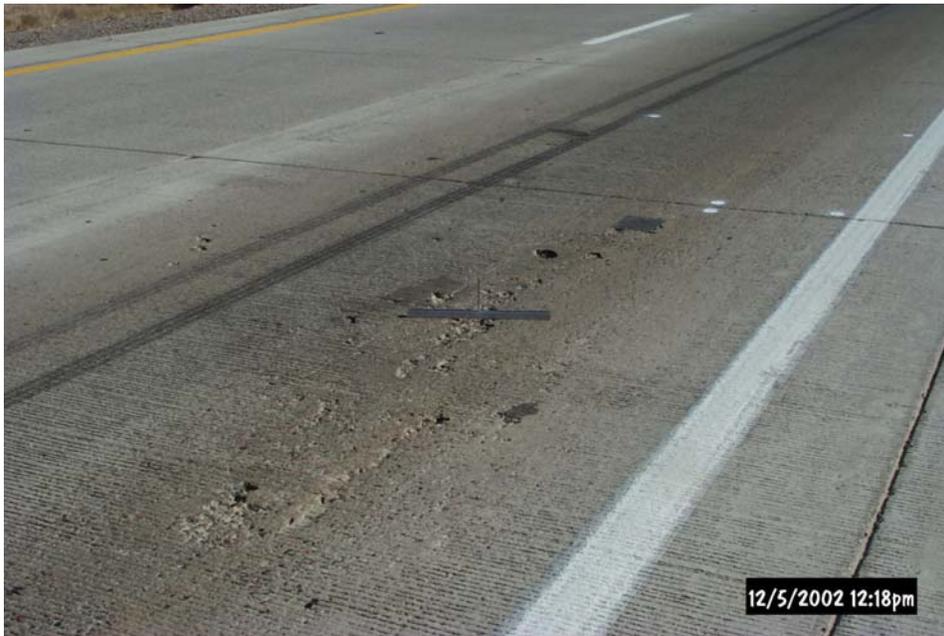
Image 6

Description: “Non-standard photo - PCC pavement with surface material missing from the left wheel path.”

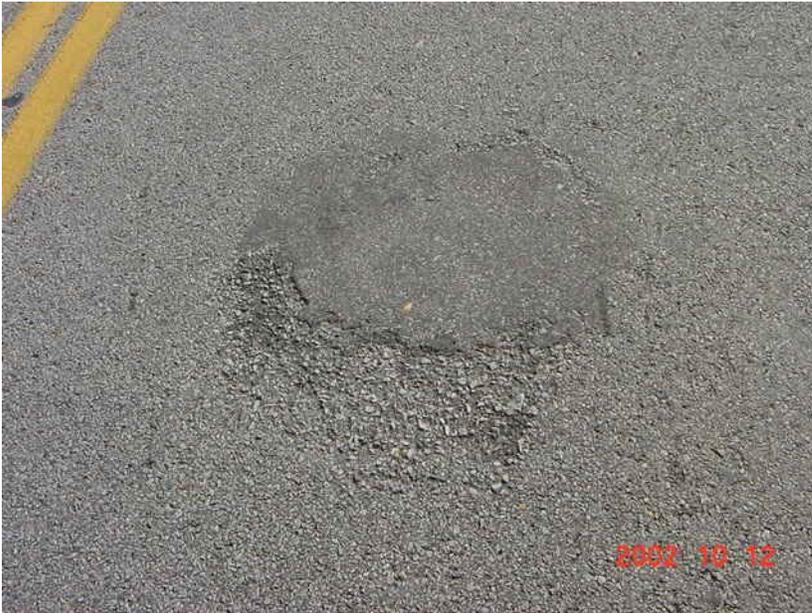
Image 7

The distresses in this photo are easily recognizable and should have been recorded on the distress maps and forms. Unless the surveyor feels that the photo is noteworthy or of particular interest to users of the distress survey data, then the photo is not warranted under D-34. Nonetheless, a possible description is provided below.

Description: “Non-standard photo - circular AC patch with small area of adjacent raveling.”

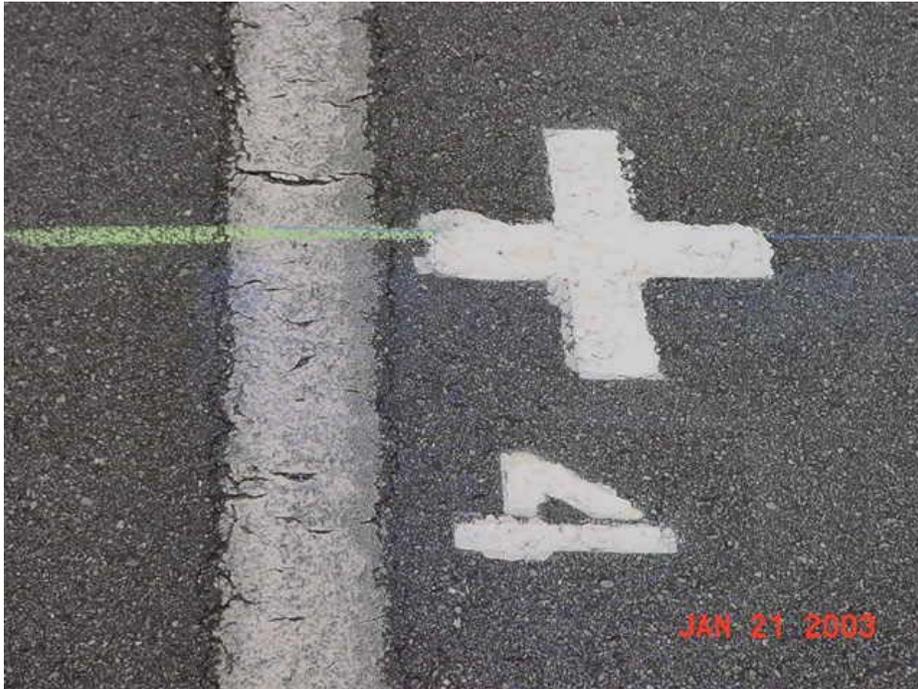
Image 8

Description: “Non-standard photo - fine cracks propagate across the painted edge line as well as longitudinally along both sides.”

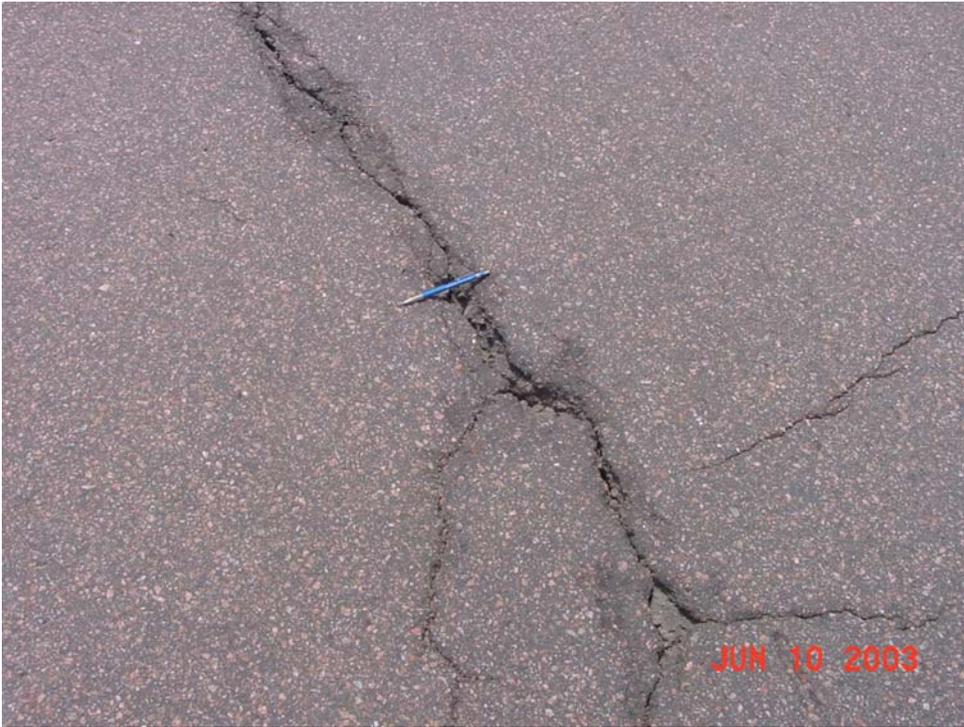
Image 9

This photo lacks an indication of direction. It is important that the orientation of the cracks can be determined. The description should clearly state this. A possible description is provided below.

Description: “Non-standard photo - severe transverse crack extending across the lane and a series of smaller cracks radiating from it, perpendicular and diagonal to the lane.”

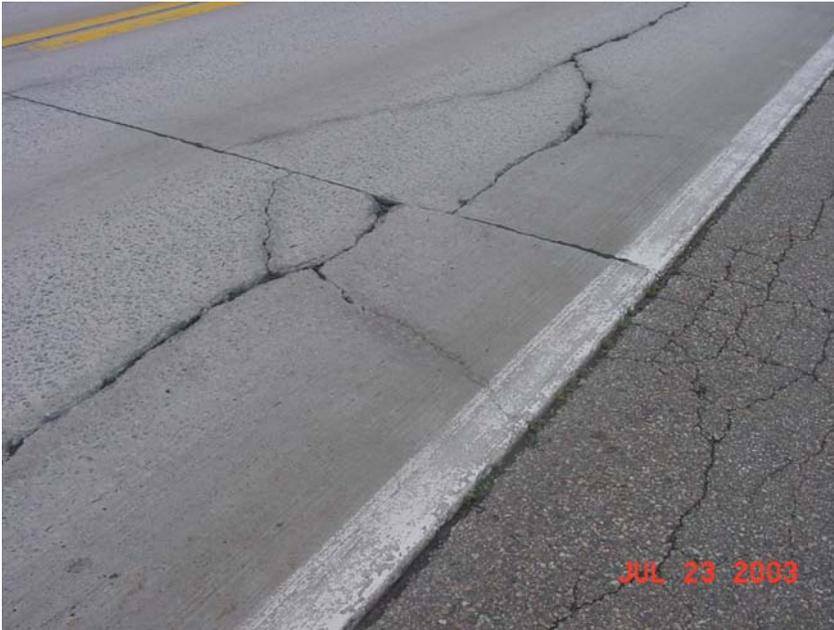
Image 11

Note: If the diamond grinding in this image is visible in standard photos, then this non-standard one is not required.

Description: “Non-standard photo - transverse joint, a severe longitudinal crack with polished aggregate to the left and striations caused by diamond grinding to the right of it.”

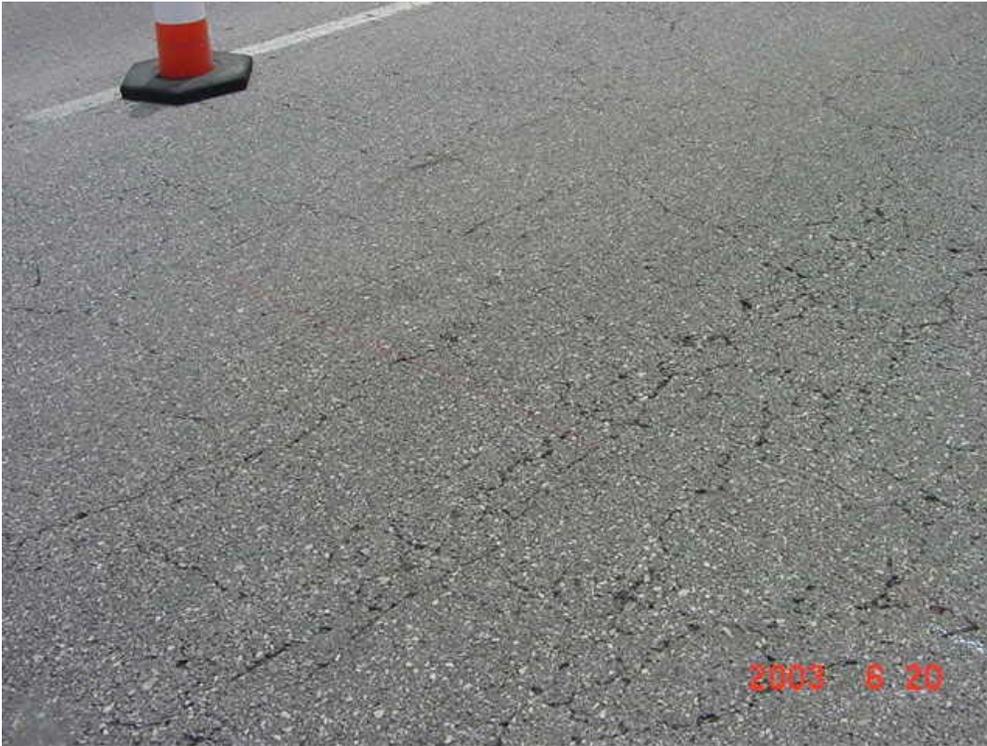
Image 12

“Non-standard photo – a chicken wire pattern of cracking across the whole lane.”
