# Study of Long-Term Pavement Performance (LTPP): Pavement Deflections

PUBLICATION NO. FHWA-RD-03-093

AUGUST 2006

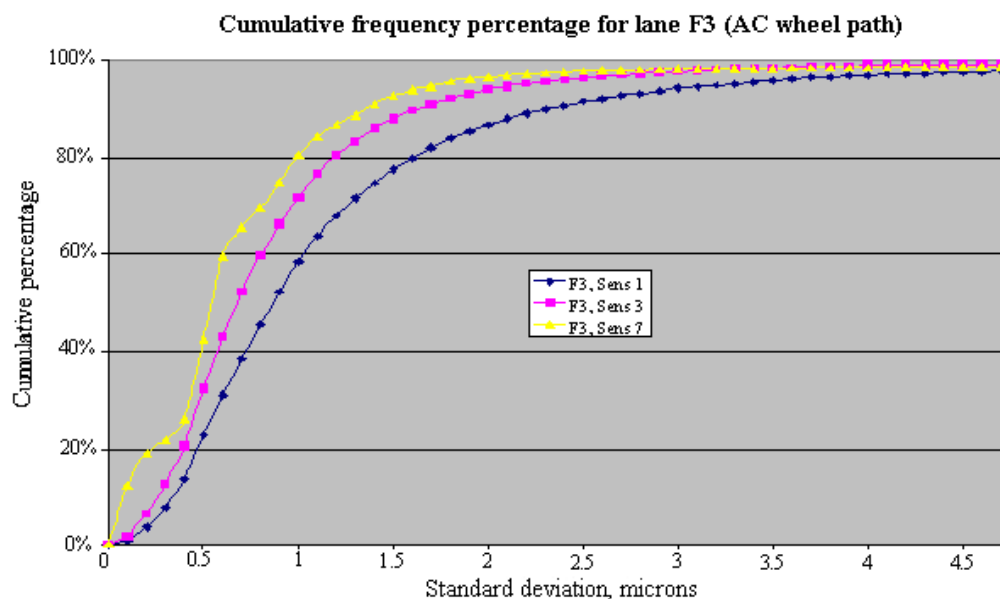
**Figure 1. Graph. Frequency distribution of standard deviations for repeated deflections.**

These marked and flagged data were an uncommon occurrence in the database. For example, figure 1 shows a typical distribution of the calculated (load-normalized) standard deviations for all AC type pavements tested along the wheelpath (designated in the database as “lane F3”).

The task of identifying the distribution of standard deviations was facilitated by shifting the standard deviation limits by 1 percent of the deflection reading. As shown, a standard deviation level of 4  $\mu\text{m}$  or greater (after the 1 percent of adjustment) only exists in 1 to 2 percent of the entire pre-autumn 1998 FWD load-deflection database.

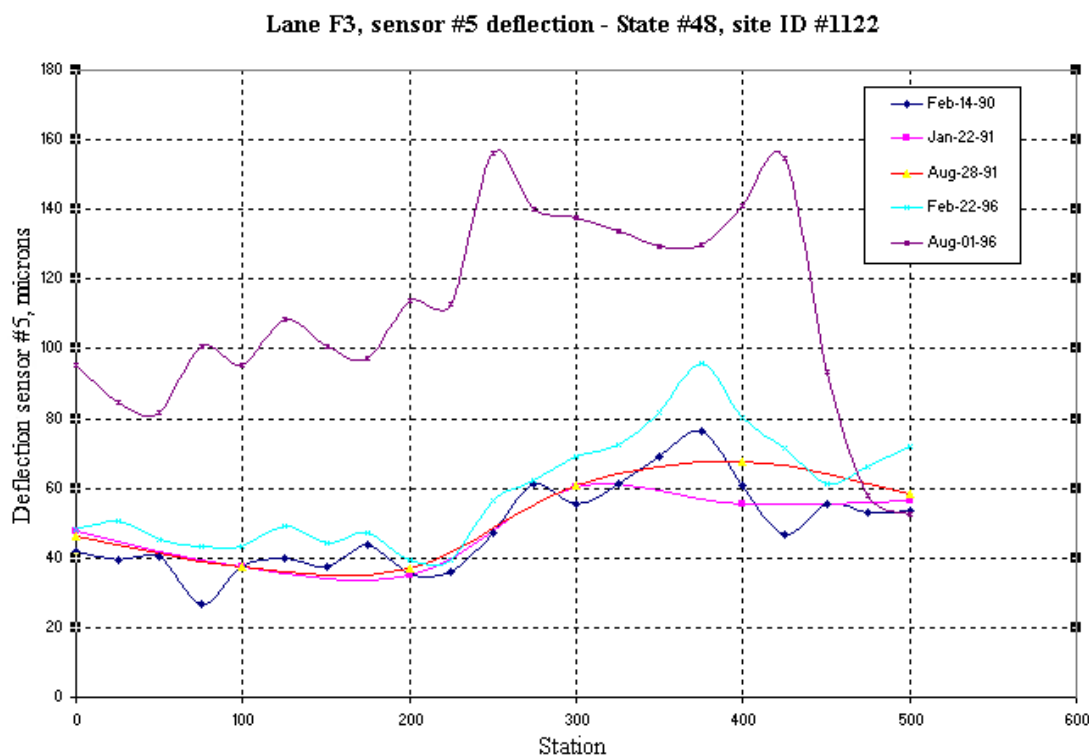
**Figure 2. Graph. Sensor 5 deflection readings for one LTPP section.**

A sample section error is shown in figure 2, where the deflections of sensor #5 (mainly corresponding to the response of the subgrade) are plotted as a function of station number and date of test. The tests conducted on August 1, 1996, bear little resemblance to the tests conducted on that section on any previous dates, even those as recent as 6 months earlier. This erroneous dataset was deleted from the database, as recommended.

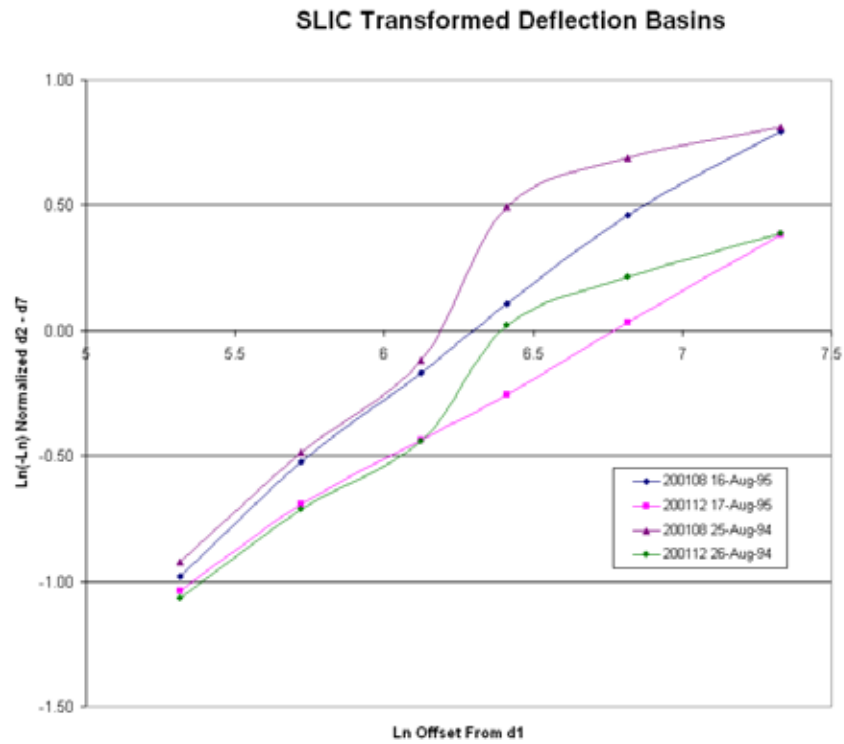
Figure 3. Graph. Sample deflection basins transformed with SLIC (input protocol positions).

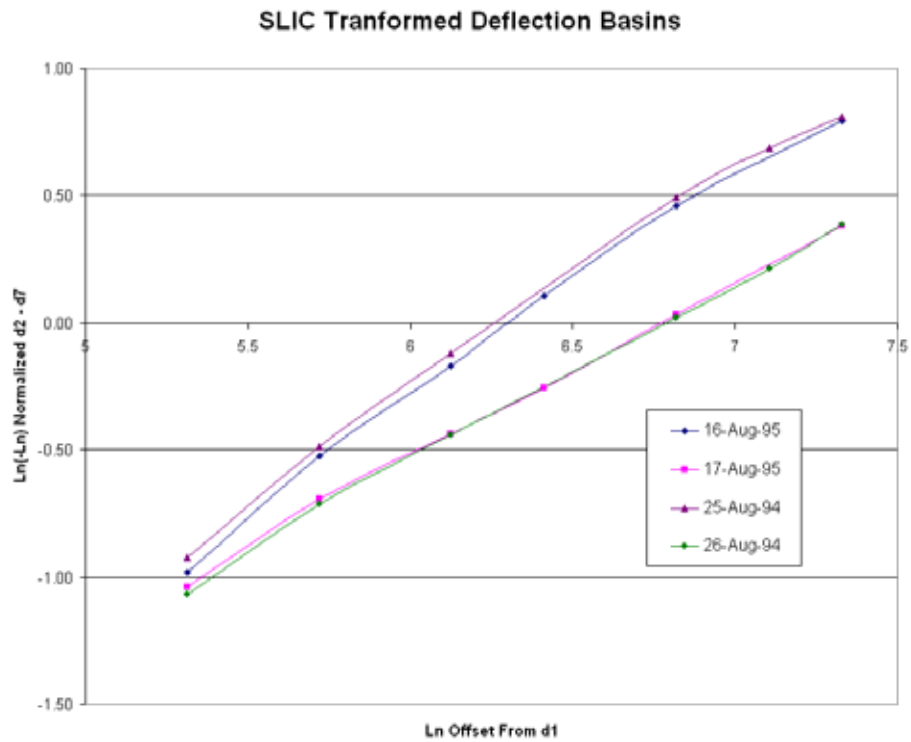
Figure 4. Graph. Sample deflection basins transformed with SLIC (input actual positions).

In figure 4, the two basins where sensors 5 and 6 were misplaced by 30.5 cm (12 inches) are replotted using their actual positions against the two correct (protocol) basins. Here it can be seen that the two pairs of lines are almost perfectly parallel; in fact, for all practical purposes, they overlap.

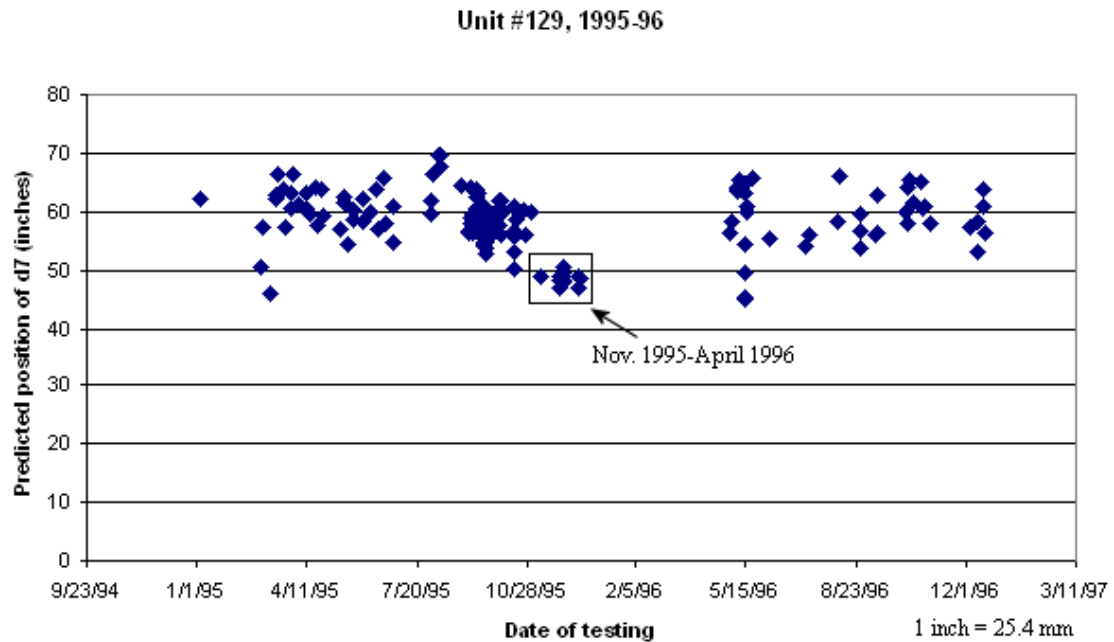
**Figure 12. Graph. Predicted position of d7, unit #129, 1995-96.**

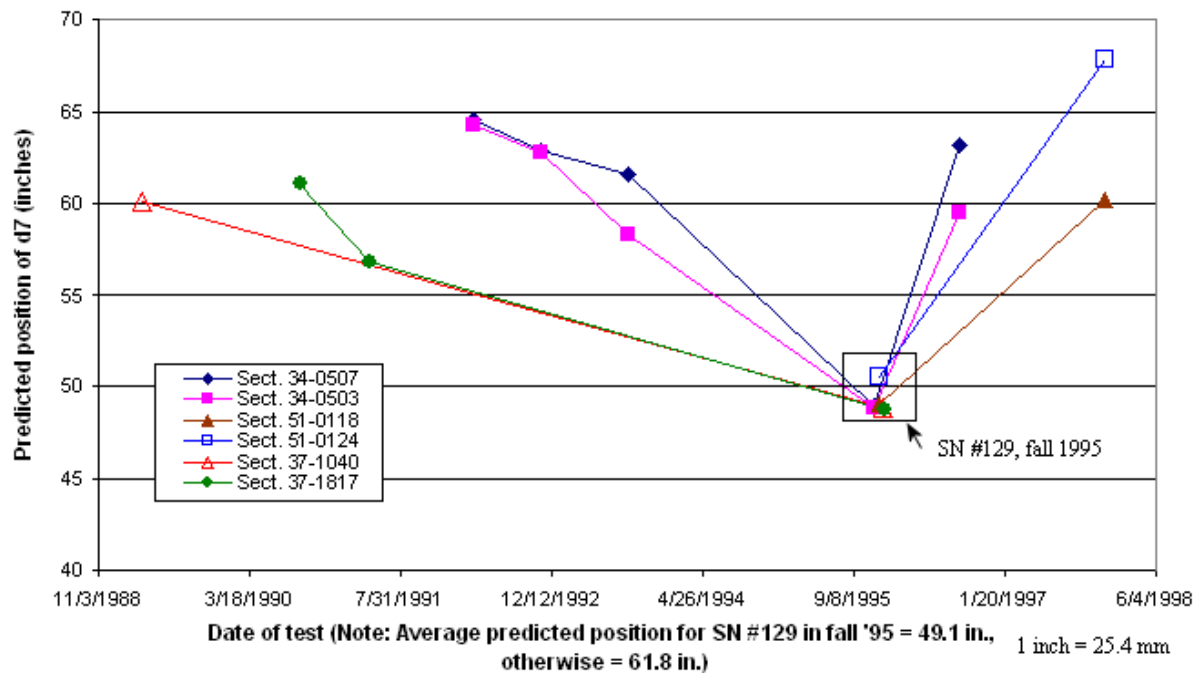
**Same section data: SLIC prediction of d7 position for FWD SN #129 during fall 1995**  
 (Other data from 2 different FWDs = SN's #058 & #129)

**Figure 13. Graph. Same section data for d7 position, two different FWDs.**

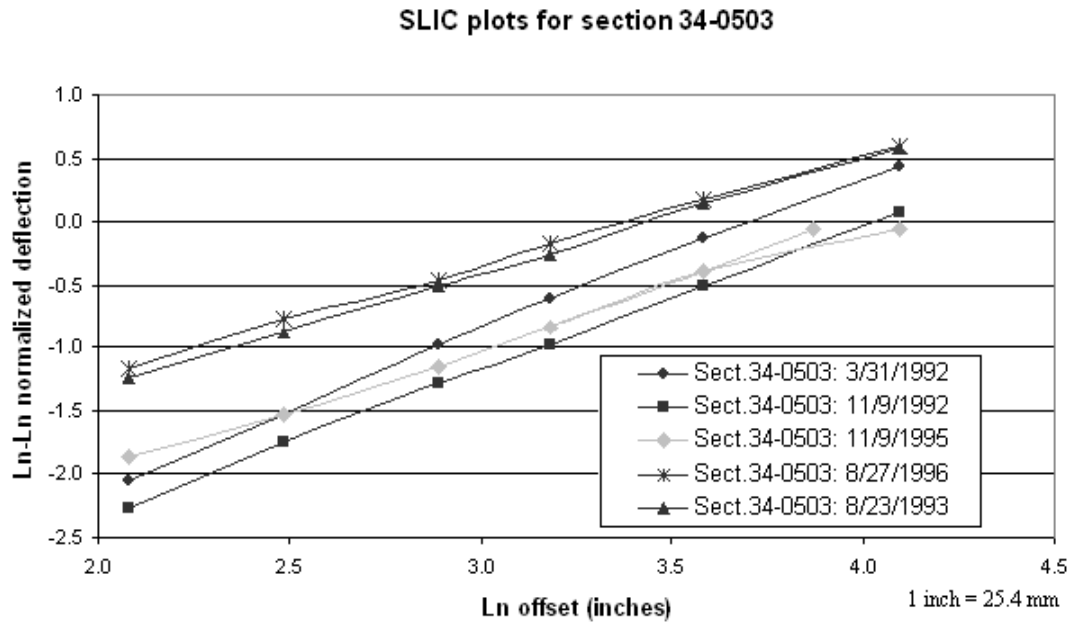
Figure 14. Graph. SLIC plots for section 34-0503 including unit #129, November 1995.

In the two following figures (see figures 14 and 15), the same results are shown graphically, with the lines and data points labeled 11/9/1995 showing the SLIC plot for d7 in both its actual (121.9 cm (48 inches)) and protocol but incorrect (152.4 cm (60 inches)) offset position. The portions of the 11/9/1995 lines that are parallel to the rest of the protocol position data are the correct plots, with d7 set at 121.9 cm (48 inches).

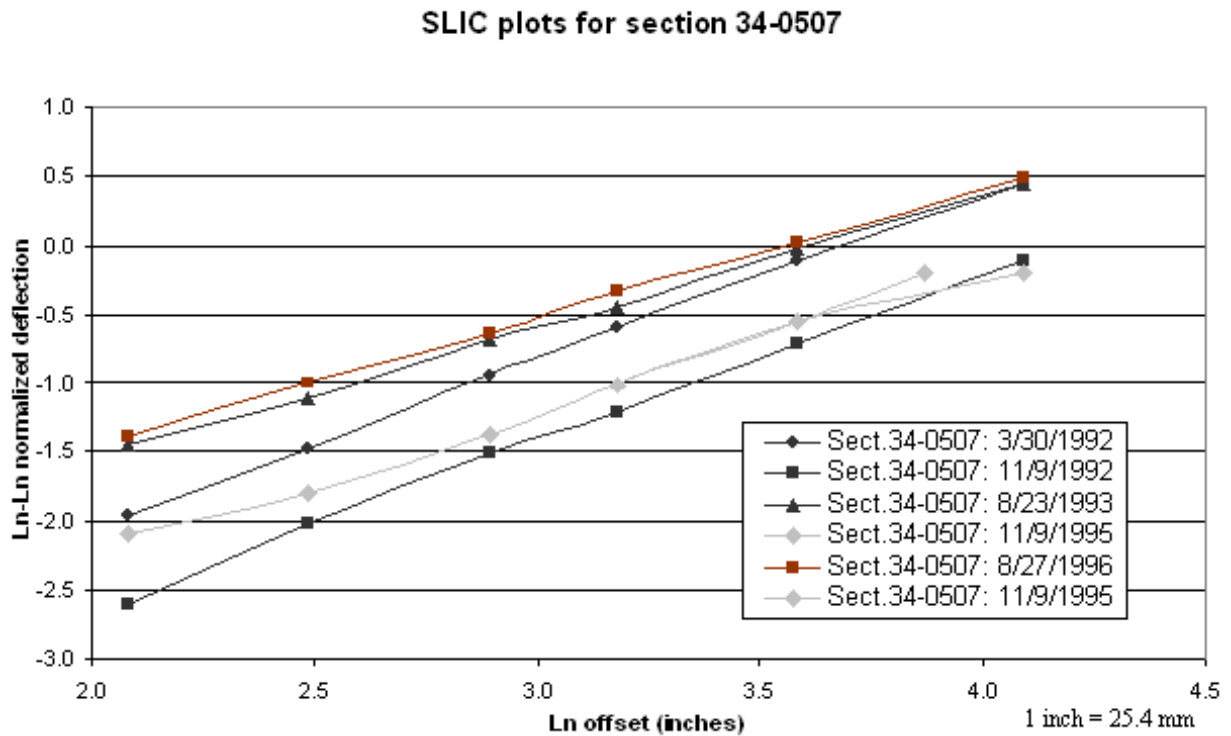
Figure 15. Graph. SLIC plots for section 34-0507 including unit #129, November 1995.

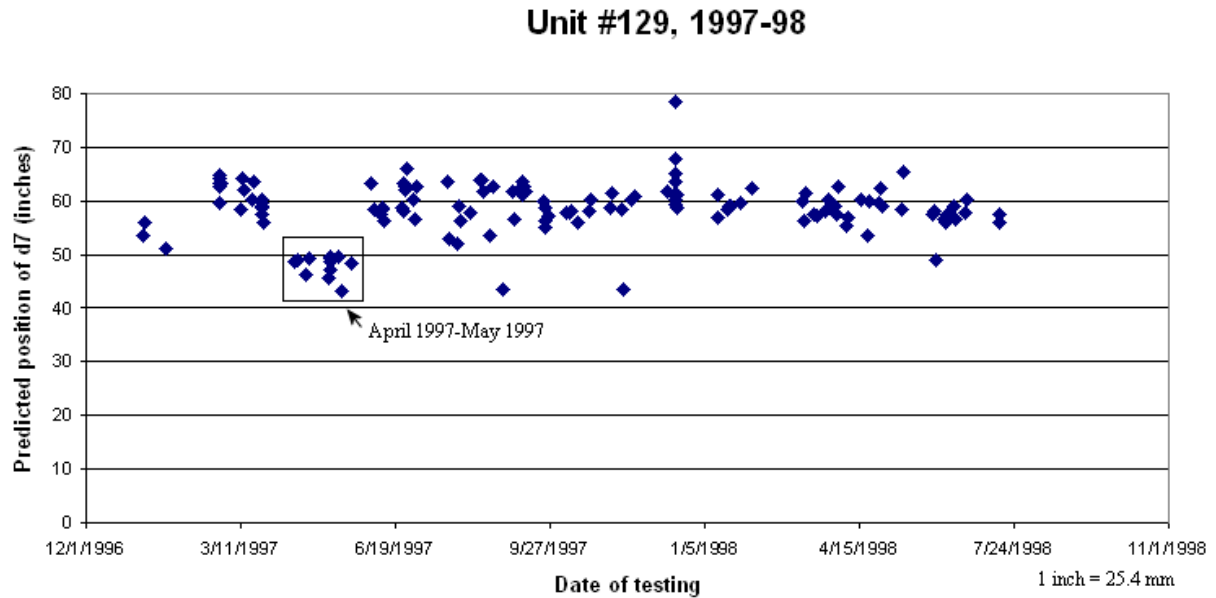
**Figure 16. Graph. Predicted position of d7, unit #129, 1997-98.**

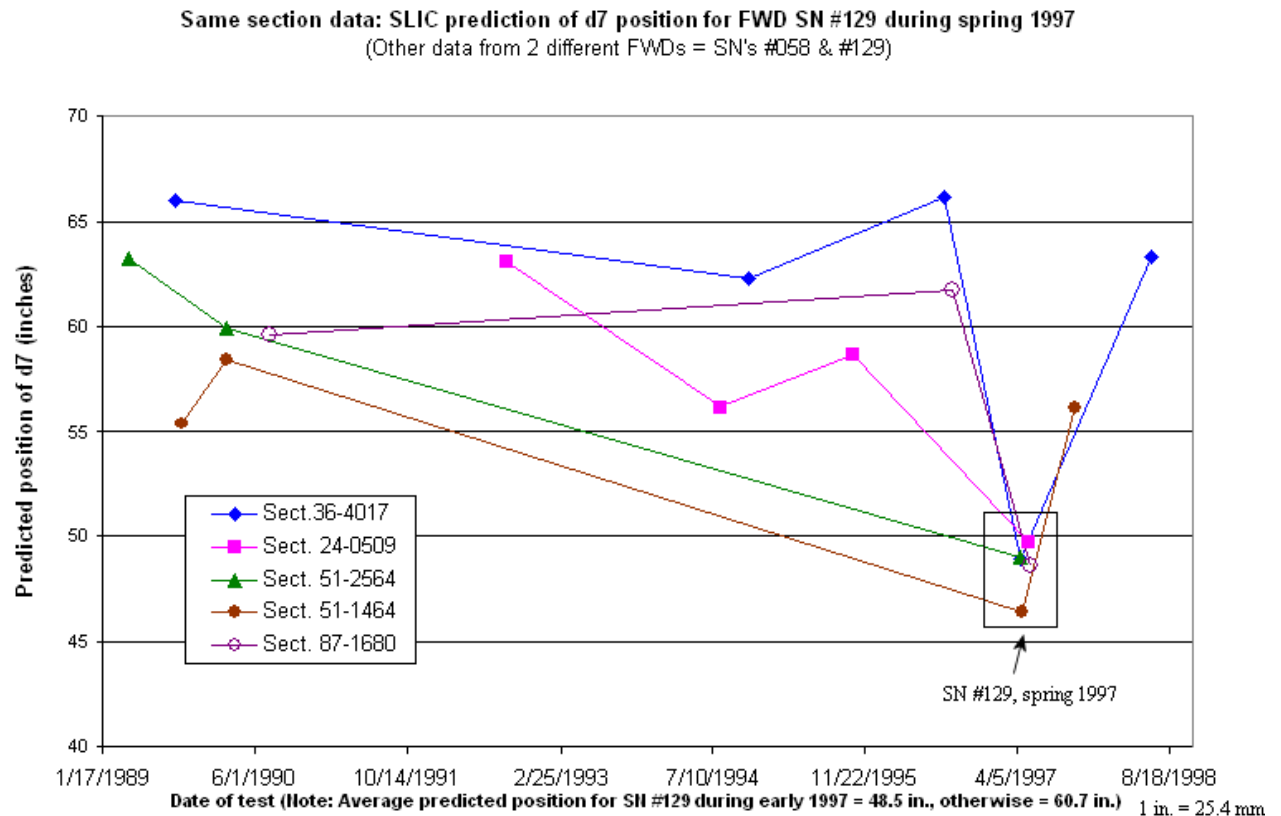
**Figure 17. Graph. Same section data for d7 position, two different FWDs.**

In figure 17, it can be seen clearly that the SN #129 predicted positions for sensor 7 in the spring of 1997 are outliers relative to the predicted positions for sensor 7 when other (correctly configured) FWDs are used. For the five test sections shown (from two different FWDs), the average predicted position of d7 was 154.2 cm (60.7 inches), while the average prediction for SN #129 during the period of time in question was 123.2 cm (48.5 inches).

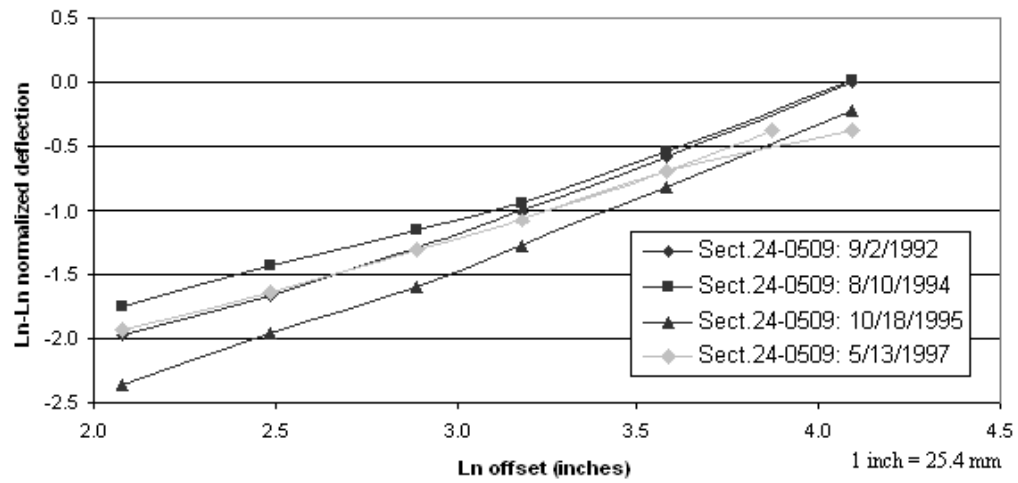
Figure 18. Graph. SLIC plots for section 24-0509 including unit #129, May 1997.

In the two following graphs in this appendix, figures 18 and 19, respectively, the same results are shown graphically, with lines and data points labeled 5/13/1997 in figure 18 and 4/15/1997 in figure 19 showing the SLIC plot for d7 in both its actual position (121.9 cm (48 inches)) and the protocol but incorrect offset position (152.4 cm (60 inches)). The portions of the 5/13/1997 and 4/15/1997 lines that are parallel to the rest of the data are the correct plots, with d7 set at 121.9 cm (48 inches). Because of this information, it can be concluded with certainty that d7 was not positioned correctly at 152.4 cm (60 inches); rather, it was positioned at 121.9 cm (48 inches) (or very close to 121.9 cm (48 inches)) on FWD SN #129 between April 15, 1997 and May 21, 1997, inclusively. These dates correspond to the dates when lane 1 tests were conducted at drop height 4. This period of time may need to be extended somewhat if other tests were conducted along different lanes or at different drop heights. In any case, FWD tests conducted on or before March 25, 1997, and on or after June 3, 1997, clearly show d7 positioned at 152.4 cm (60 inches) (as per protocol).

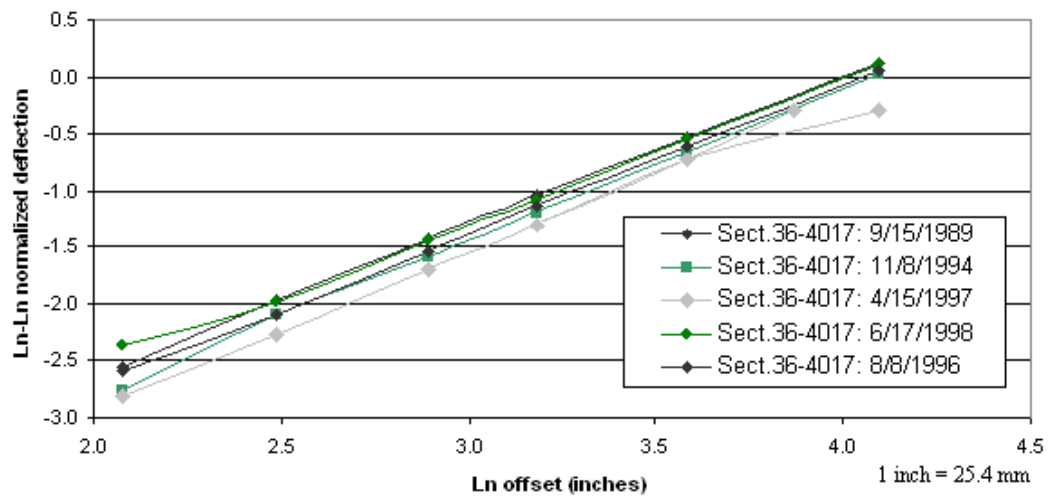
Figure 19. Graph. SLIC plots for section 36-4017 including unit #129, April 1997.

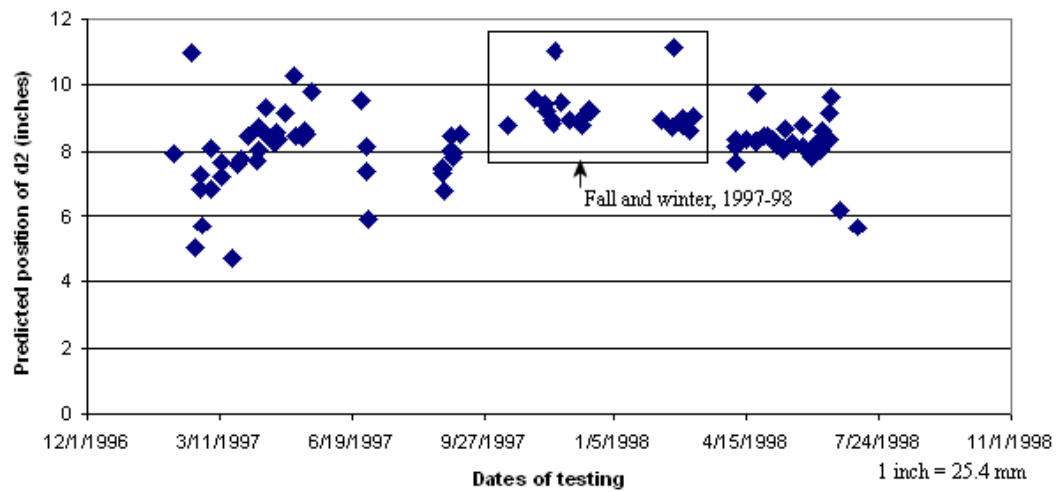
Figure 20. Graph. Predicted position of d2, unit #058, 1997-98.

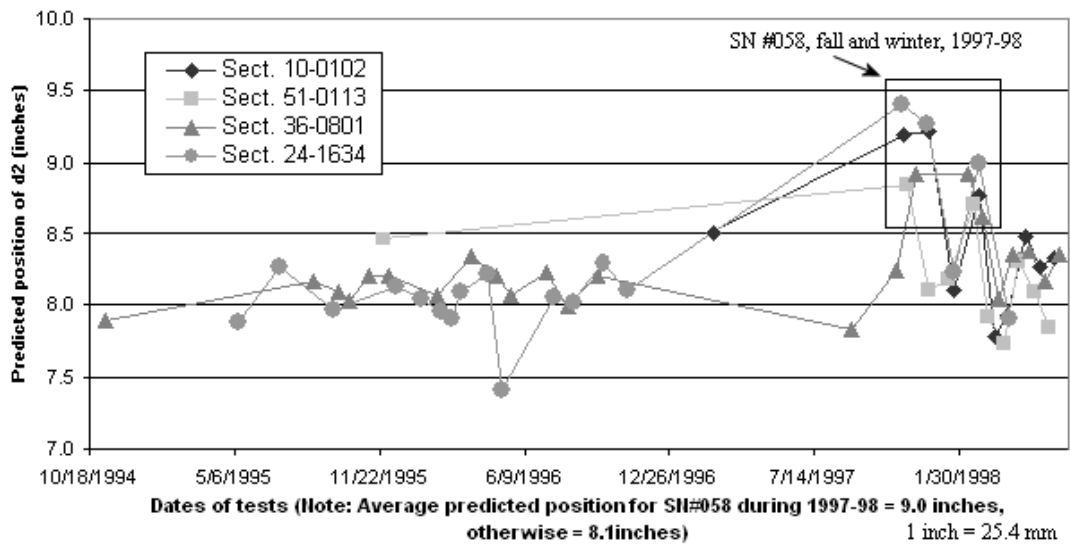
Figure 21. Graph. Same section data for d2 position, two different FWDs.

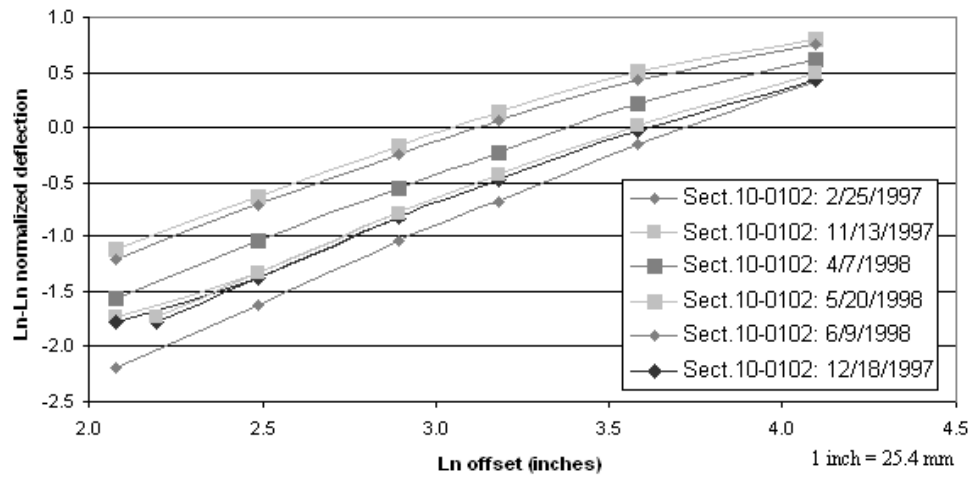
Figure 22. Graph. SLIC plots for section 10-0102 including unit #058, November-December 1997.

Because of this information, it can be concluded with certainty that d2 was not positioned correctly at 20.3 cm (8 inches); rather, it was positioned at 22.9 cm (9 inches) (or very close to 22.9 cm (9 inches)) on FWD SN #058 between October 15, 1997 and March 5, 1998, inclusively. These dates correspond to the dates where lane 1 tests were conducted at drop height 4. This period of time may need to be extended slightly, if other tests were conducted along different lanes or at different drop heights. In any case, FWD tests conducted on or before September 9, 1997, and on or after April 6, 1998, clearly show d2 positioned at 20.3 cm (8 inches) (per protocol).

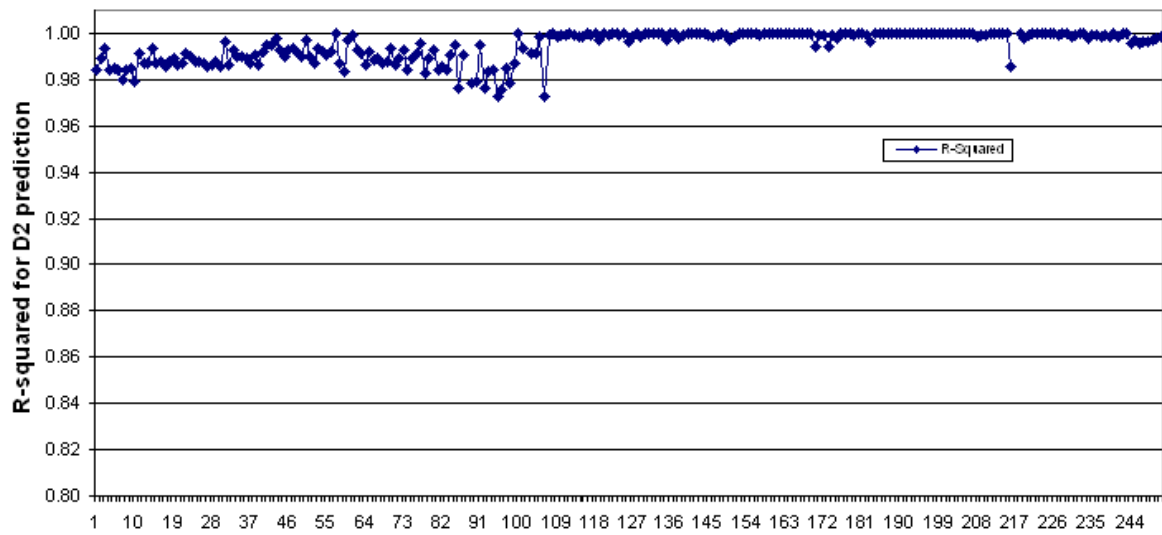
Figure 23. Graph.  $R^2$  model for d2 prediction, unit #061, 1989–90.

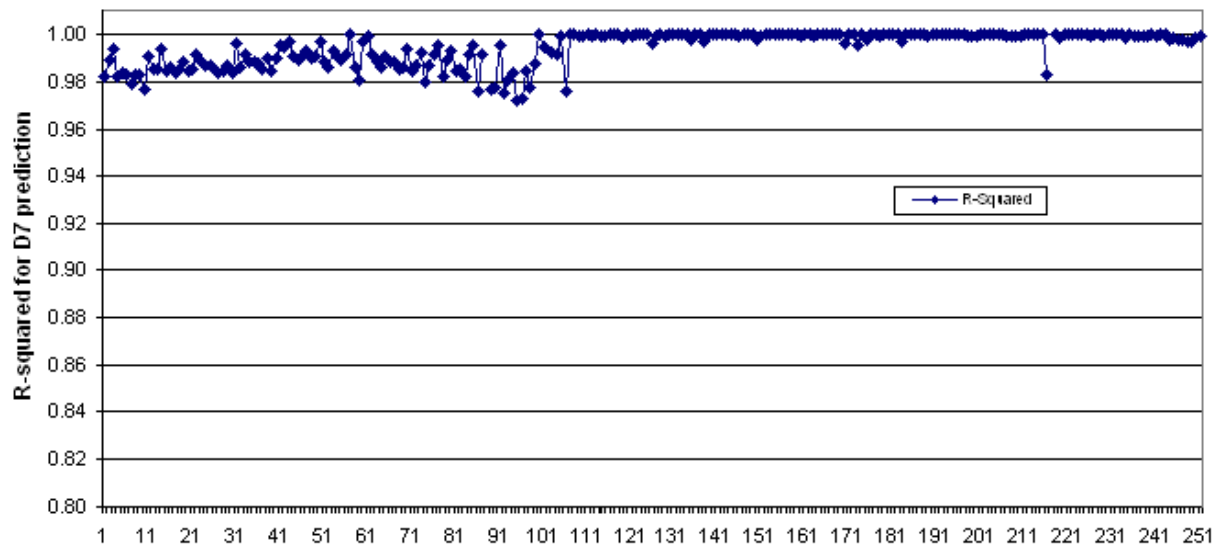
Figure 24. Graph.  $R^2$  model for d7 prediction, unit #061, 1989–90.

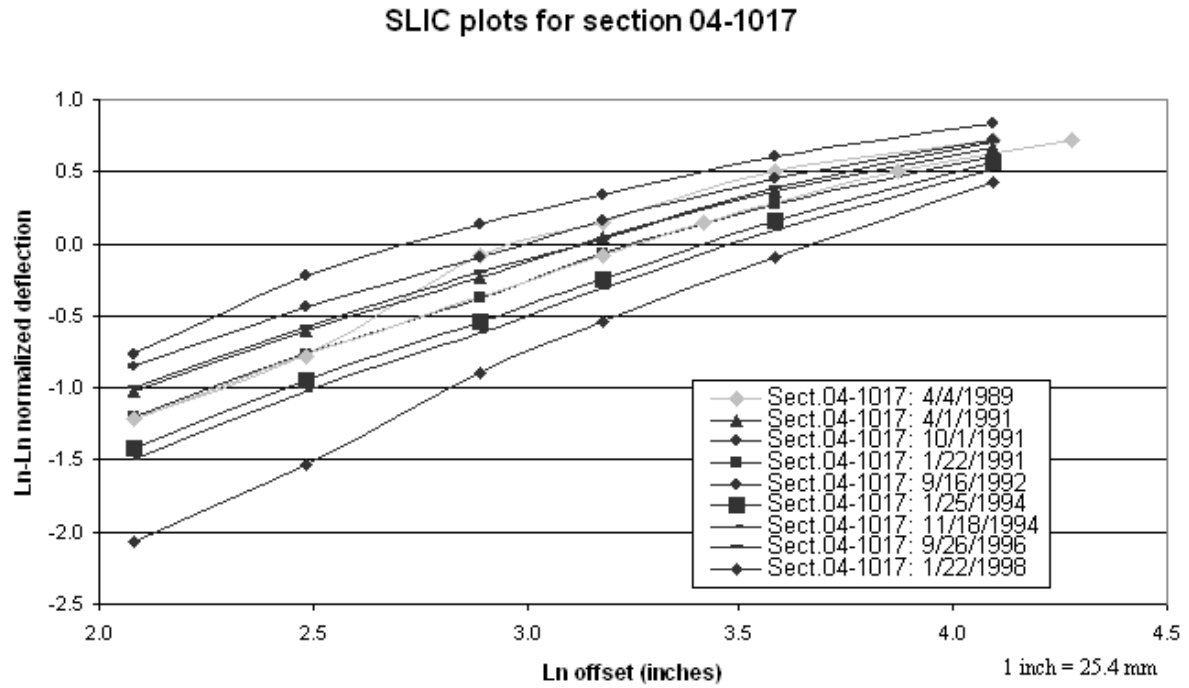
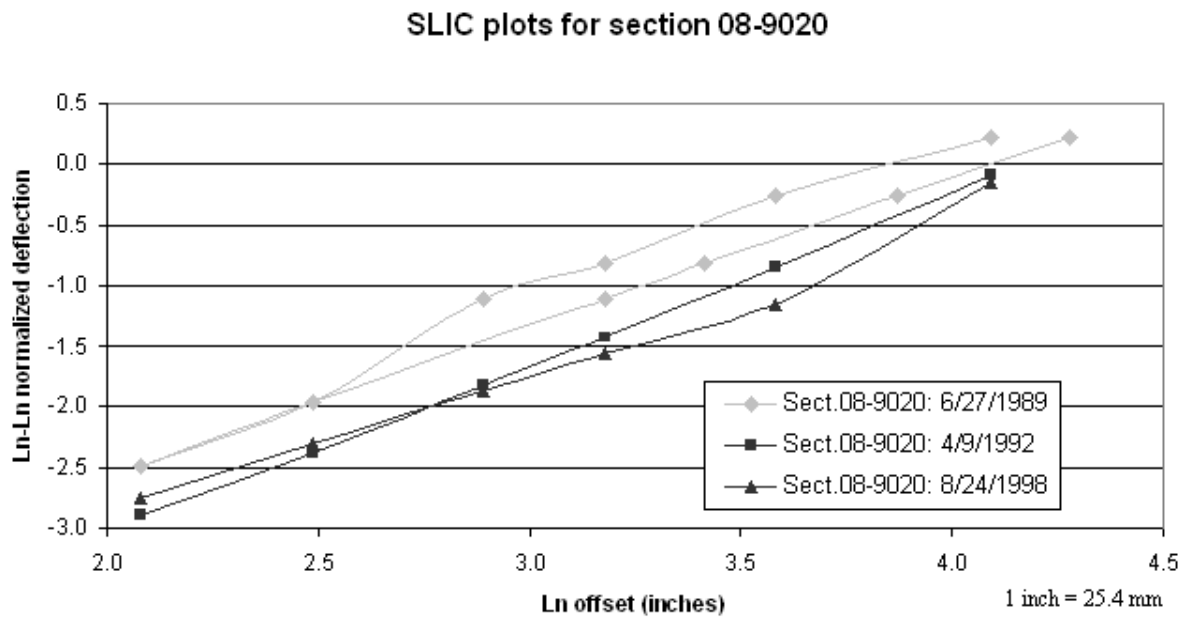
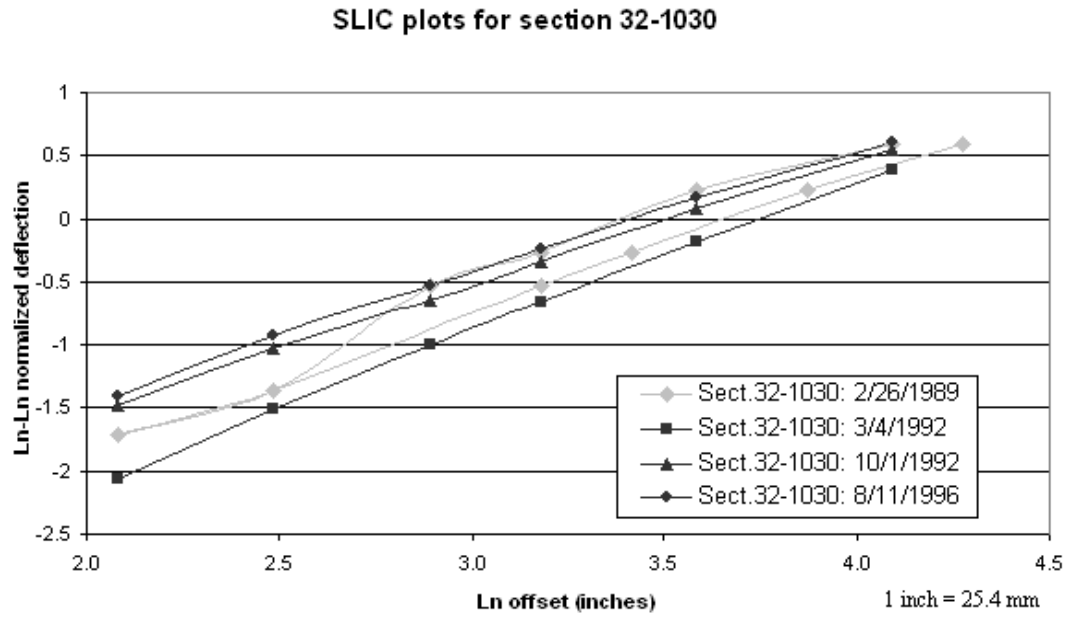
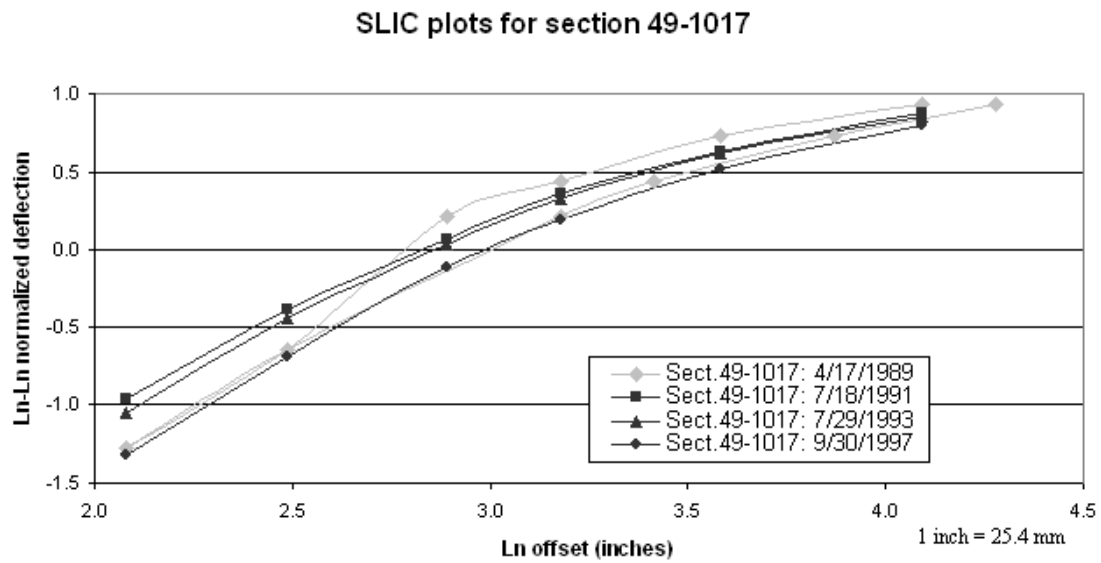
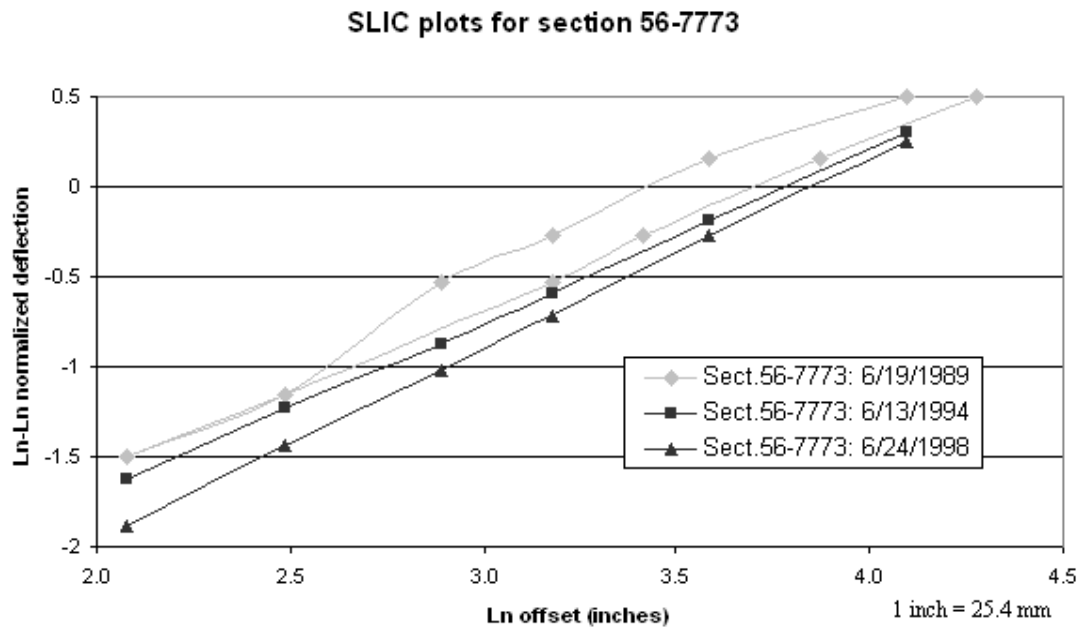
**Figure 25. Graph. SLIC plots for section 04–1017 including unit #061, April 1989.**

**Figure 26. Graph. SLIC plots for section 08–9020 including unit #061, June 1989.**

Figure 27. Graph. SLIC plots for section 32–1030 including unit #061, February 1989.

Figure 28. Graph. SLIC plots for section 49–1017 including unit #061, April 1989.

**Figure 29. Graph. SLIC plots for section 56–7773 including unit #061, June 1989.**

Because of this information, and the previous information supplied to FHWA, it can be concluded with certainty that the reported (protocol) sensor configuration was incorrect; rather, the correct configuration was either 0, 200, 300, 600, 750, 1200, and 1800 mm or 0, 8, 12, 24, 30.5, 48, and 72 inches on FWD SN #061 between February 26, 1989 and September 8, 1989. These dates correspond to the dates when lane 1 tests were conducted at drop height 4. This period of time may need to be extended slightly, if other tests were conducted along different lanes or at different drop heights. In any case, FWD tests conducted on or after September 11, 1989, indicate protocol sensor positions. FWD SN #061 was delivered to SHRP and driven to the Western Region sometime prior to February 26, 1989; all tests from the time of delivery through the beginning of September 1989 were conducted using the SLIC-determined sensor positions in lieu of the reported (protocol) positions.

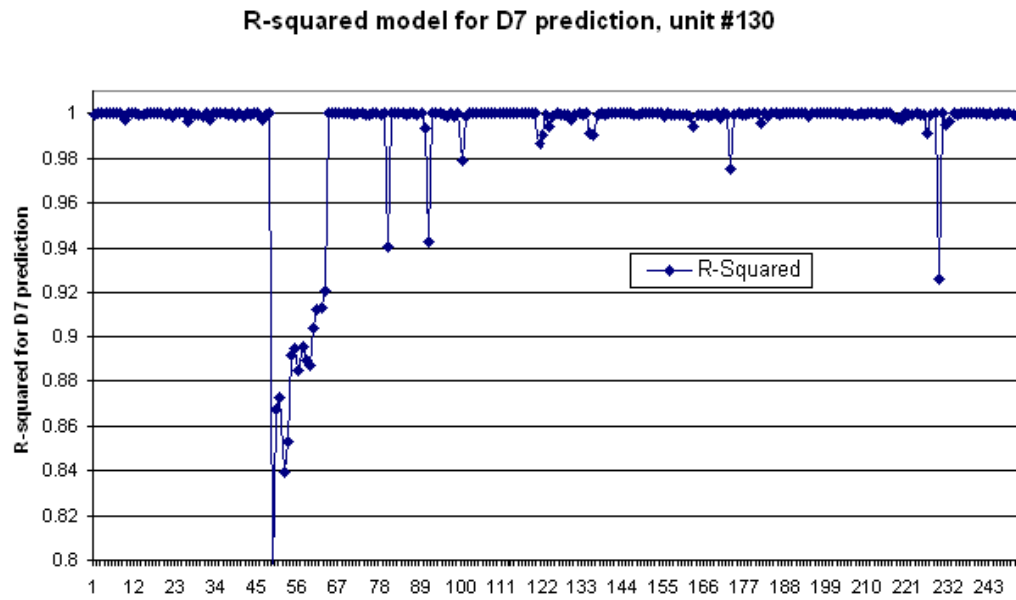
**Figure 30. Graph.  $R^2$  model for d7 prediction, unit #130, 1994–96.**

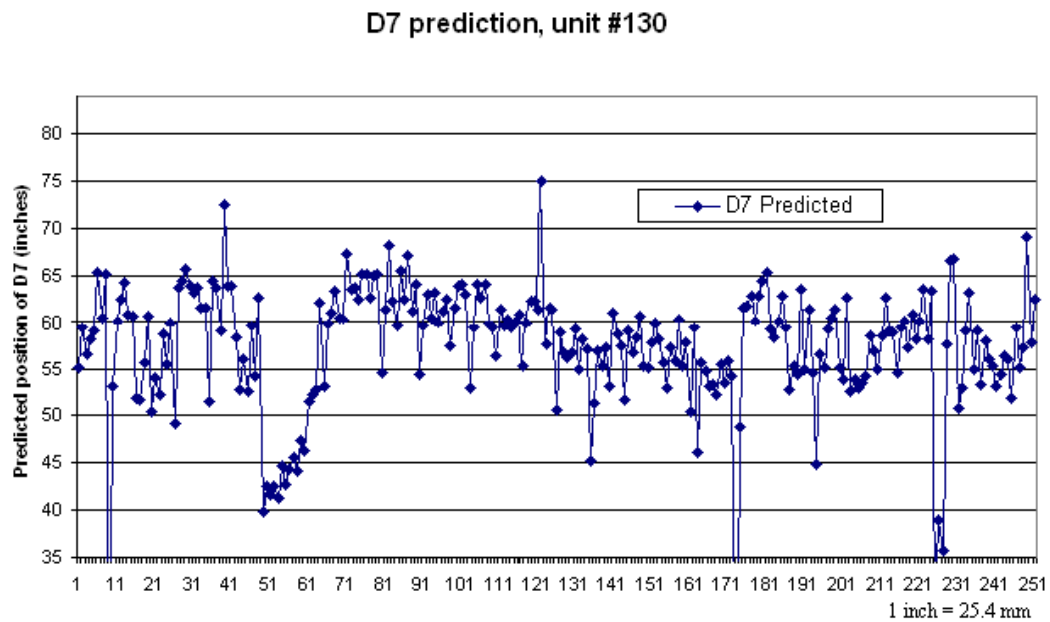
**Figure 31. Graph. Predicted position of d7, unit #130, 1994–96.**

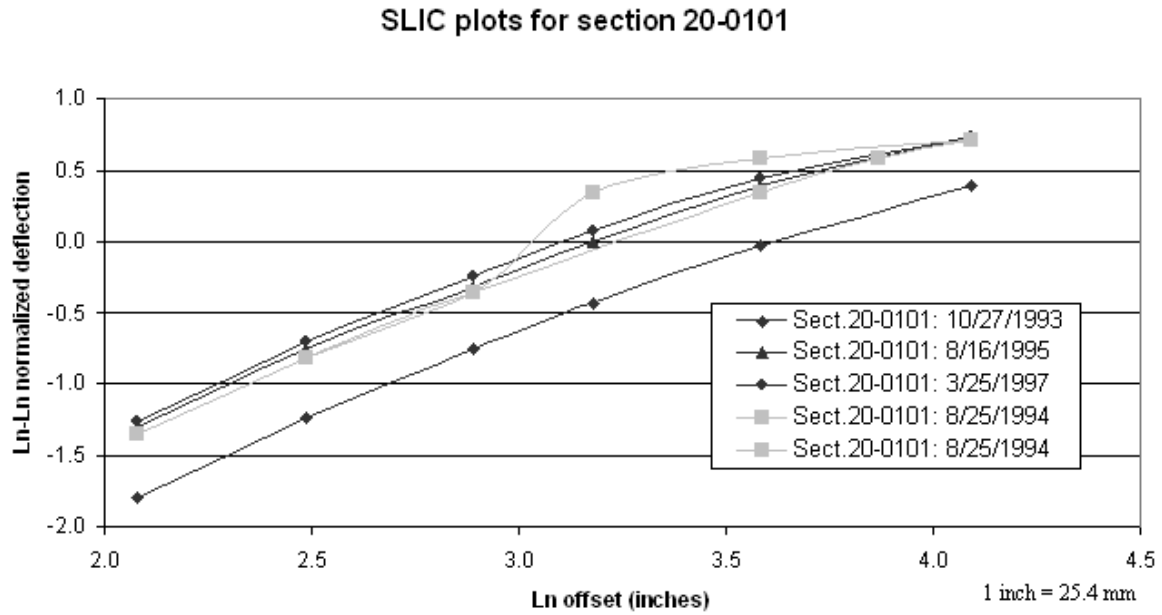
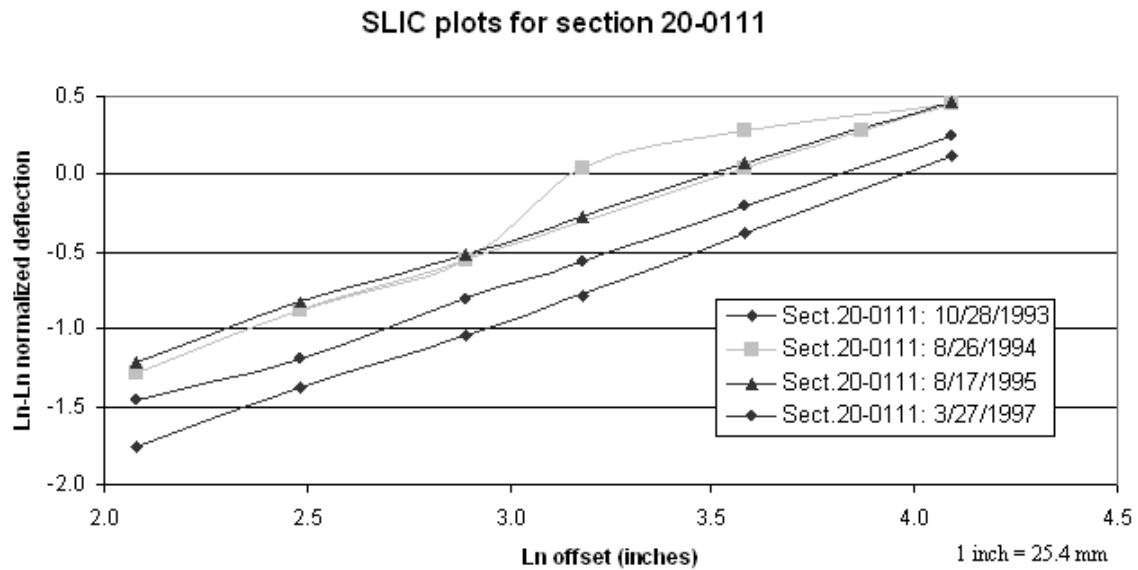
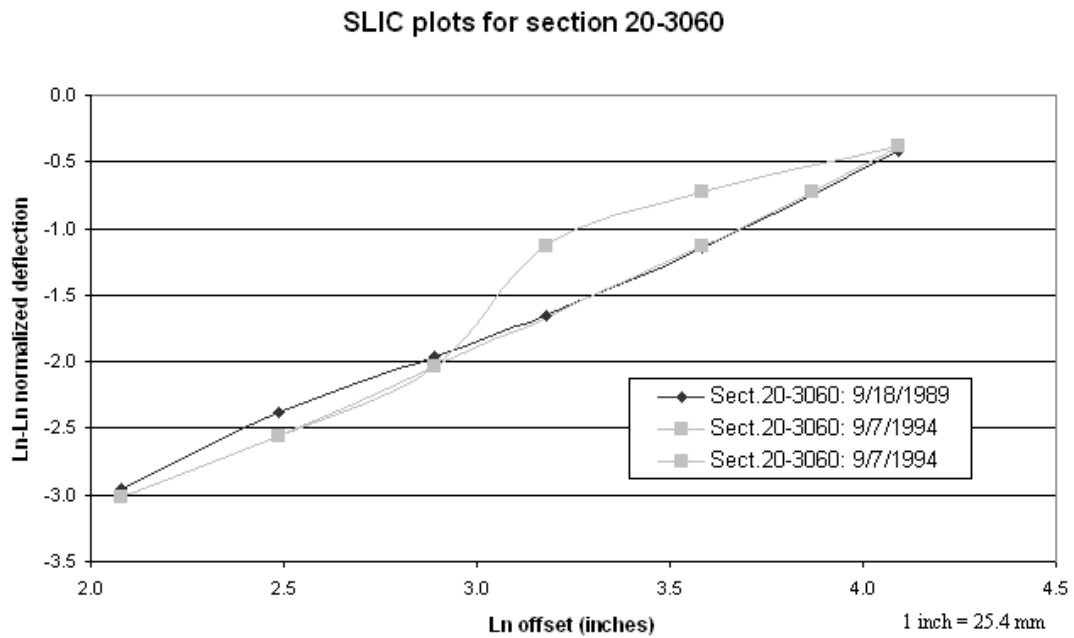
**Figure 32. Graph. SLIC plots for section 20–0101 including unit #130, August 1994.**

**Figure 33. Graph. SLIC plots for section 20–0111 including unit #130, August 1994.**

**Figure 34. Graph. SLIC plots for section 20–3060 including unit #061, September 1994.**

In figures 32, 33, and 34, the gray lines and data points are plots of both actual and erroneous data for d5 and d6 for the particular date. The gray lines that are parallel to the rest of the data are the correct plots, with d5 and d6 set to 61 cm (24 inches) and 91.4 cm (36 inches), respectively.

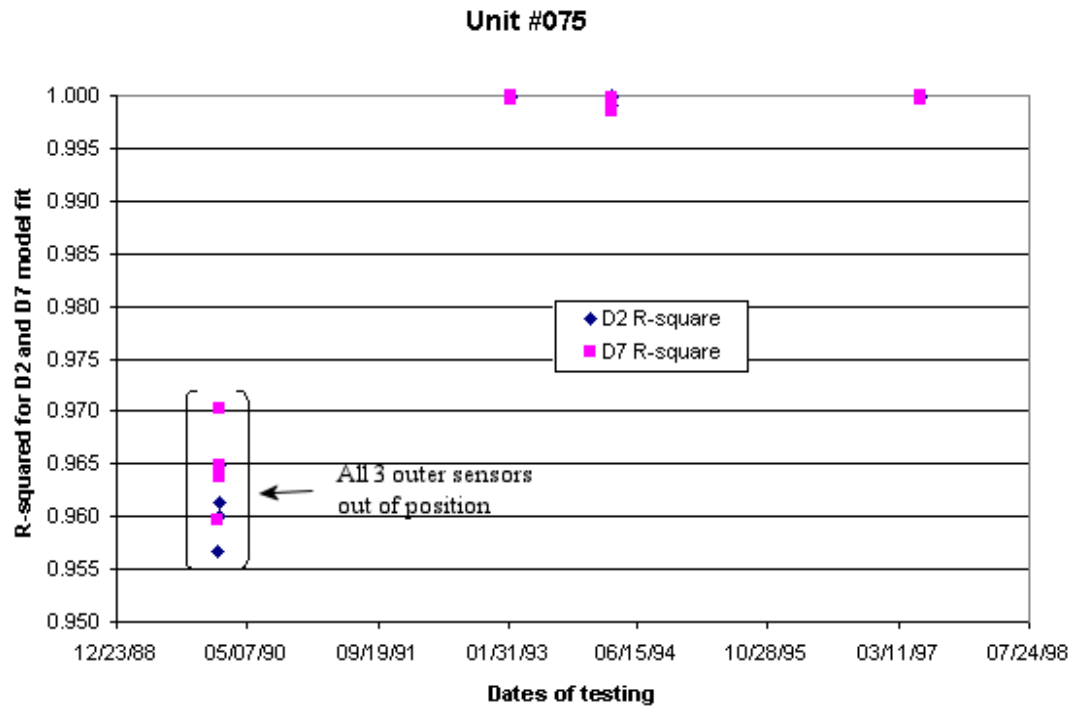
Figure 35. Graph.  $R^2$  model for d2 and d7 predictions, unit #075, 1990–97.

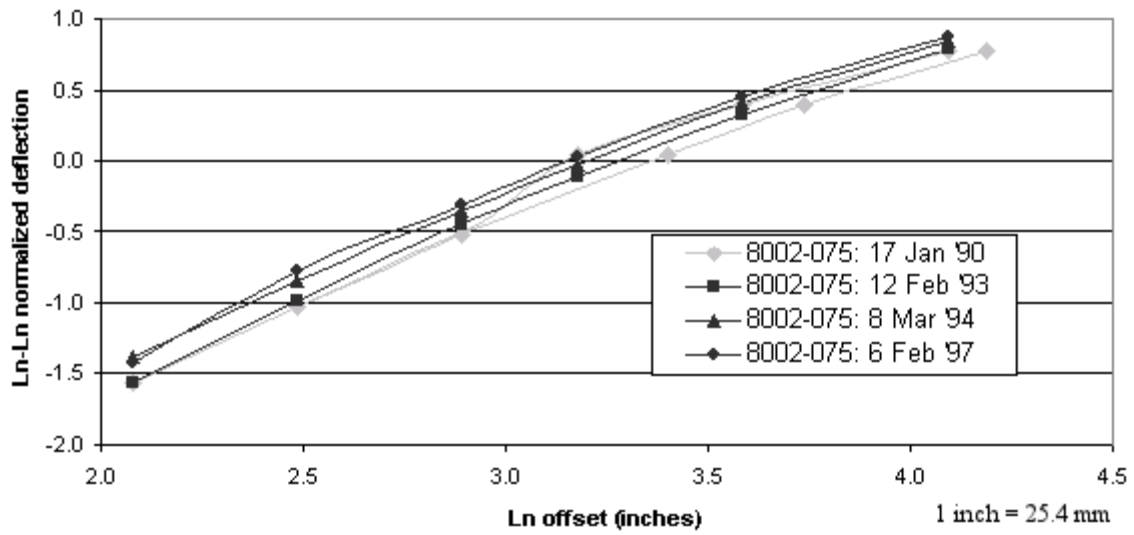
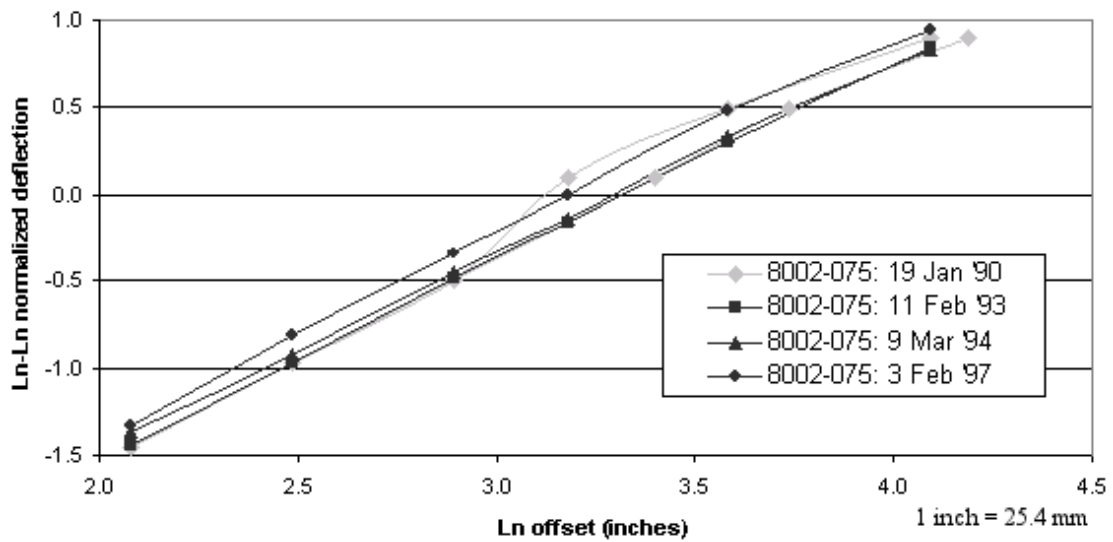
Figure 36. Graph. SLIC plots for section 72-1003 including unit #075, January 1990.

Figure 37. Graph. SLIC plots for section 72-4122 including unit #075, January 1990.

In figures 36 and 37, the gray lines and data points are plots of both actual and erroneous data for d5, d6, and d7 for the particular date. The gray lines that are parallel to the rest of the data are the correct plots, with d5, d6, and d7 set to 76.2 cm (30 inches), 106.7 cm (42 inches) and 167.6 cm (66 inches), respectively.
