# Study of Long-Term Pavement Performance (LTPP): Pavement Deflections

PUBLICATION NO. FHWA-RD-03-093

AUGUST 2006

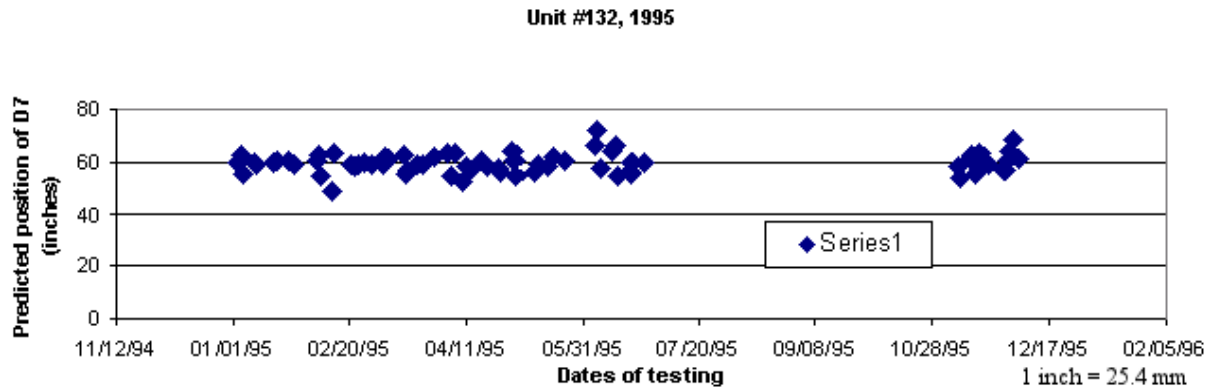
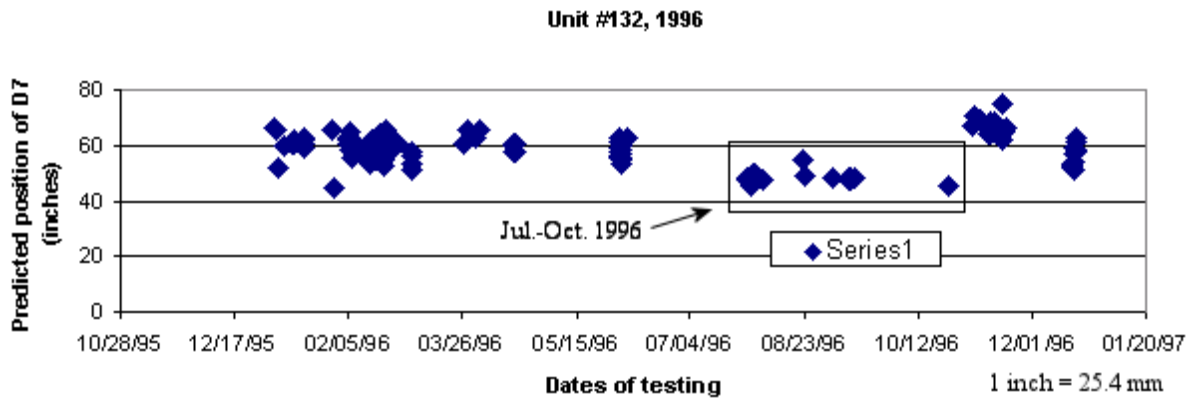
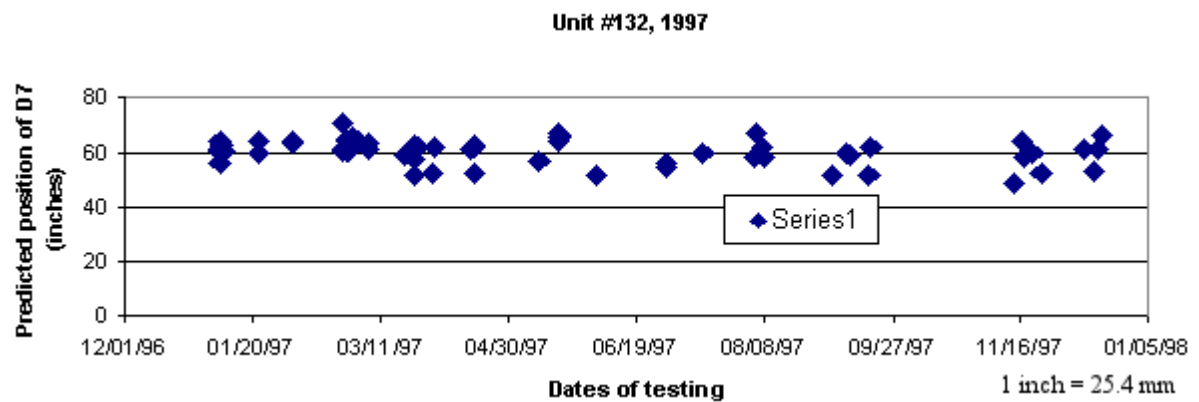
**Figure 38. Graph. Predicted position of d7, unit #132, 1995.**

**Figure 39. Graph. Predicted position of d7, unit #132, 1996.**

**Figure 40. Graph. Predicted position of d7, unit #132, 1997.**

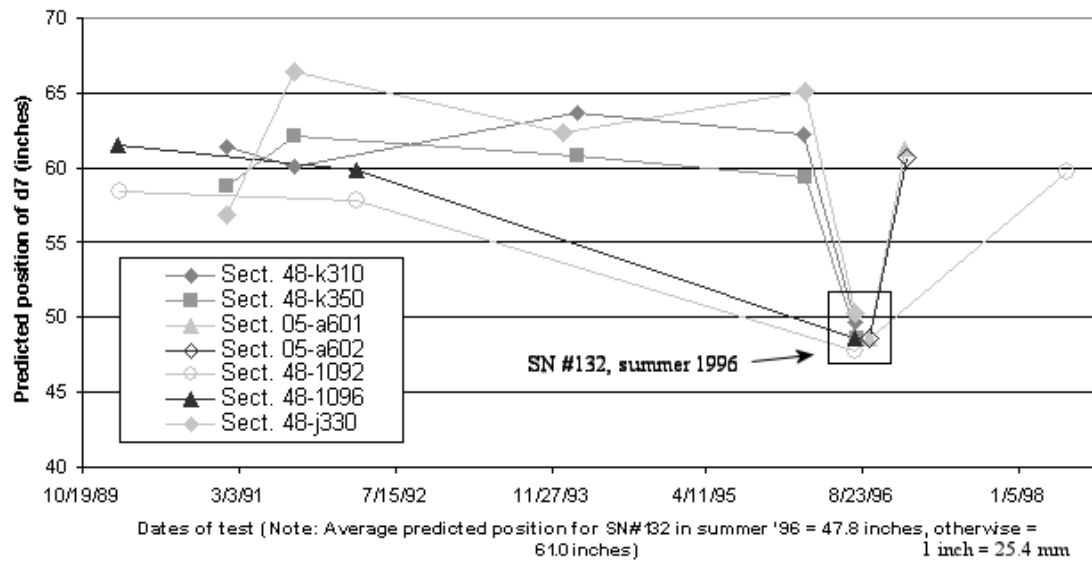
**Same section data: SLIC prediction of d7 position for FWD SN #132, summer 1996**

**Figure 41. Graph. Same section data for d7 position, three different FWDs.**

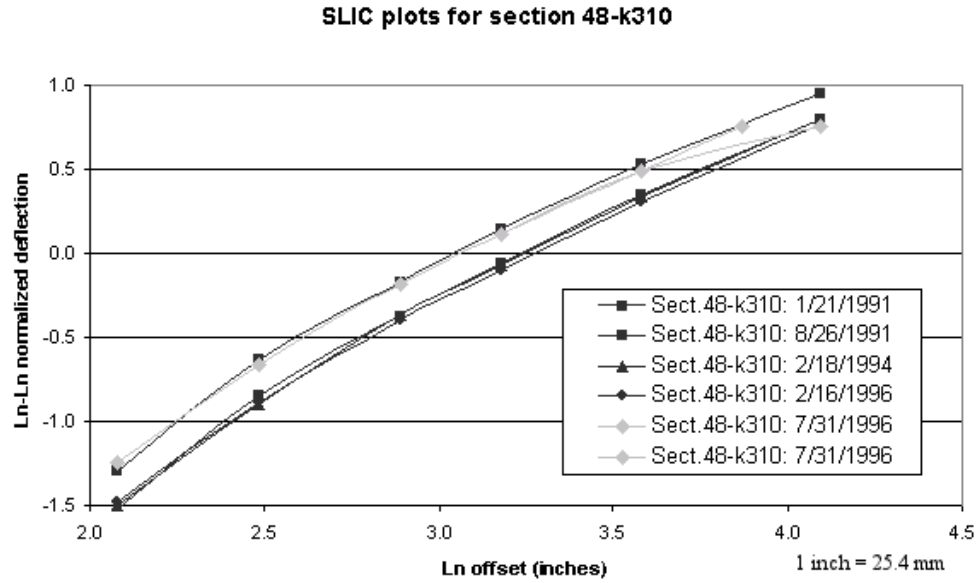
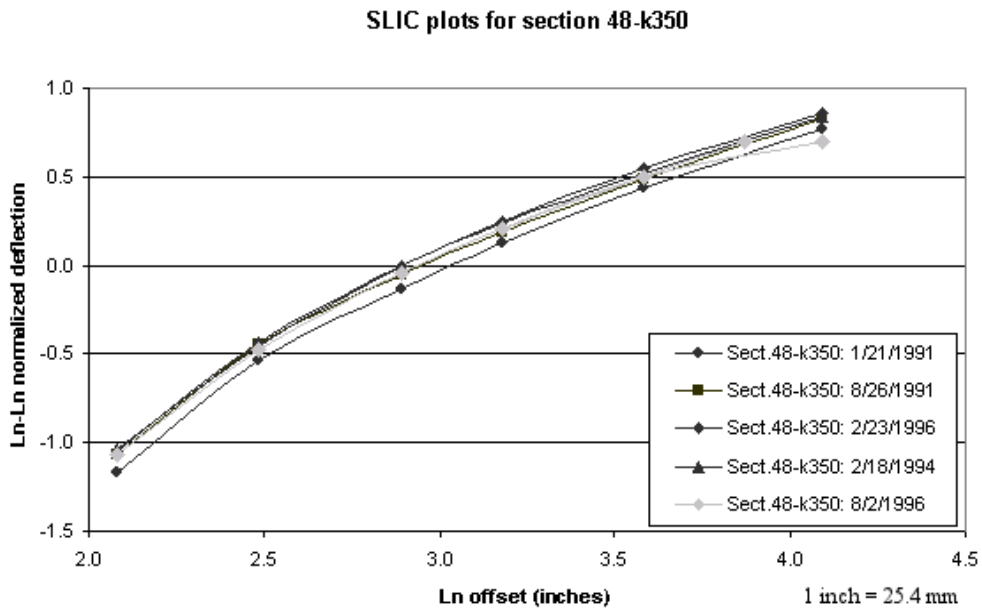
**Figure 42. Graph. SLIC plots for section 48-k310 including unit #132, July 1996.**

**Figure 43. Graph. SLIC plots for section 48-k350 including unit #132, August 1996.**

In the two figures that follow, figures 42 and 43, the same results are shown graphically, with the gray lines and data points showing the SLIC plots for d7 in both its actual (121.9 cm (48 inches)) and protocol but incorrect (152.4 cm (60 inches)) offset positions. The gray lines that are parallel to the rest of the lines are the correct plots, with d7 set to 121.9 cm (48 inches).

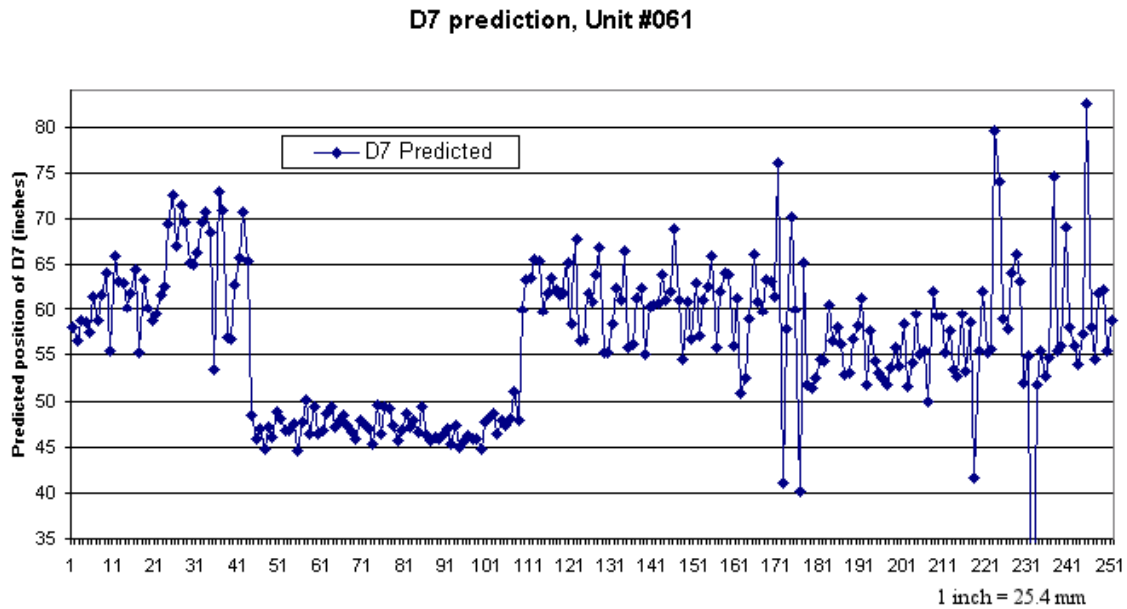
**Figure 44. Graph. Predicted position of d7, unit #061, 1994–97.**

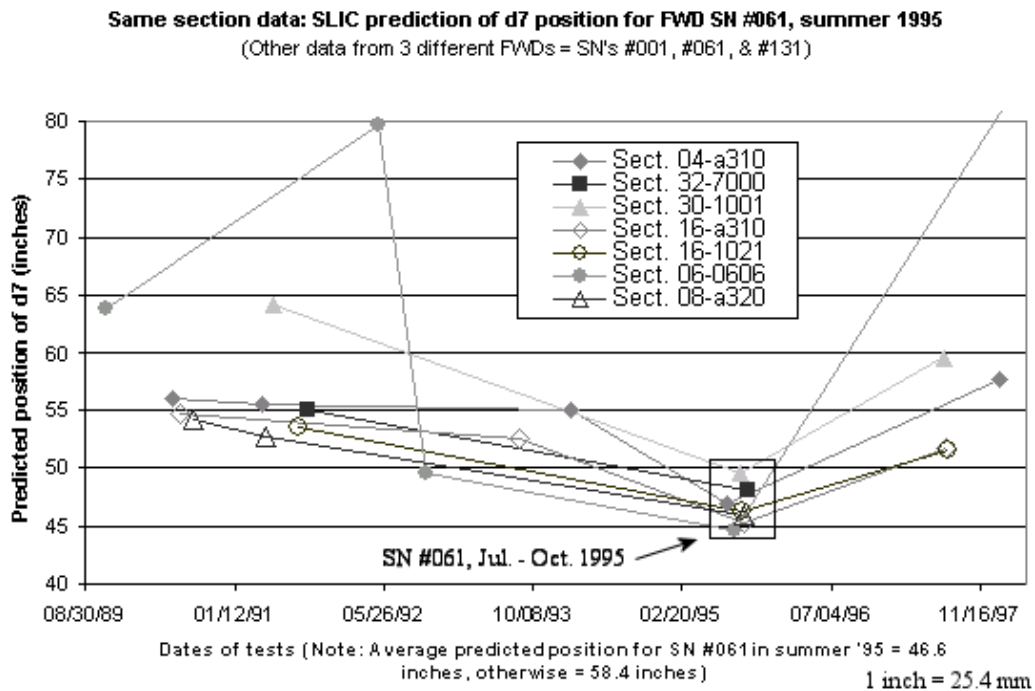
**Figure 45. Graph. Same section data for d7 position, three different FWDs.**

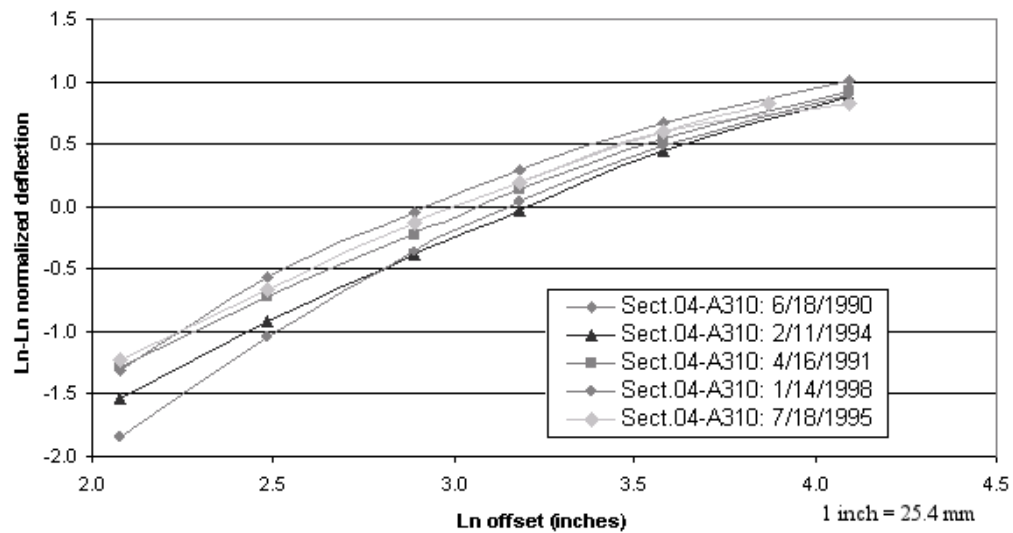
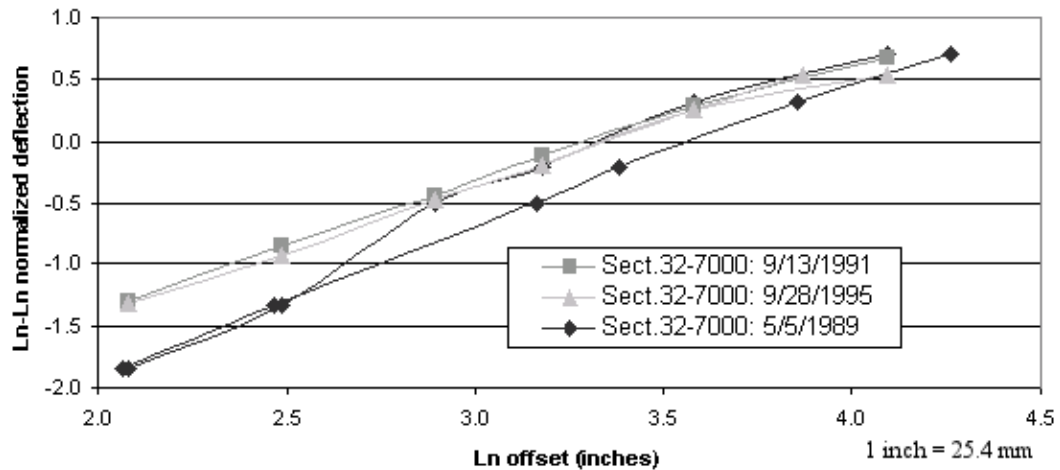
Figure 46. Graph. SLIC plots for section 04-A310 including unit #061, July 1995.

Figure 47. Graph. SLIC plots for section 32-7000 including unit #061, September 1995.

Because of this information, and the previous information supplied to FHWA, it can be concluded with certainty that d7 was *not* positioned correctly at 152.4 cm (60 inches); rather, it was positioned at 121.9 cm (48 inches) (or very close to 121.9 cm (48 inches)) on FWD SN #061 between July 17, 1995, and October 31, 1995. These dates correspond to the dates when lane 1 tests were conducted at drop height 4. This period of time may need to be extended slightly, if other tests were conducted along different lanes or at different drop heights. In any case, FWD tests conducted on or before March 31, 1995, and on or after November 14, 1995, clearly show d7 positioned at 152.4 cm (60 inches) (per protocol).

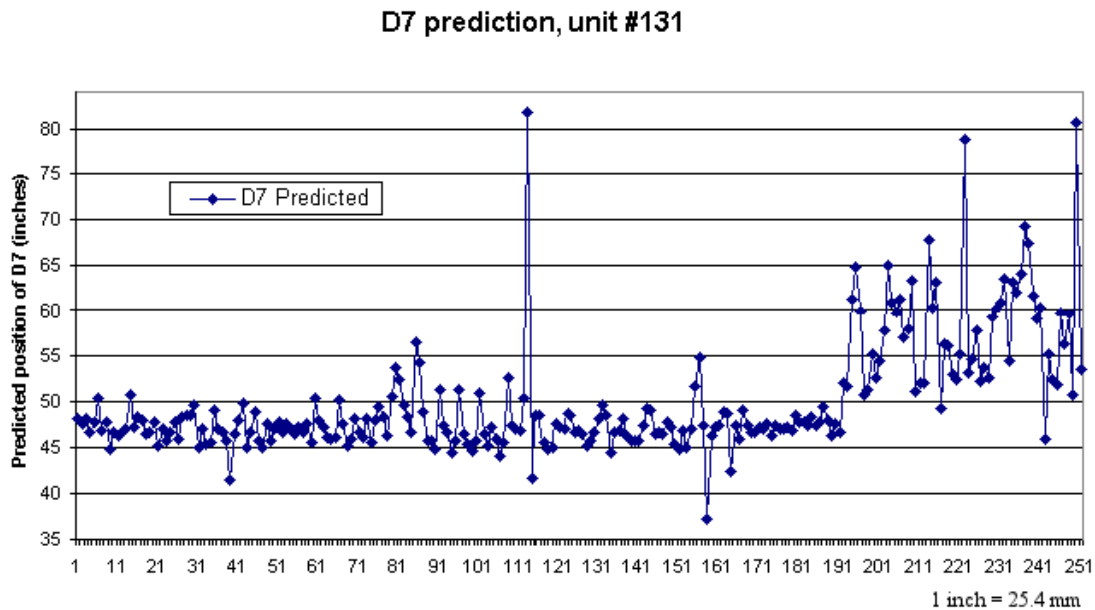
**Figure 48. Graph. Predicted position of d7, unit #131, 1994–97.**

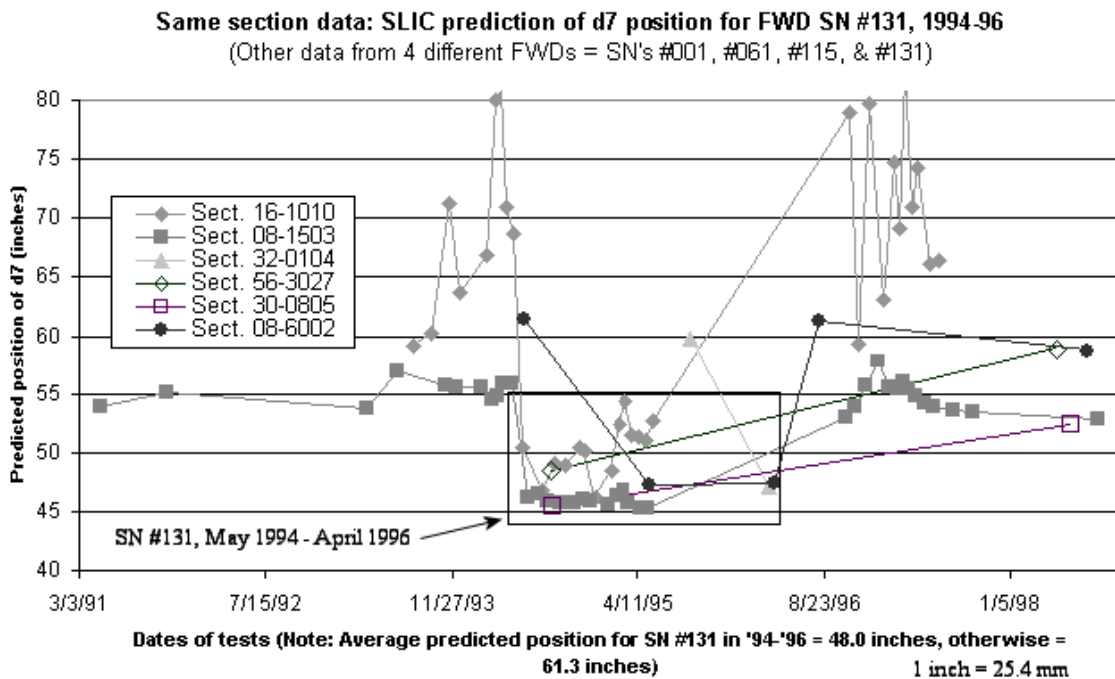
**Figure 49. Graph. Same section data for d7 position, four different FWDs.**

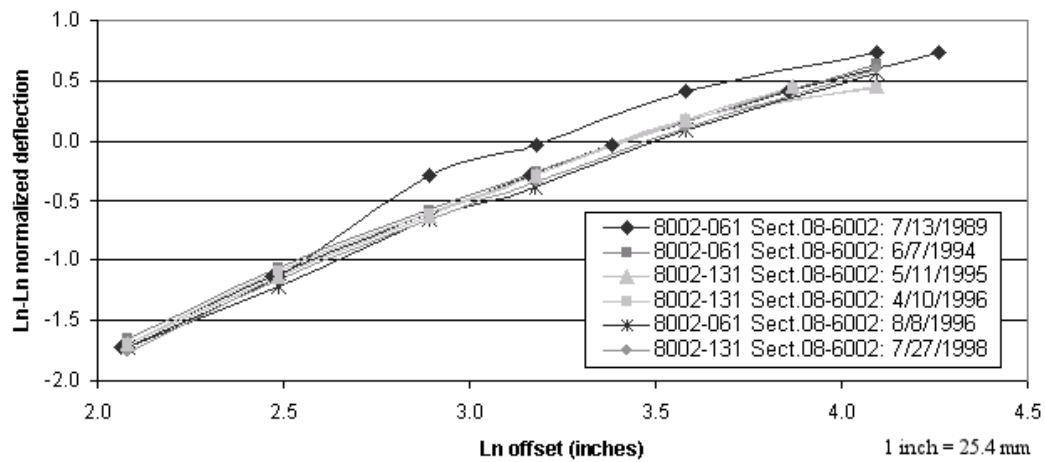
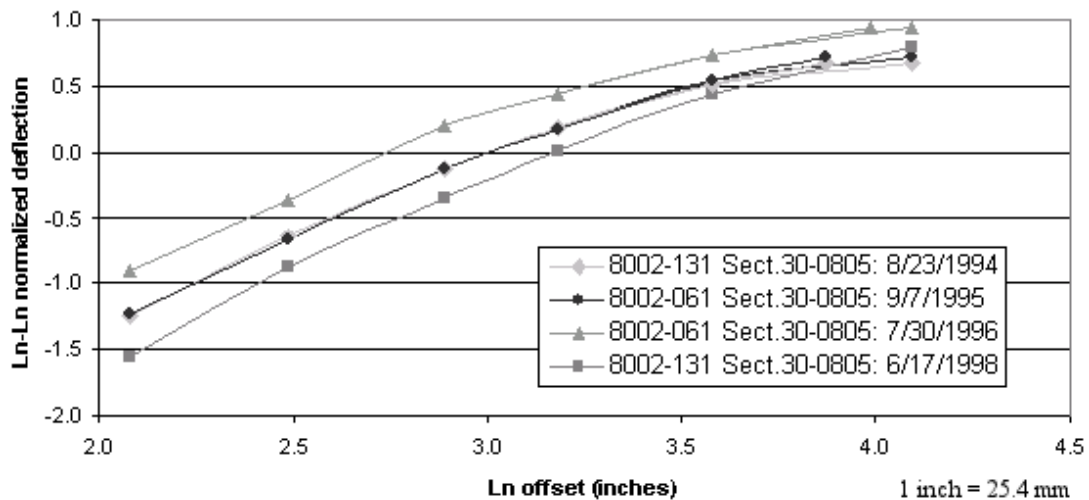
Figure 50. Graph. SLIC plots for section 08-6002 including unit #131, May 1995 and April 1996.

Figure 51. Graph. SLIC plots for section 30-0805 including unit #131, August 1994.

May 24, 1994. Evidently, all tests from the time of delivery through the end of June 1996 were conducted using the SLIC-determined d7 sensor position of 121.9 cm (48 inches) in lieu of the reported protocol position of 152.4 cm (60 inches).

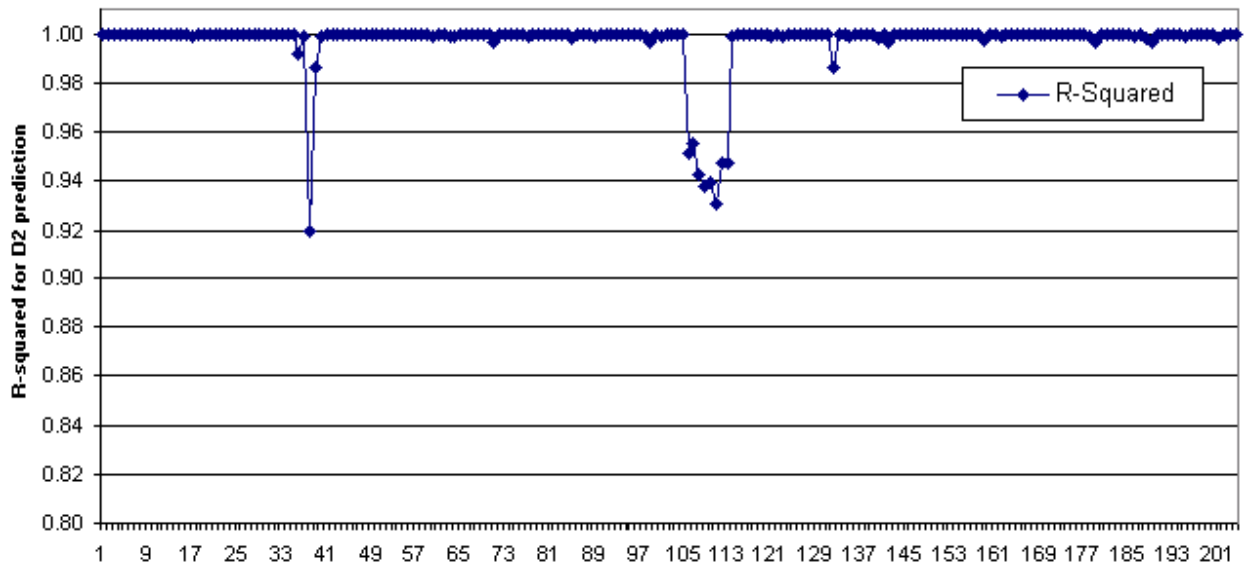
Figure 52. Graph. R-squared model for d2 prediction, unit #131, 1997–98.

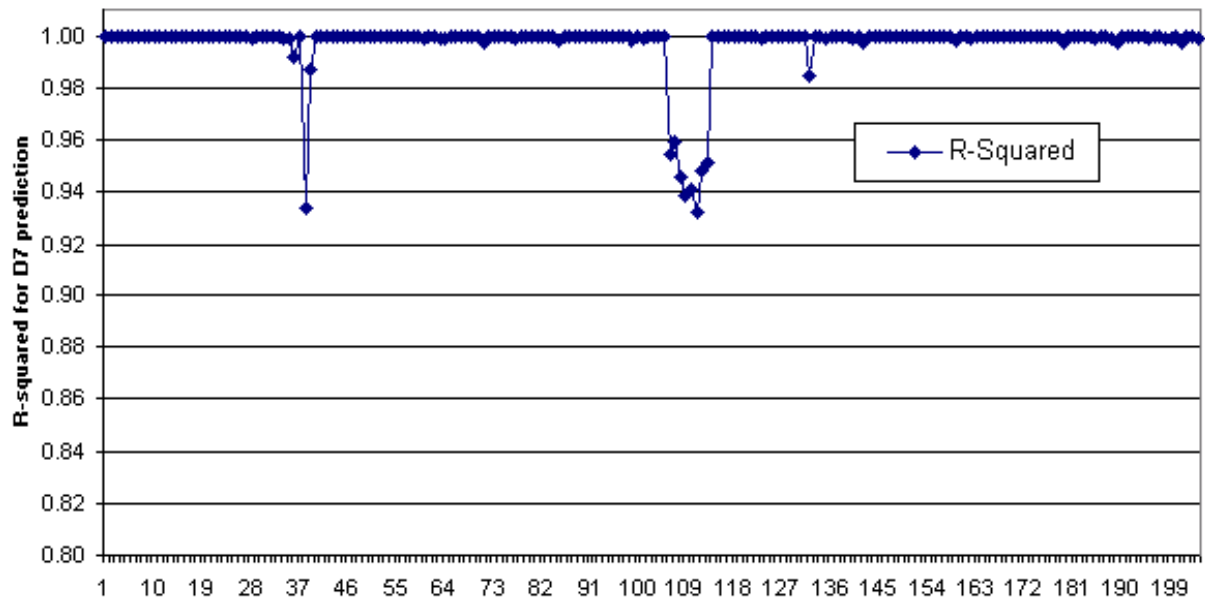
Figure 53. Graph. R-squared model for d7 prediction, unit #131, 1997–98.

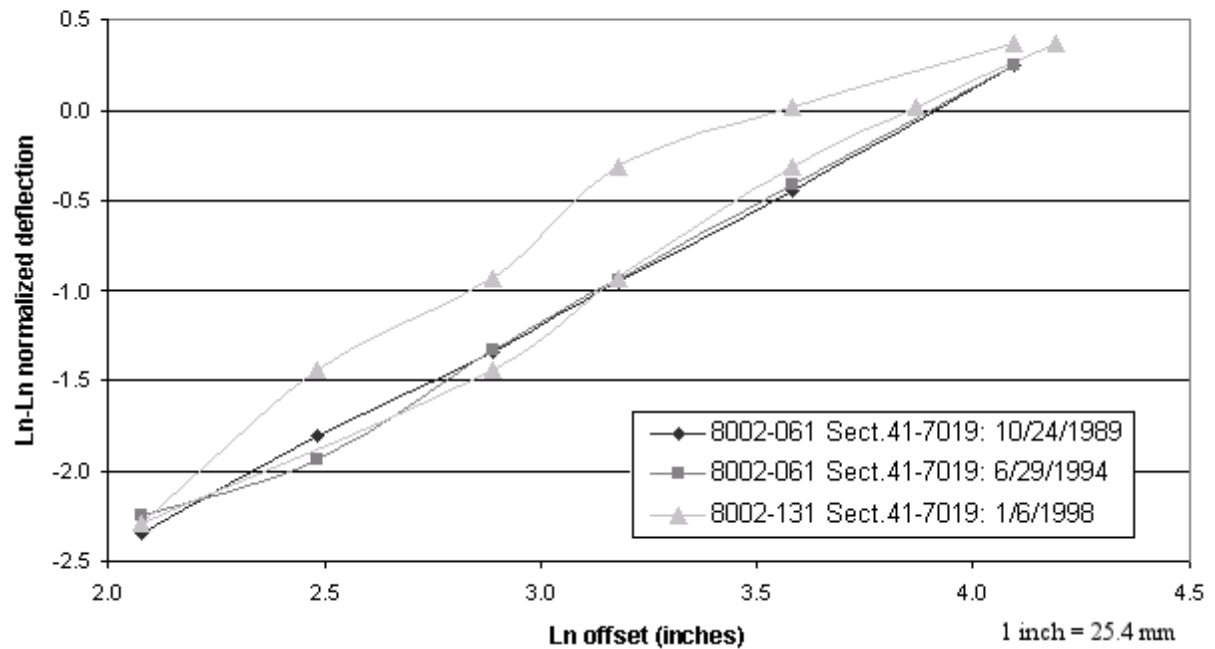
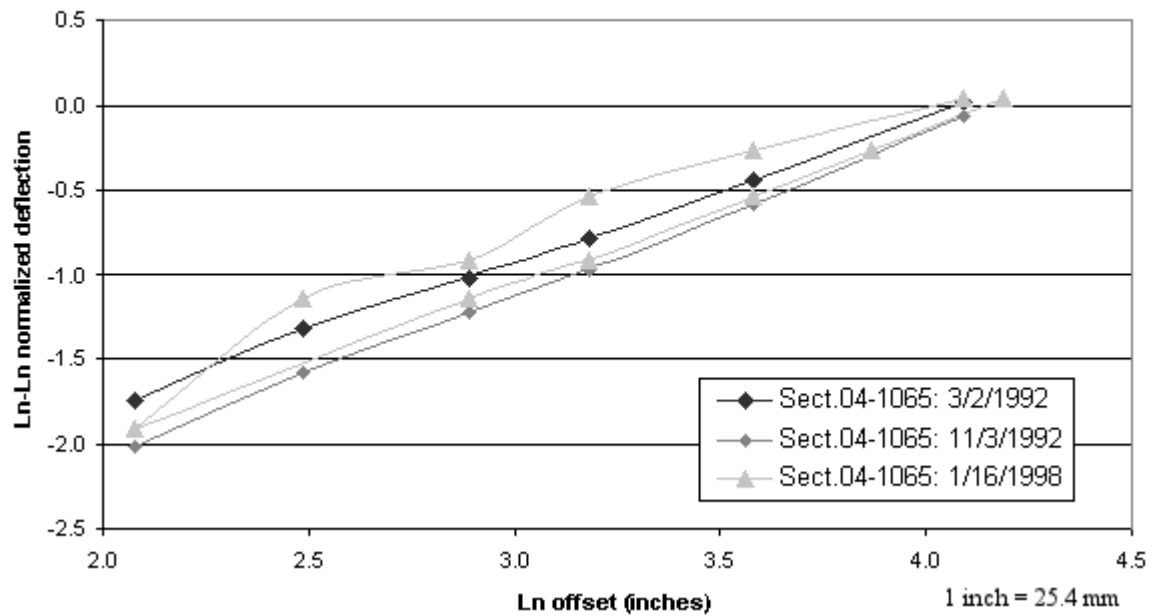
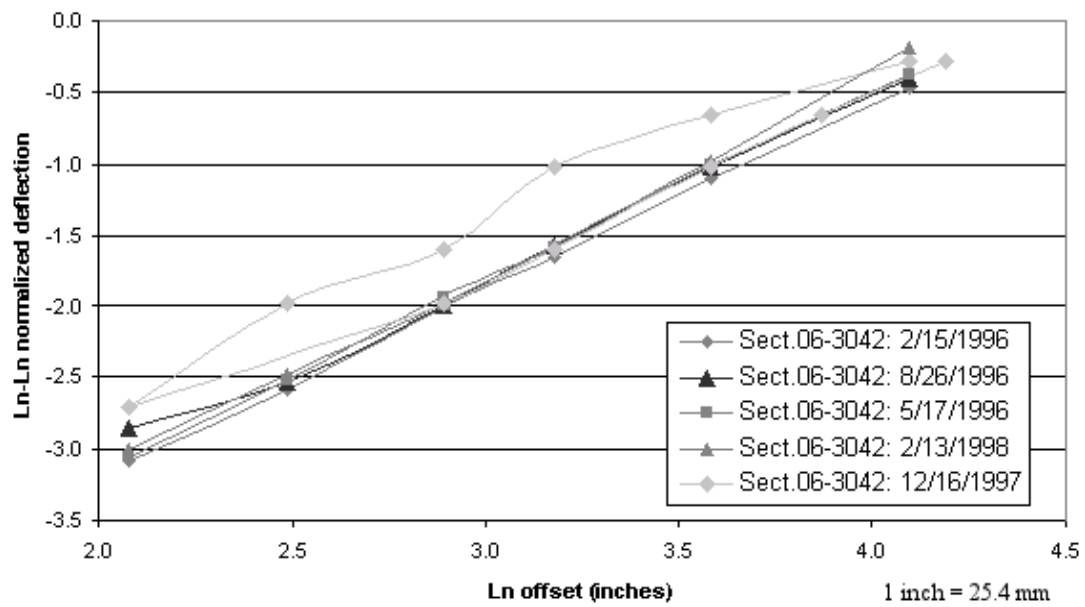
Figure 54. Graph. SLIC plots for section 41-7019 including unit #131, January 1998.

Figure 55. Graph. SLIC plots for section 04-1065 including unit #131, January 1998.

Figure 56. Graph. SLIC plots for section 06-3042 including unit #131, December 1997.
