## TECHBRIEF

# Reducing Roughness in Rehabilitated Asphalt Concrete (AC) Pavements

PUBLICATION NO. FHWA-RD-98-149

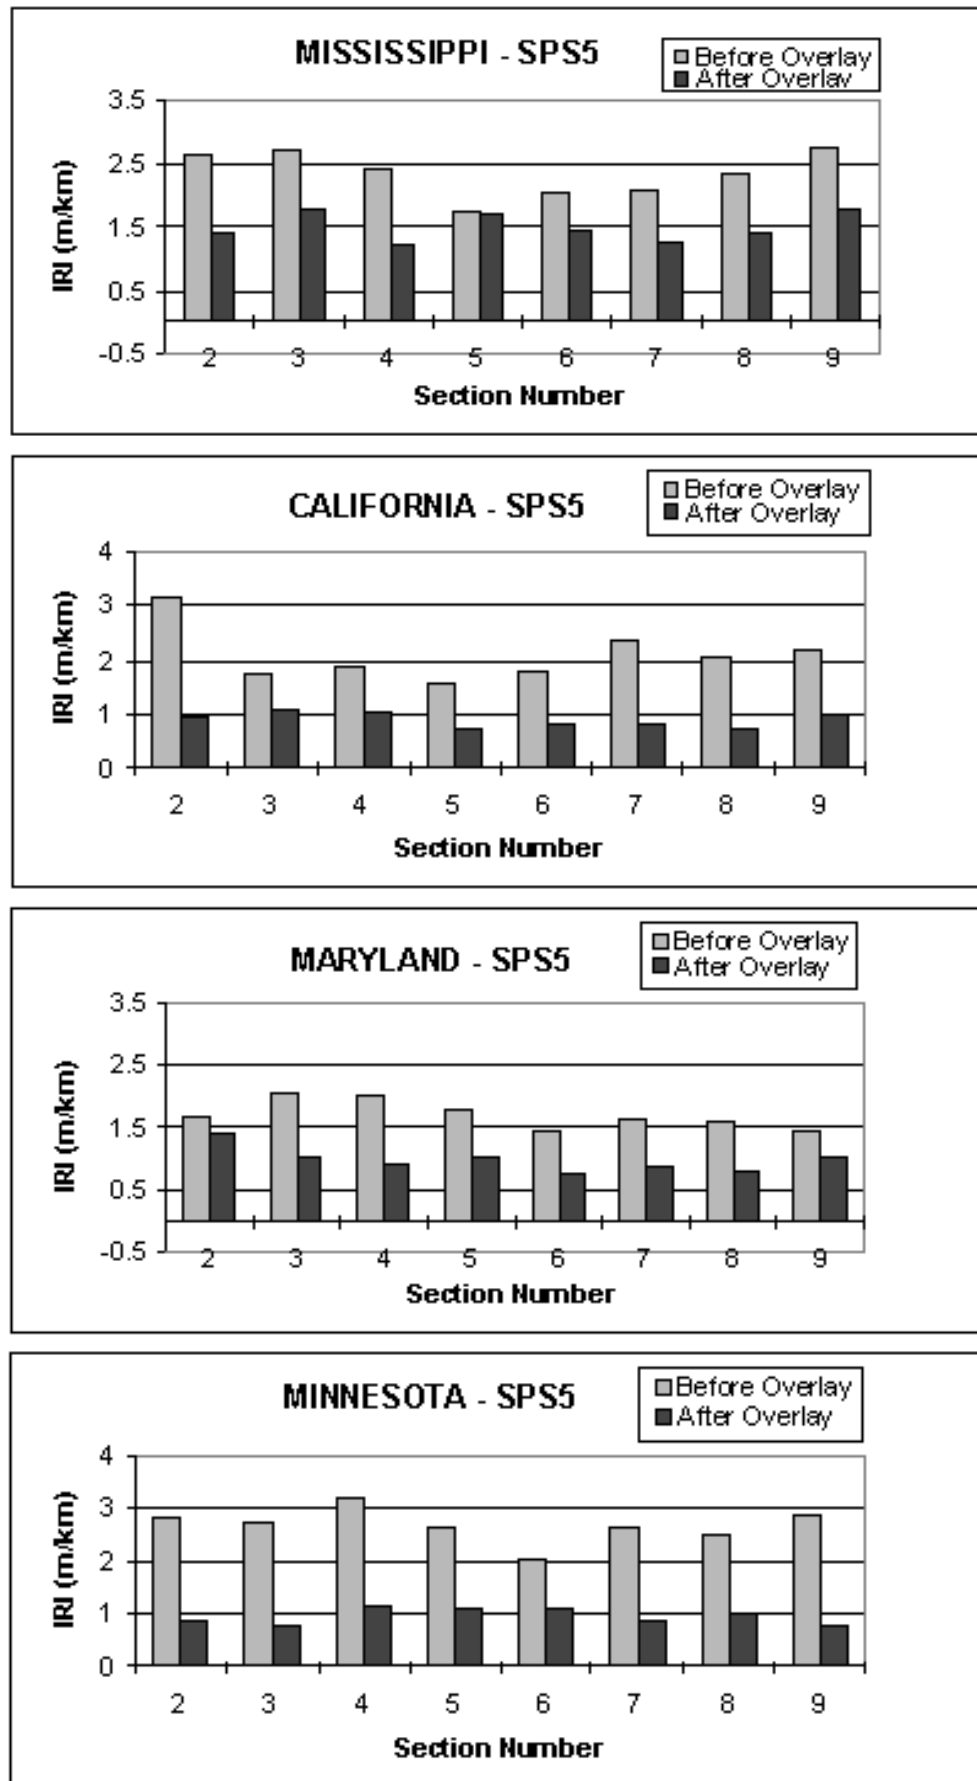
**Figure 1.** IRI before and after overlay for four SPS-5 projects.

Figure 1 (on the following page) shows the roughness before and after rehabilitation for four Special Pavement Study (SPS)-5 projects. As you will note, regardless of the roughness before the overlay of a section, the roughness after the overlay for all treatments fell within a narrow band, which varied from project to project. Factors that could determine the range of this band include construction procedures, contractor capabil-

ity, and the predominant wavelengths that contribute to roughness and are present in the pavement prior to overlay.

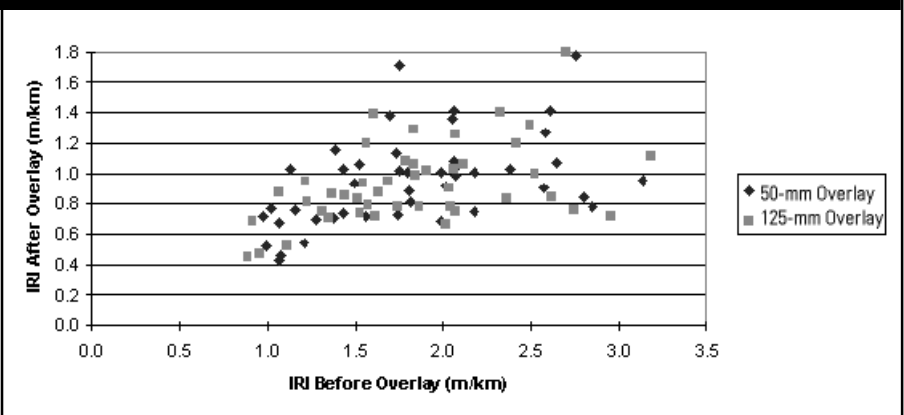
**Figure 3. IRI before and after overlay.**

Figure 3 shows the relationship between roughness before and after overlay for all sections. The sections that have an IRI before overlay of less than 1.4 m/km are from two projects. If the sections in these two projects are not considered, and only the sections that have an IRI greater than 1.4 m/km before overlay are considered, data in figure 3 show that there is no relationship between the IRI before and after the overlay. Thin overlays are seen to be capable of reducing the roughness of a pavement by a substantial amount in some cases. For example, figure 3 shows that in three sections that had IRI between 2.5 and 3 m/km, a 50-mm-thick overlay reduced the IRI to approximately 0.8 m/km.

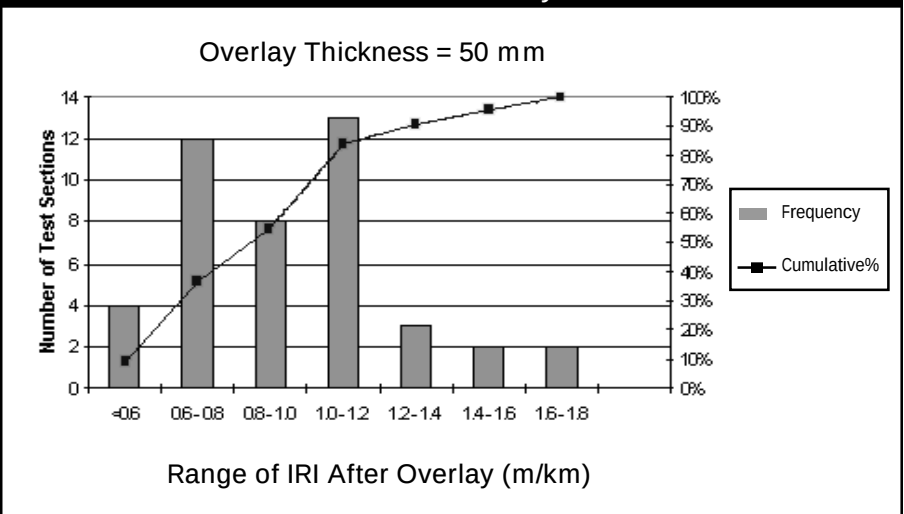
**Figure 4. Frequency distribution of IRI after overlay for sections that received a 50-mm overlay.**

A frequency distribution of the IRI after overlay for the test sections

that received a 50-mm overlay are shown in figure 4. This figure also presents the cumulative frequency curve, and shows that approximately 55 percent of the test sections had an IRI value of less than 1 m/km, while 85 percent of the test sections had an IRI value of less than 1.2 m/km.

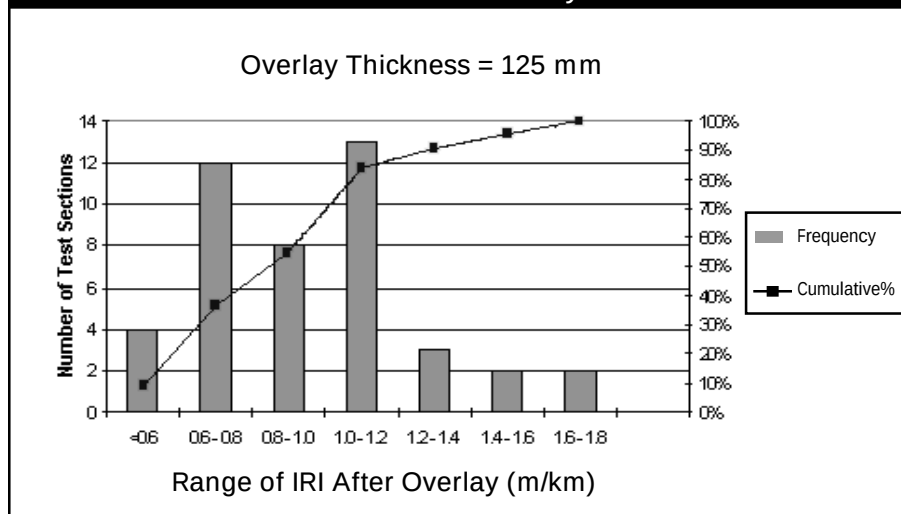
**Figure 5.** Frequency distribution of IRI after overlay for sections that received a 125-mm overlay.

A frequency distribution of the IRI after overlay of the test sections that received a 125-mm overlay is shown in figure 5. The frequency distribution curve in this figure shows that approximately 65 percent of the test sections had an IRI after overlay of less than 1 m/km, while 85 percent of the test sections had

an IRI after overlay of less than 1.2 m/km. These data indicate that in 85 percent of the cases the IRI of an overlaid pavement would be less than 1.2 m/km.
