- Site Service Report -

Project Name/Location: Service Date(s): Maine I-95 Ltp Maintenance

Job Description: Perform Preventative Maintenance on the I-95 Ltp site

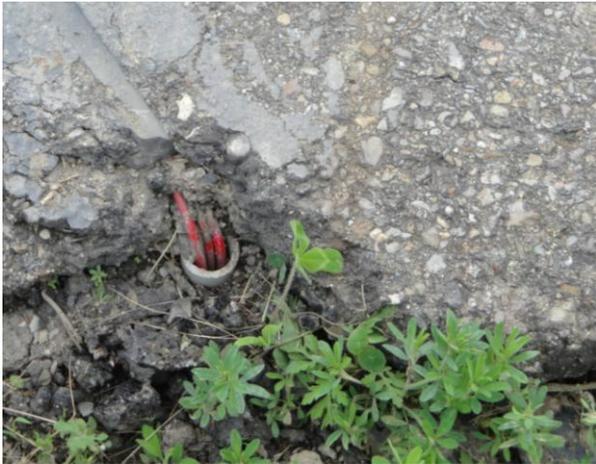
Arrived on site at approximately 2:00pm Tuesday June 30. Opened the cabinet and inspected and inspected the in road sensors. I noticed that loop sealant was gone from the conduit of the upstream Kistler sensors and the pavement around the conduit had broken away exposing the conduit and the sensor leads. I then connected to the Isinc with my Laptop to ensure that there was no problem with the sensors and everything appeared to be fine. I proceeded to patch the missing loop sealant and pavement, first sealing the conduit with duct seal and then using a can of Durant Stat-a-flex loop sealant to seal the conduit and protect the sensor leads. Proceed to measure the electrical charcthersitcs of the sensors, all sensors tested good. See below table for test results.

Before patching

Since the pavement around the conduits are starting to break away this needs to be monitored and most likely be patched more in the future. Future maintenance visits field personnel need to be prepared to patch area if needed.

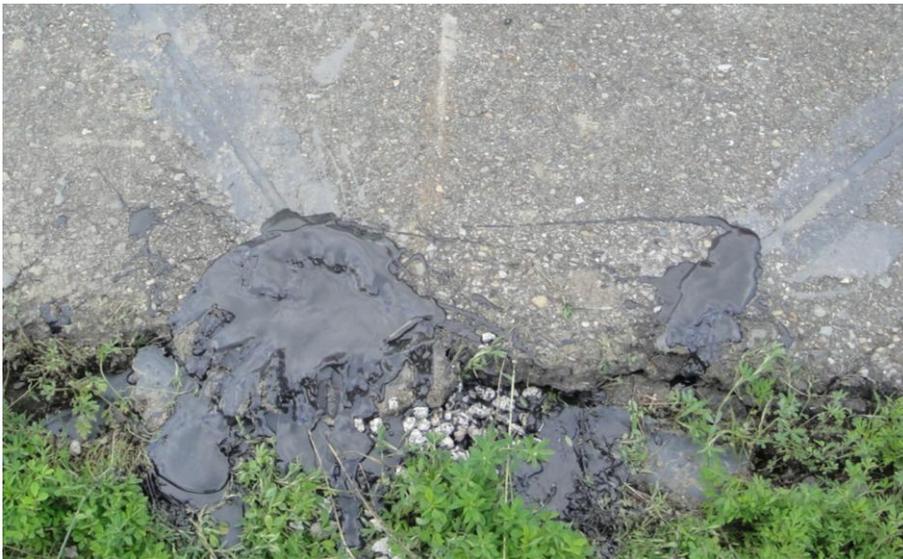
After Patching

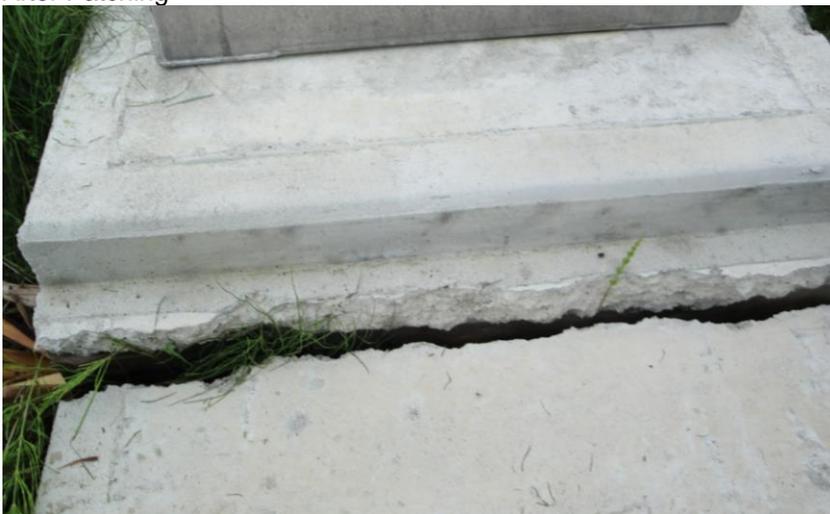
The 12 Volt batteries were tested with a battery anylzier and where 13.4V and tested good. More anti-corrison grease was put on the battery terminals. The cabinet was cleaned and was inspected for any abnormalities including the pole for the solar panel. The concrete foundation for the cabinet has broken away from the standing pads on either side of the foundation. No need for repair as it is purely an aesthetic issue now and the break is a fairly clean one and it doesn't look bad. Standing pads and cabinet foundation should not be one continuous pour.

Standing pad separating from cabinet foundation
