## - Site Report -

**Project Name/Location:** Jackson LTPP (TN) / I-40 Mile Post 91.6

**Service Date(s):** December 11<sup>th</sup>, 2009

- Performed routine site maintenance

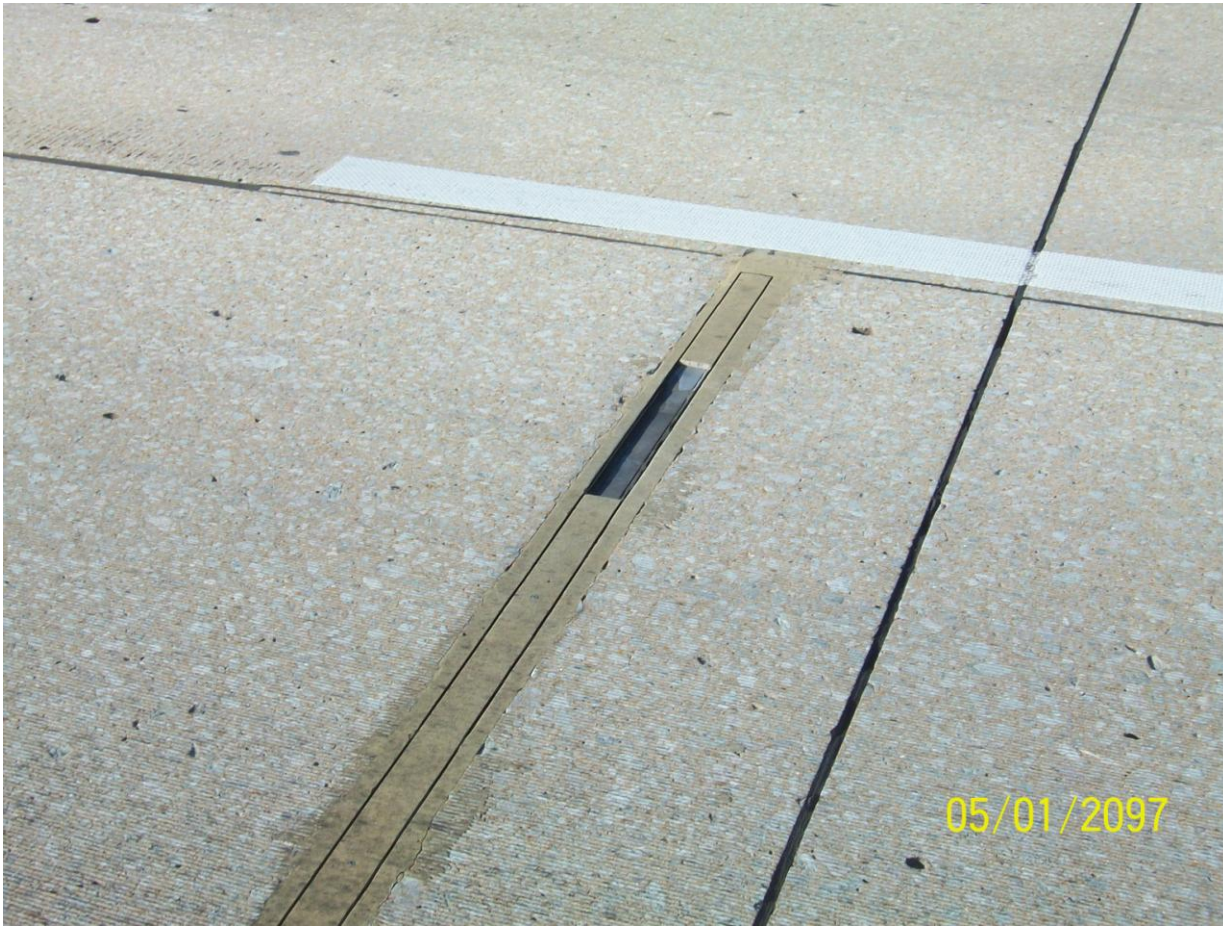
- There is a small piece of grout missing from the upstream Kistler in the right lane (slow lane) on the east bound side. A lane closure and warm temperature is needed to perform the repair.

**Other Notes:** even though the Kistler sensor is missing a piece of grout, it is still functioning properly.

Kistler Damage.
