CELL 53  
0 - 50 ft

Cell 53

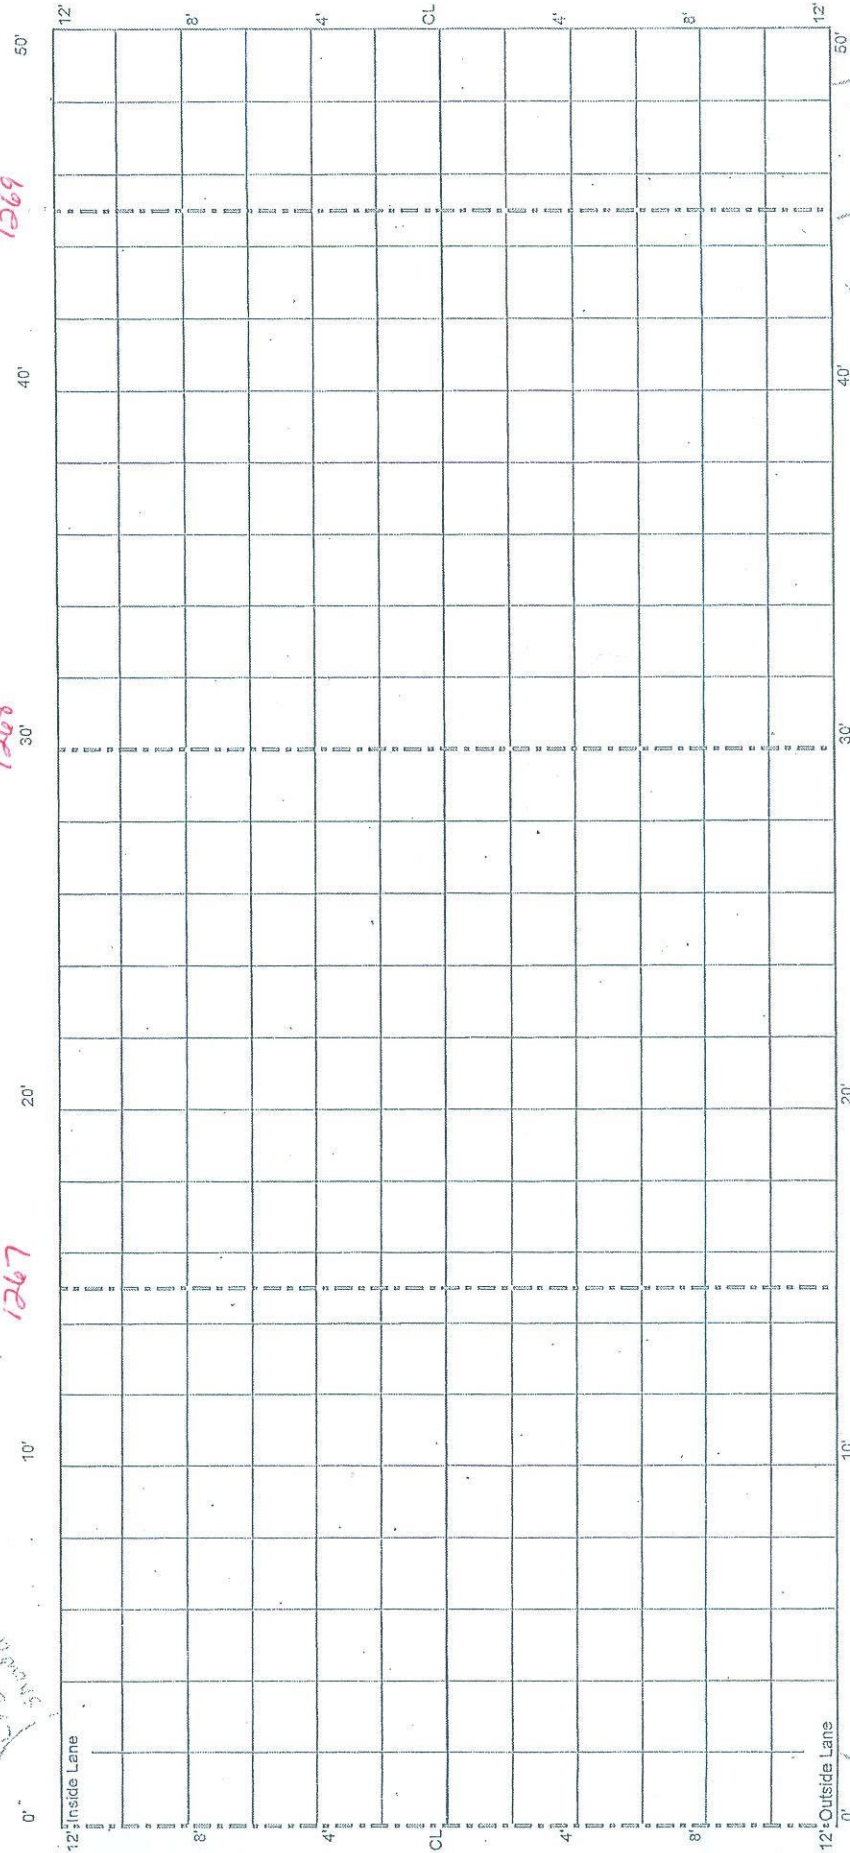
-1st panel on east end in both shlds (OL & IL) is cracked

8/16 panels cracked  
inside shld JT 8  
1269

9/16 panels cracked  
outside shld
